## Inspection Photos

**Location Name: CAERUS PICEANCE LLC CHEVRON-66S96W /17SESW**

**Location ID: 335780**

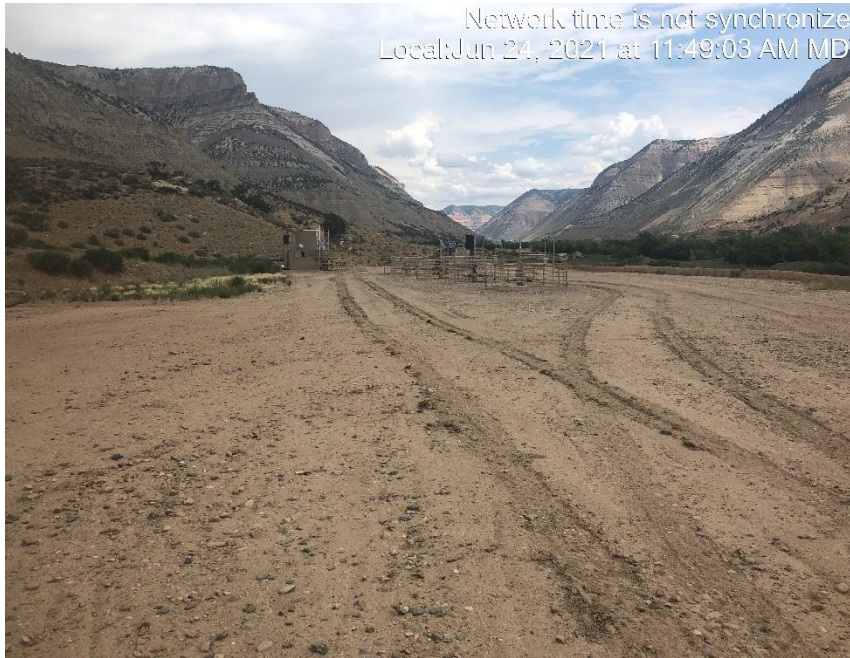
**Photo #4160 from entrance to location.**

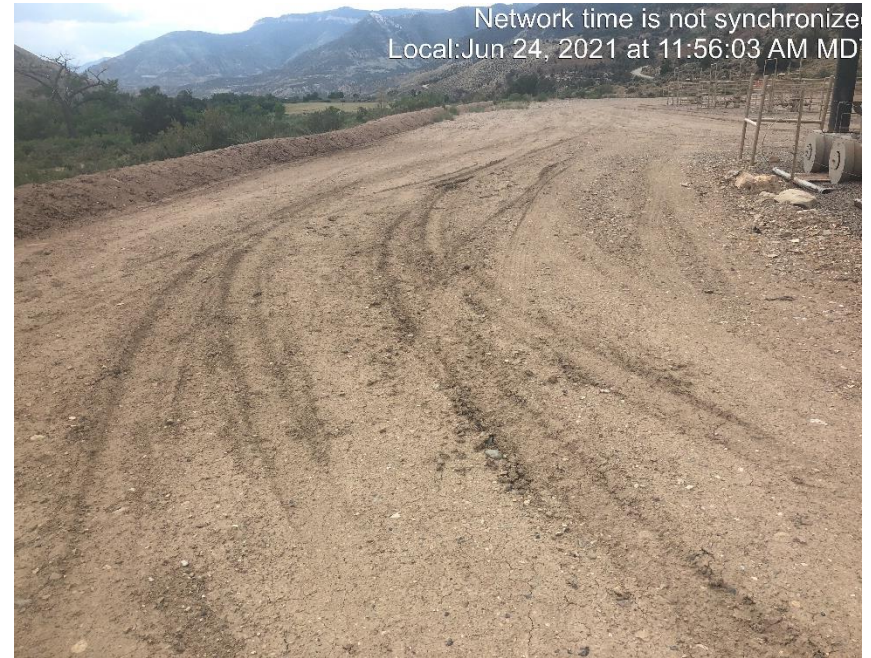
**Photo #4161 Location lacks stabilization**

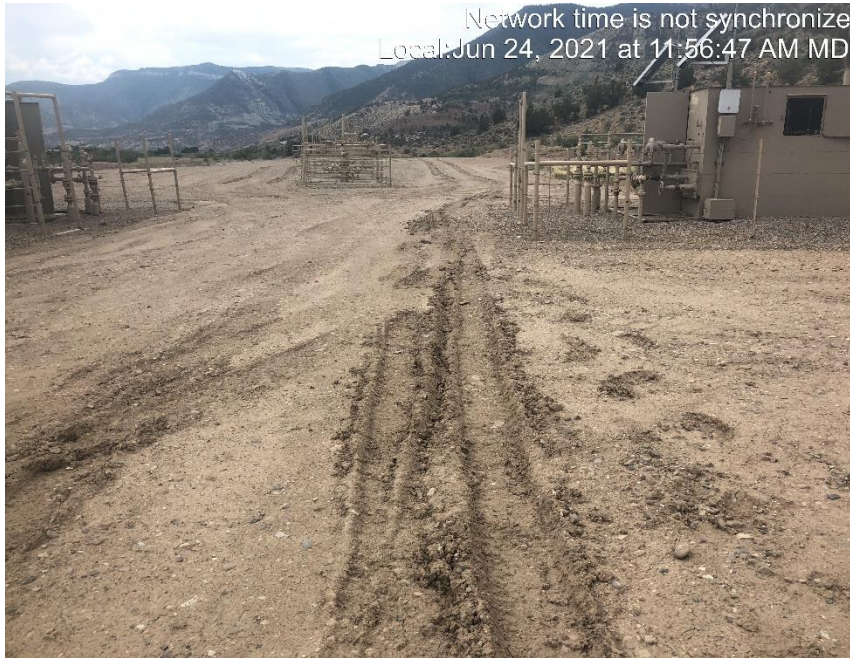
**Photo #4162 Location lacks stabilization**

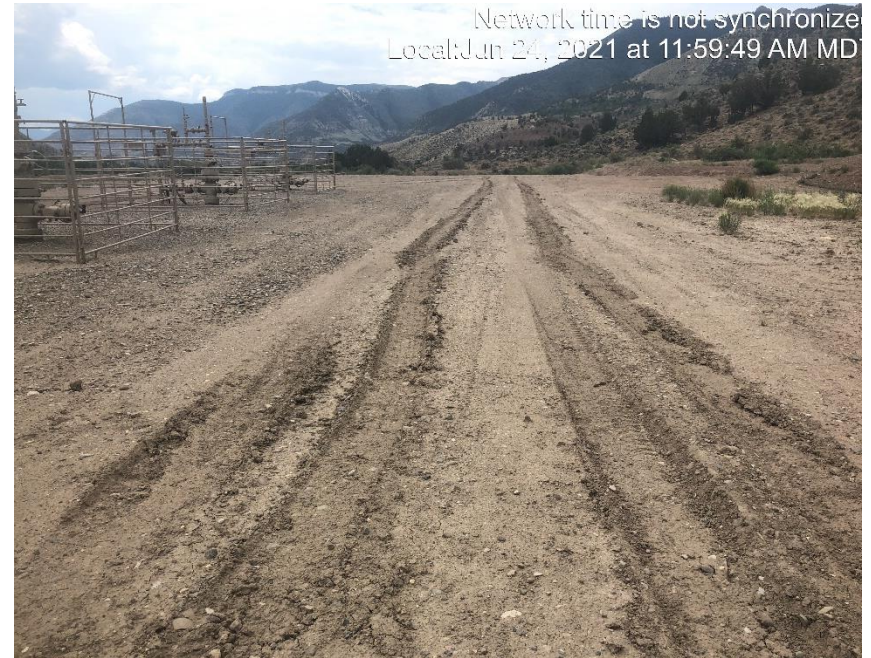
**Photo #4163 Location lacks stabilization.**

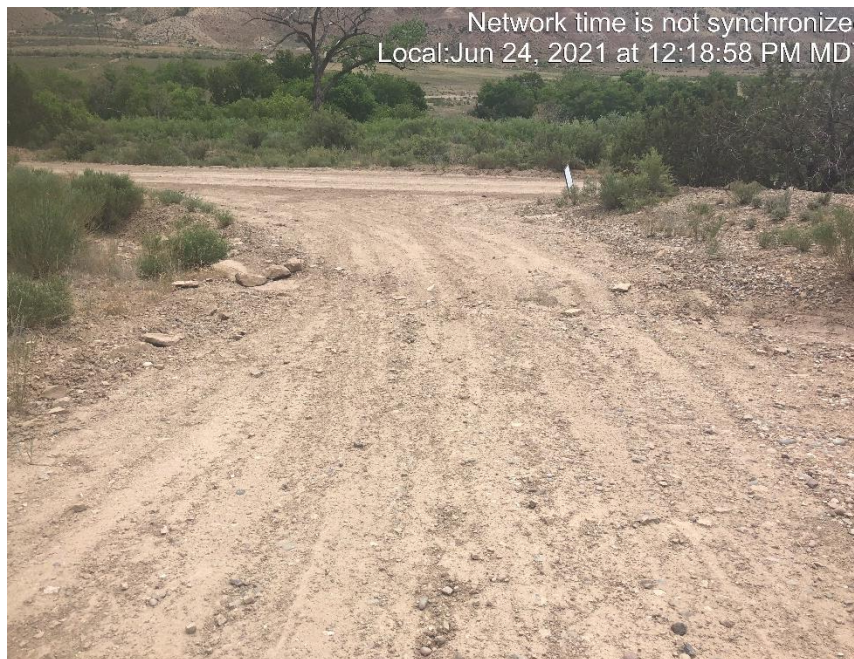
**Photo #4165 No form of tracking BMP located at the entrance to location.**

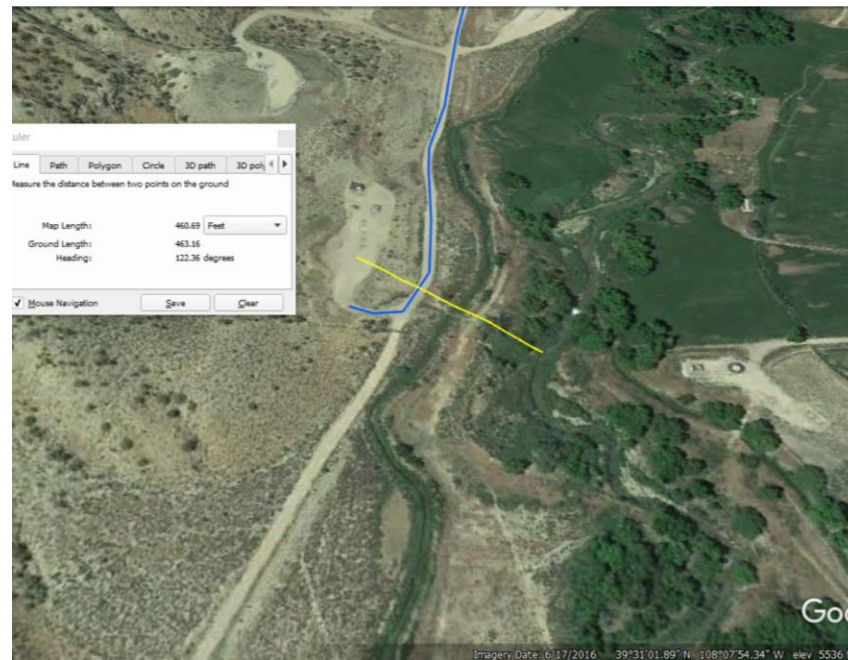
**Location is approximately 460 feet from North Parachute creek.**

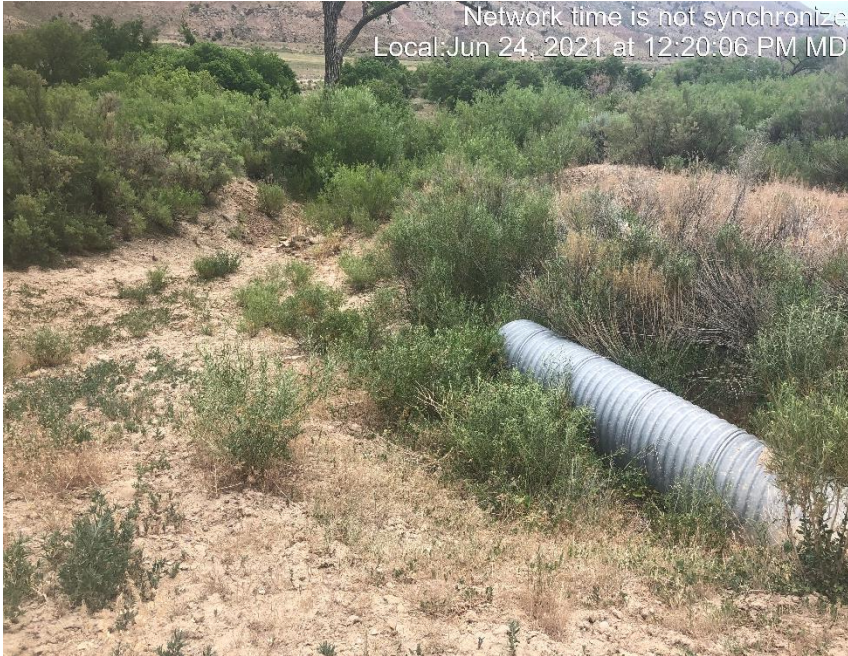
**Photo #4166 Culvert and drainage that contributes to North Parachute Creek to the East of location and access road.**
