Inspection Photos
Operator: Maralex Resources
API: 007-06208
Date: 6/29/2021

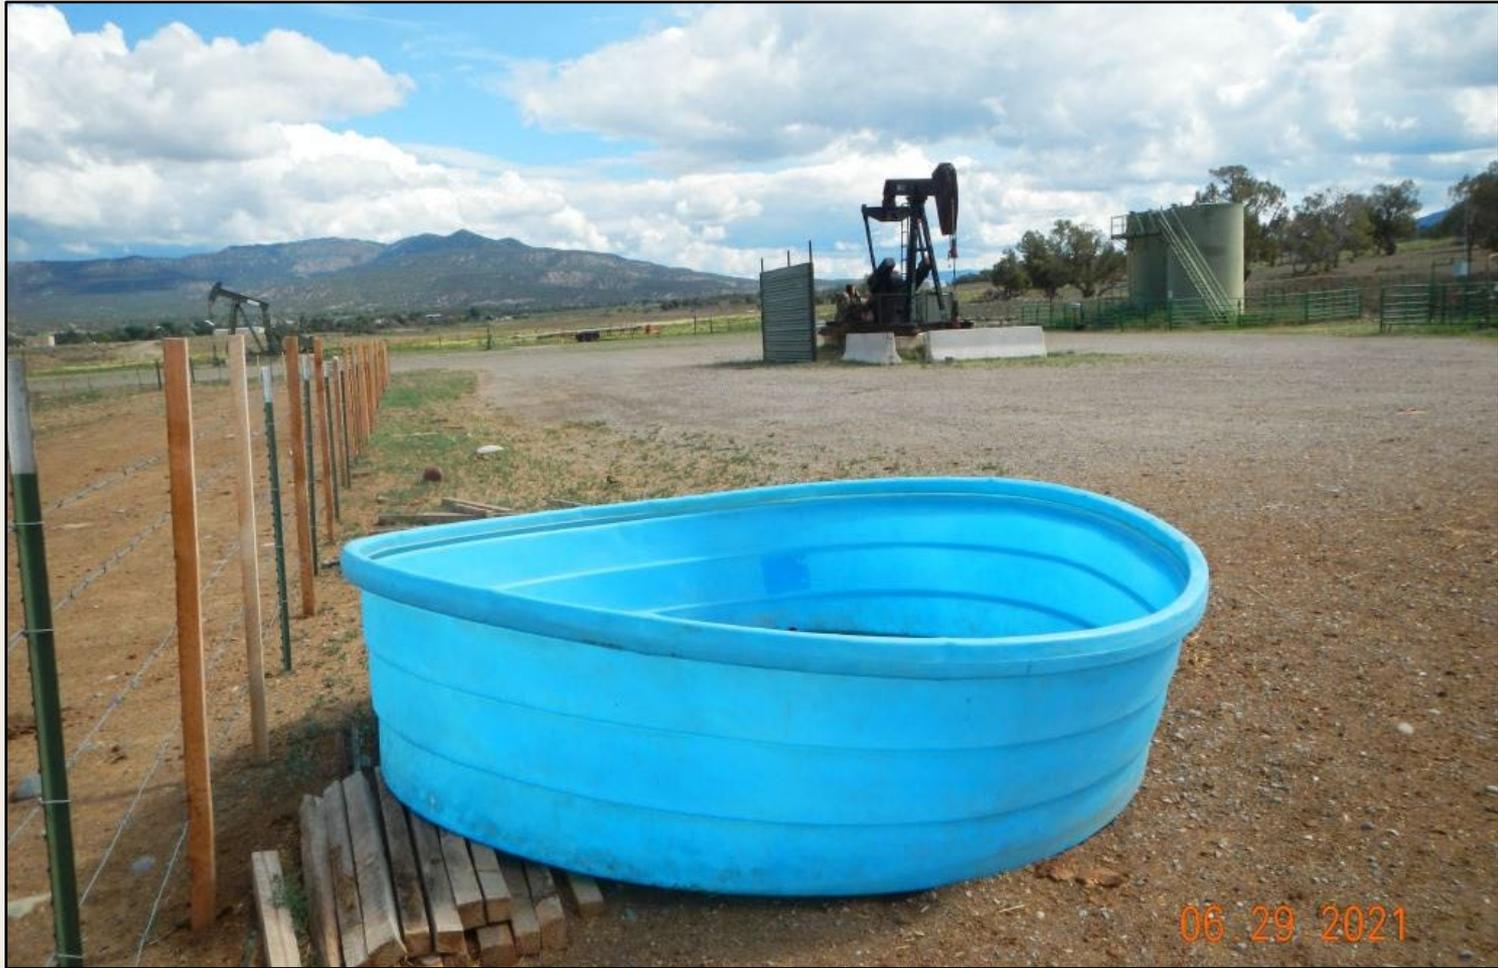
Photo 1. View the southwestern project area from the southwestern corner facing northward.

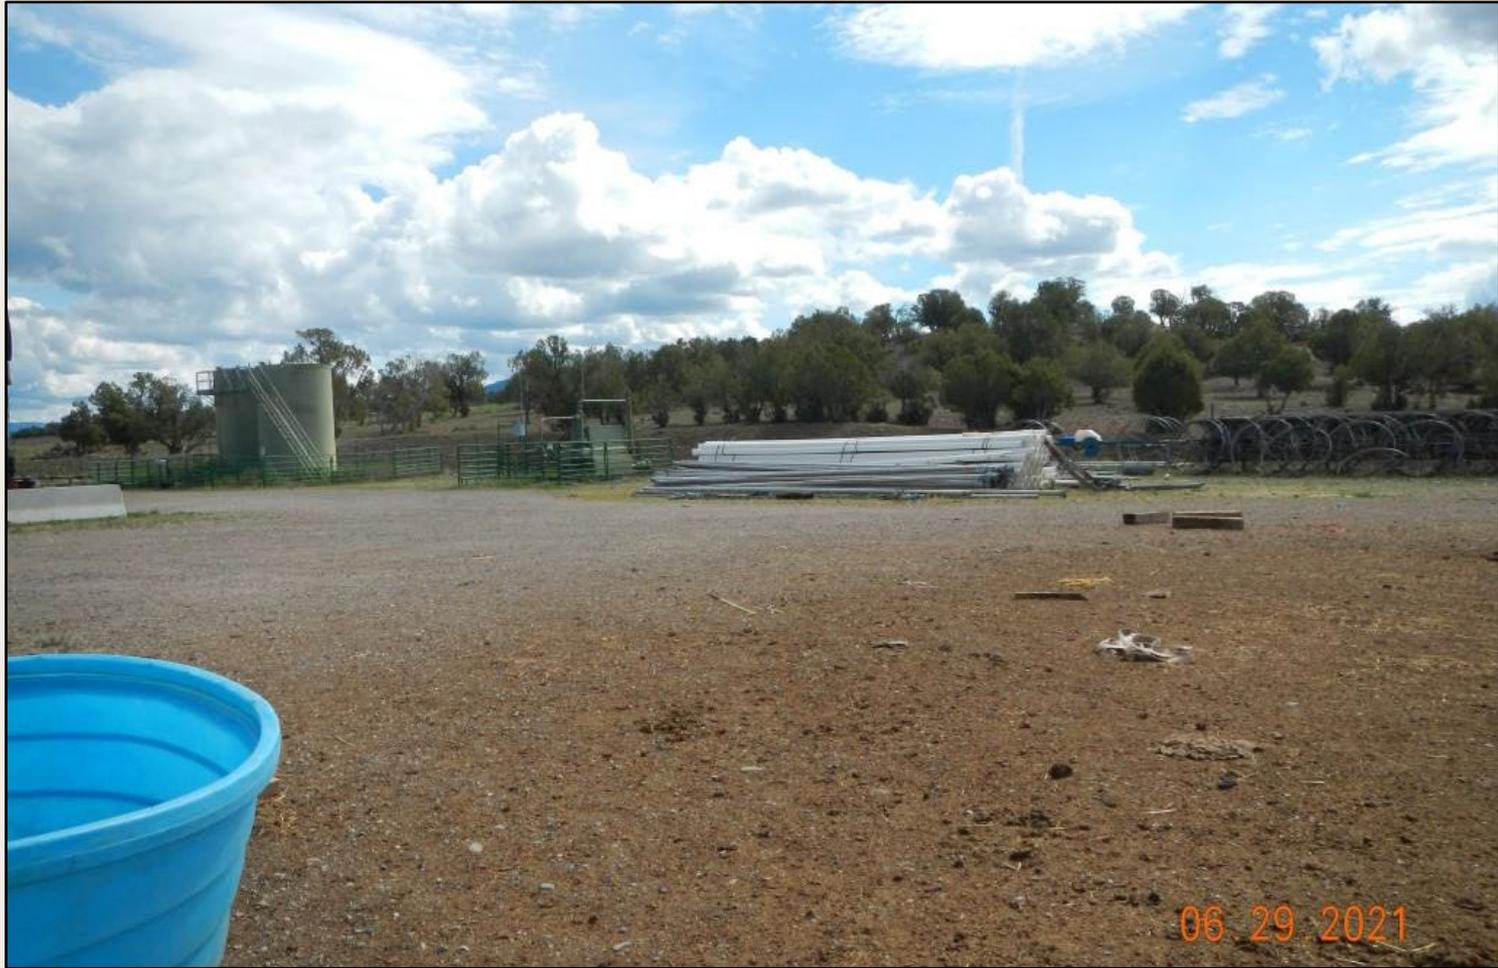
Photo 2. View of the southern project area from the southwestern corner facing eastward. Several pipes, and farm implements are stored within the project area. Several pieces of scattered trash and debris observed around the well pad.

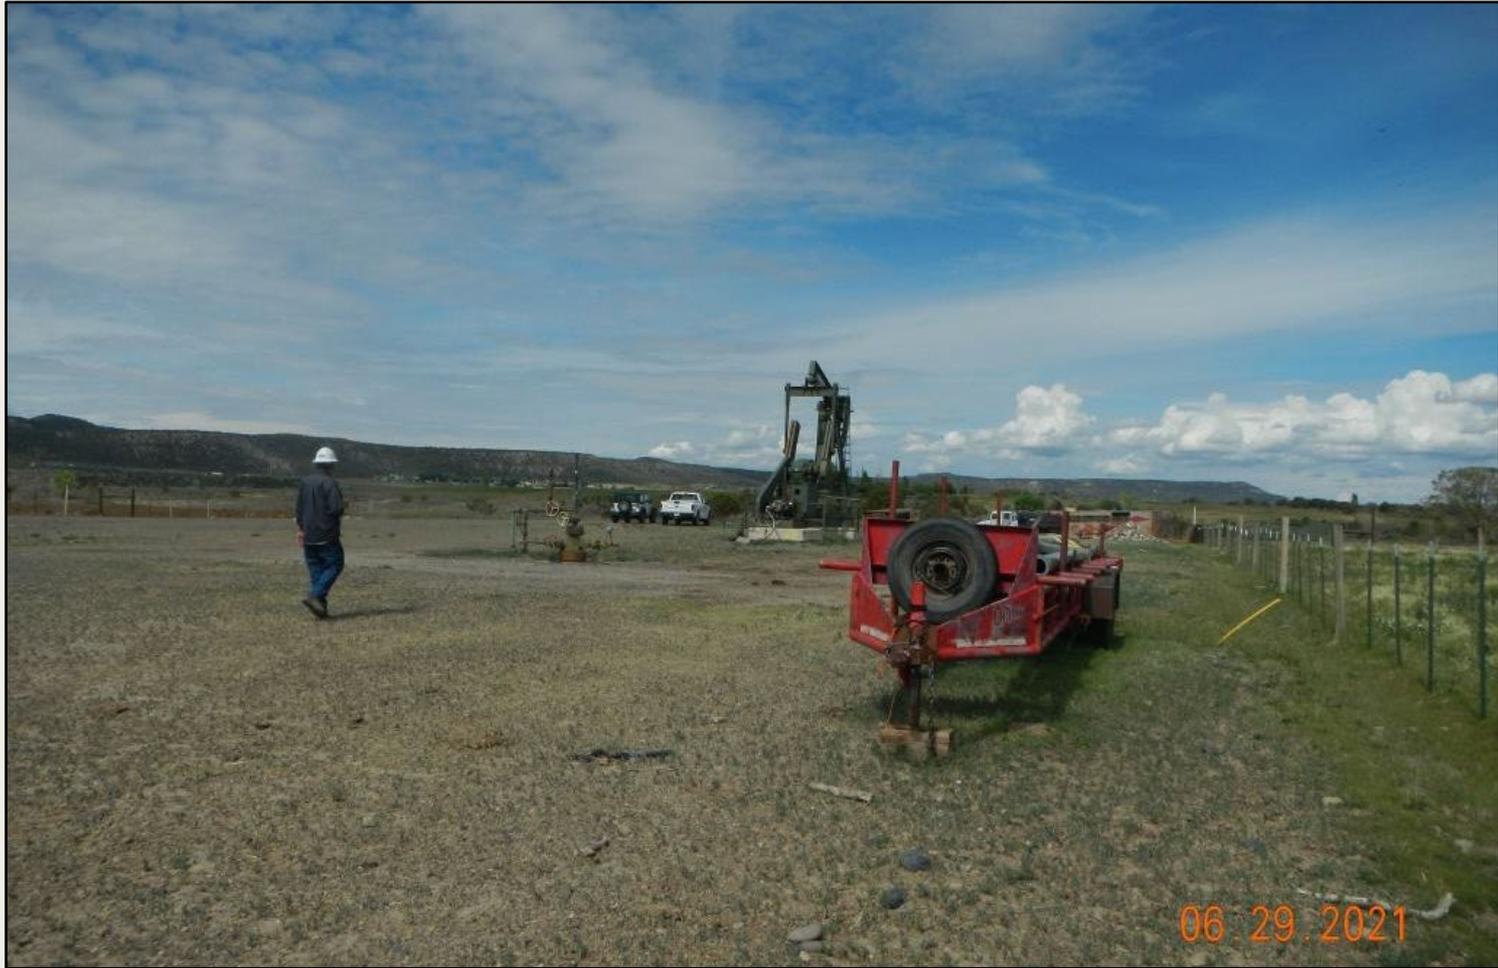
Photo 3. View of the northern project area from the northeastern corner facing westward.

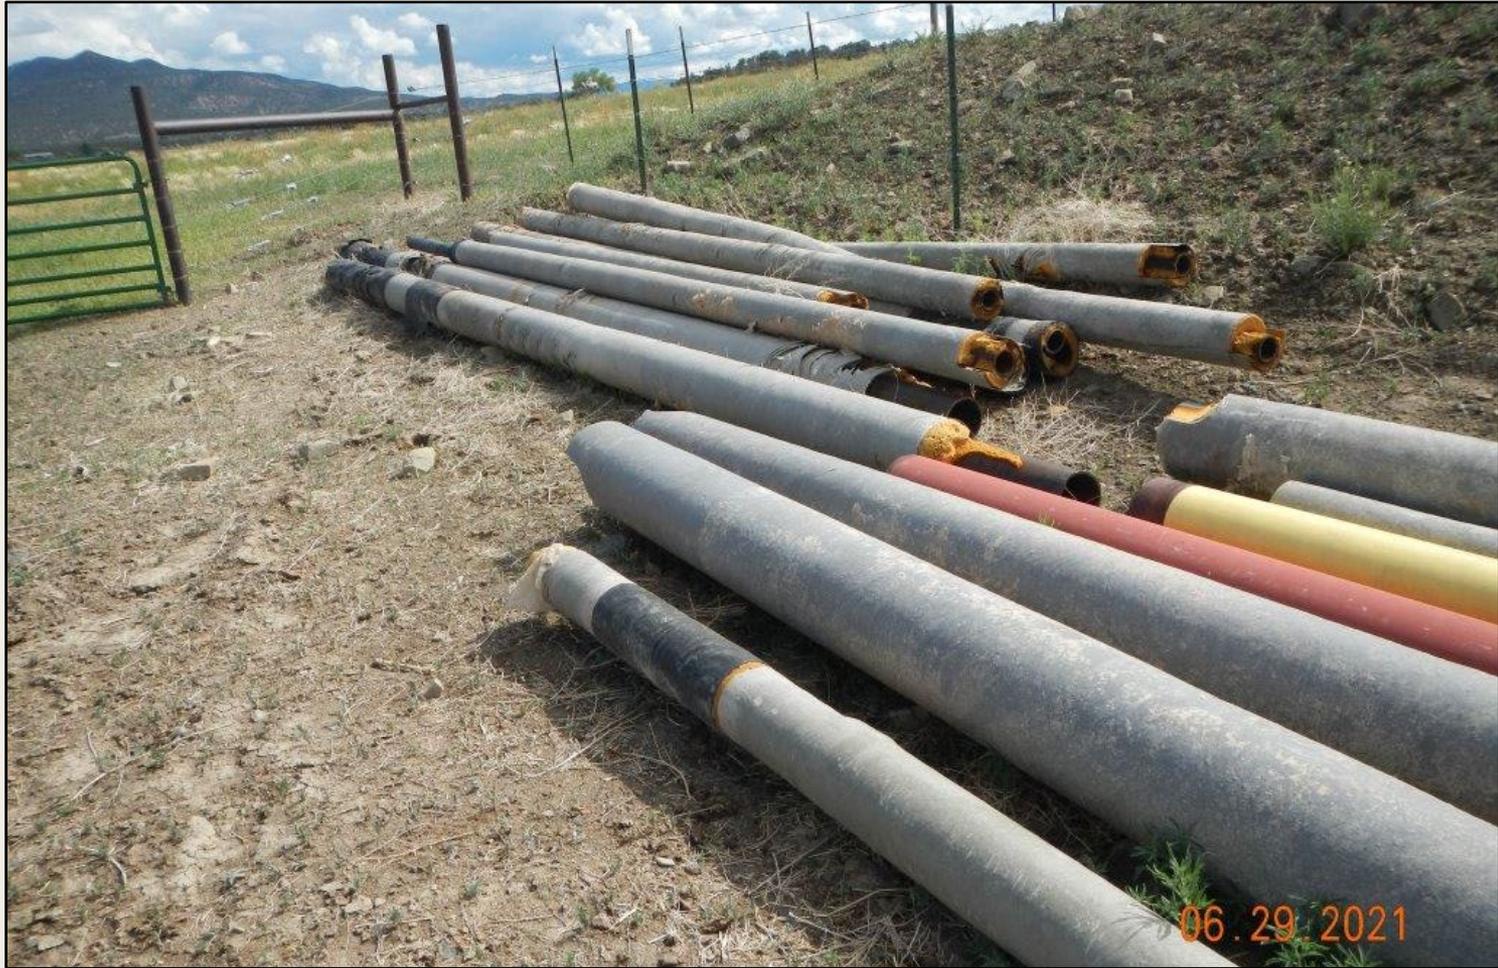
Photo 4. View of pipes stores in the northeastern project area.

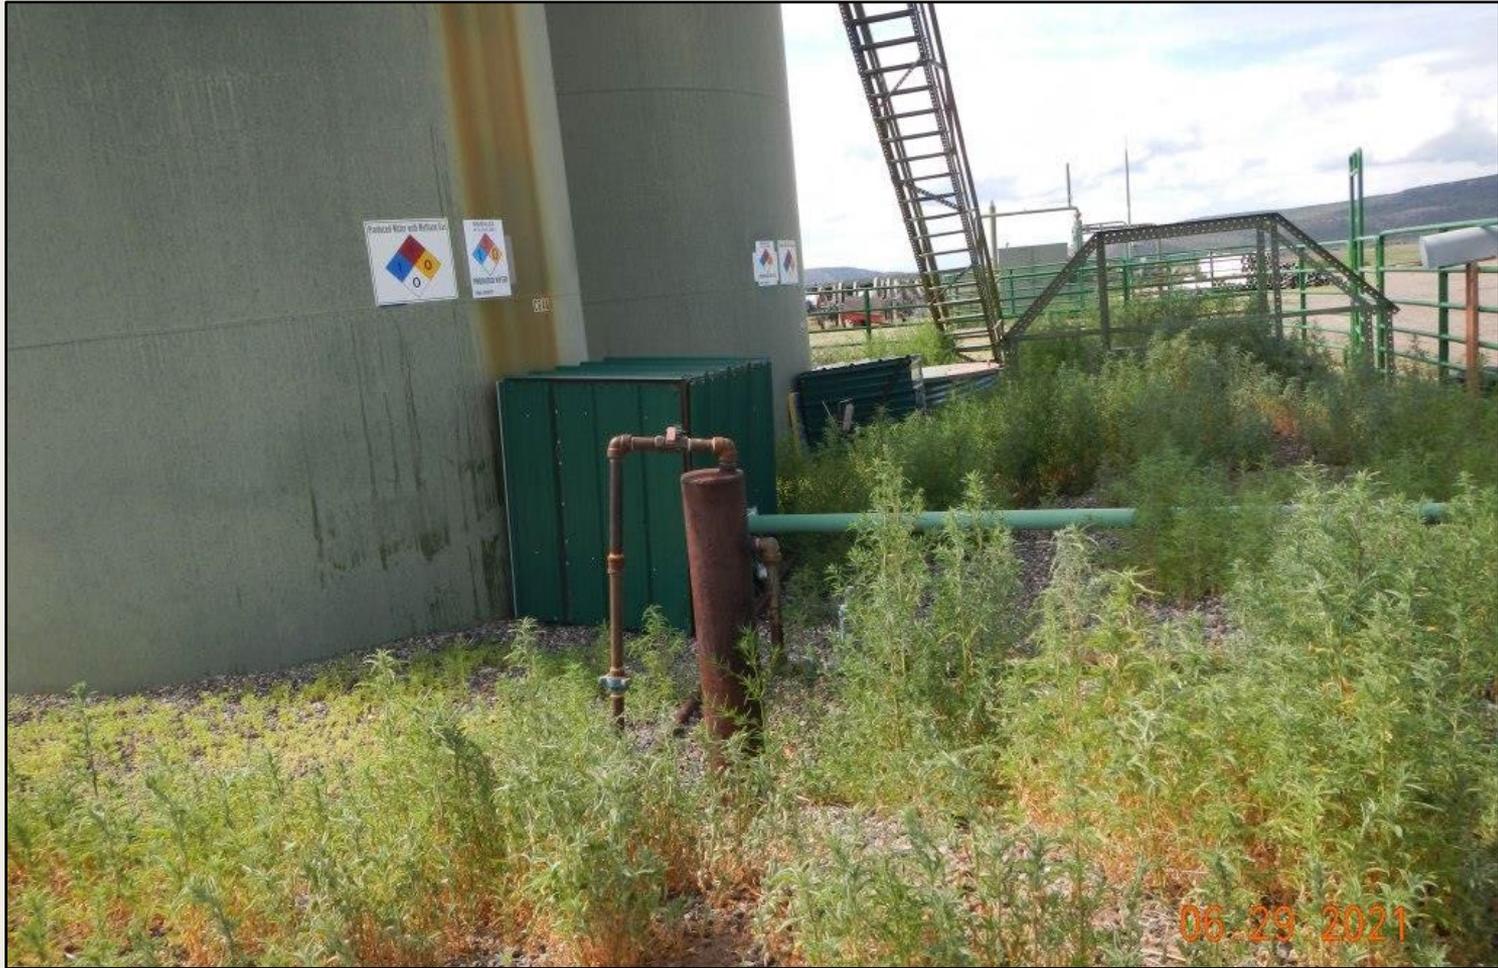
Photo 5. View of dense kochia growing in and around equipment areas.

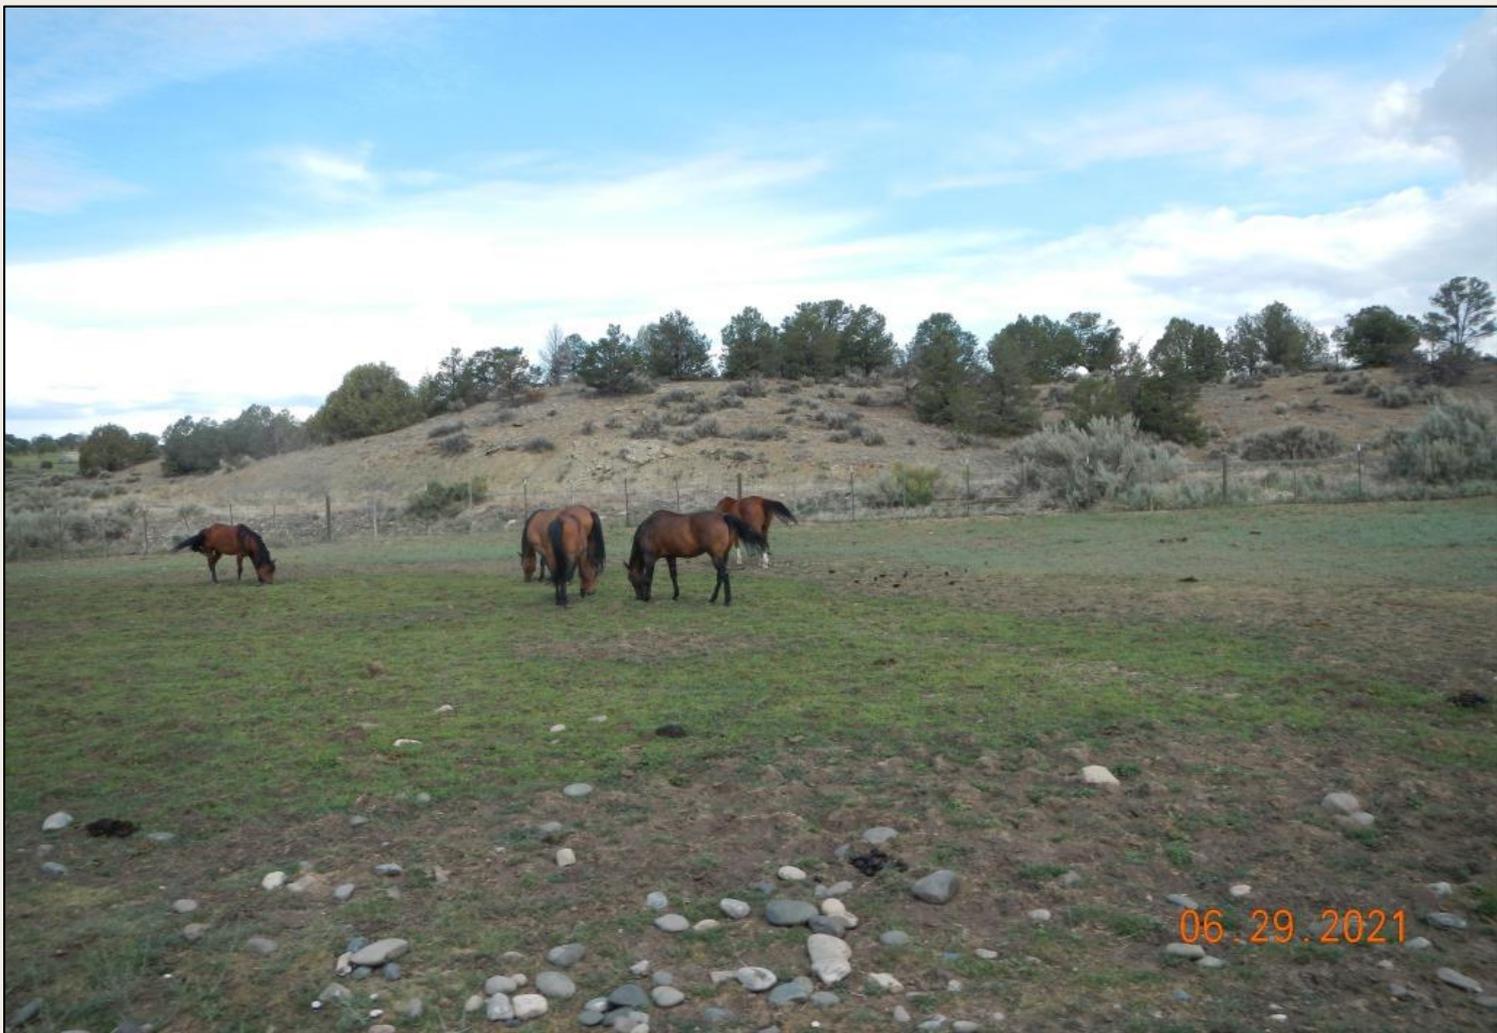
Photo 6. View of reference area comprised of irrigated field, in a grazed vegetative condition.
