Inspection Photos

Operator: Maralex Resources
API: 007-06246
Date: 6/29/2021

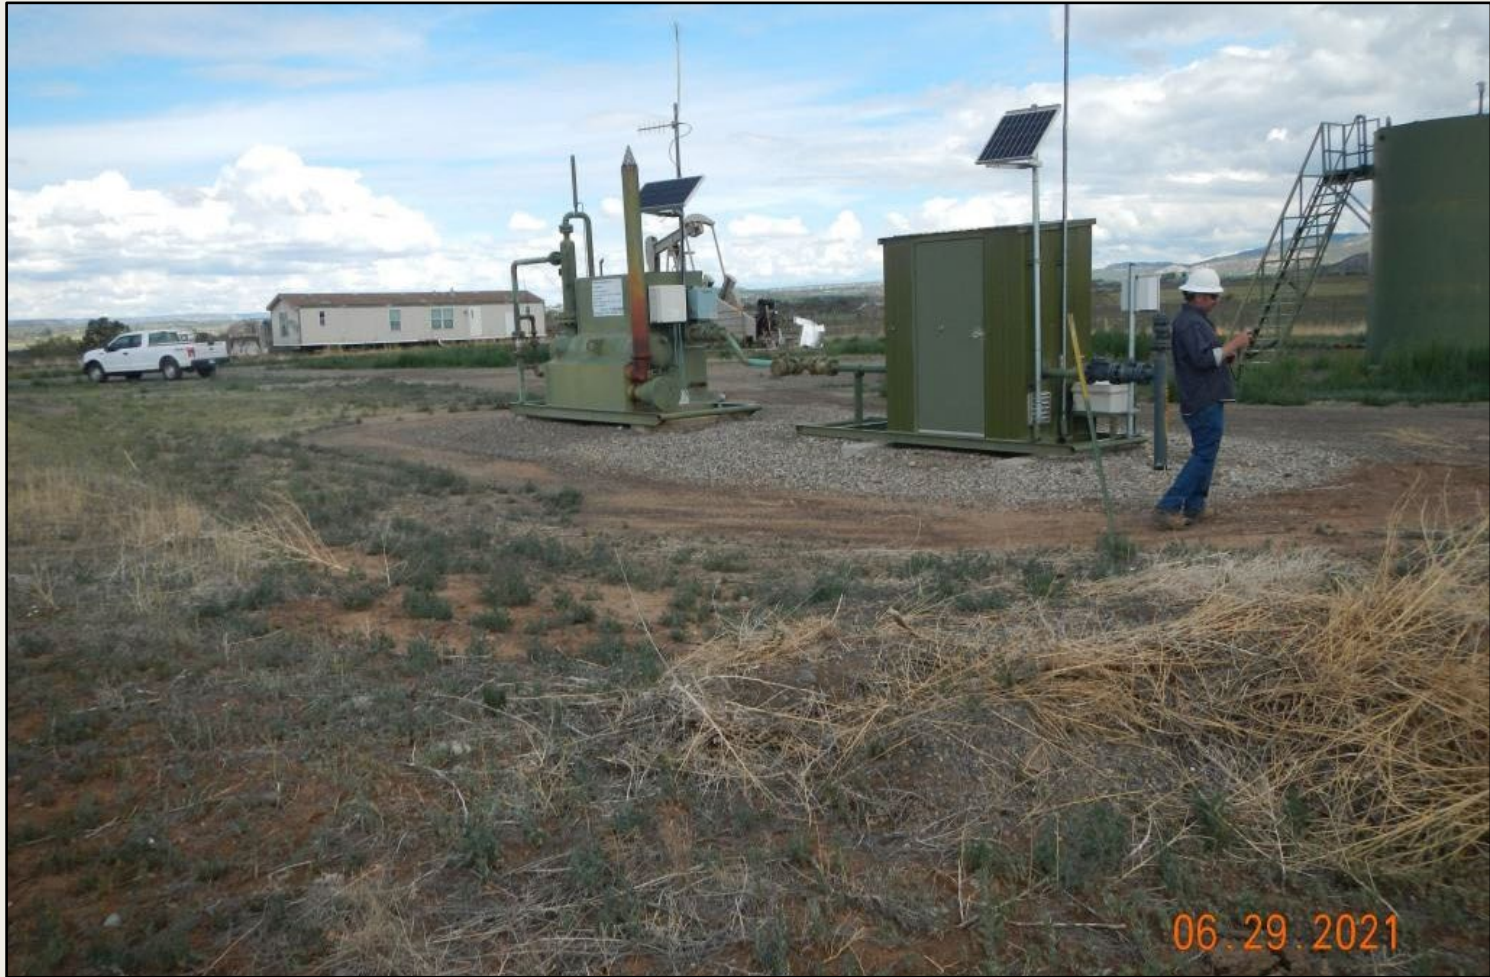
Photo 1. View the project area from the southeastern corner facing center.

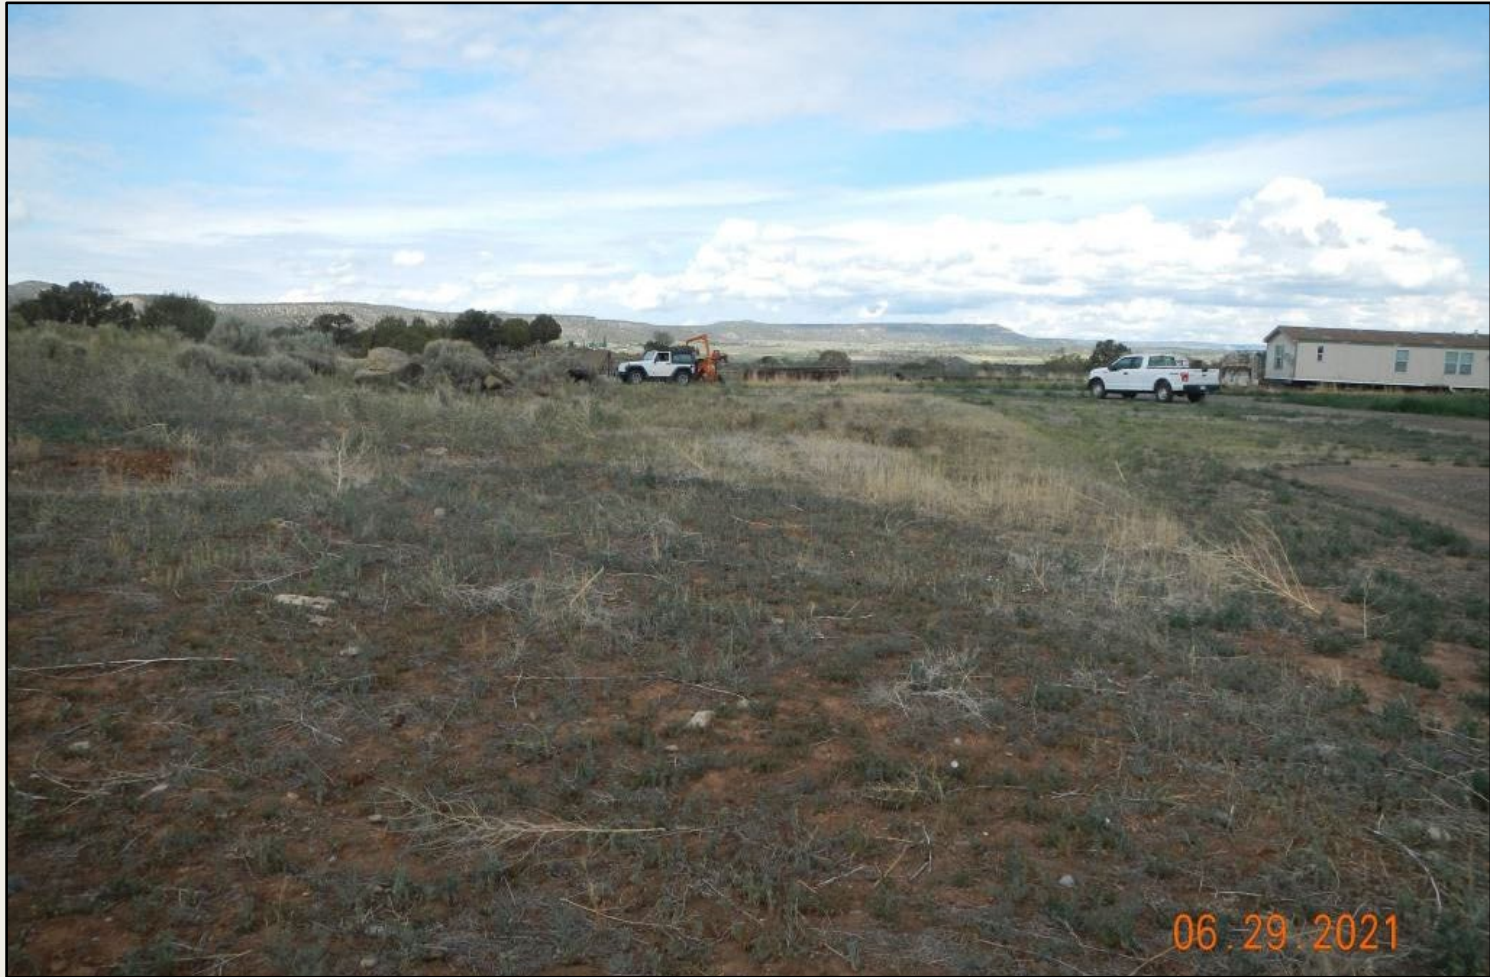
Photo 2. View of the southern project area from the southeastern corner facing westward. Vegetation here is largely comprised of weeds such as Russian knapweed, cheatgrass, and bindweed.

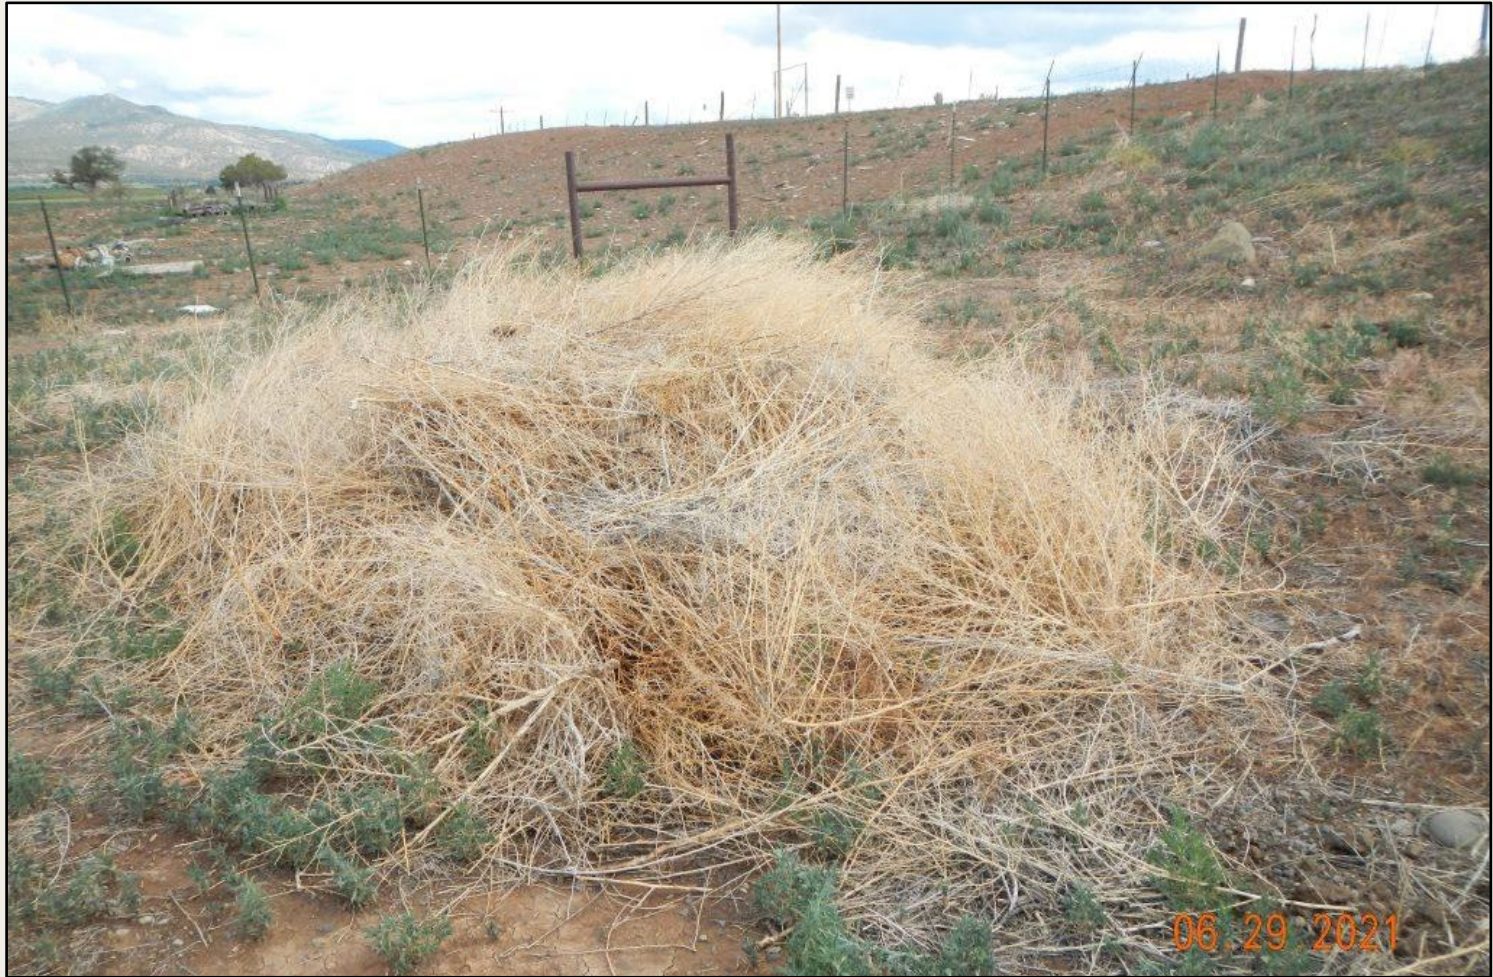
Photo 3. View of debris pile within the northeastern project area.

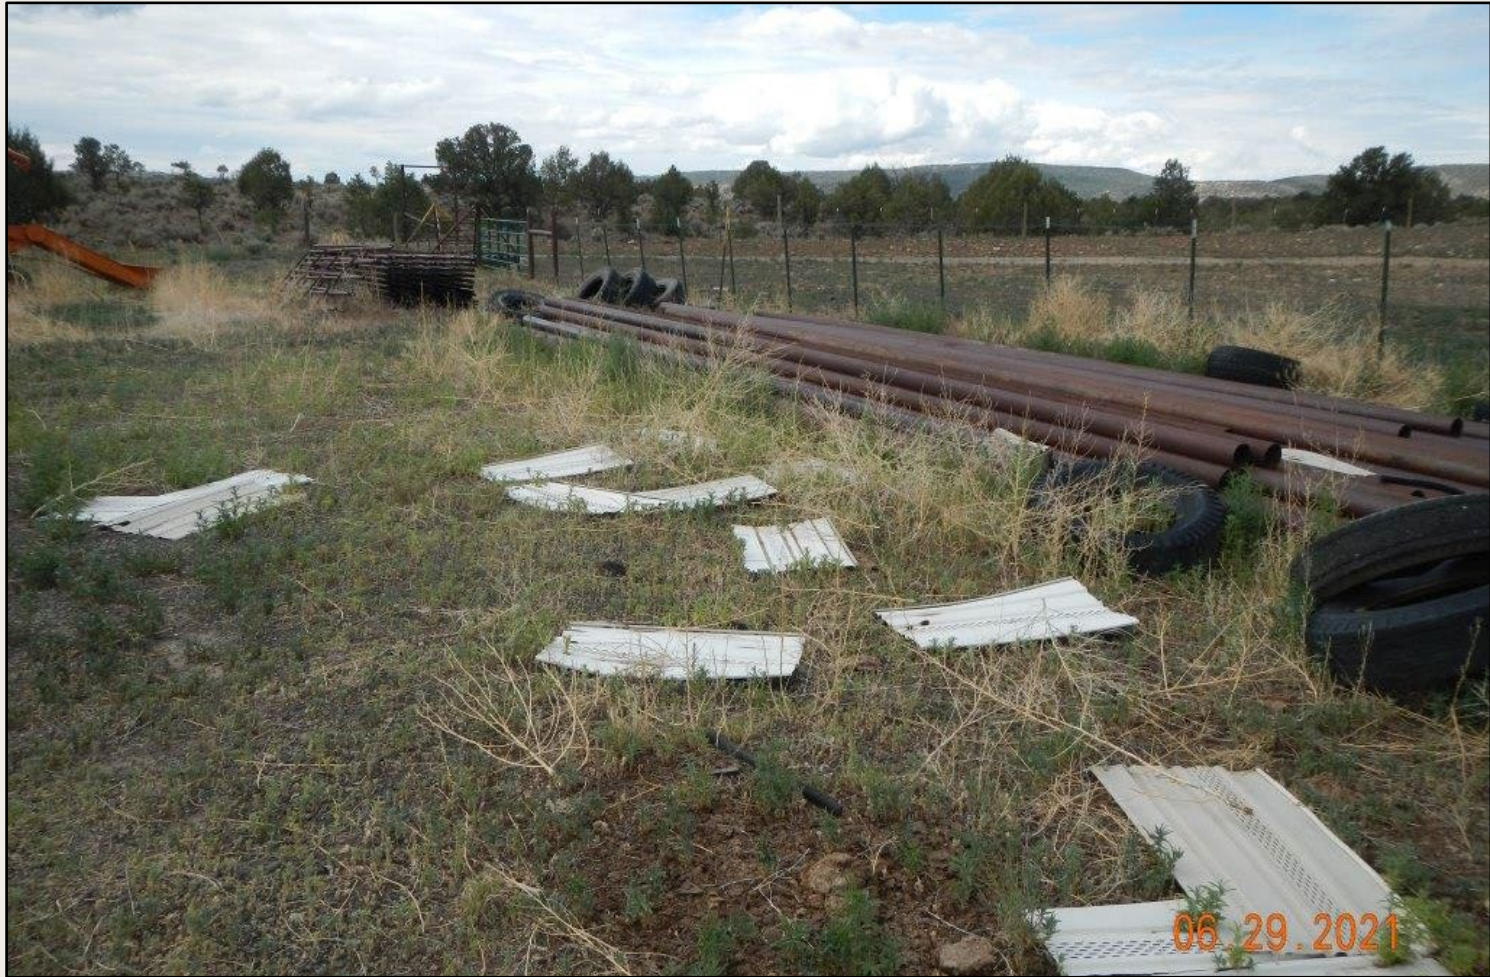
Photo 4. View of tubing, tires, and metal debris stored within the western project area.

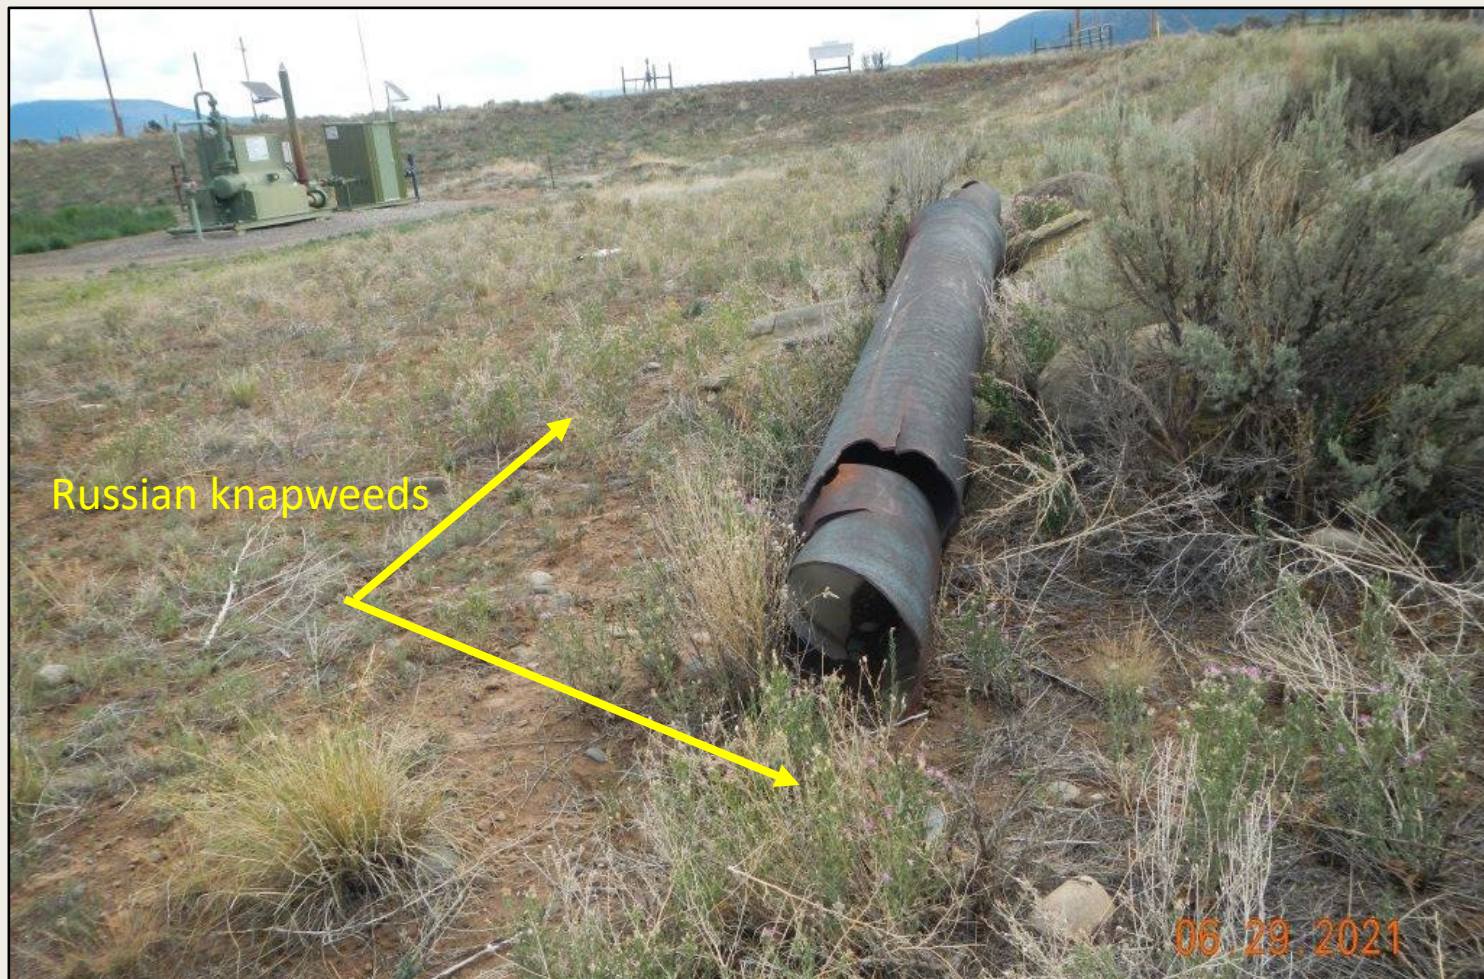
Photo 5. View of culvert debris and Russian knapweeds within the southern project area.

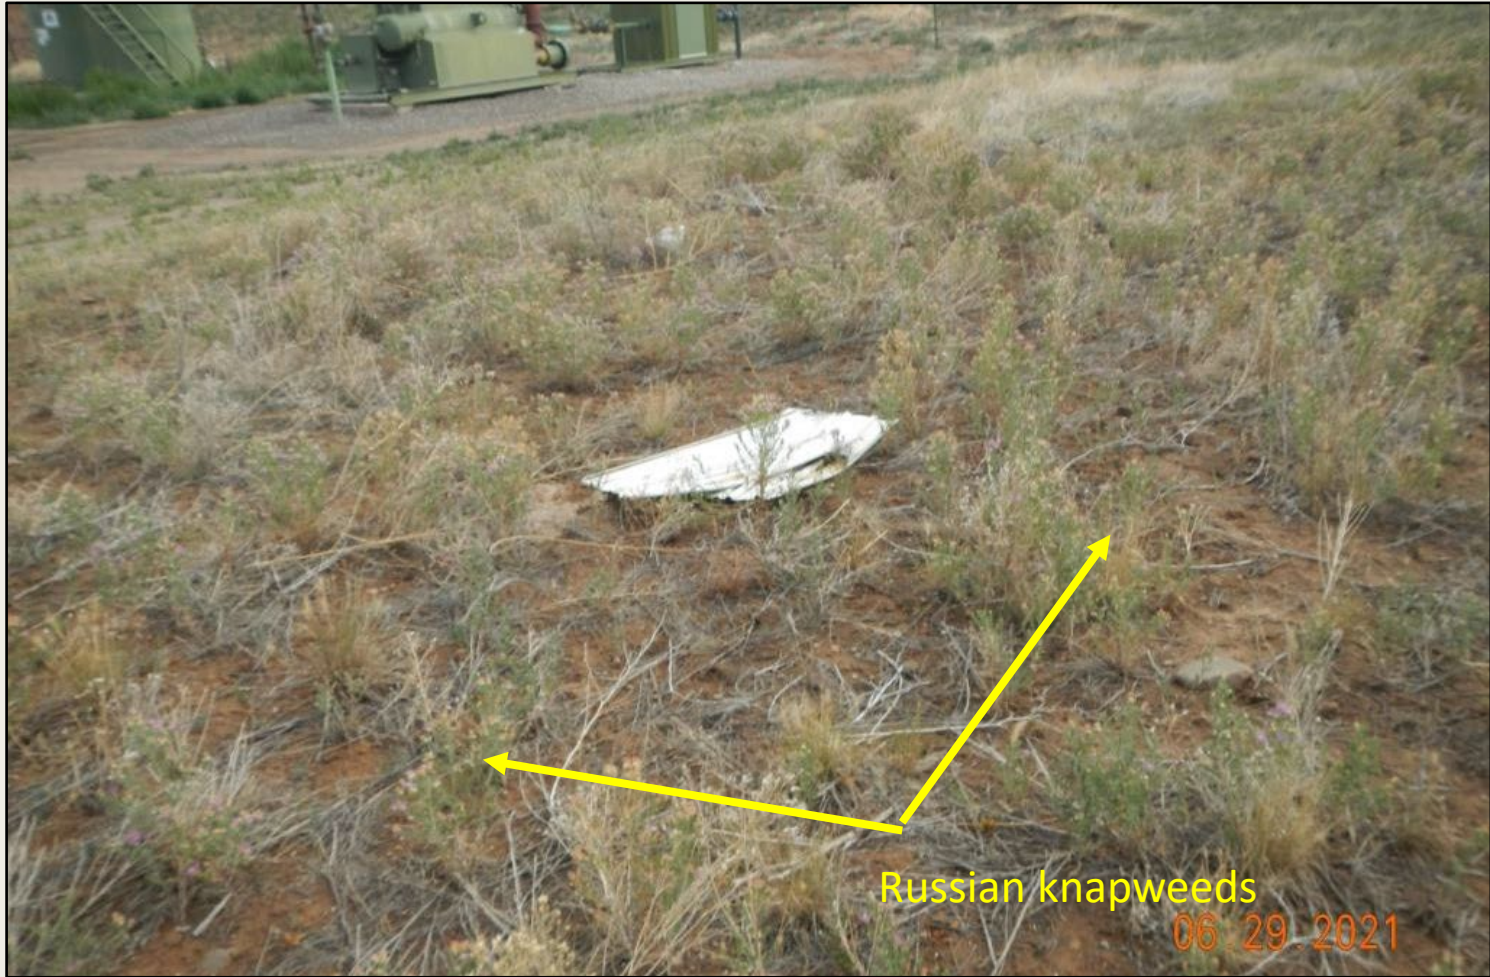
Photo 6. View of dense Russian knapweeds and debris within the southern project area. Approximately 5000 individuals observed.

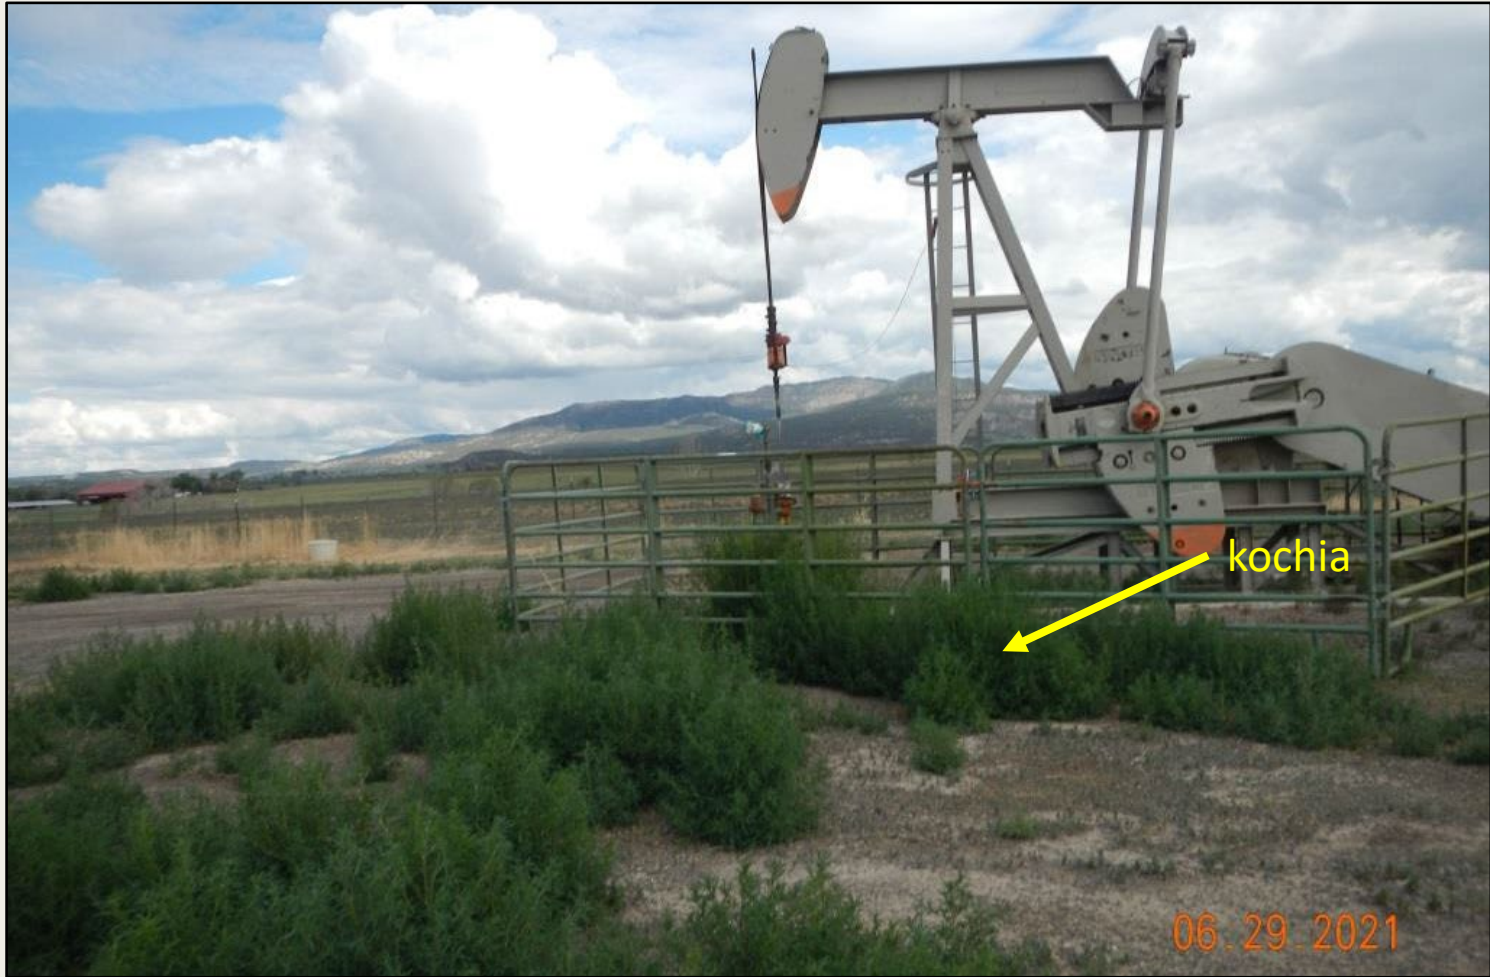
Photo 7. View of dense kochia growing in and around equipment areas.

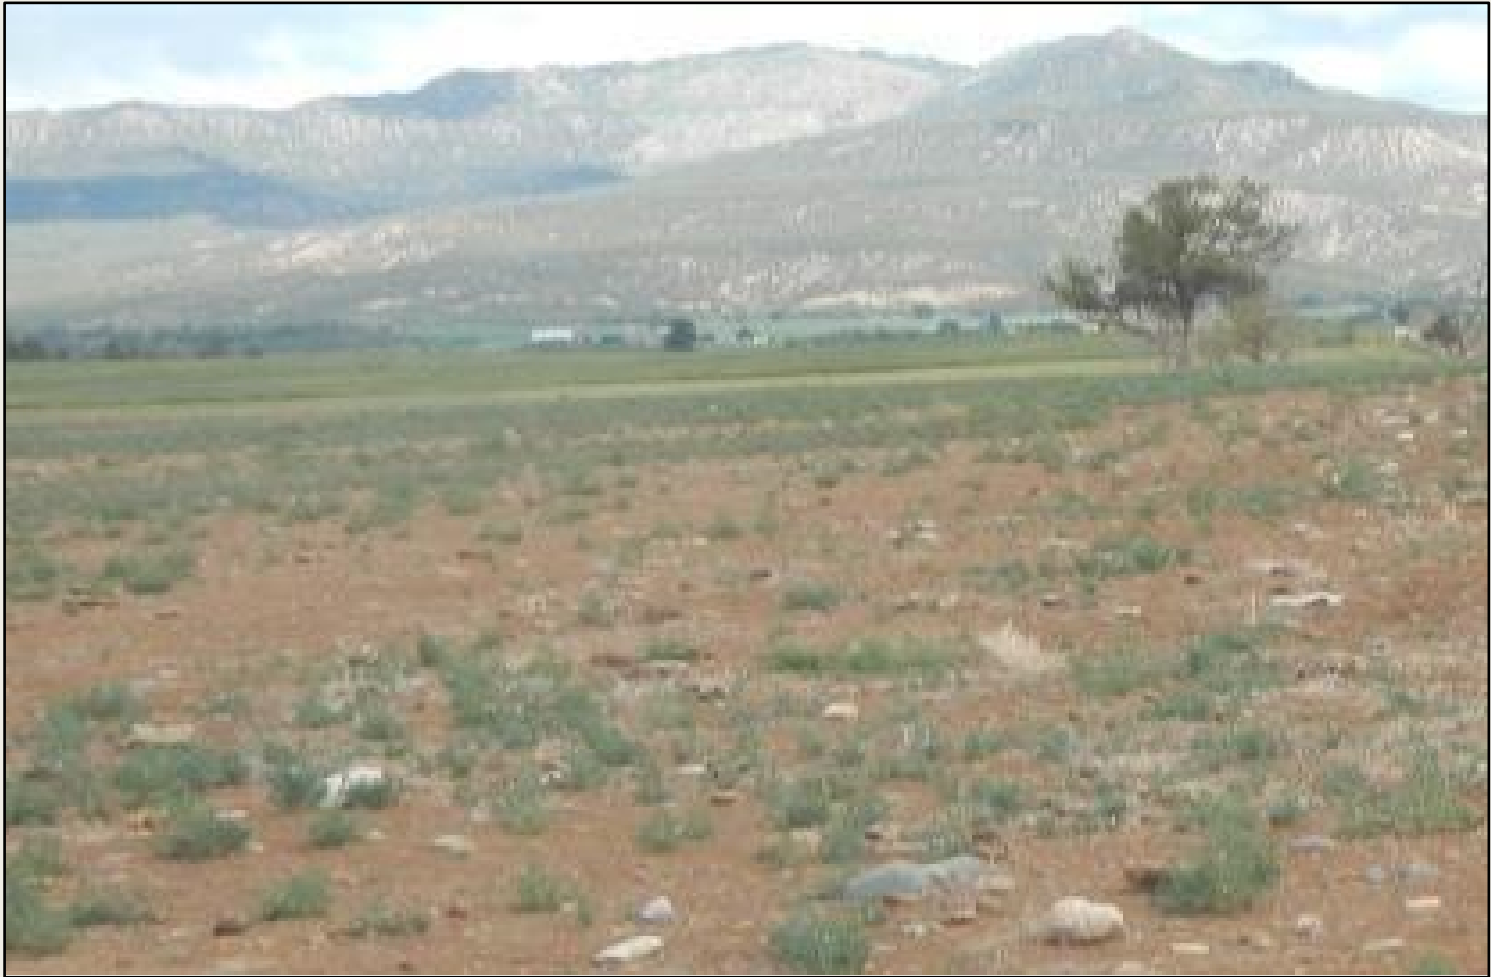
Photo 8. View of reference area comprised of open field, with grasses such as crested wheatgrass.
