Inspection Photos

Operator: Morningstar Res.
API: 007-06202
Date: 6/29/2021

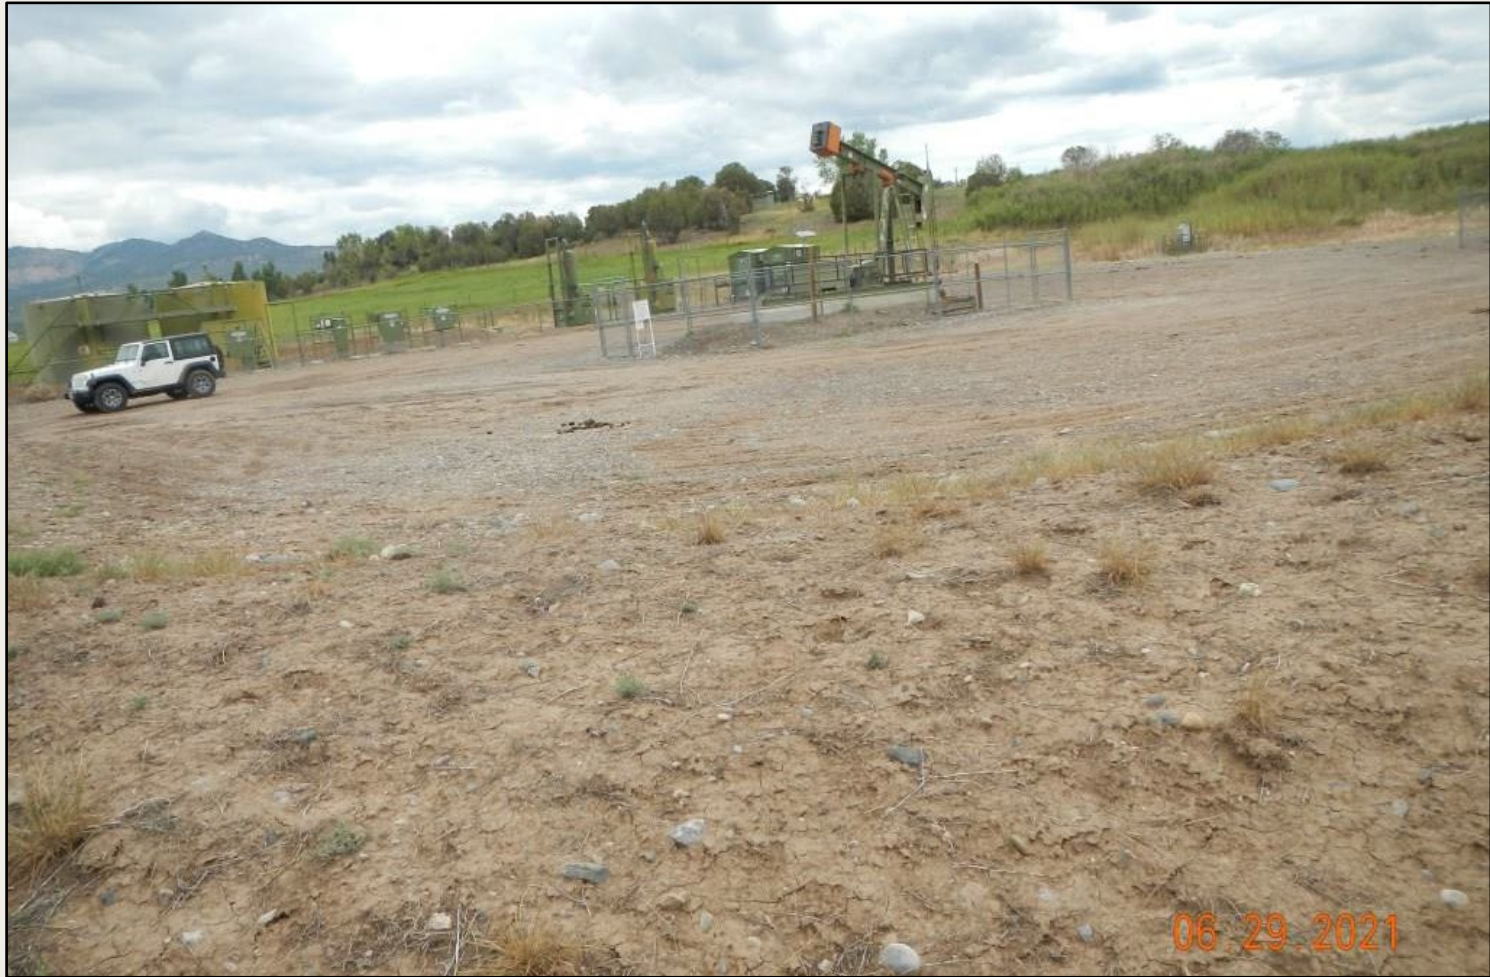
Photo 1. View the project area from the southwestern corner facing center.

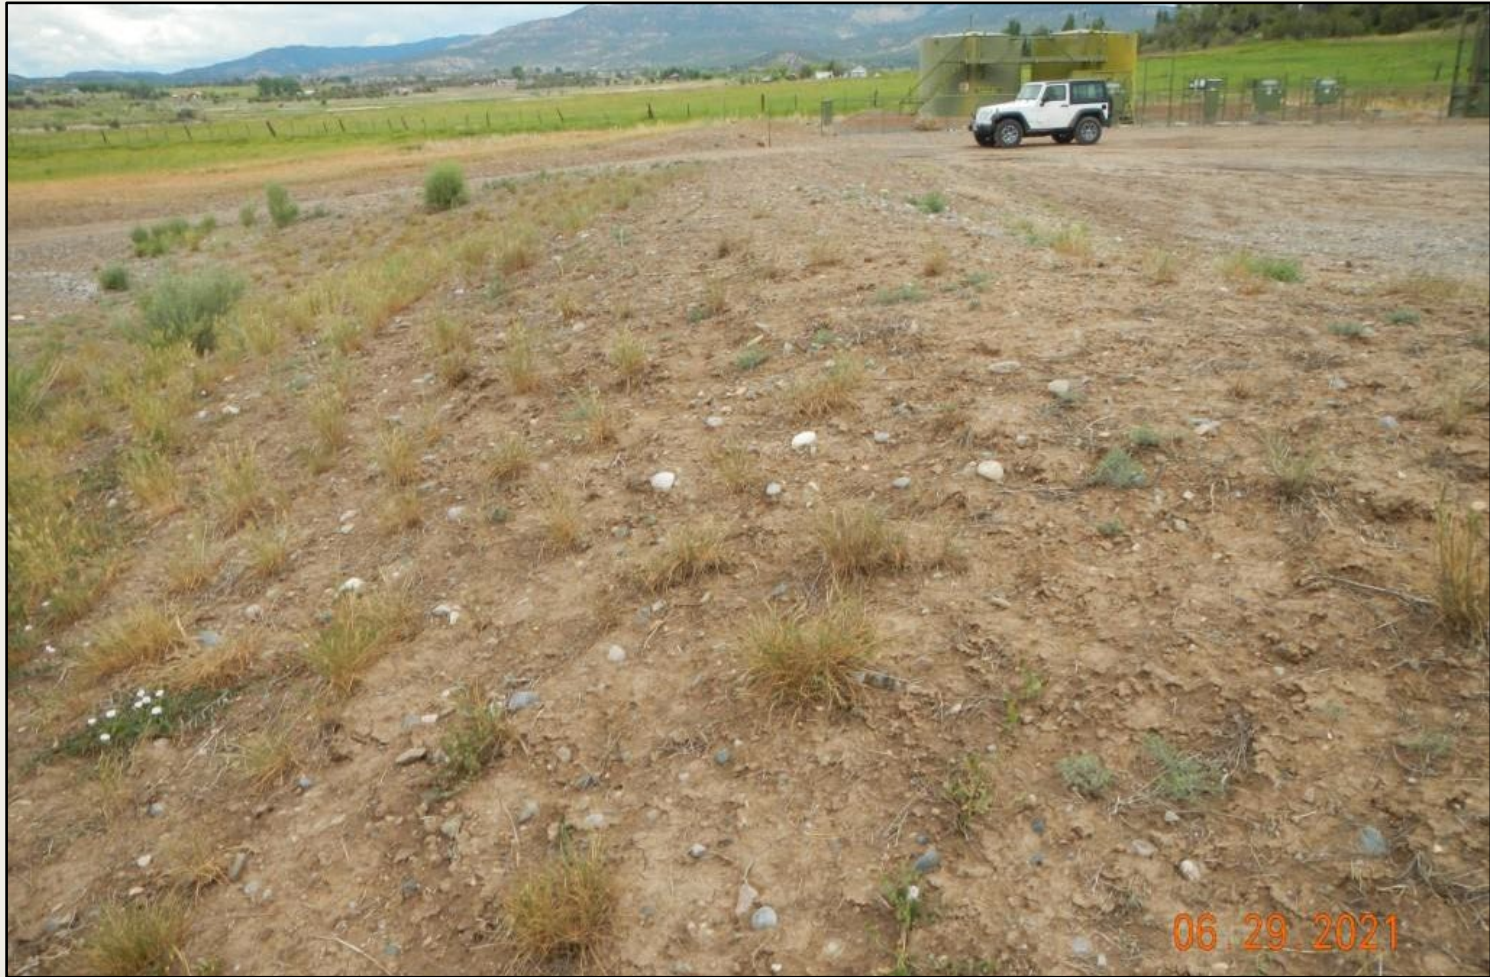
Photo 2. View of the western project area from the southwestern corner facing northward. Revegetation is progressing with crested wheatgrass, western wheatgrass, and rubber rabbitbrush.

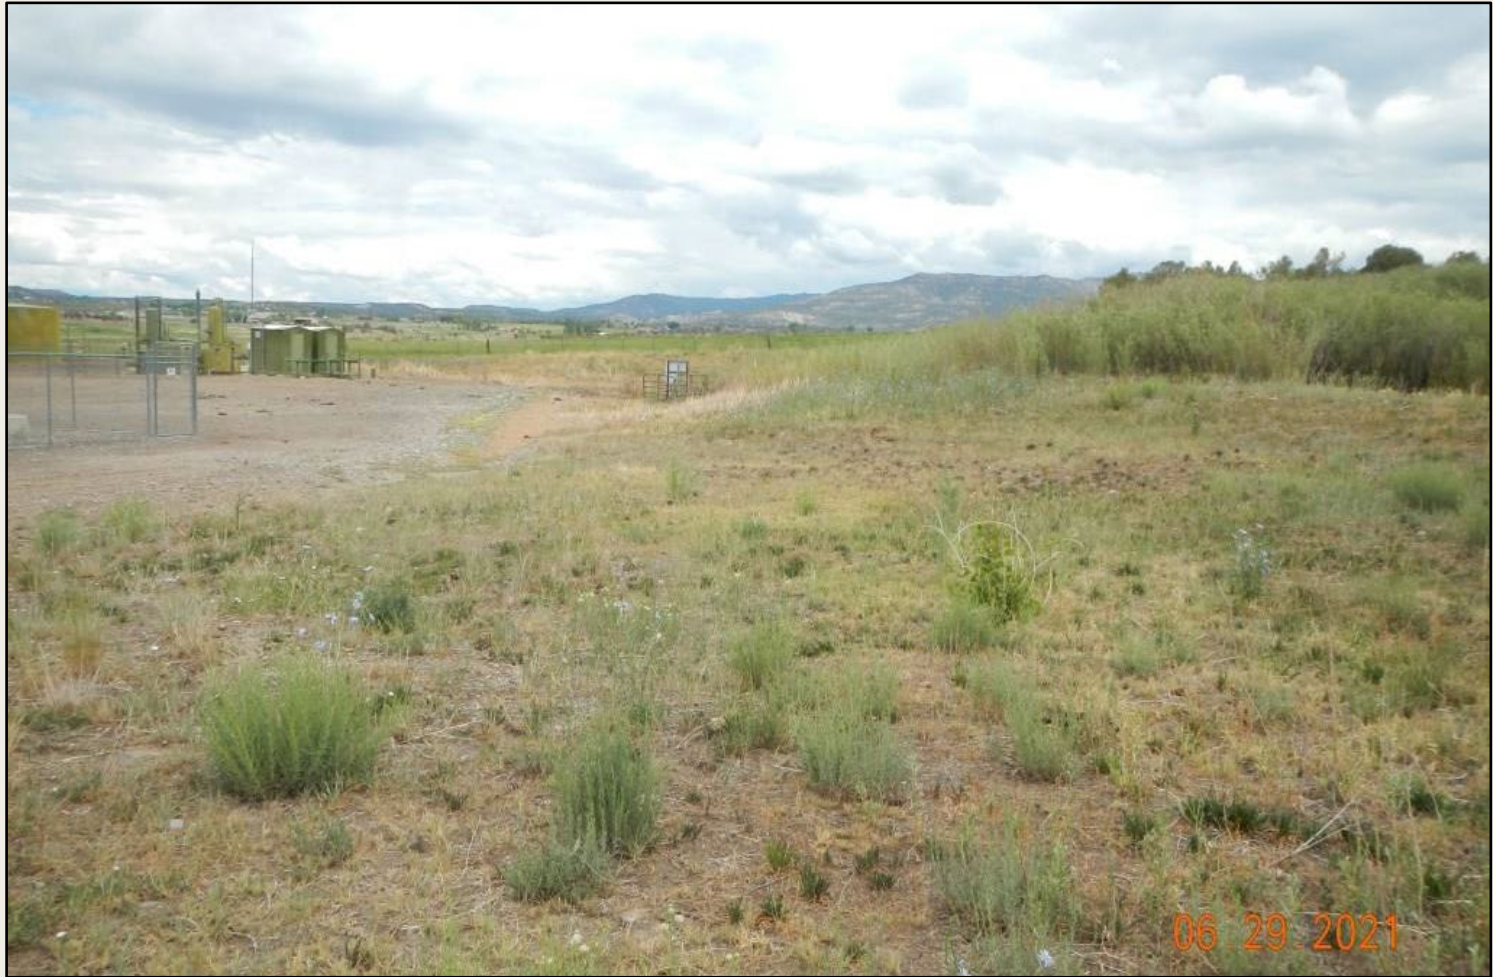
Photo 3. View of the eastern project area from the southeastern corner facing northward.

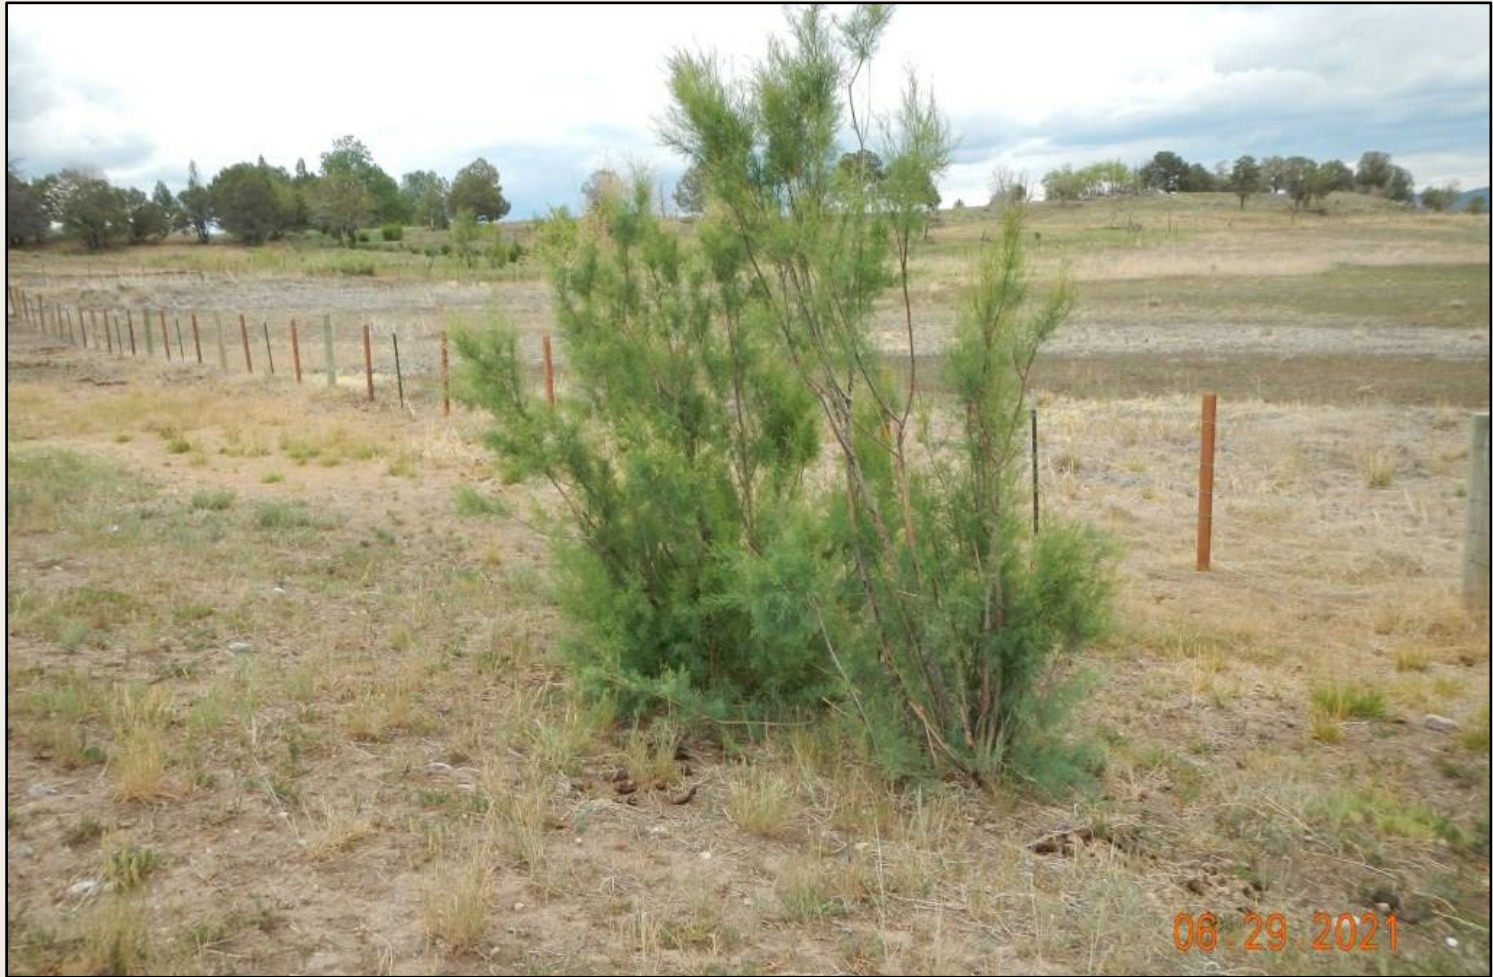
Photo 4. View of saltcedar trees within the southern project area, need to be treated and removed.

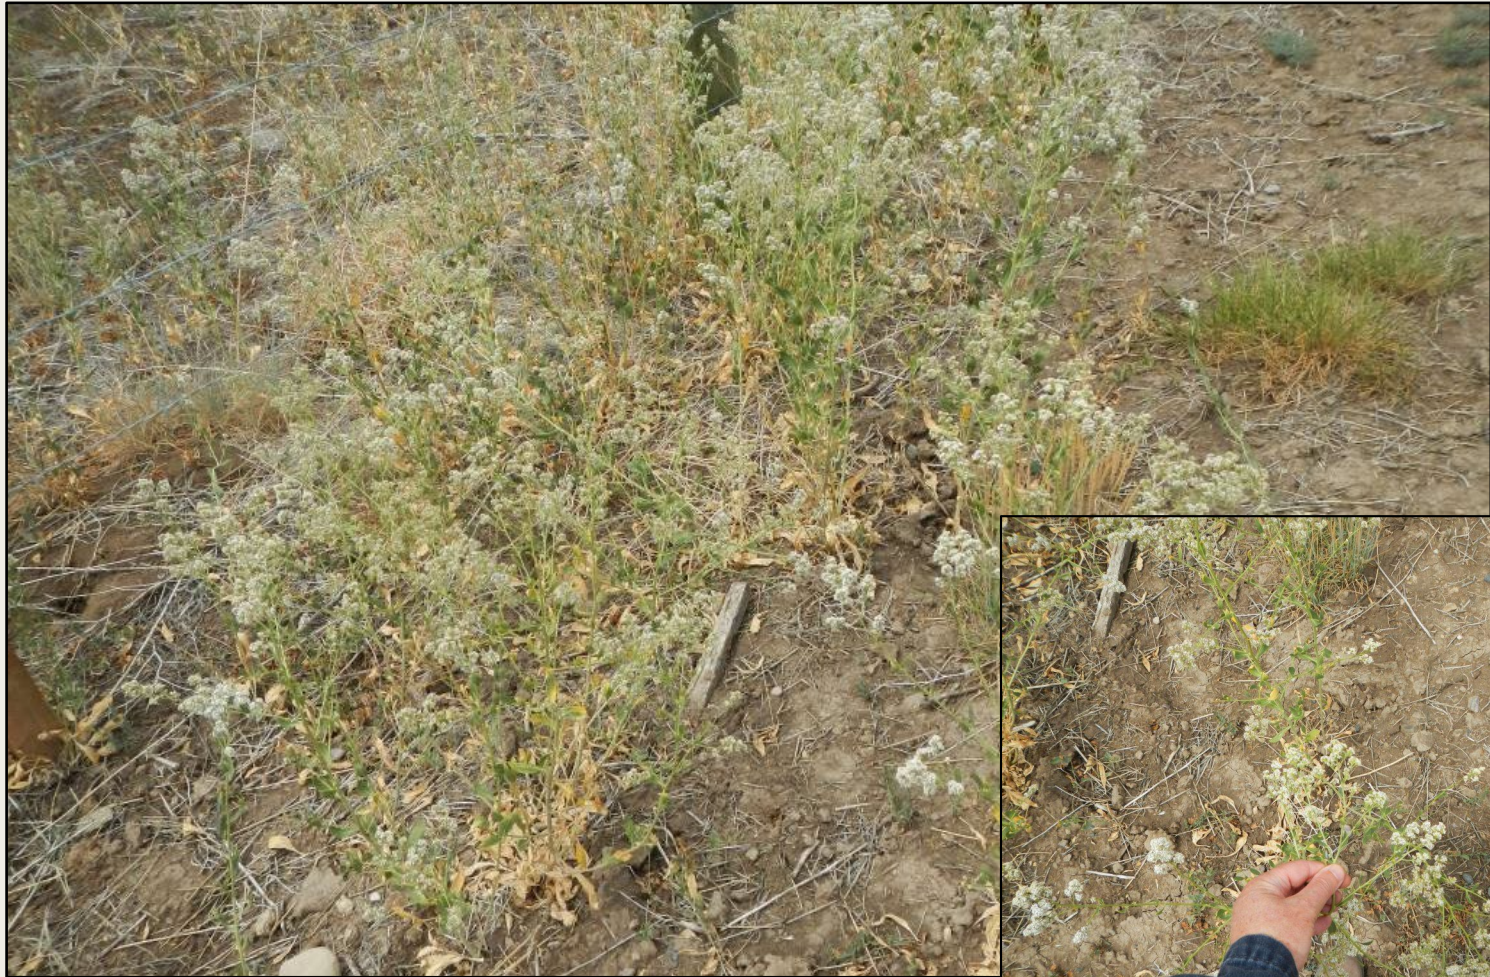
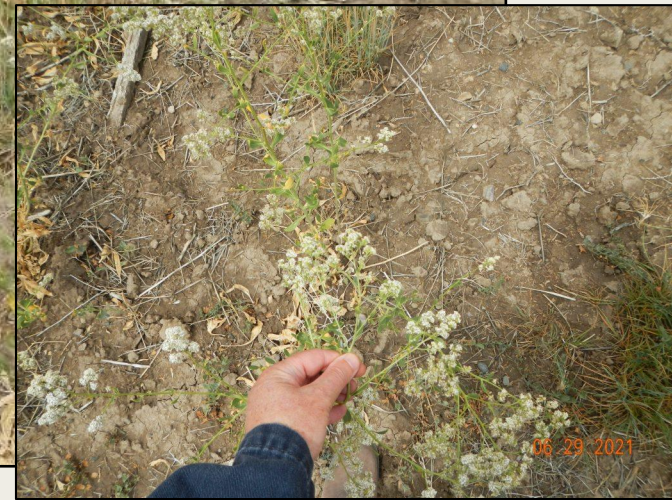
Photo 5. View of perennial pepperweeds (approximately 100) within the southern project area. Need to be treated and controlled.

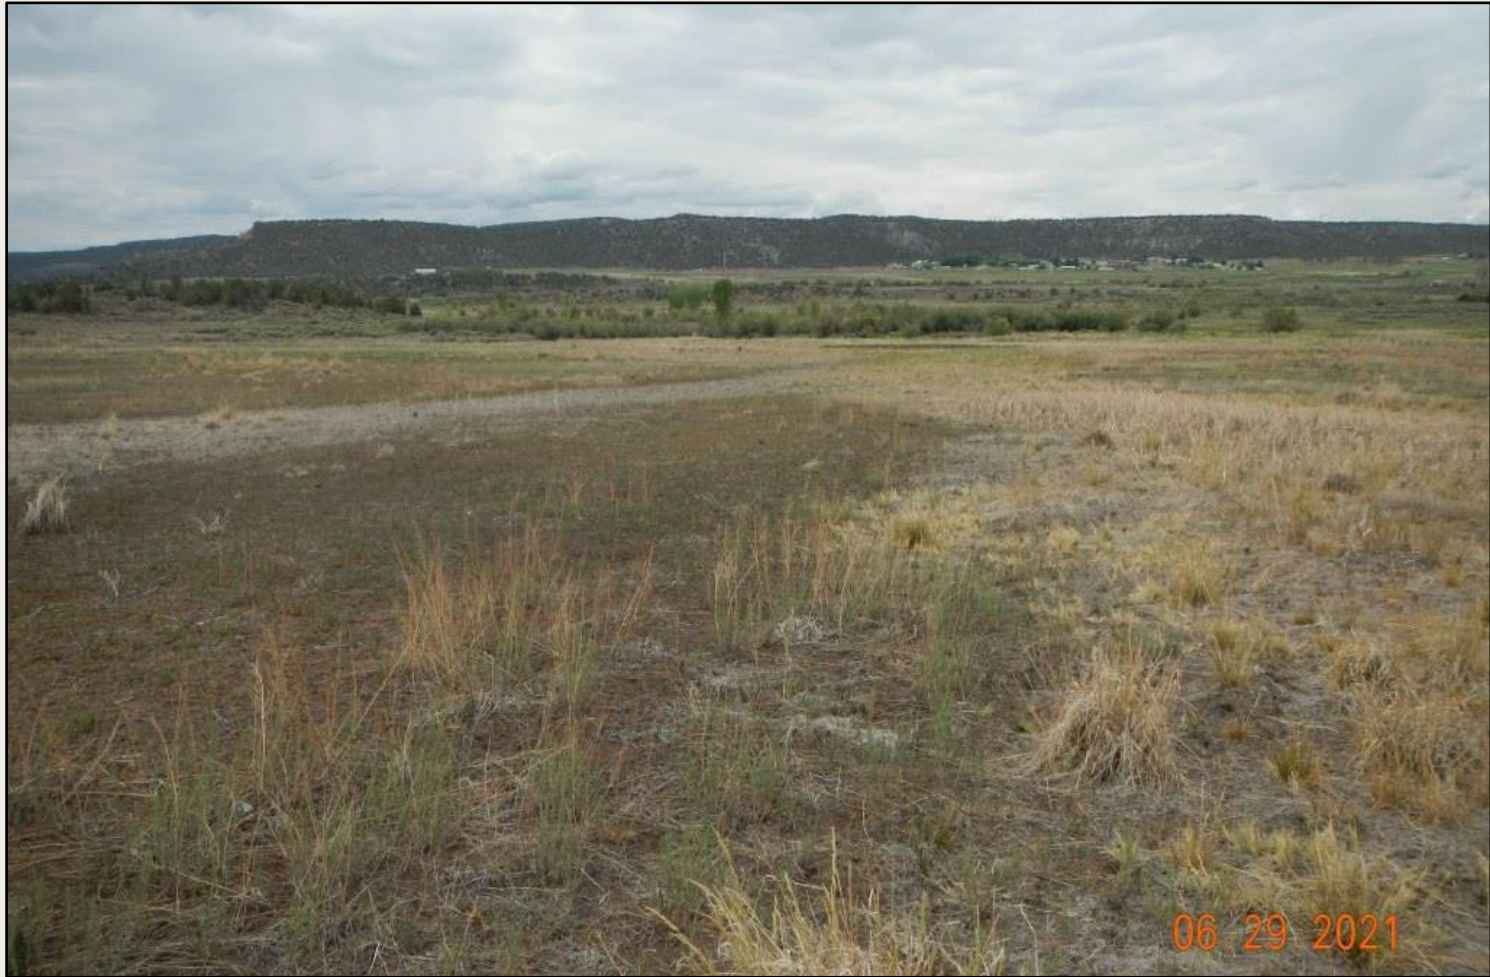
Photo 6. View of reference area comprised of open field, with grasses such as western wheatgrass, and foxtail barley, forbs such as wormwood, sedges, and cattails.
