Inspection Photos

6/30/2021

Operator: CHEVRON USA INC - 16700

Location ID: 398839

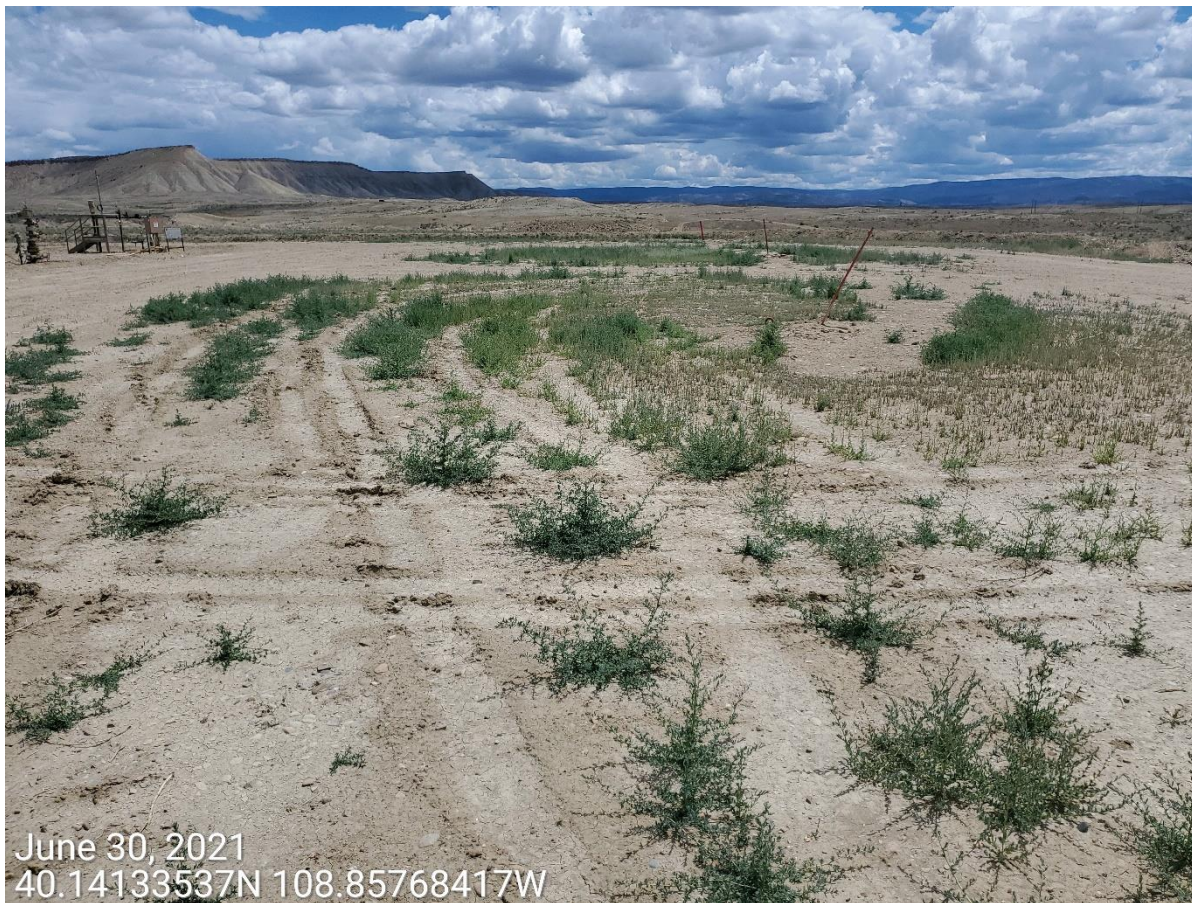
Photo 1: Photo taken from the south end of the Location, facing east. Photo shows example of areas where undesirable plant and noxious weed establishment was observed.

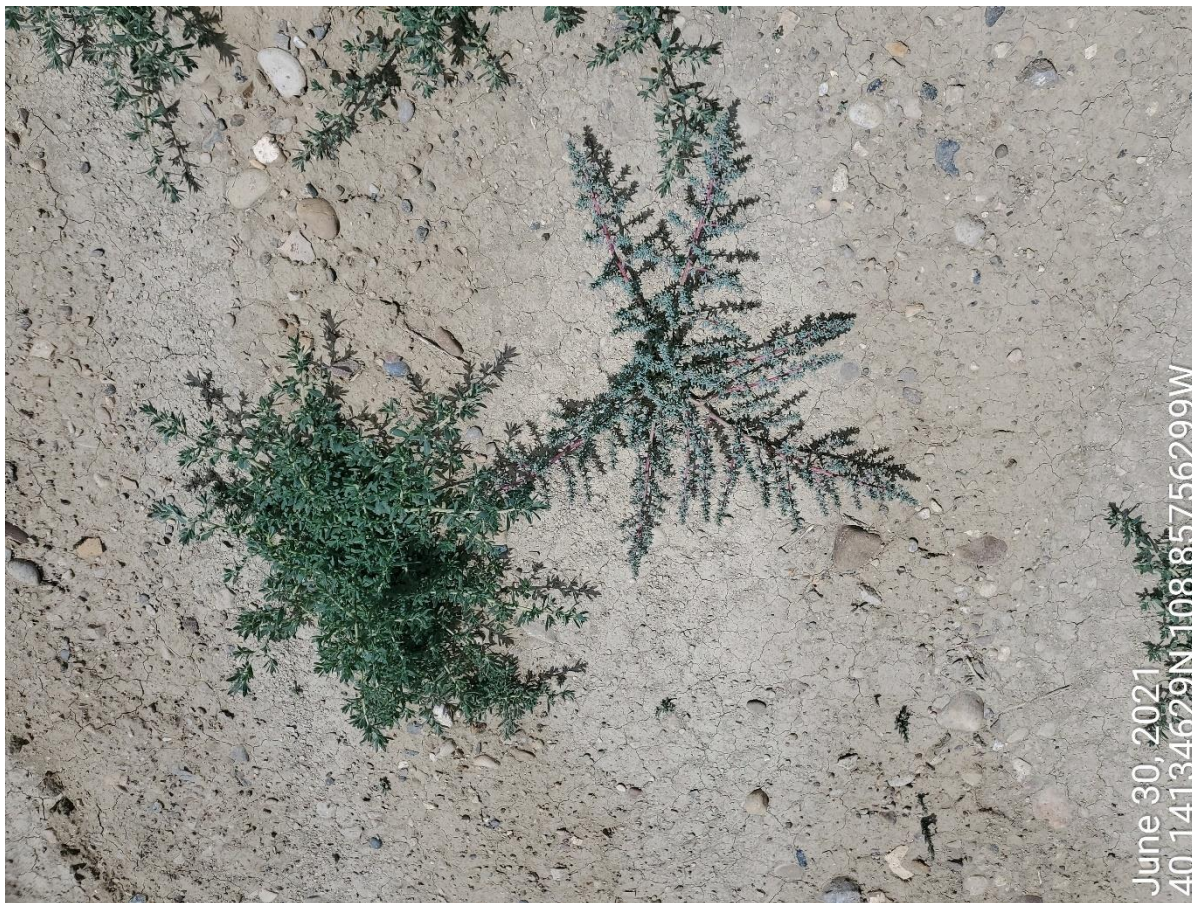
Photo 2: Continued from photo 1. Photo shows example of undesirable plant and noxious weed establishment was observed on Location.

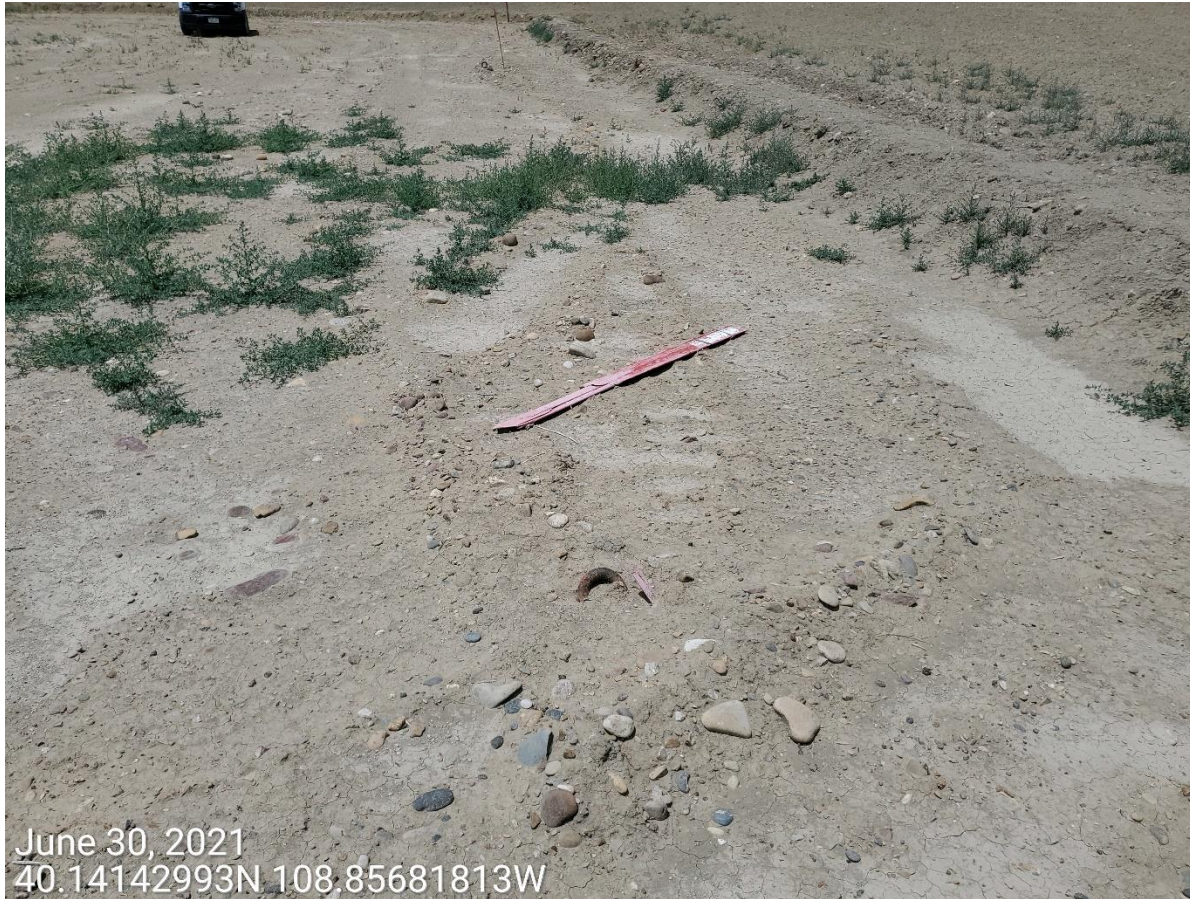
Photo 3: Photo shows marker for the anchor on the northeast end of the Location is in disrepair.

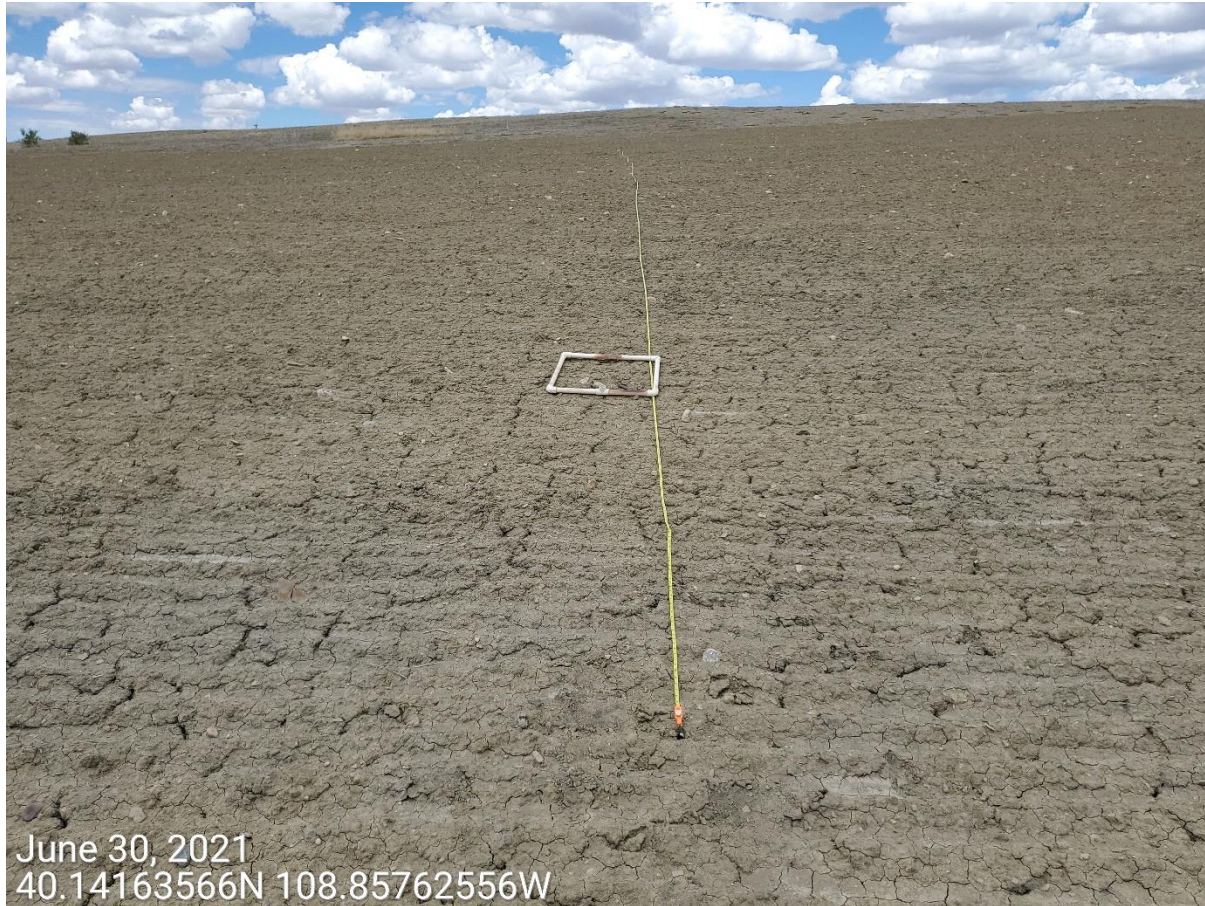
Photo 4: Photo shows germination transect #1 on the western interim areas of the Location.

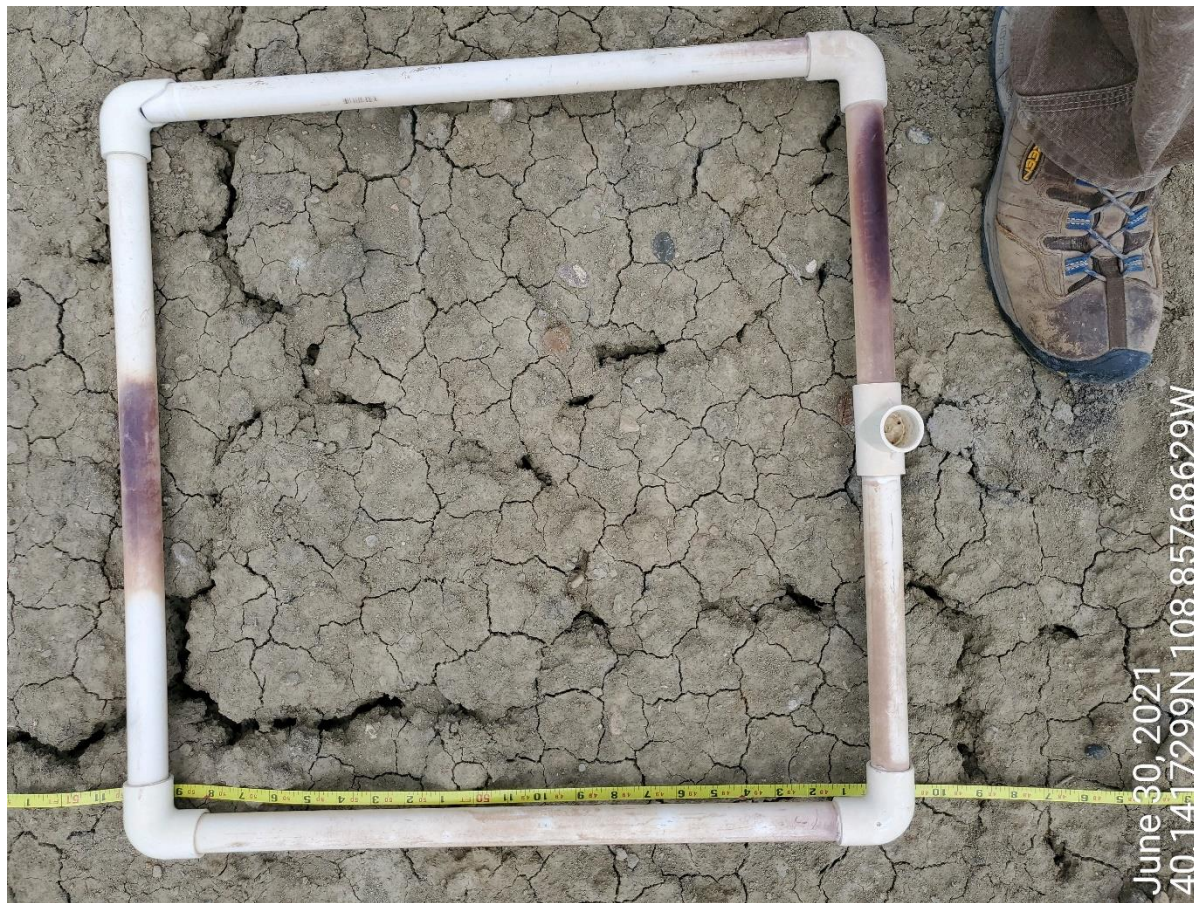
Photo 5: Photo shows soil surface for the 50th point of the 1st germination transect; desirable vegetative germination/establishment not observed, or negligible; approximately 1 seedling was observed for every 8 quadrats.

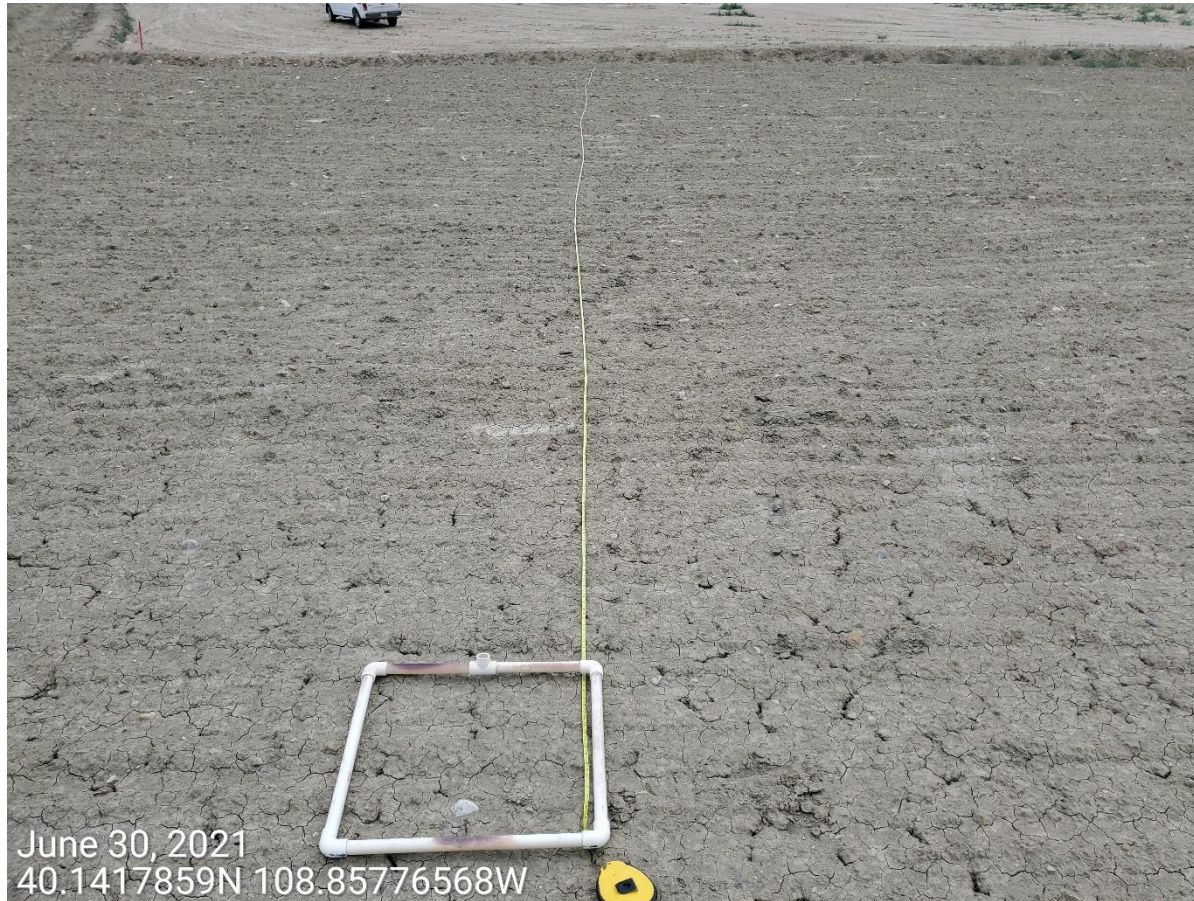
Photo 6: Photo shows germination transect #2 on the northern interim areas of the Location.

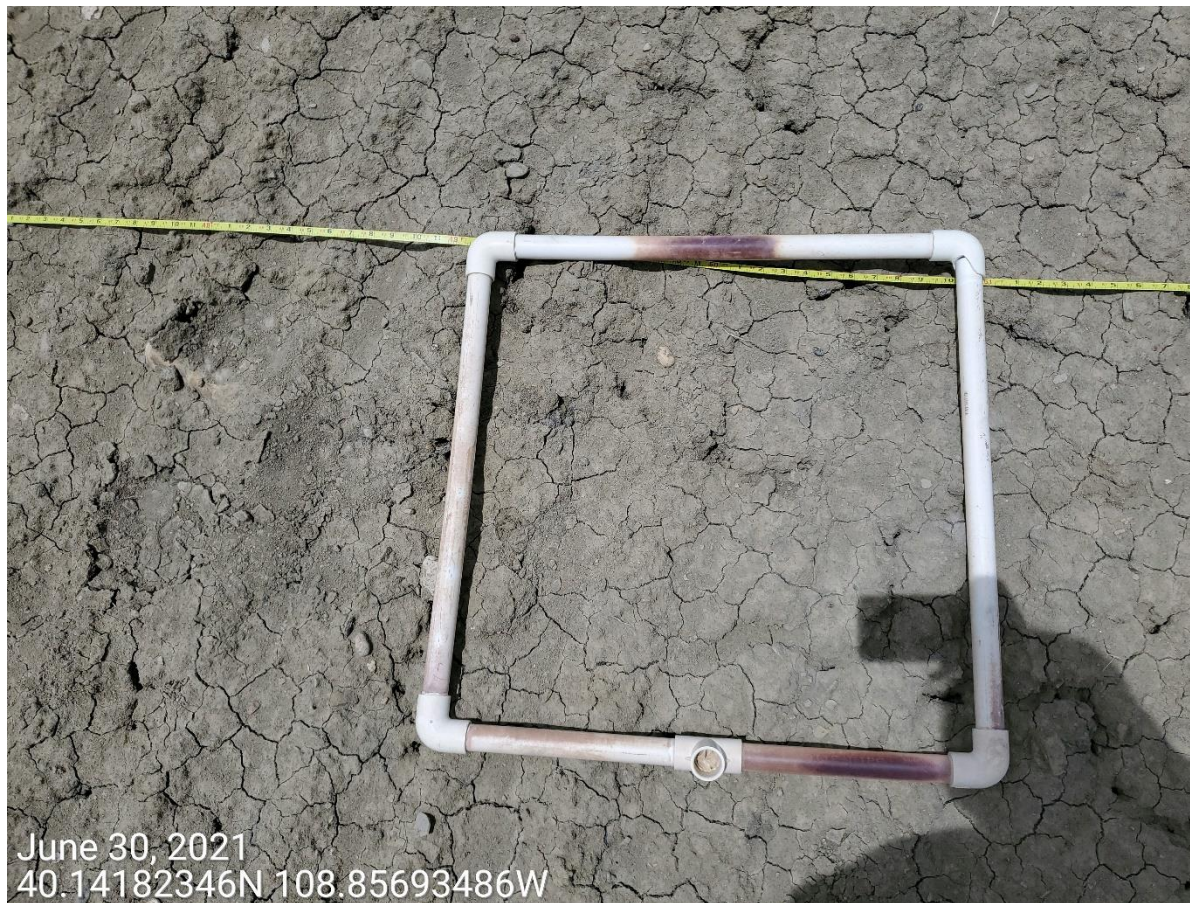
Photo 7: Photo shows soil surface for the 50th point of the 2nd germination transect; desirable vegetative germination/establishment not observed, or negligible; approximately 1 seedling was observed for every 8 quadrats.

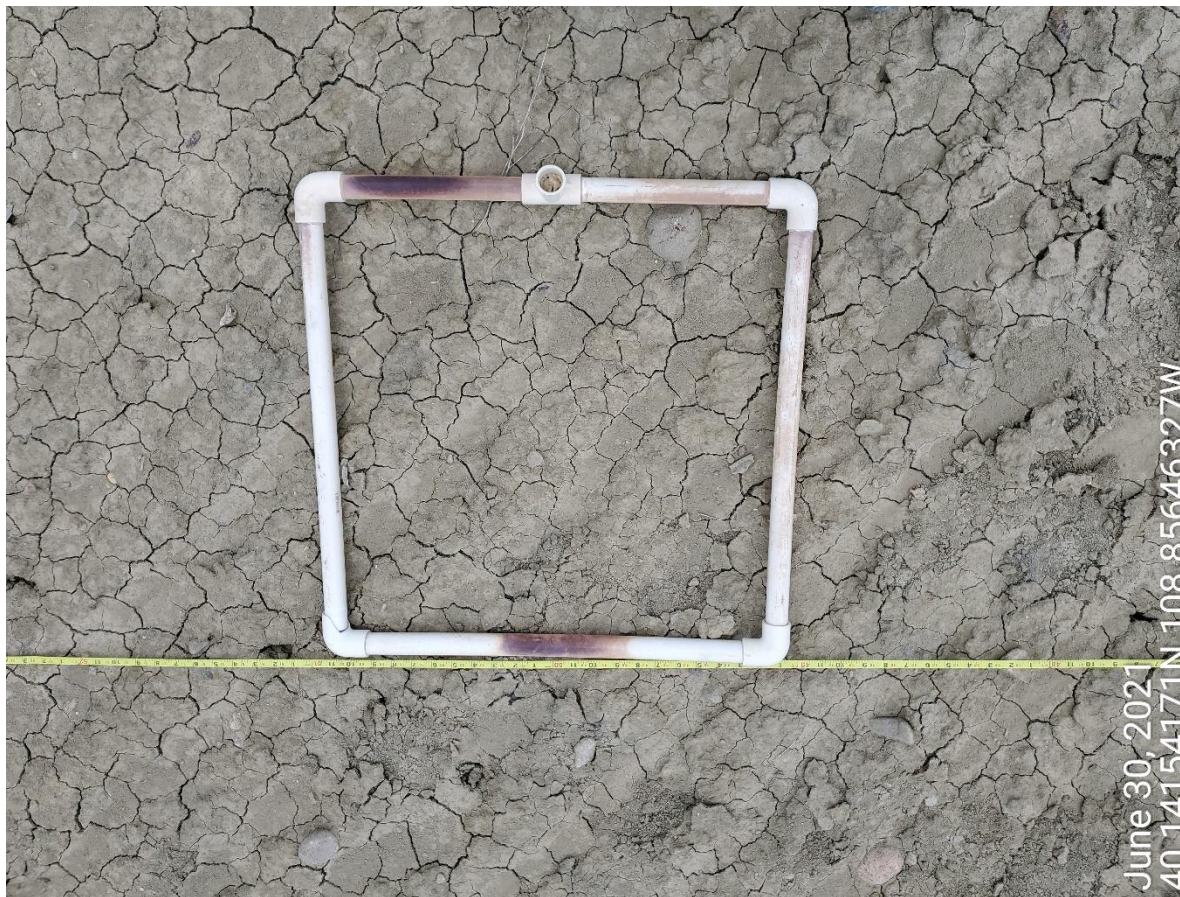
Photo 8: Photo shows soil surface for the 50th point of the 3rd germination transect on the northeast end of the Location; desirable vegetative germination/establishment not observed, or negligible; approximately 1 seedling was observed for every 8 quadrats.

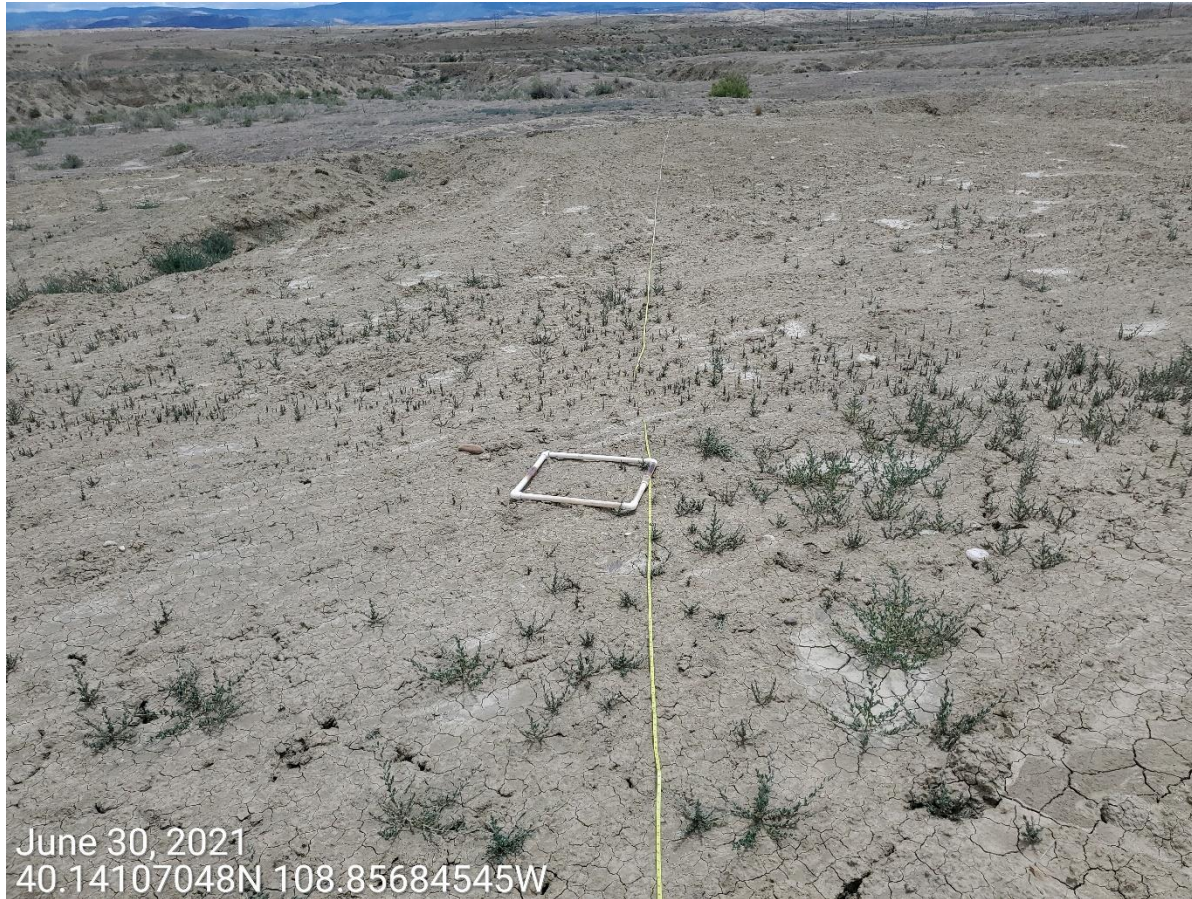
Photo 10: Photo shows germination transect #2 on the northern interim areas of the Location.

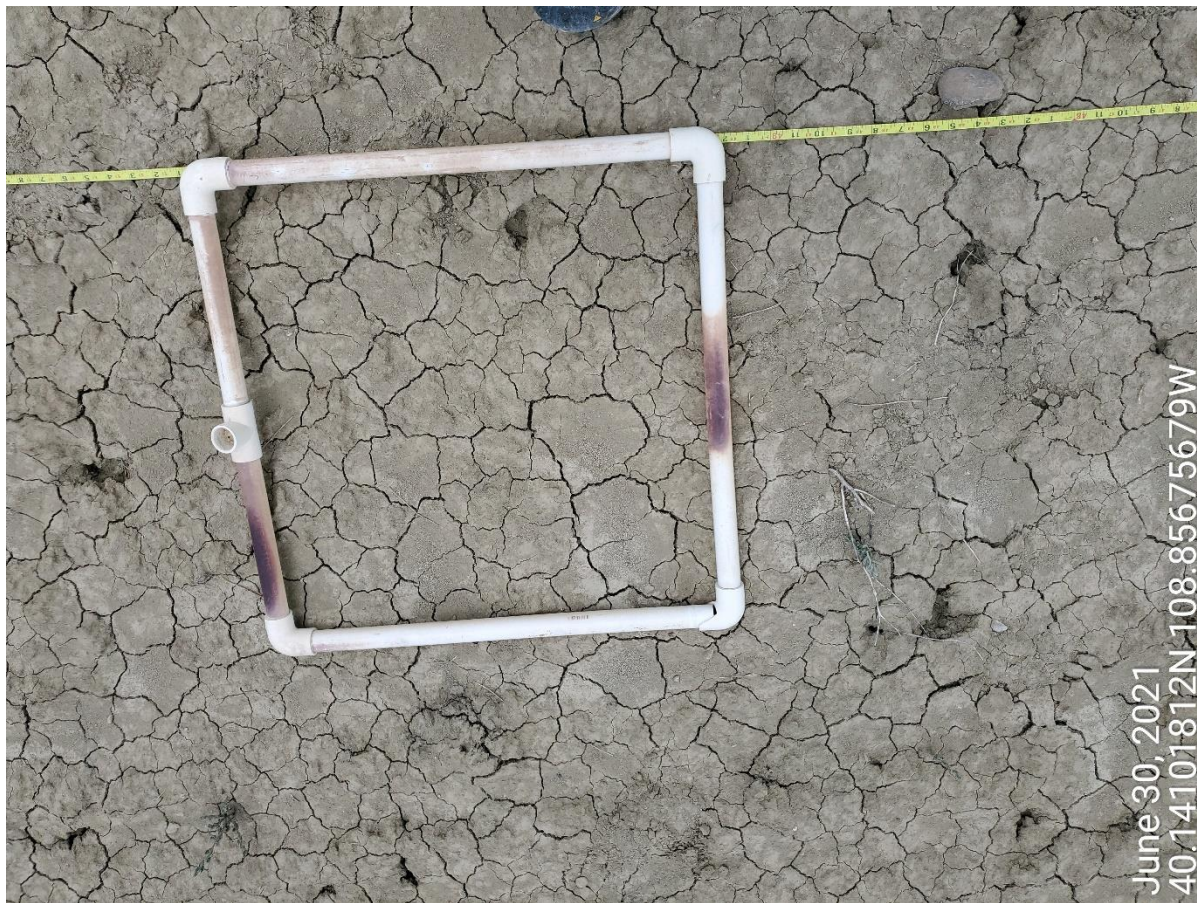
Photo 11: Photo shows soil surface for the 50th point of the 4th germination transect on the southeast end of the Location; desirable vegetative germination/establishment not observed, or negligible; approximately 1 seedling was observed for every 8 quadrats

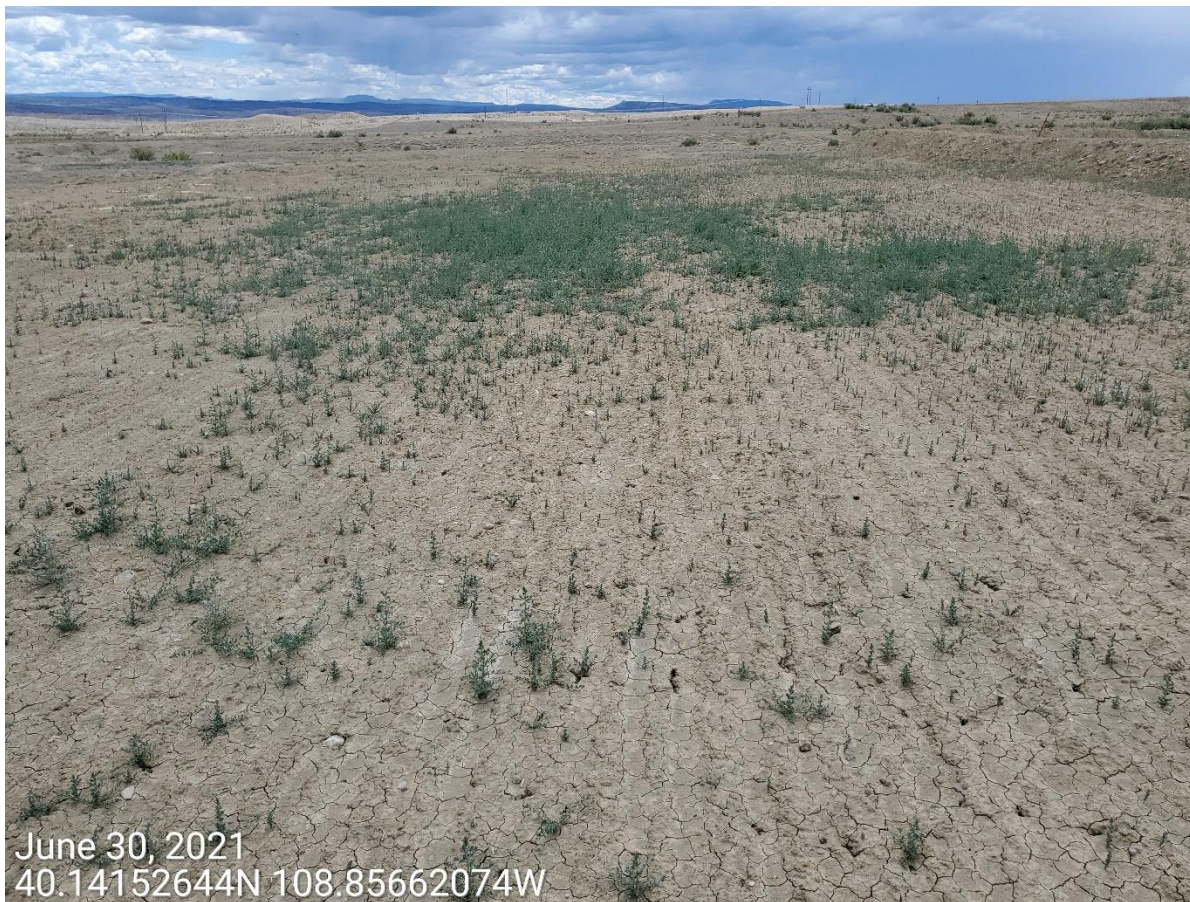
Photo 12: Photo taken from the eastern interim areas of the Location, facing south. Photo shows example of areas where undesirable plant and noxious weed establishment was observed.
