Inspection Photos
Operator: Hilcorp
API: 067-07674
Date: 7/2/2021

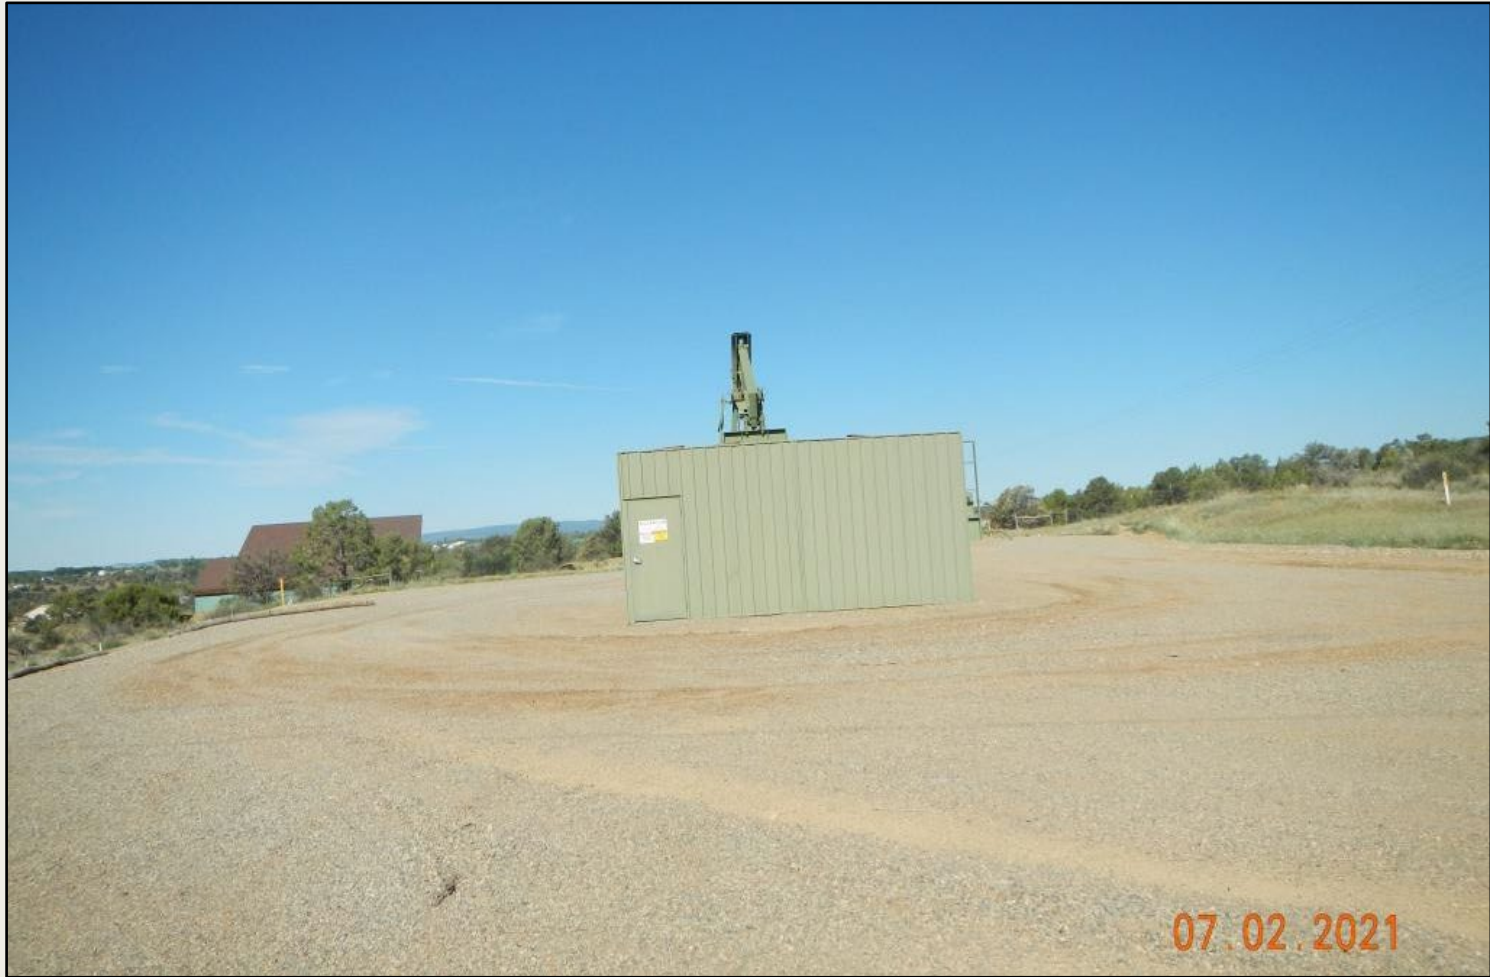
Photo 1. View the project area from the well pad entrance facing center.

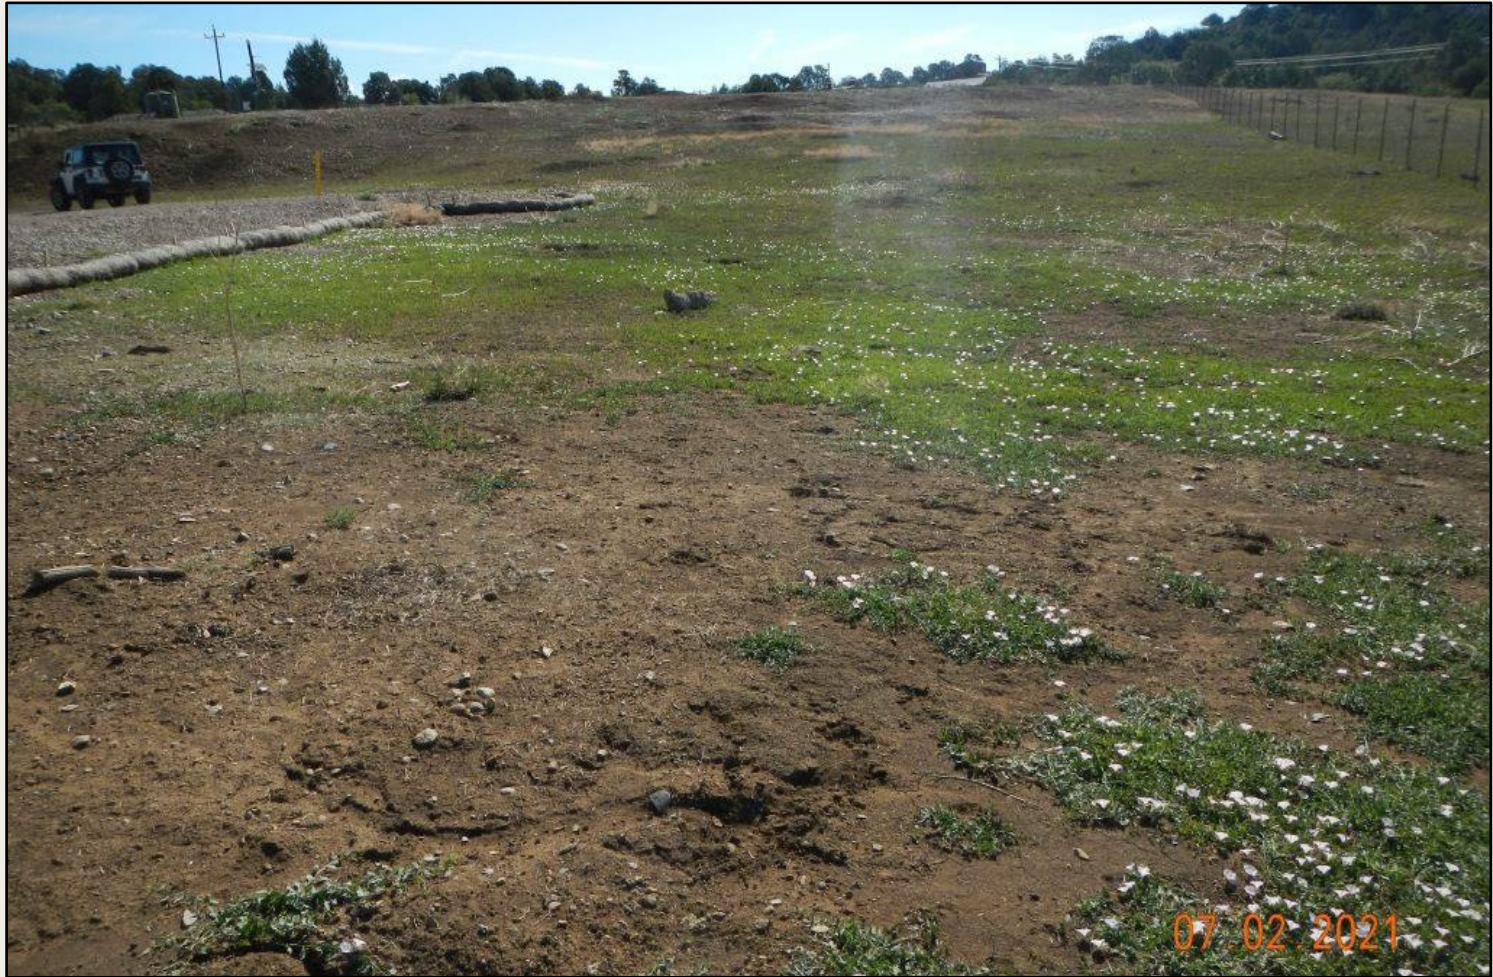
Photo 2. View the southern project area from the southwestern corner facing eastward. Little desirable vegetation here. Vegetation is largely field bindweed. Germination not observed.

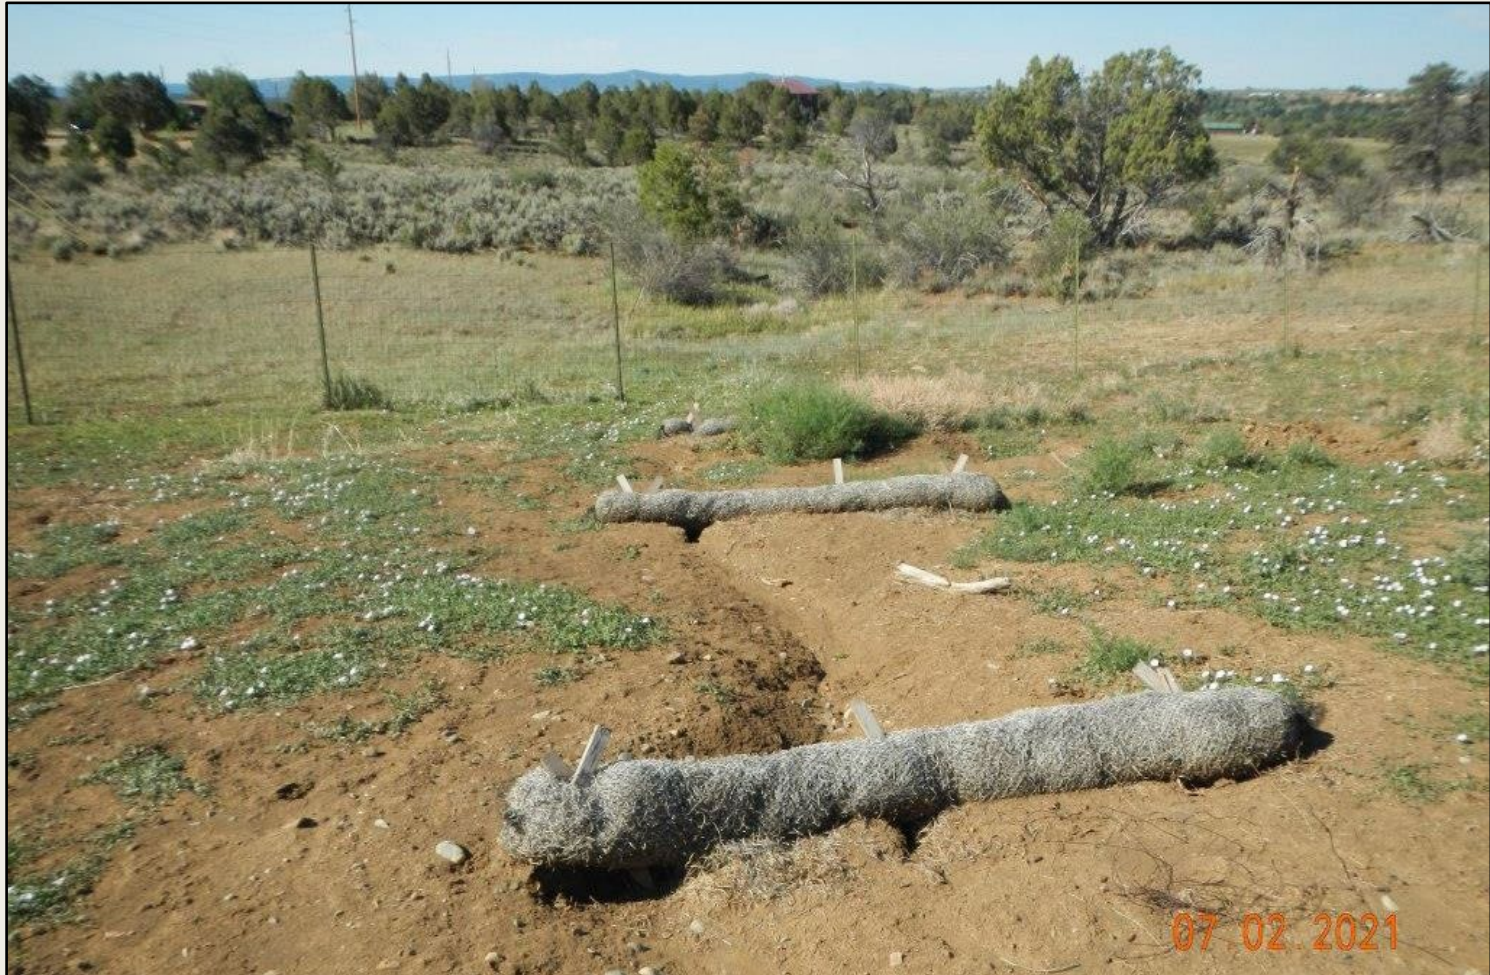
Photo 3. View of wattles and erosional channeling in the southern project area. Wattles are not an adequate BMP for this area. Little desirable vegetation present.

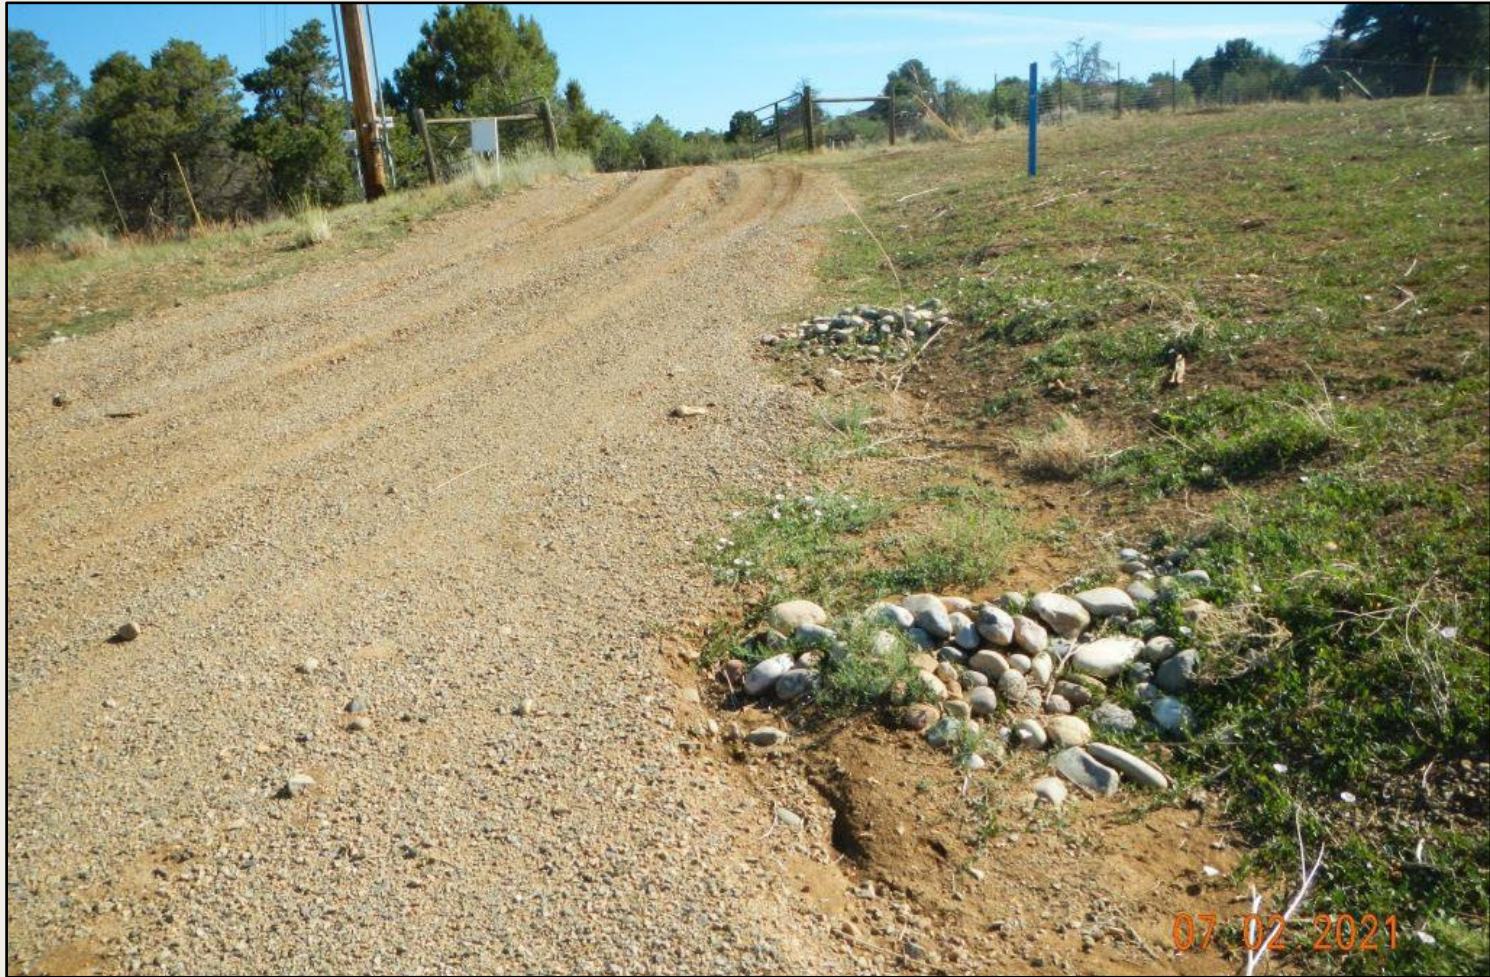
Photo 4. View of cobble BMPs along the access road, full of sediment and not functioning. These BMPs are not adequate and need to be installed using good engineering practices.

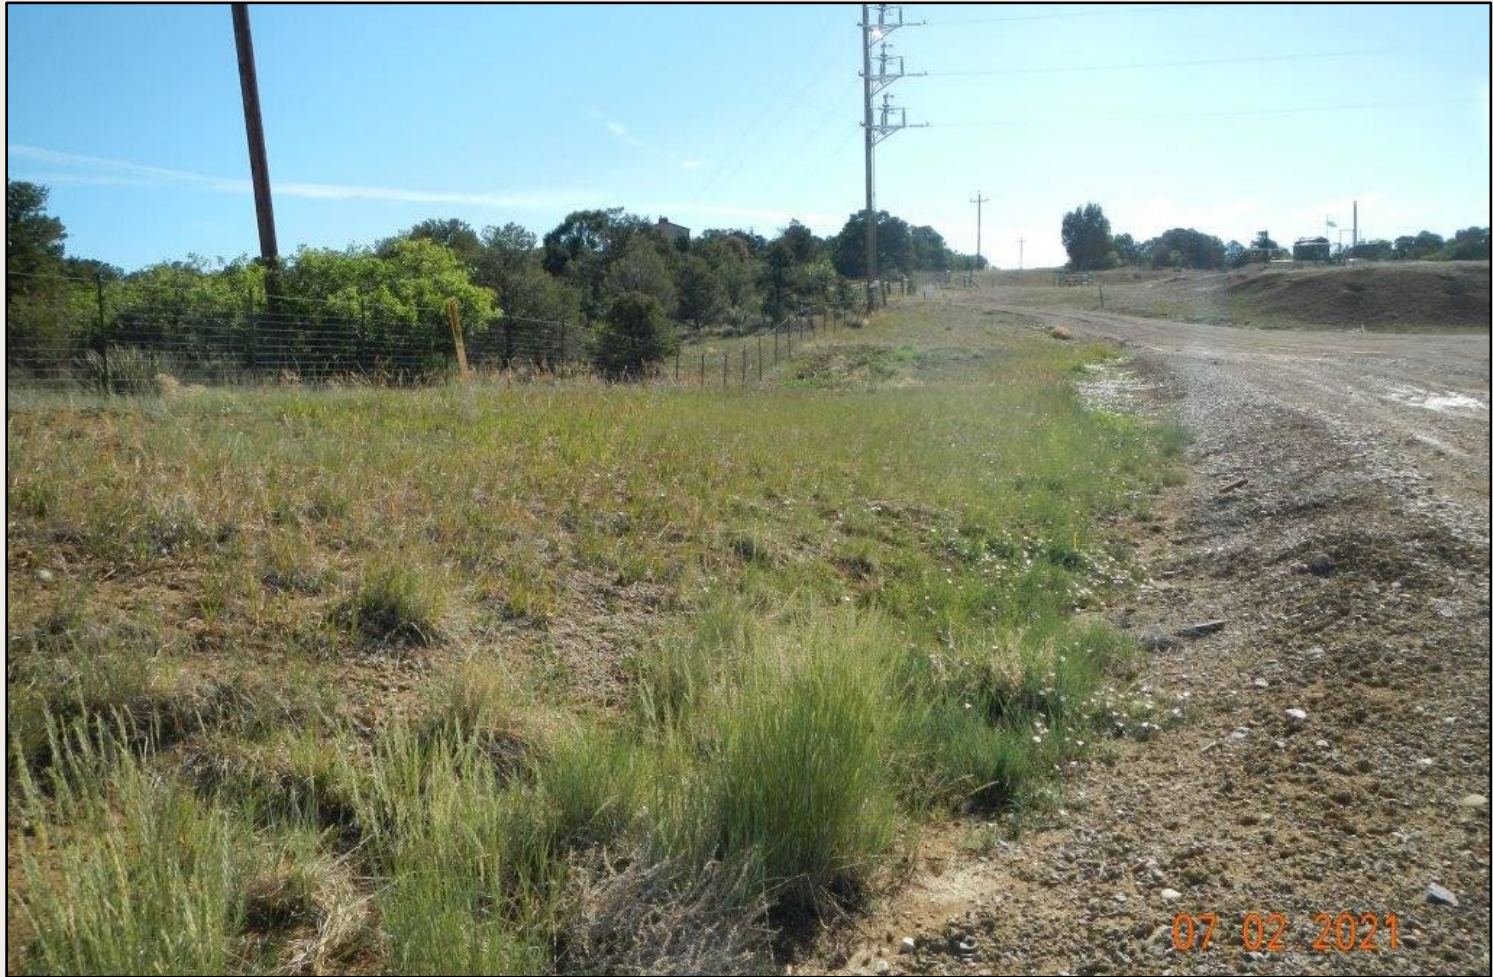
Photo 5. View of the northern project area facing eastward. Revegetation is progressing in this portion with western wheatgrass and smooth brome.

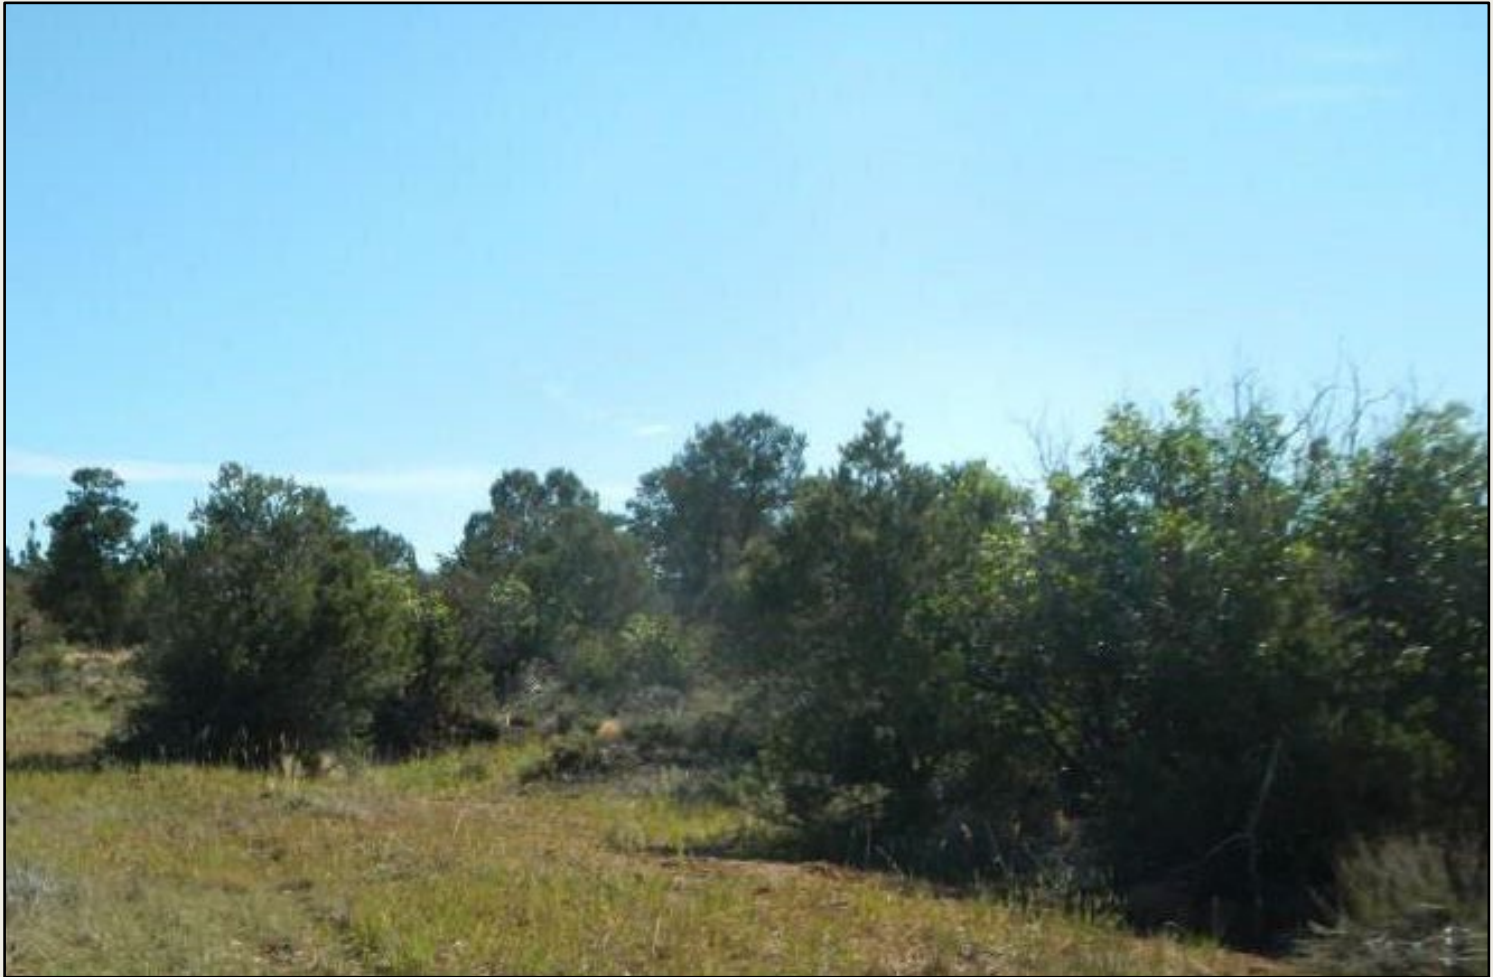
Photo 6. View the reference area comprised of Gambel oak and mountain mahogany shrubland with sagebrush, western wheatgrass, and smooth brome in the understory.
