Inspection Photos
Operator: Holcomb
API: 067-06545
Date: 7/2/2021

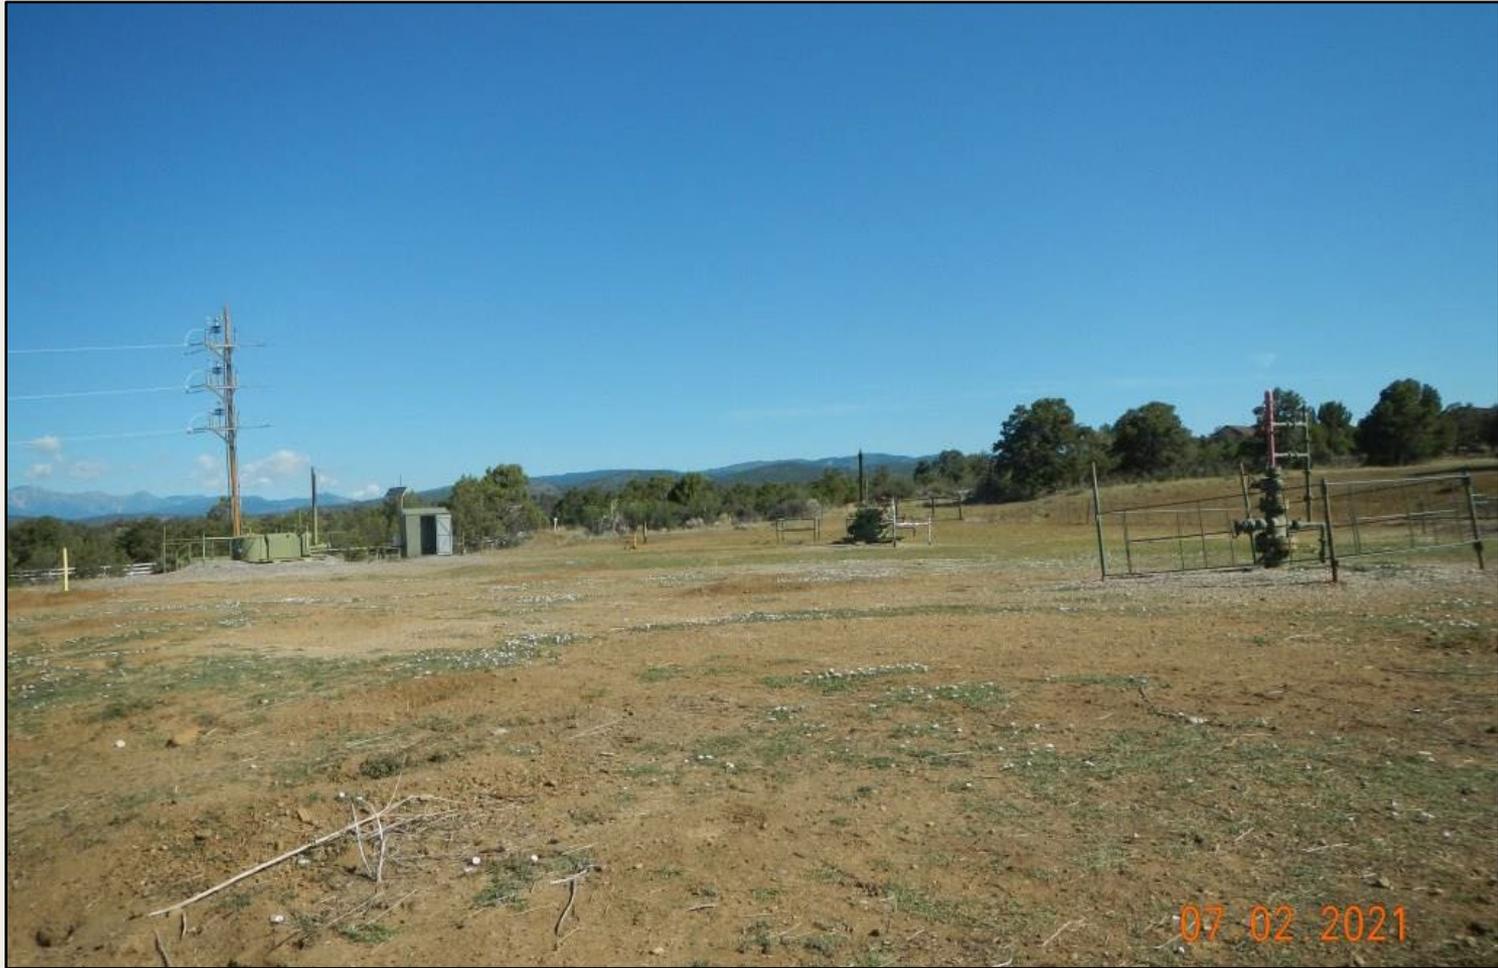
Photo 1. View the project area from the southern corner facing center.

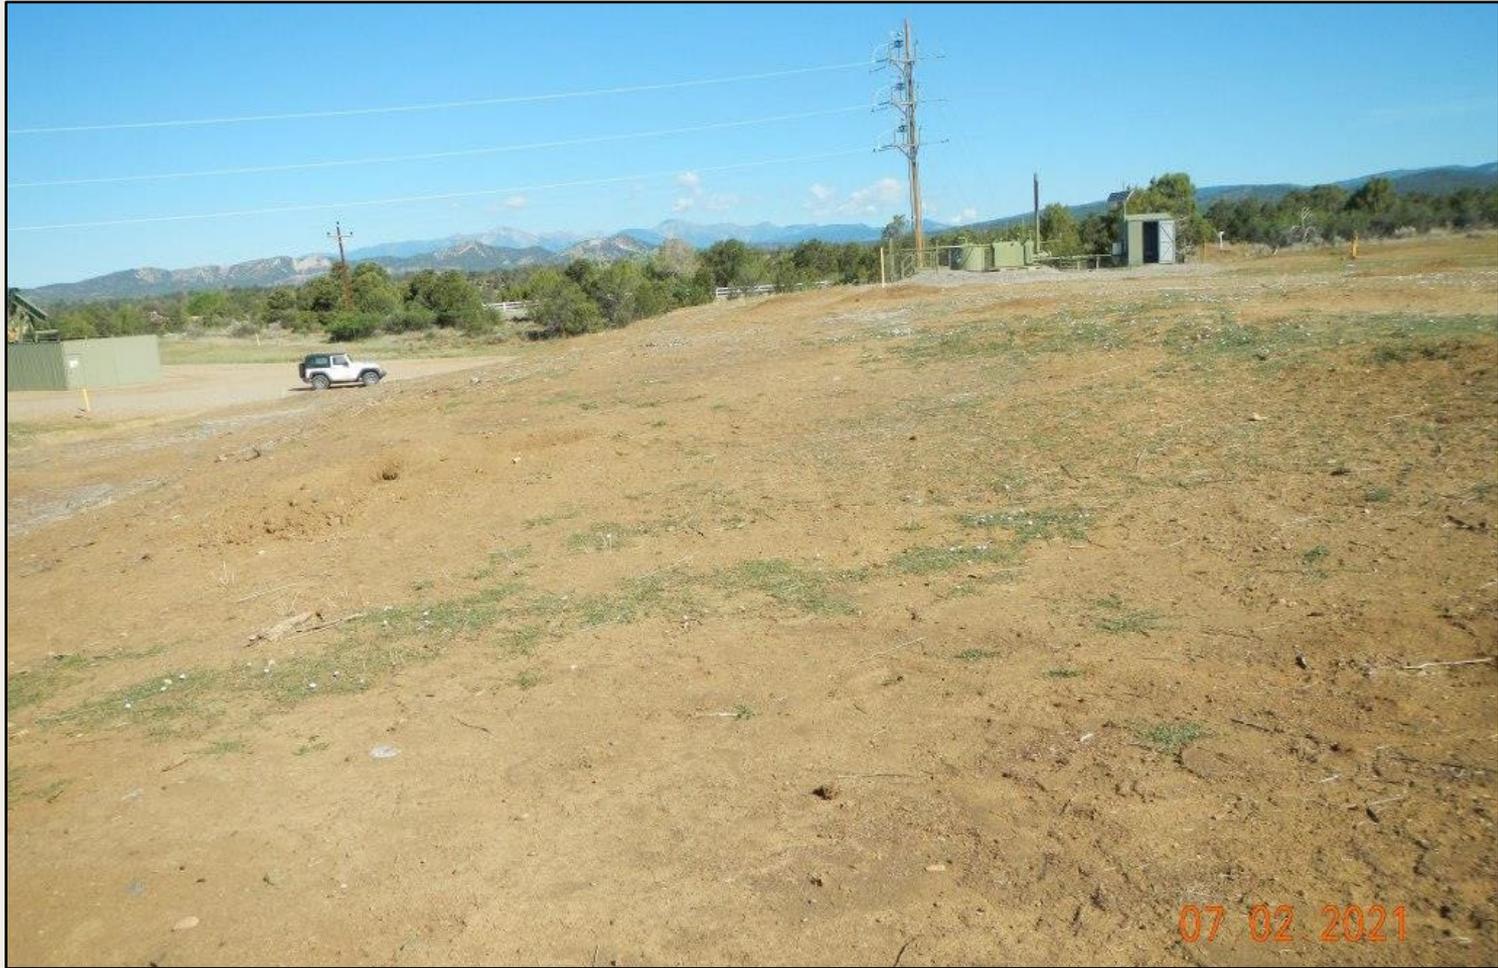
Photo 2. View the western project area from the southern corner facing northwestward. Little desirable vegetation here. Vegetation is largely field bindweed.

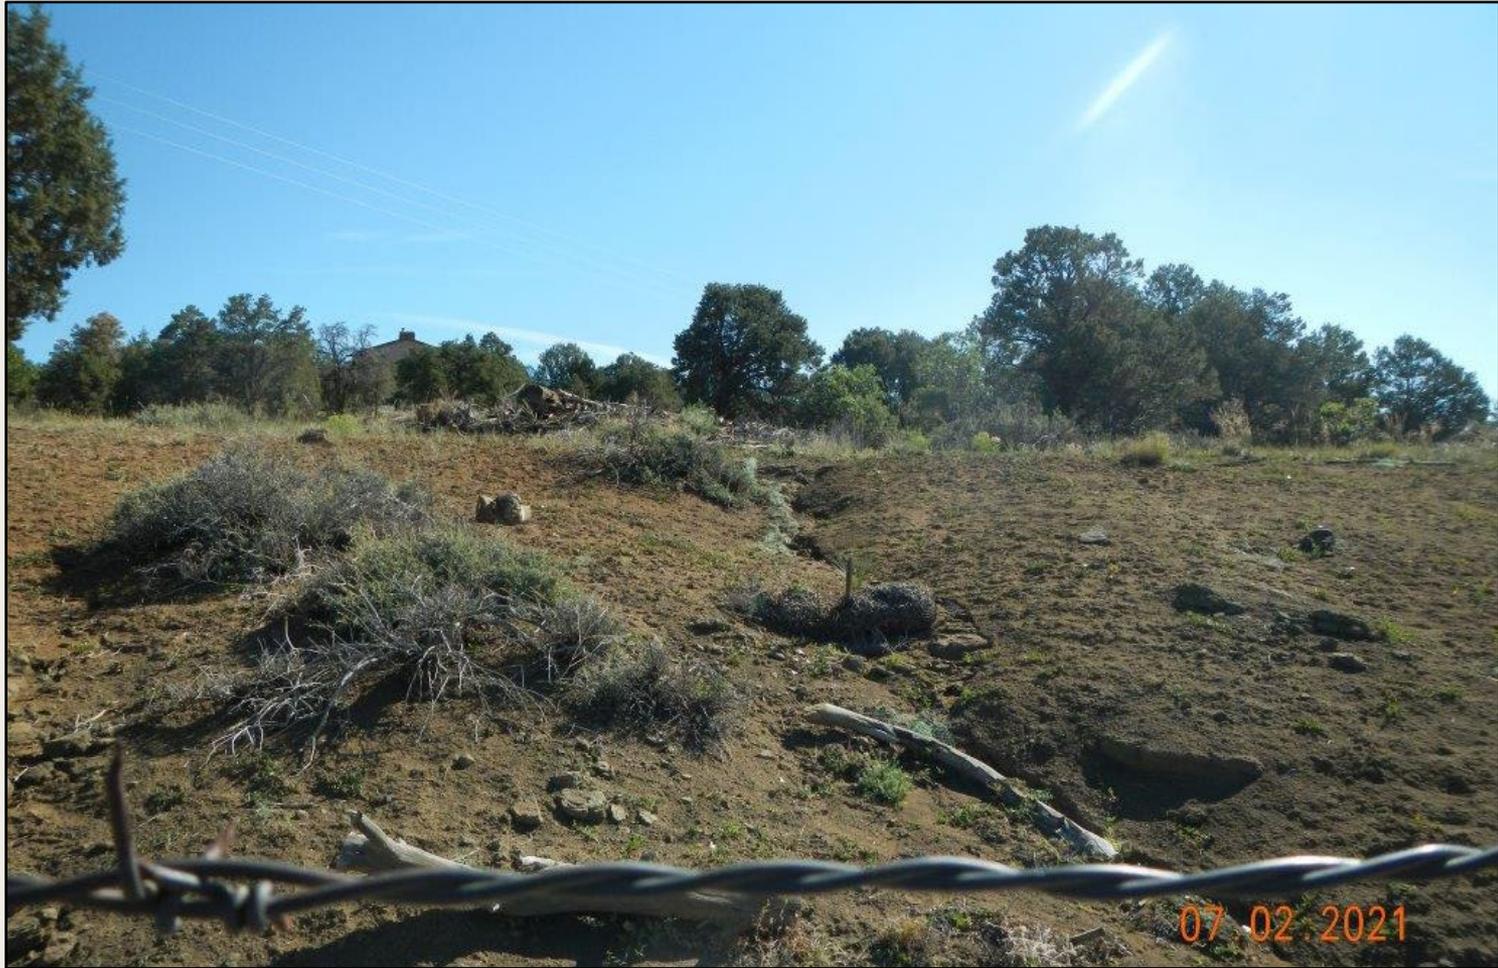
Photo 3. View of erosional channeling within the northeastern project area. Wattles are full of sediment and degrading. Green plastic debris present. These BMPs are not adequate and need to be installed using good engineering practices.

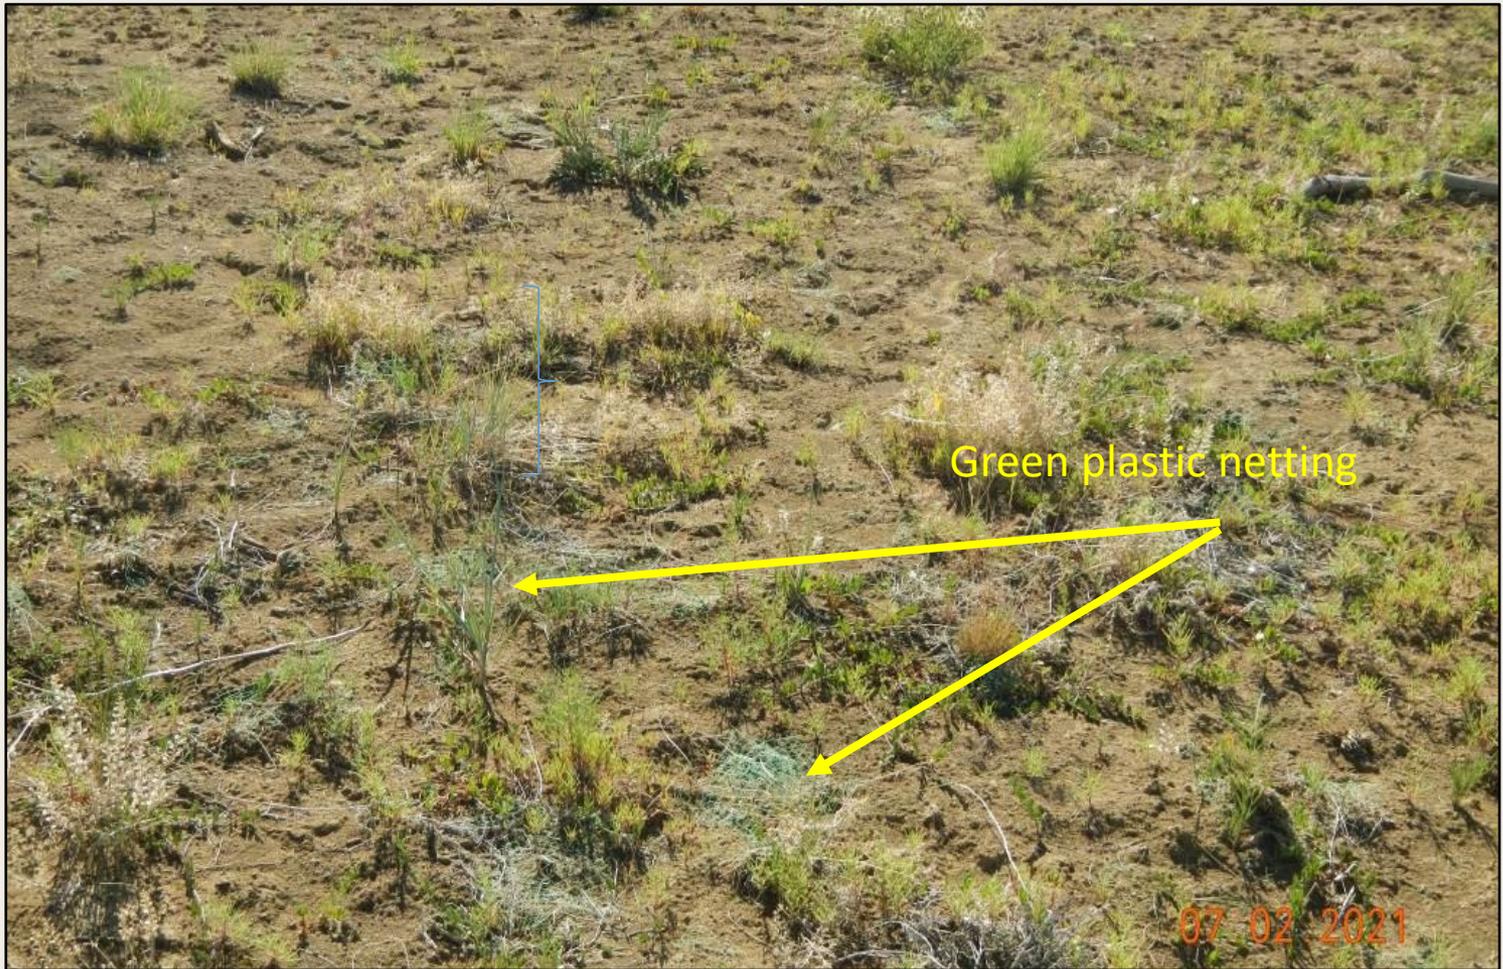
Photo 4. View of example of green plastic netting within the eastern project area, several pieces observed across northeastern and eastern project area.

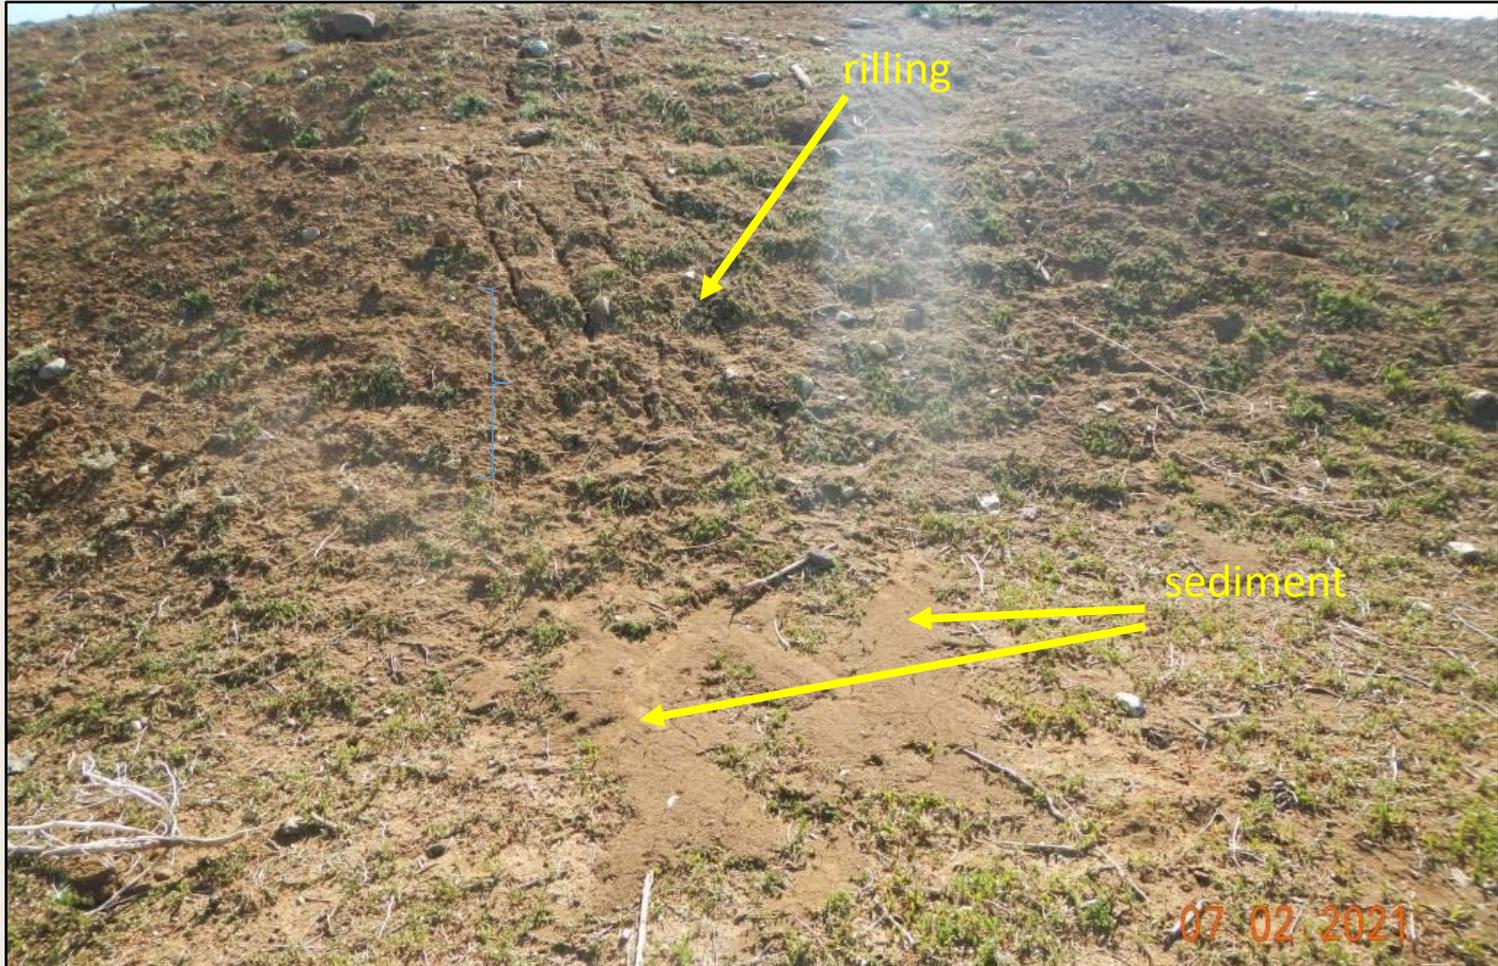
Photo 5. View of erosional rilling within the northwestern project area. Sediment piles observable.

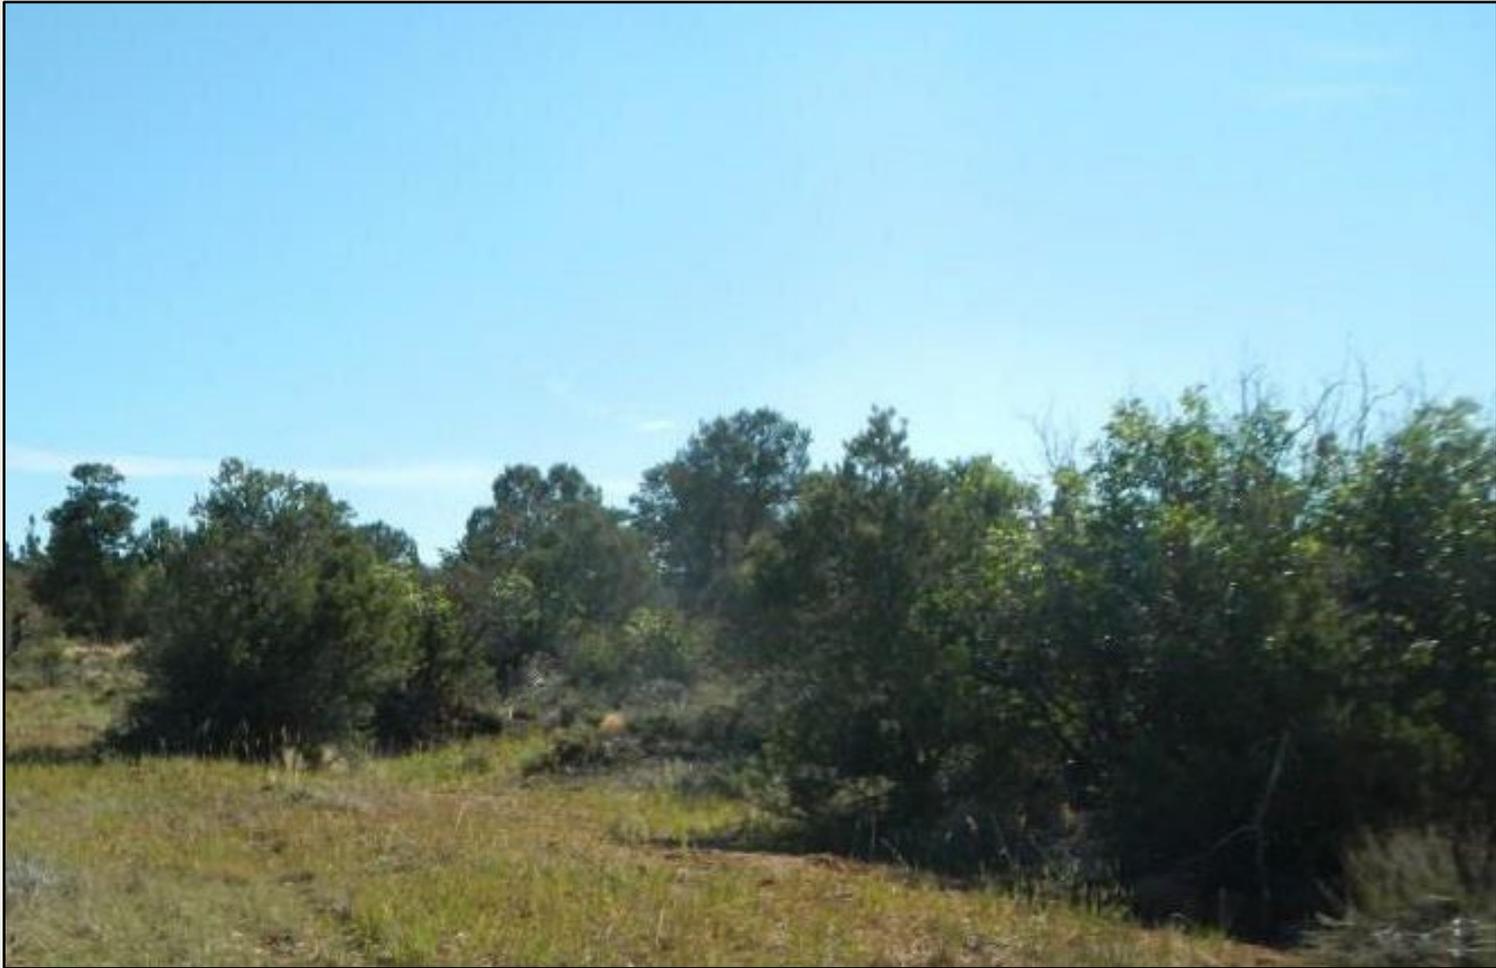
Photo 6. View the reference area comprised of Gambel oak and mountain mahogany shrubland with sagebrush, western wheatgrass, and smooth brome in the understory.
