Inspection Photos

API: 055-06278

Operator: EVERGREEN NATURAL RESOURCES

Inspection Date: 7/2/2021

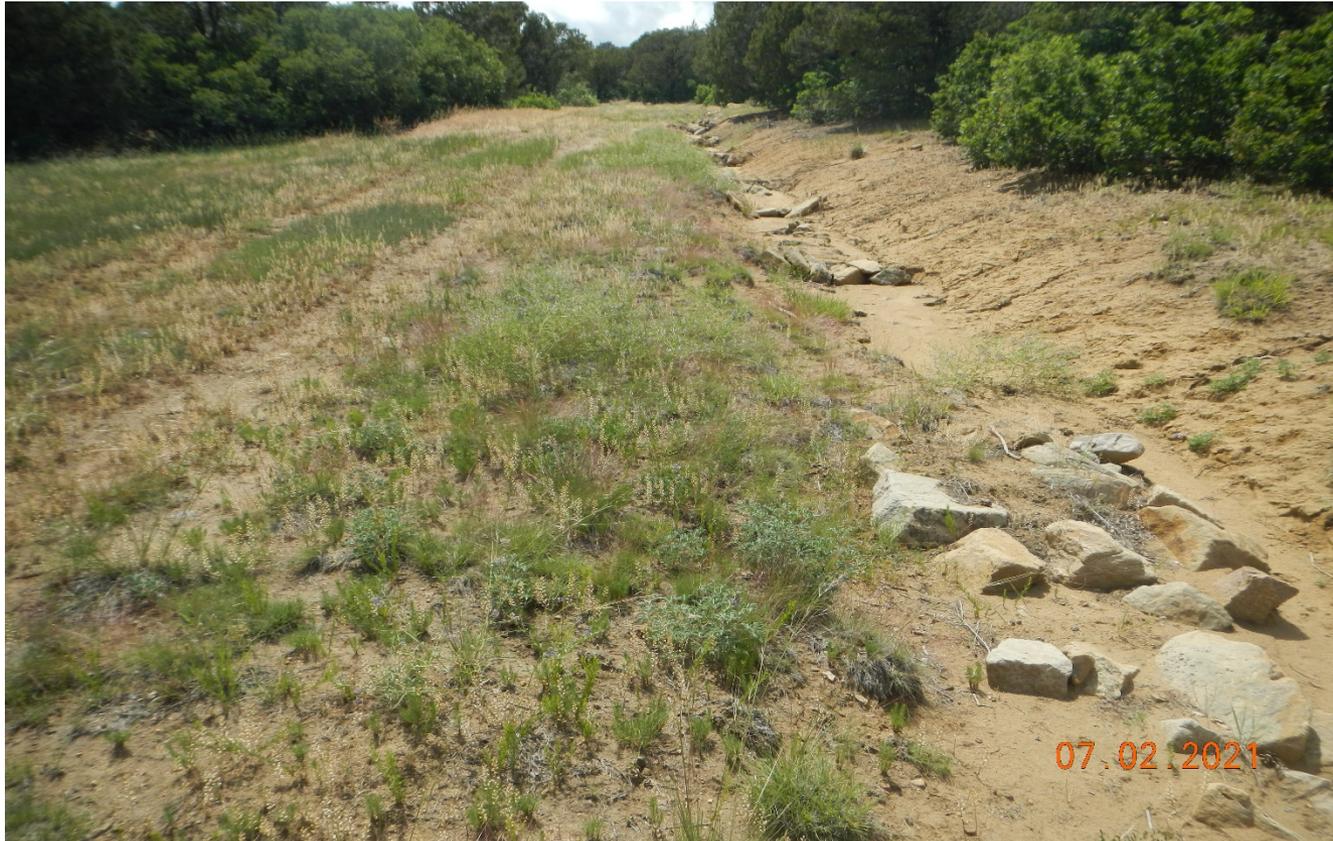
Photo 1. Facing southwest along the former access road. The road was not recontoured and reclaimed. There is erosion occurring along the road and the rock check dams are displaced.

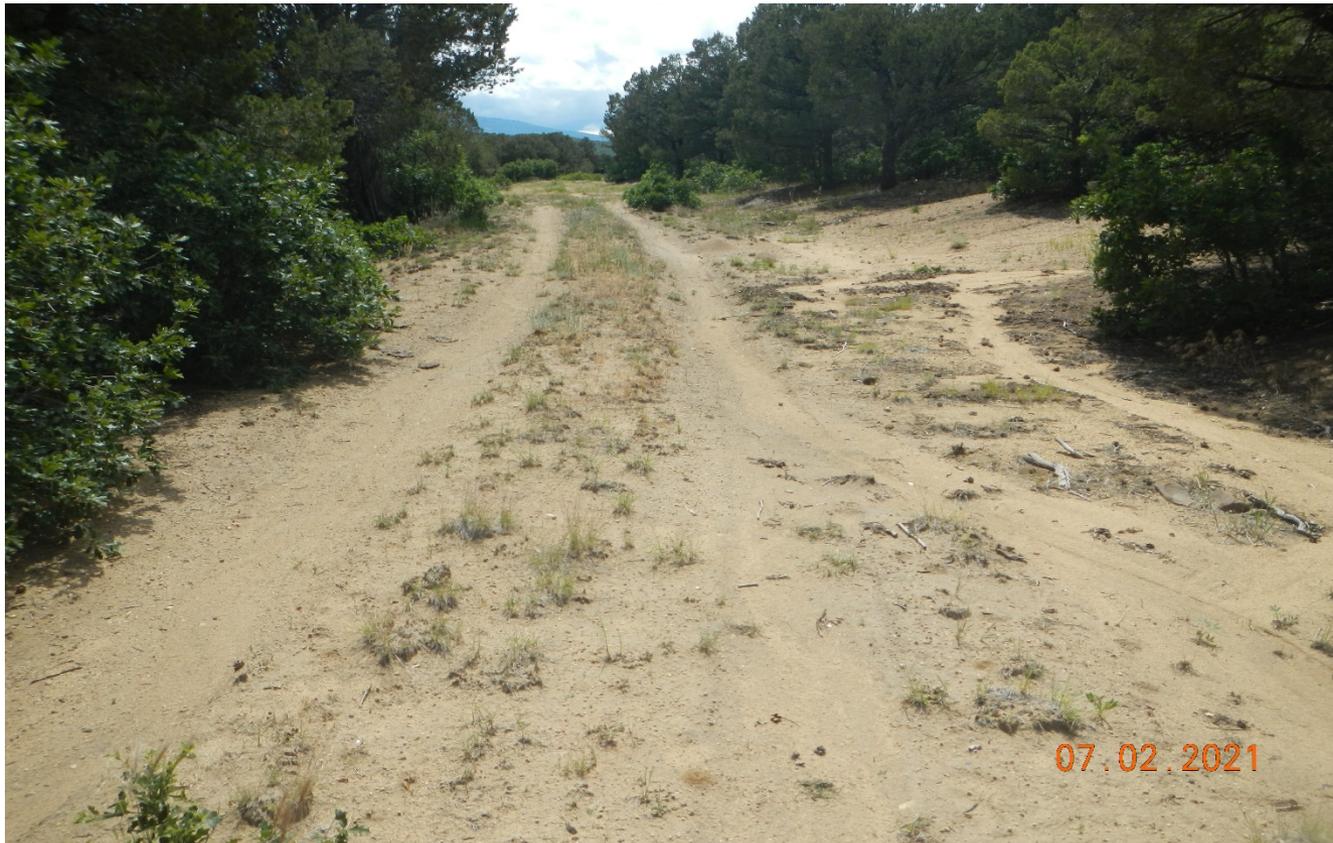
Photo 2. Facing southwest along the former access road which was not reclaimed.

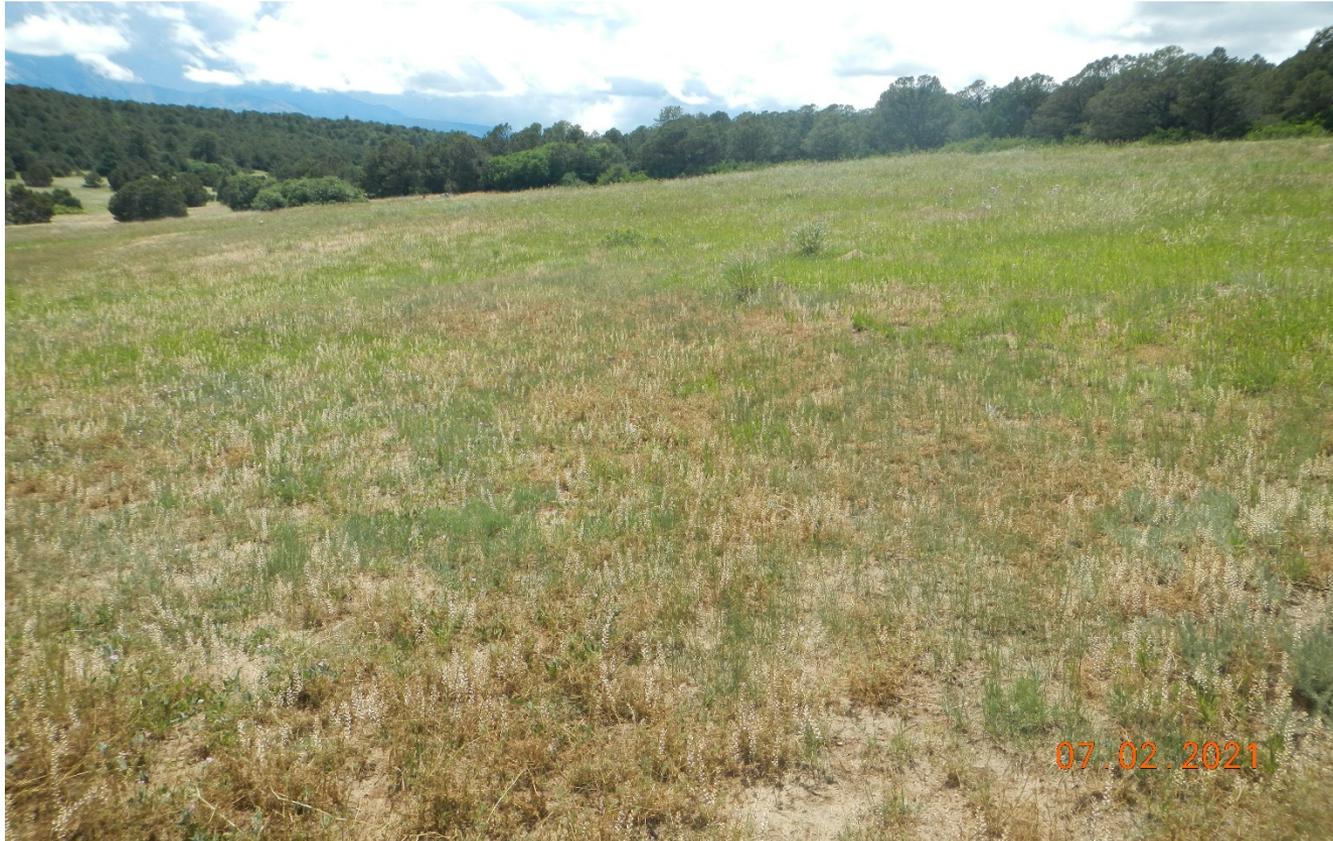
Photo 3. Facing southwest toward the location which was recontoured and reclaimed. There is desirable vegetation established throughout most of the location.

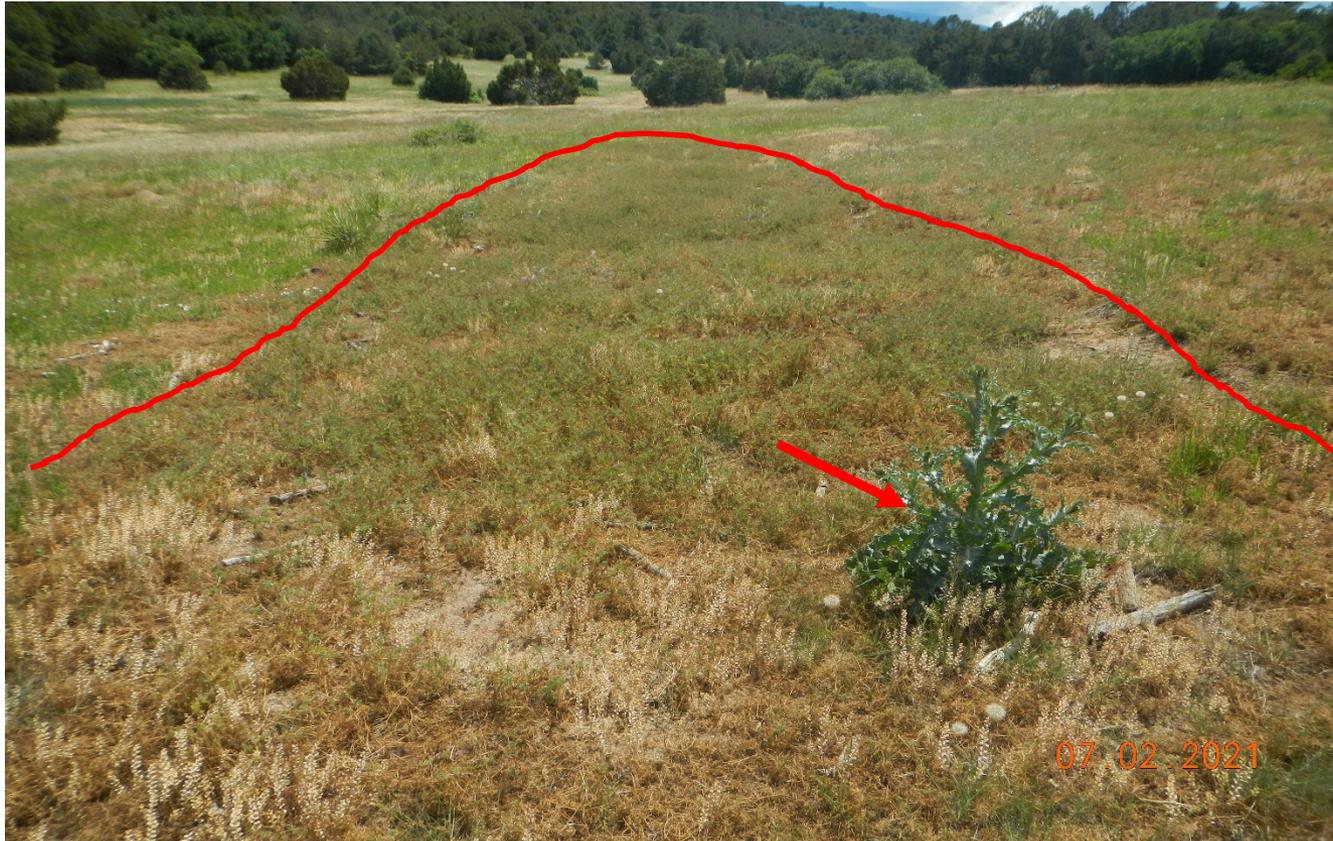
Photo 5. South side of the location facing southwest. The area under red line consists of weeds and arrow points to Scotch thistle noxious weed.

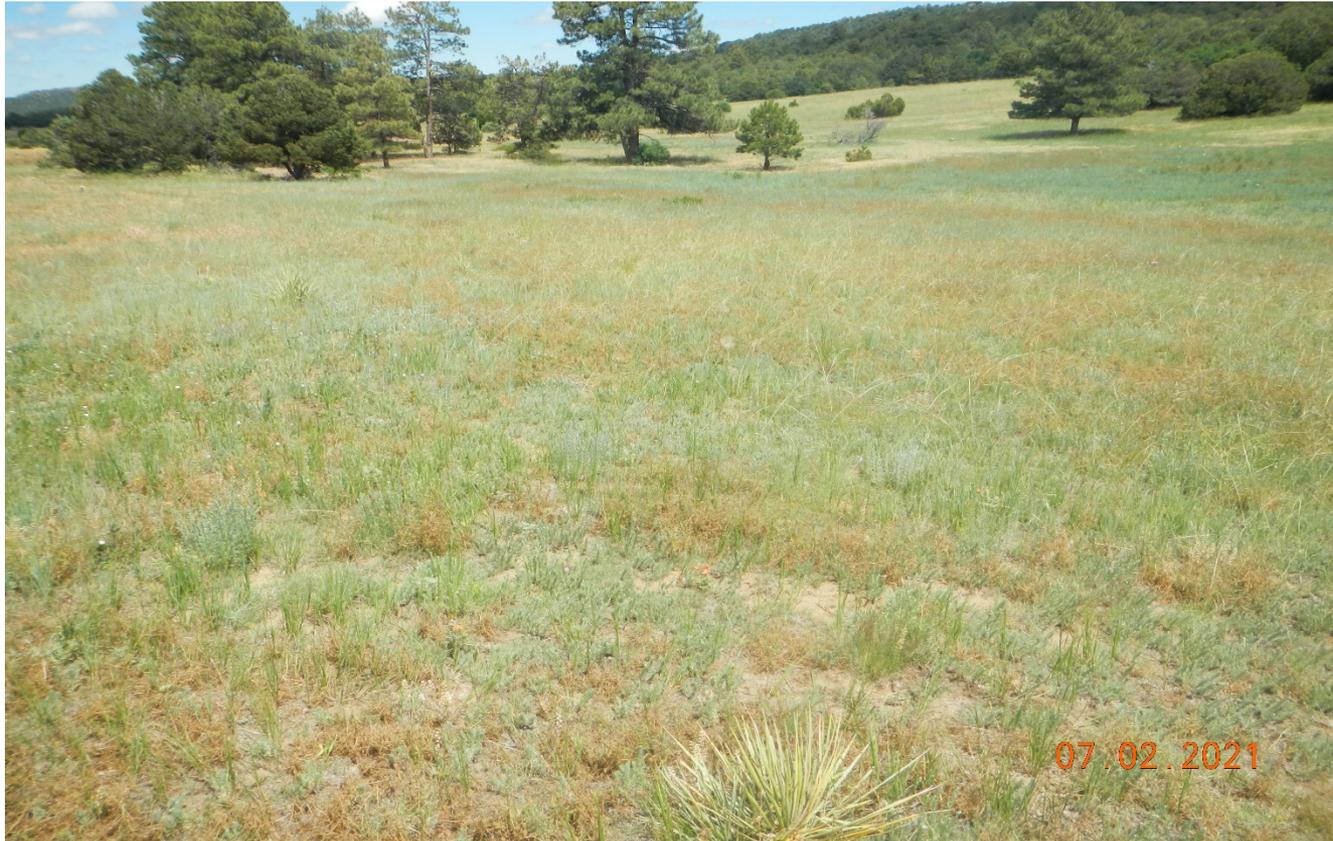
Photo 6. Facing southeast at the surrounding undisturbed vegetation which consists of Western wheat, Needle and thread grass, Blue fringed sage, among other native species as well as weeds.
