Inspection Photos  
Operator: Simcoe  
API: 067-08664  
Date: 7/2/2021

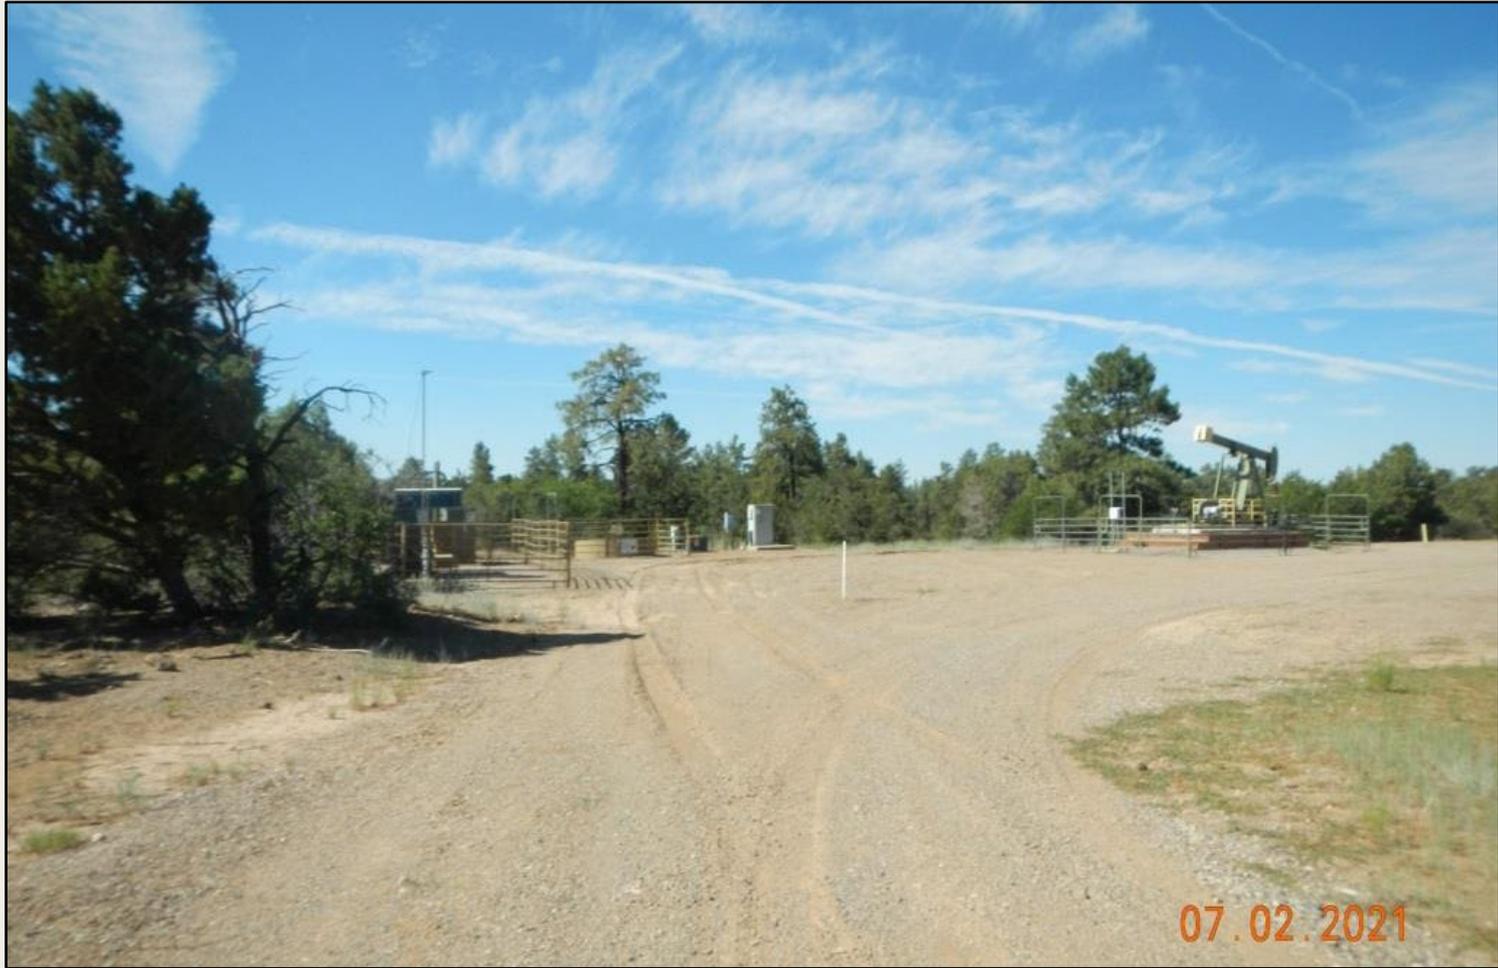
Photo 1. View the project area from the southwestern corner facing center.

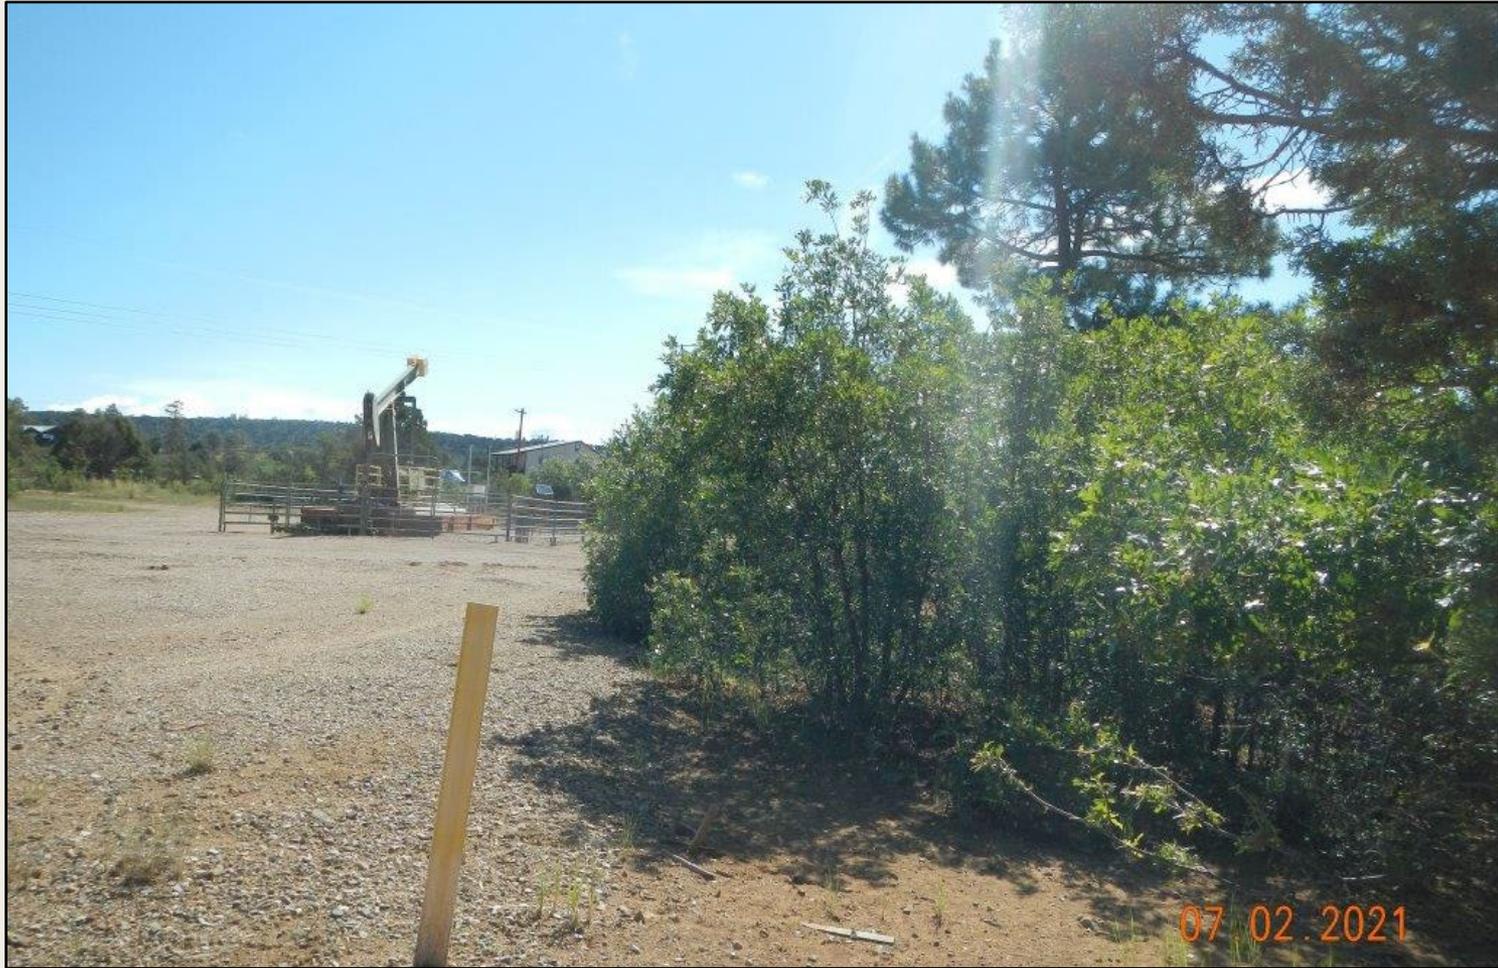
Photo 2. View of the southern project area from the southwestern corner facing eastward. Revegetation is progressing with smooth brome.

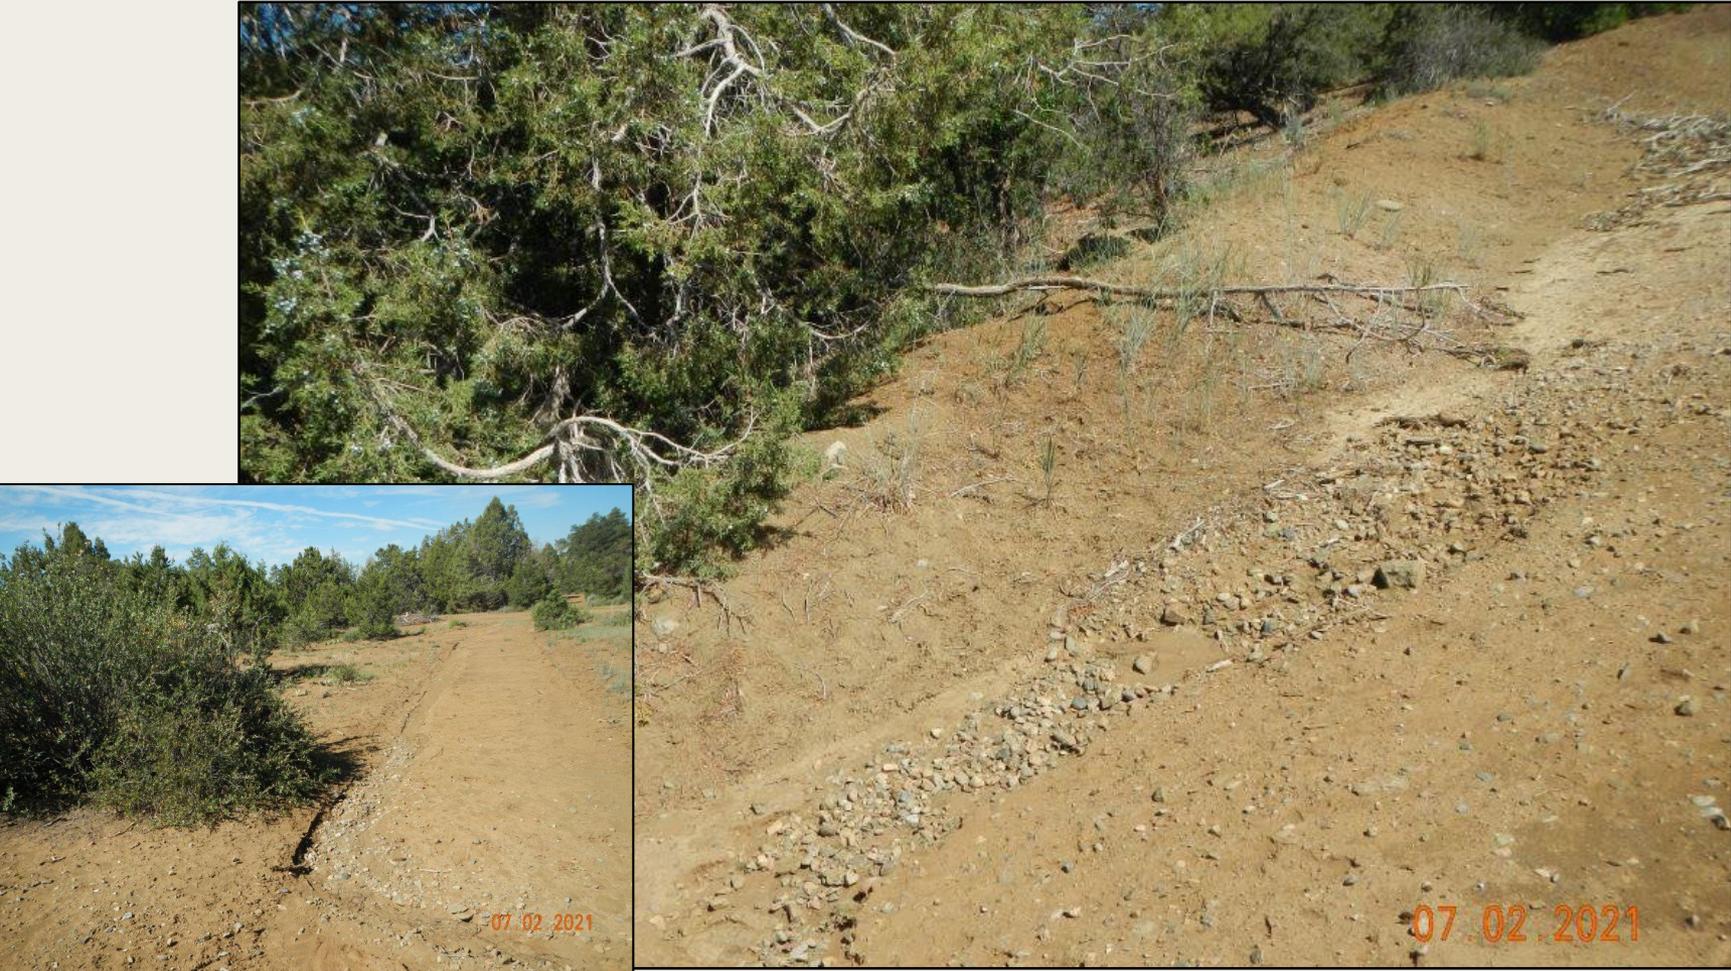
Photo 3. View of erosional channel forming (approximately 6 inches deep and 1.5 feet wide) and sediment deposition within the southwestern project area (facing upslope). Inset shows channel flowing off of the project area and downcutting.

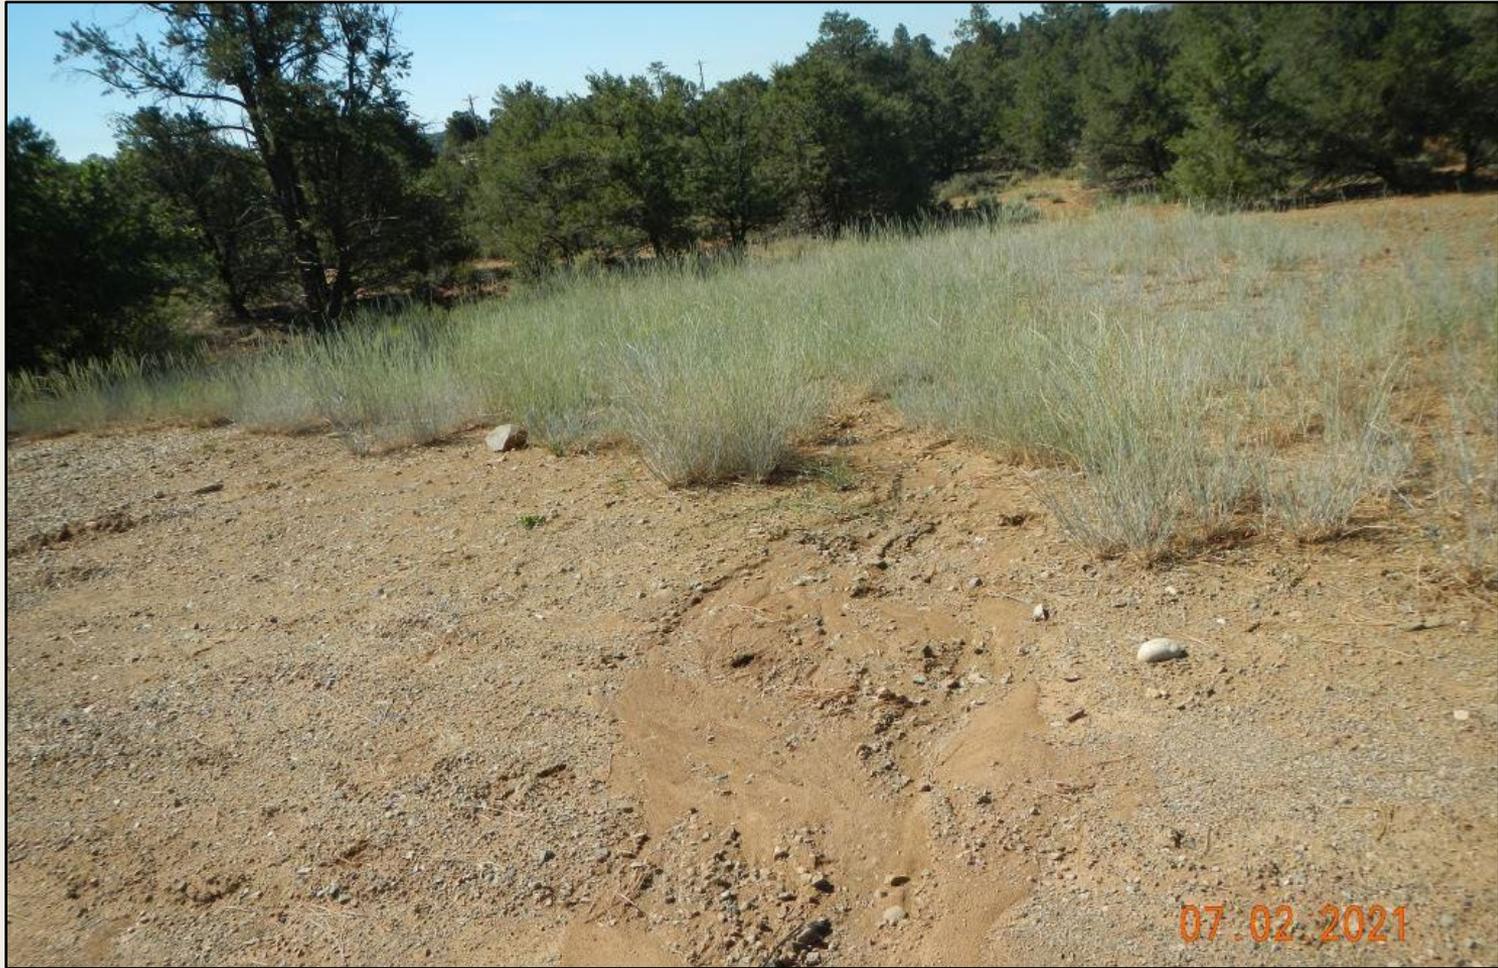
Photo 4. View of erosional channel forming and sediment deposition within the southern project area (facing downslope).

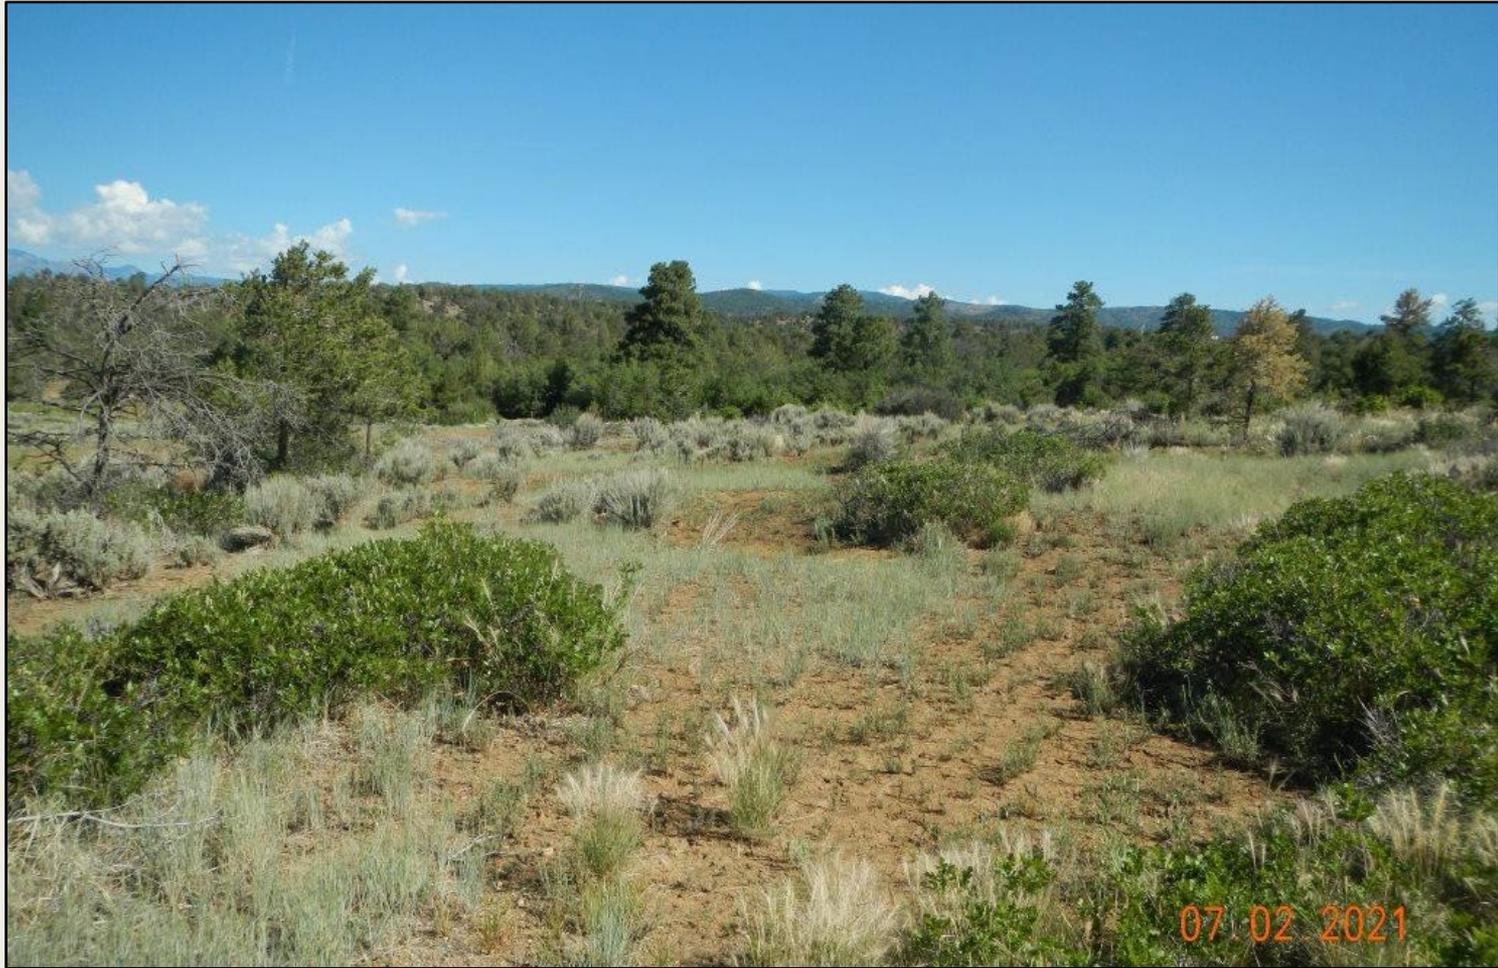
Photo 5. View the reference area comprised of black sagebrush shrubland with gambel oak, western wheatgrass, and squirreltail.
