Inspection Photos

Location Name: TEP ROCKY MOUNTAIN LLC UNOCAL-66S96W /33SESE

Location ID: 334849

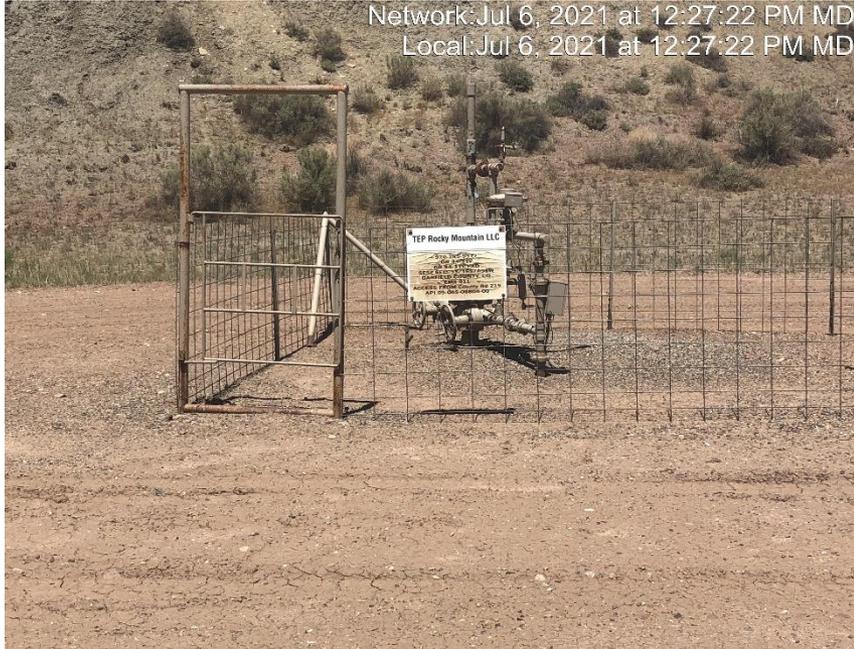
Photo #4304 Wellhead sign weathered and not legible.

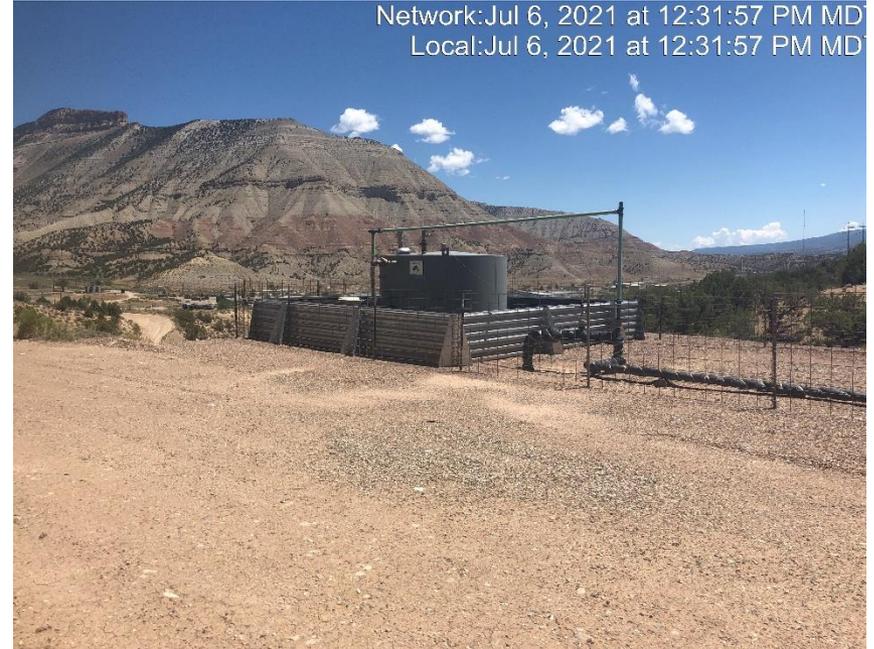
Photo #4308 No battery sign located at the tank battery.

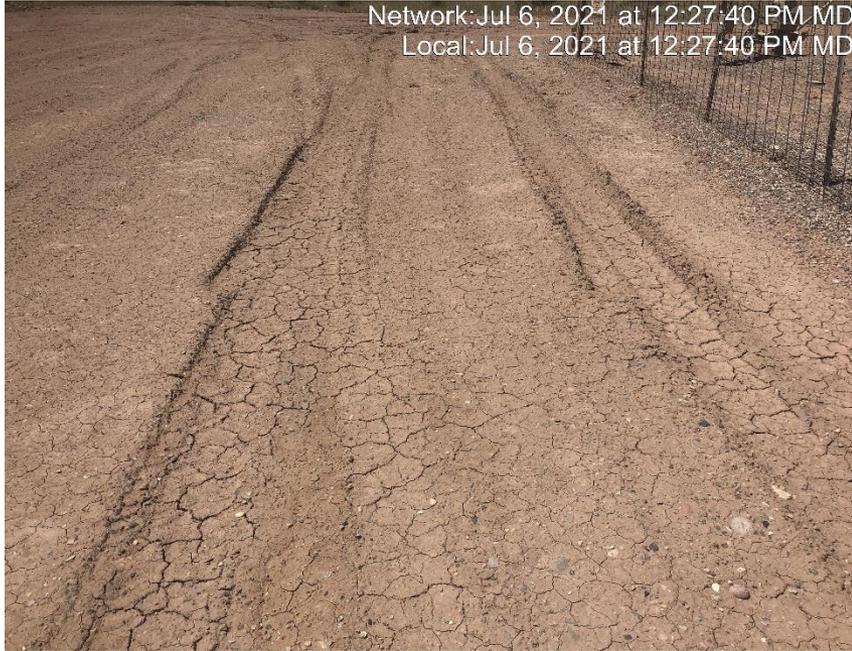
Photo #4305 Location lacks stabilization.

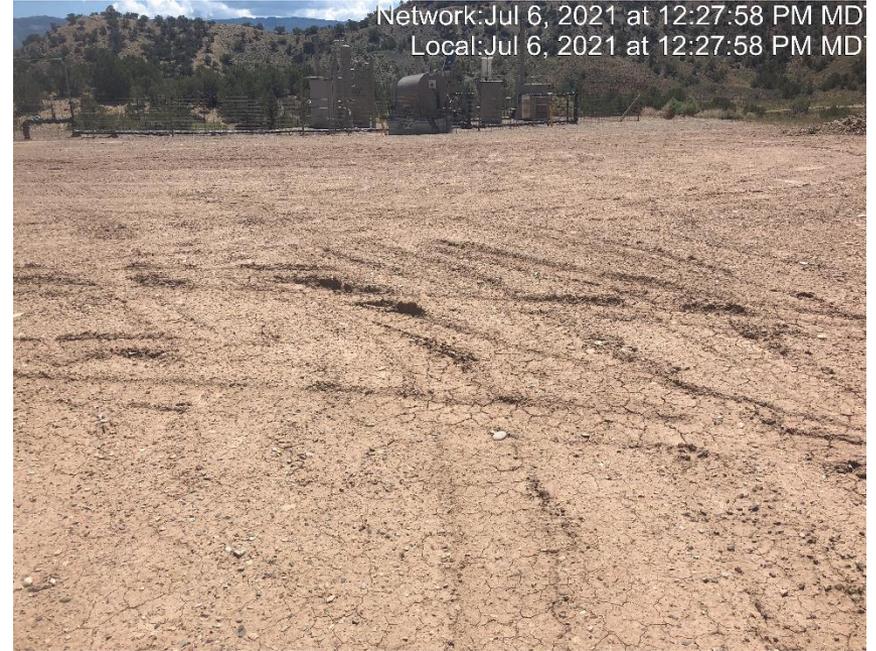
Photo #4306 Location lacks stabilization.

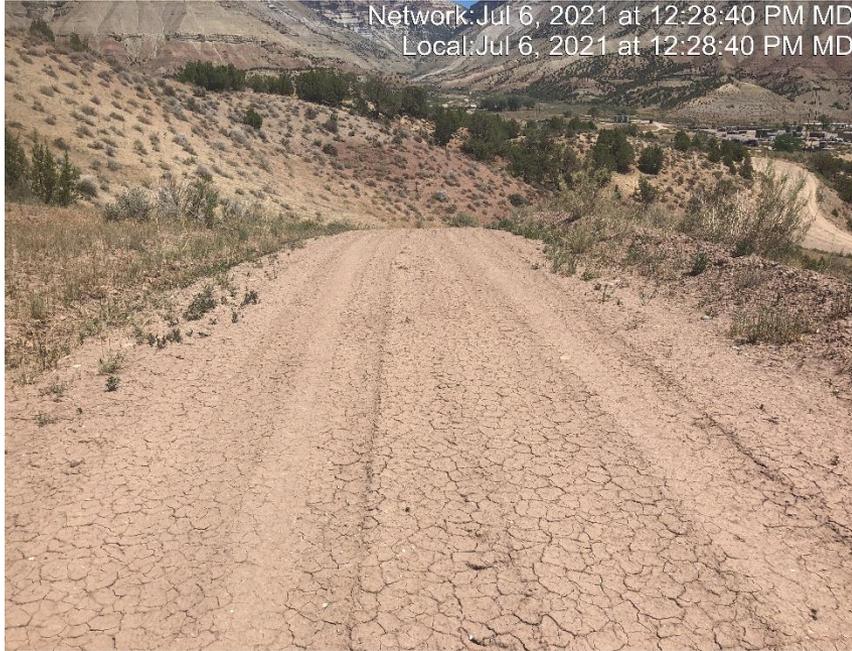
Photo #4307 No form of tracking BMP located at entrance to location.

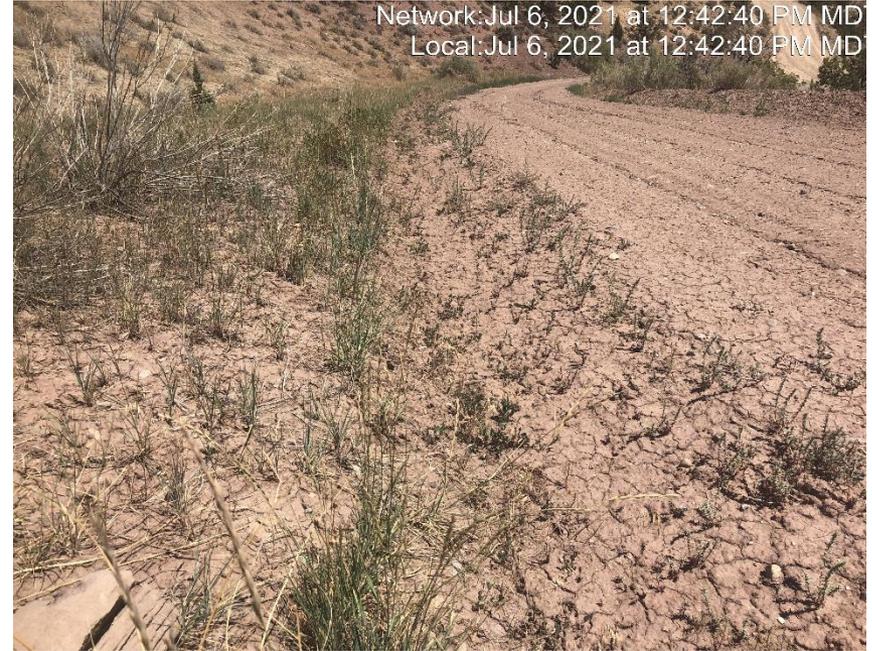
Photo #4309 No form of velocity check located in access road ditches.

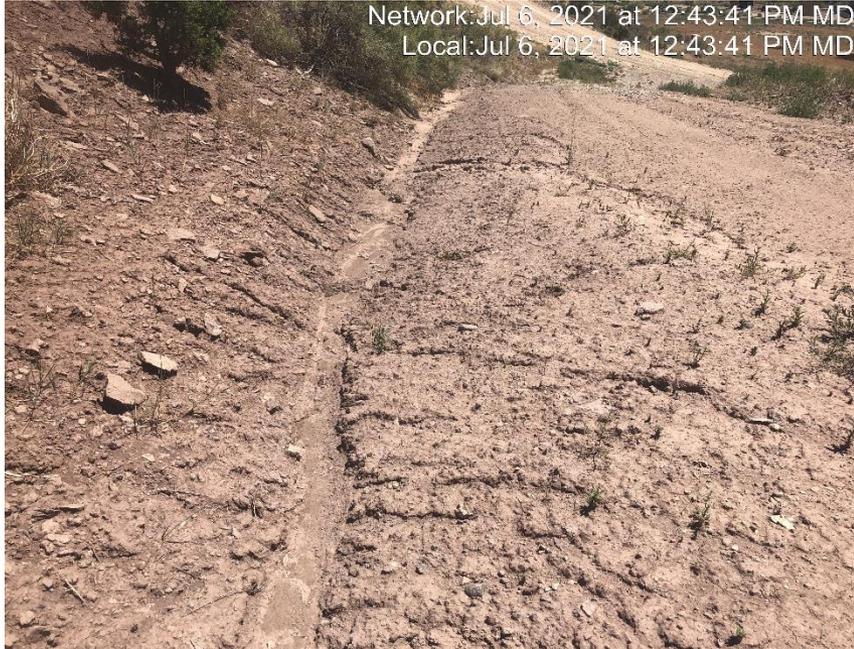
Photo #4310 Rill erosion occurring in access road ditch.

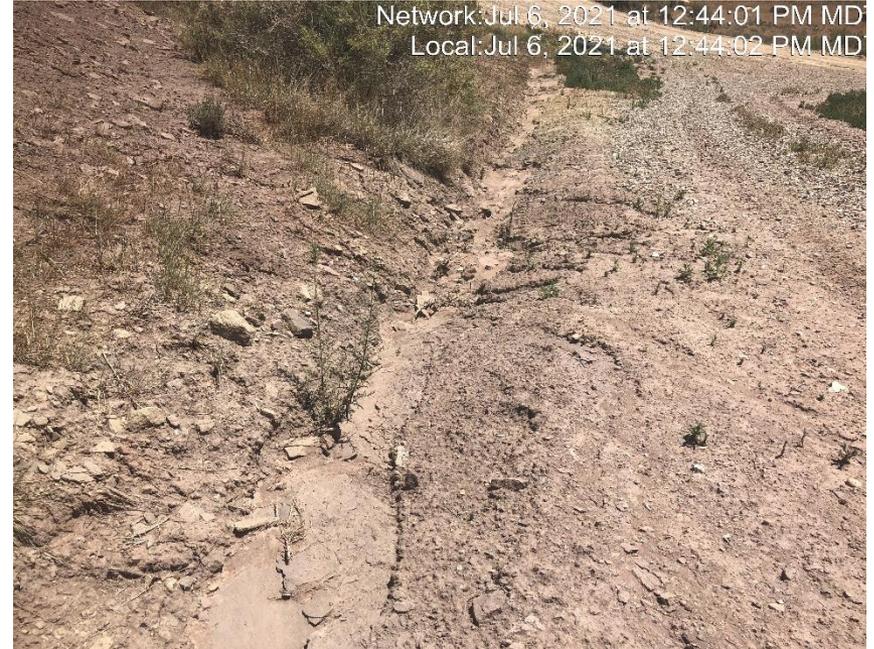
Photo #4311 Rill erosion occurring in access road ditch.

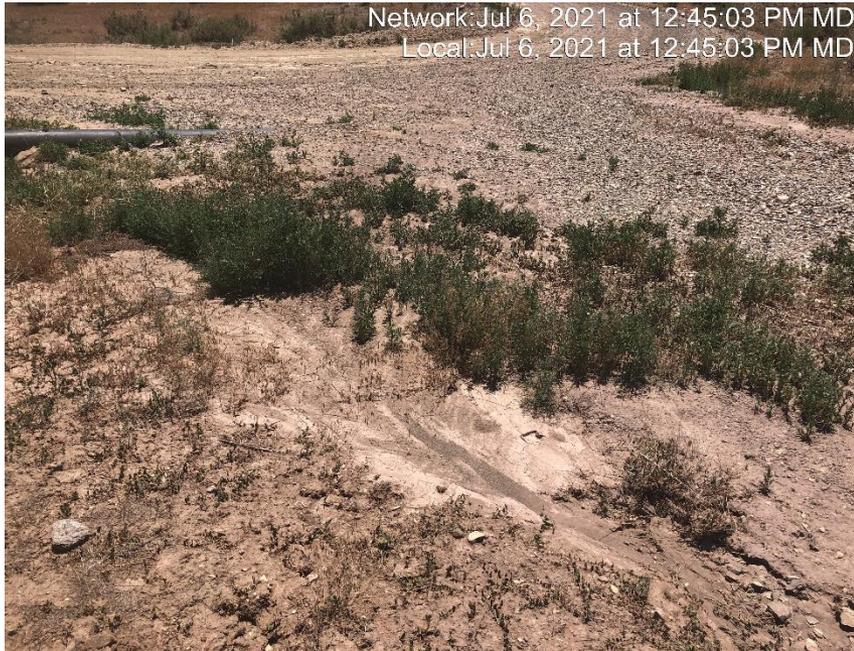
Photo #4312 Sediment accumulation at entrance to access road.

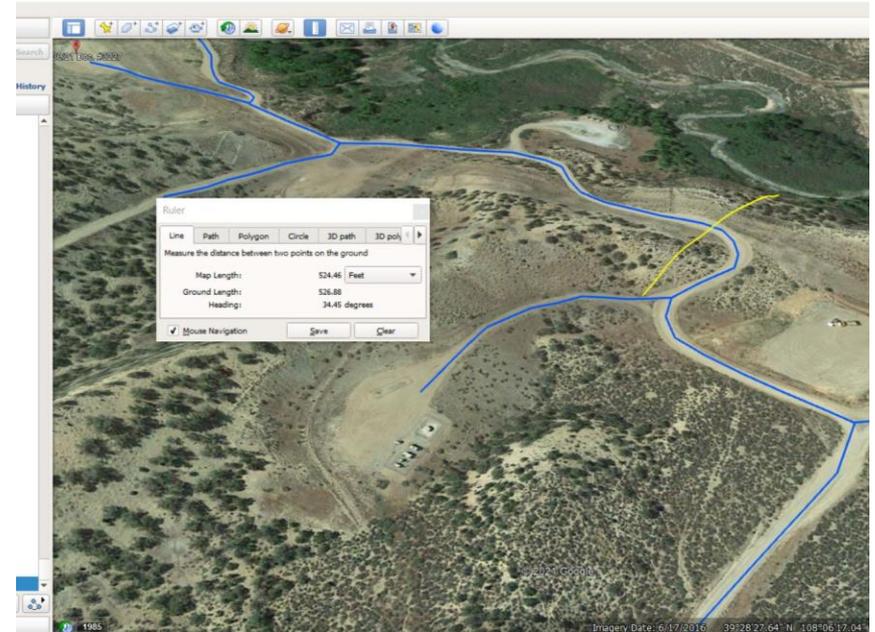
Access road is located approximately 525 feet from Parachute creek.
