Inspection Photos

Location Name: TEP ROCKY MOUNTAIN LLC UNION ENERGY MINING DIV.-66S96W /33SWSE,
Location ID: 334868

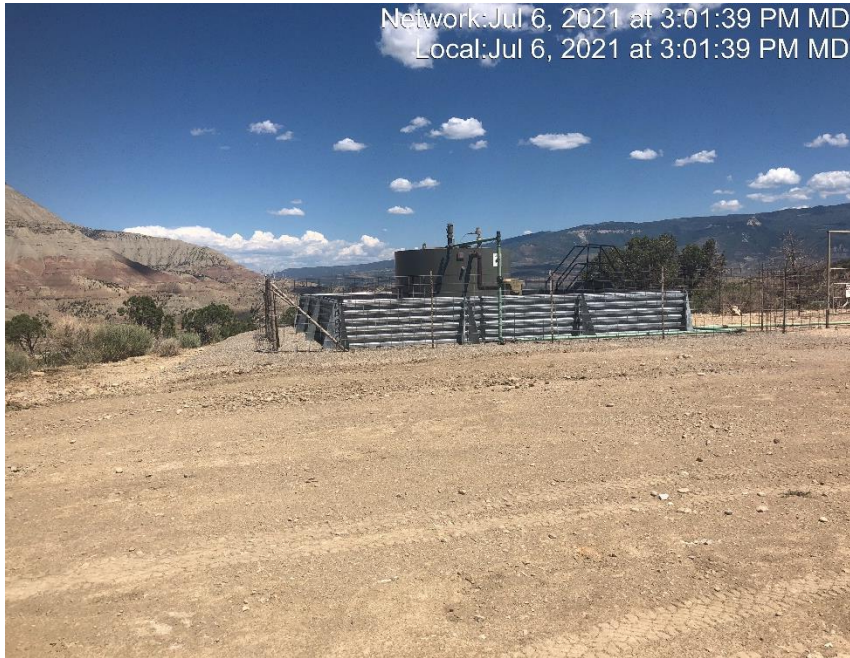
Photo #4325 No battery sign located at the tank battery.

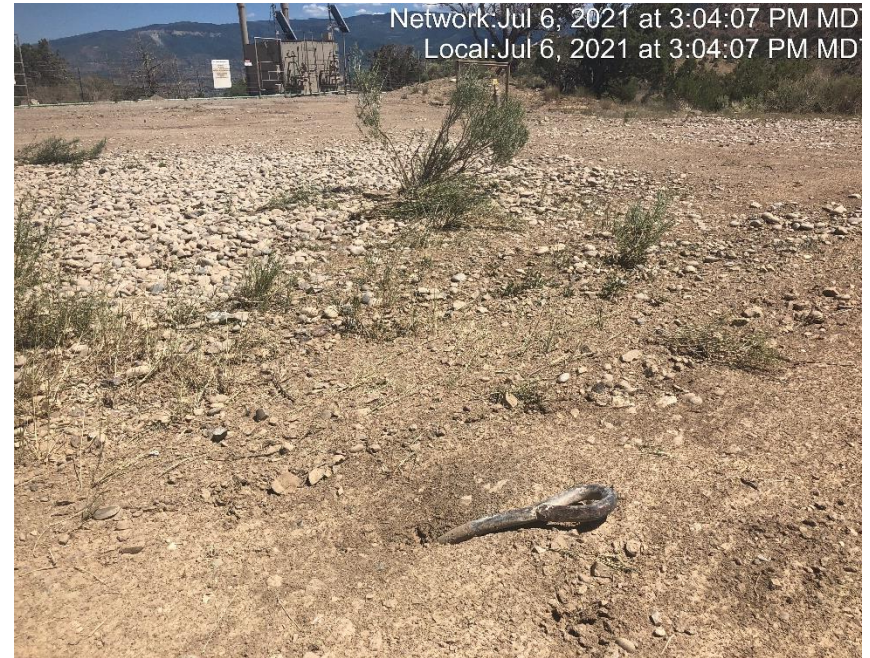
Photo #4328 Unmarked deadman.

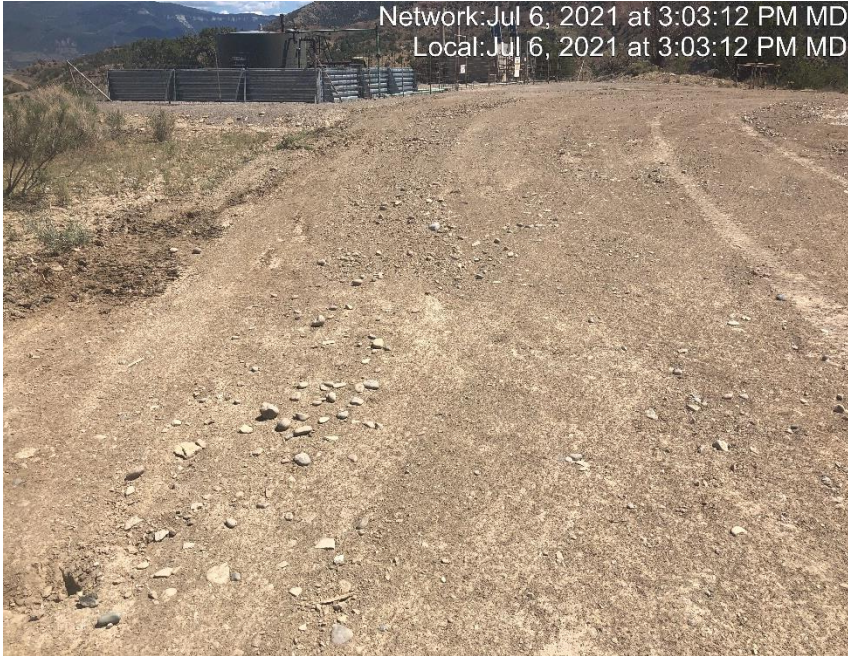
Photo #4326 Location lacks stabilization.

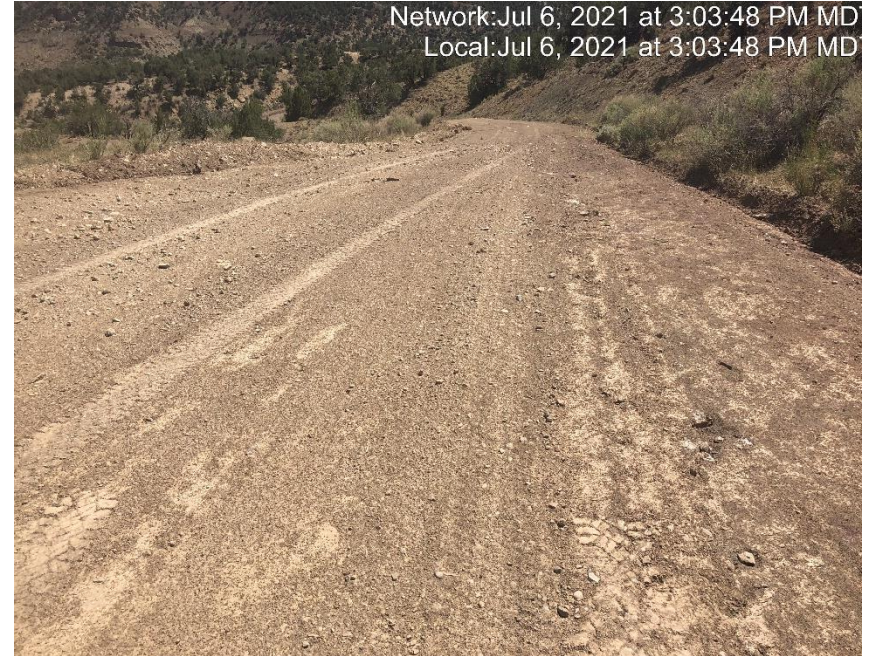
Photo #4327 Access road lacks stabilization.

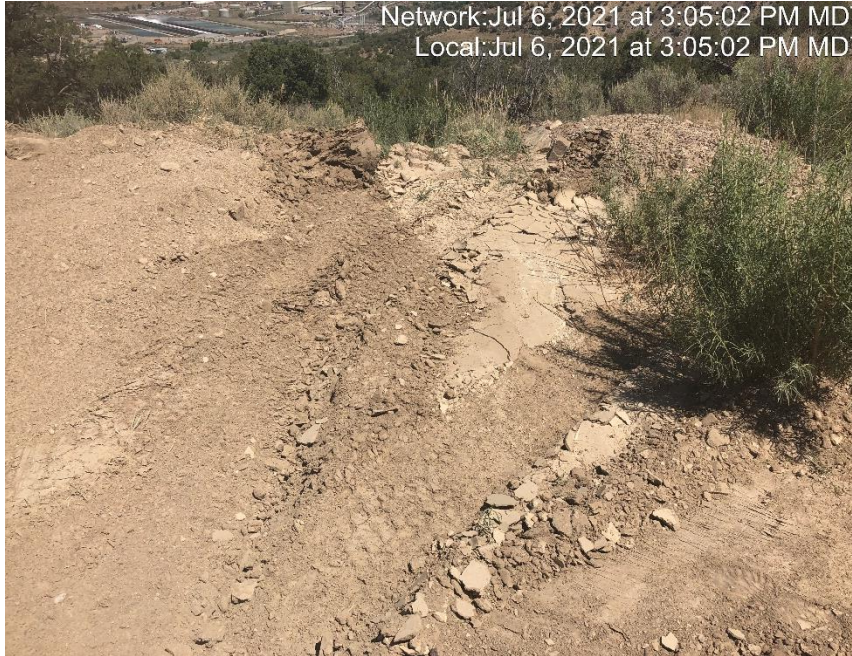
Photo #4329 Sediment trap insufficient.

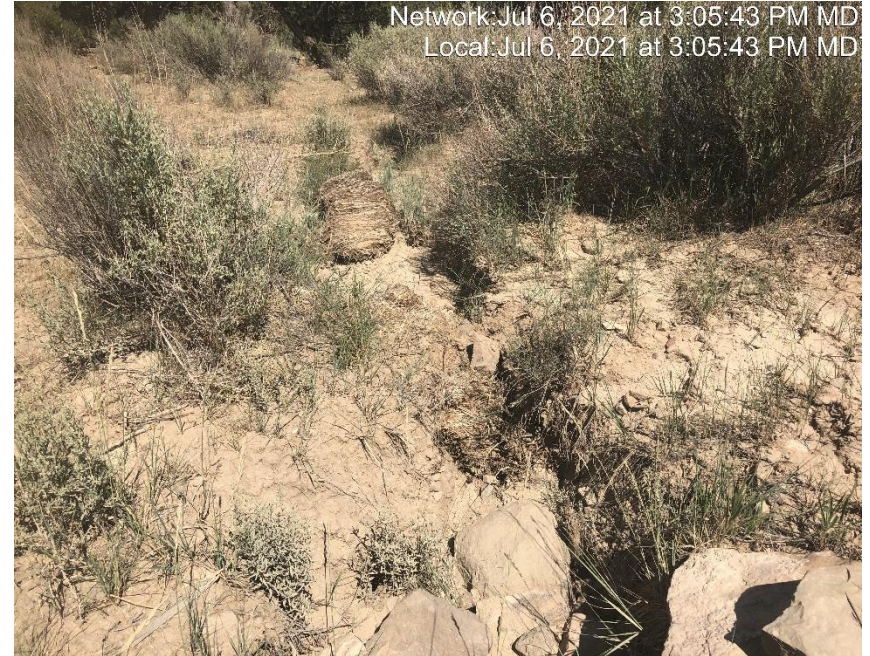
Photo #4331 Gully erosion occurring downstream of sediment trap.

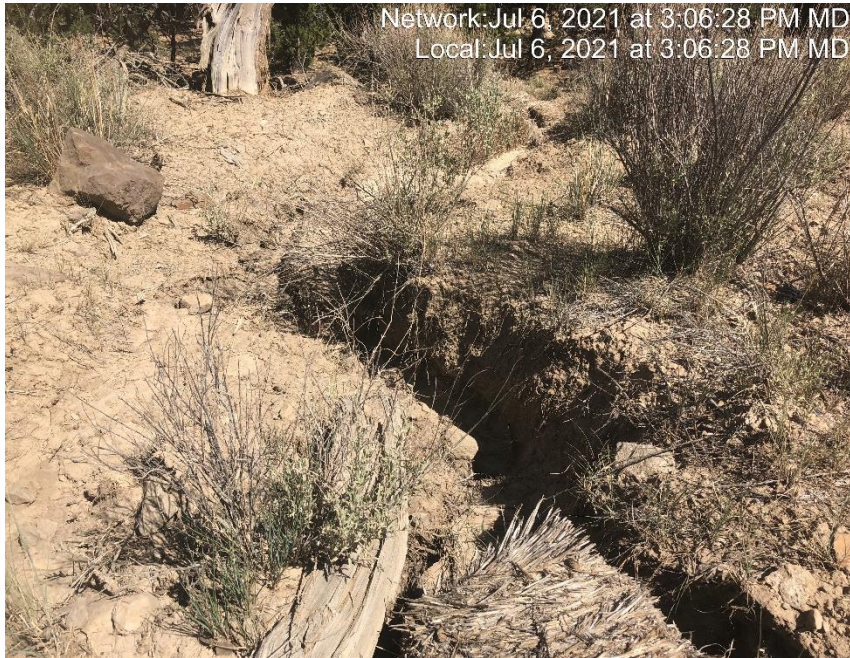
Photo #4333 Velocity checks insufficient.

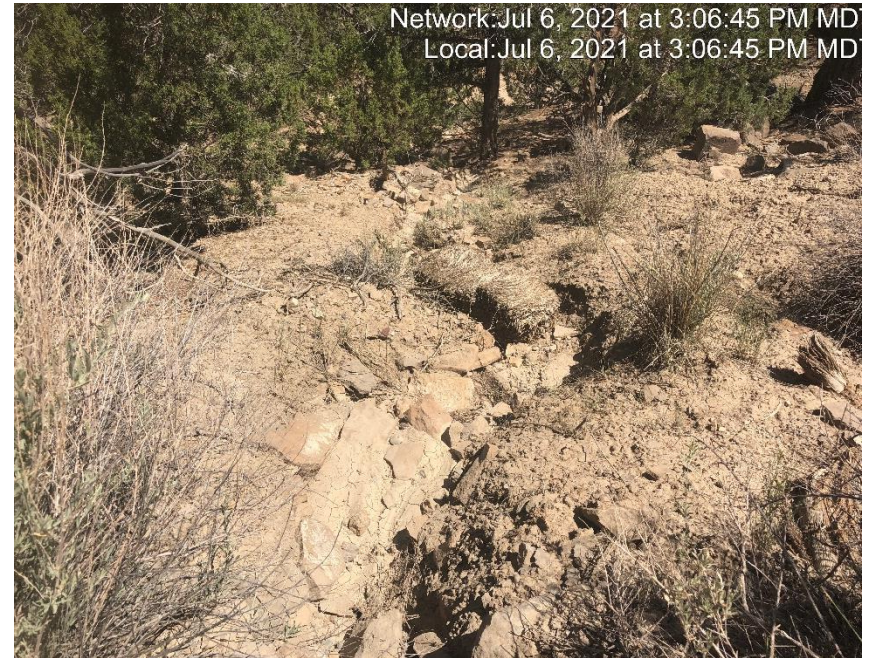
Photo #4334 Gully erosion continued. Velocity checks insufficient.

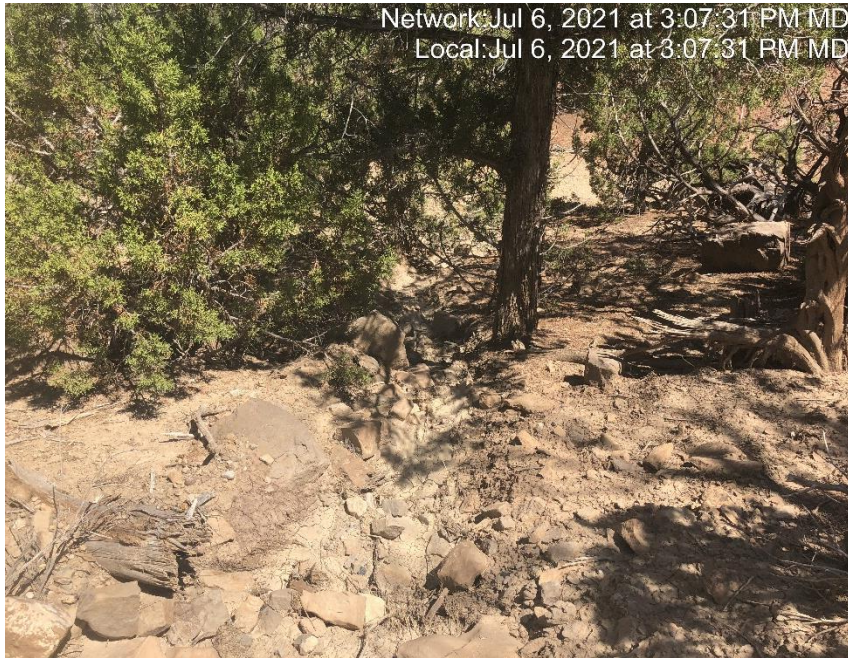
Photo #4335 Gully erosion continues into tree line.

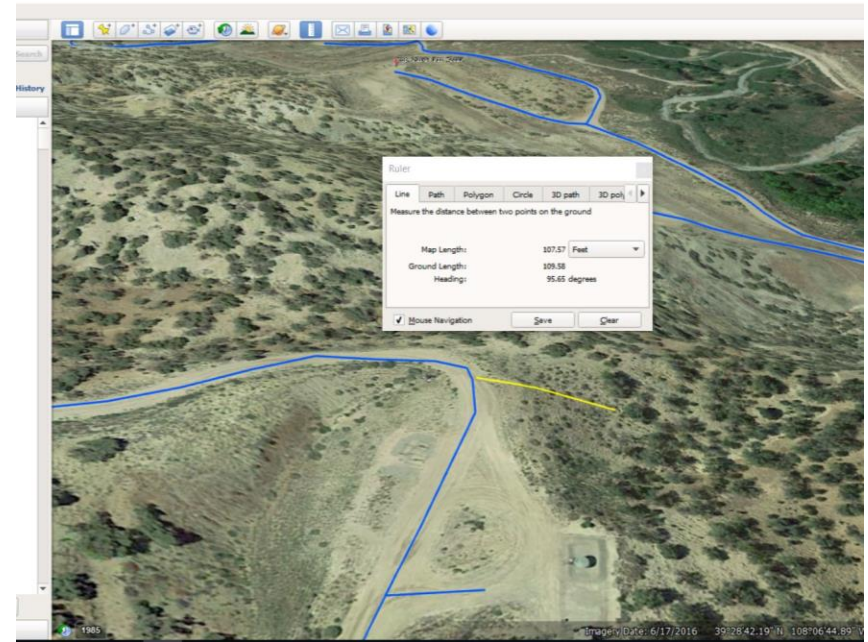
Gully erosion down cut slope for approximately 100 ft.

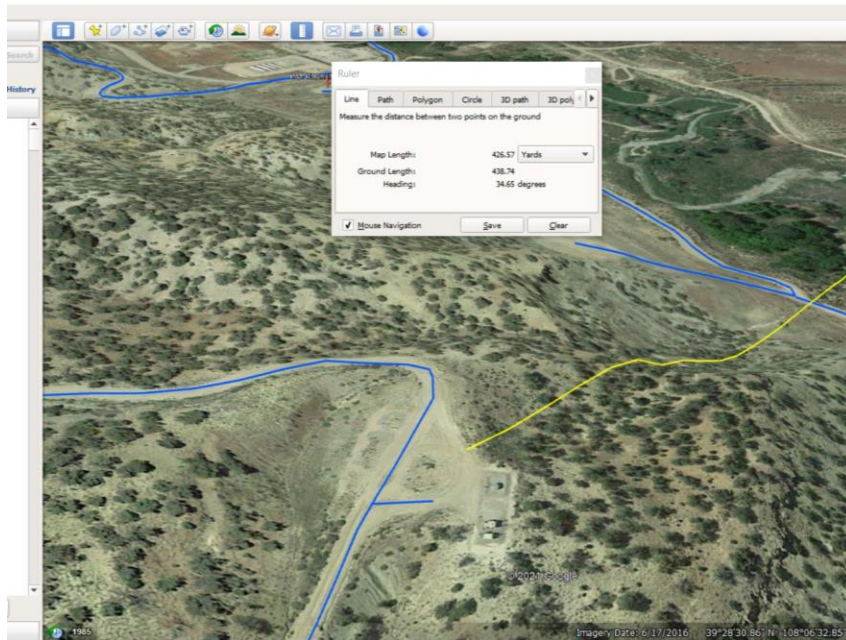
Location is approximately 440 yards form Parachute creek
with a 300 ft. elevation change.
