# Inspection Photos

API: 071-06347

Operator: OGRIS OPERATING LLC

Inspection Date: 7/7/2021

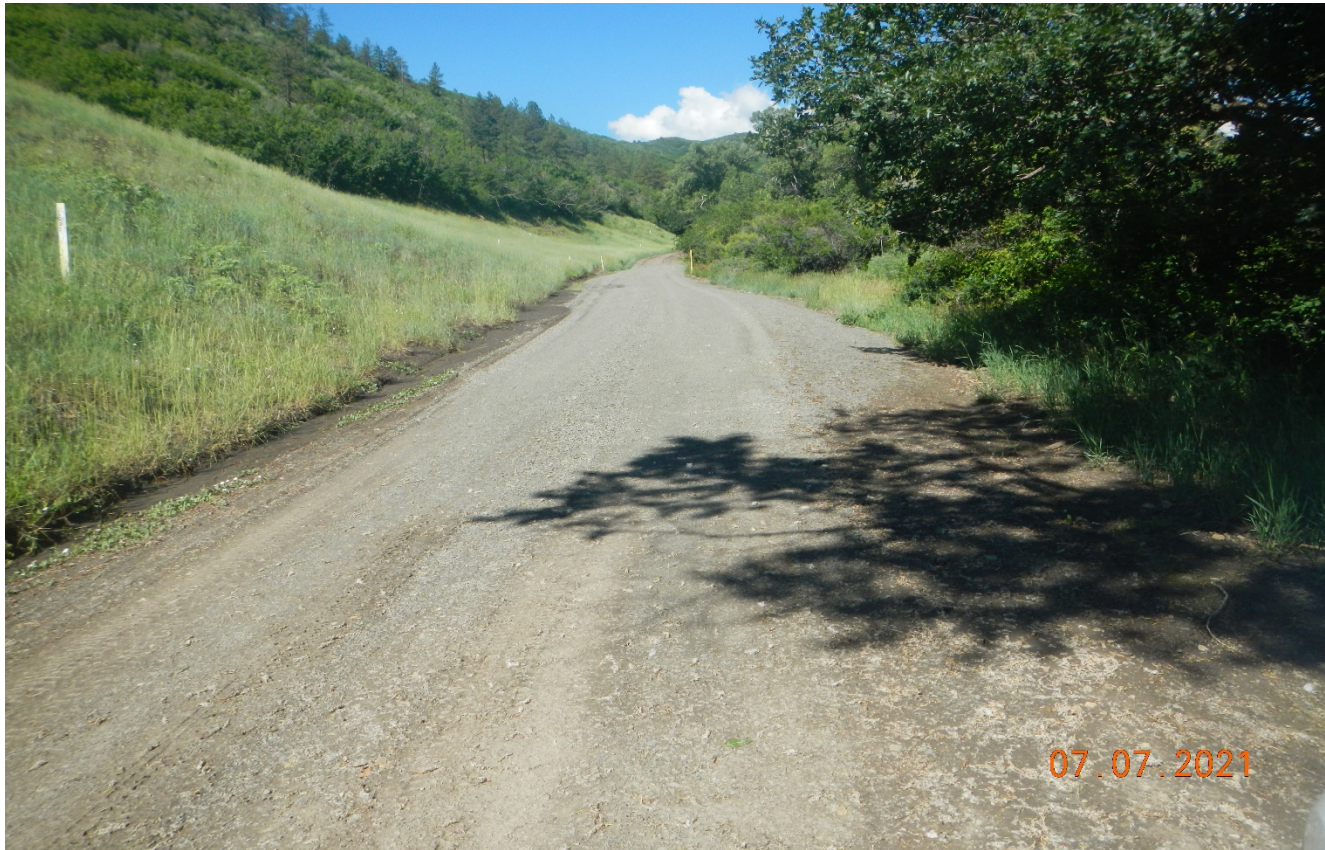
**Photo 1.** The road was regraded and gravel was applied to areas of the road.

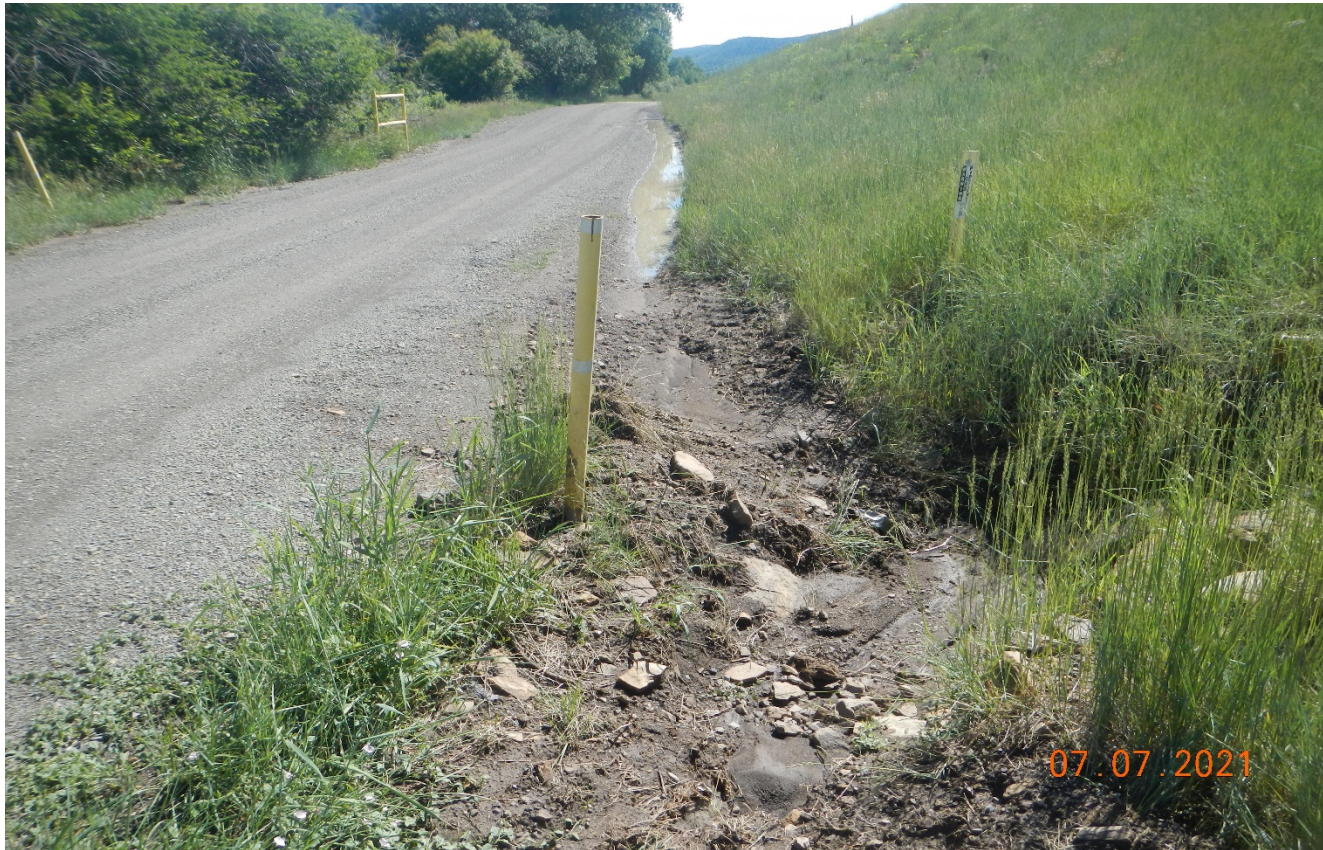
**Photo 2.** It appears recent rain events have deposited sediment into the culverts. Ongoing maintenance needs to be performed.

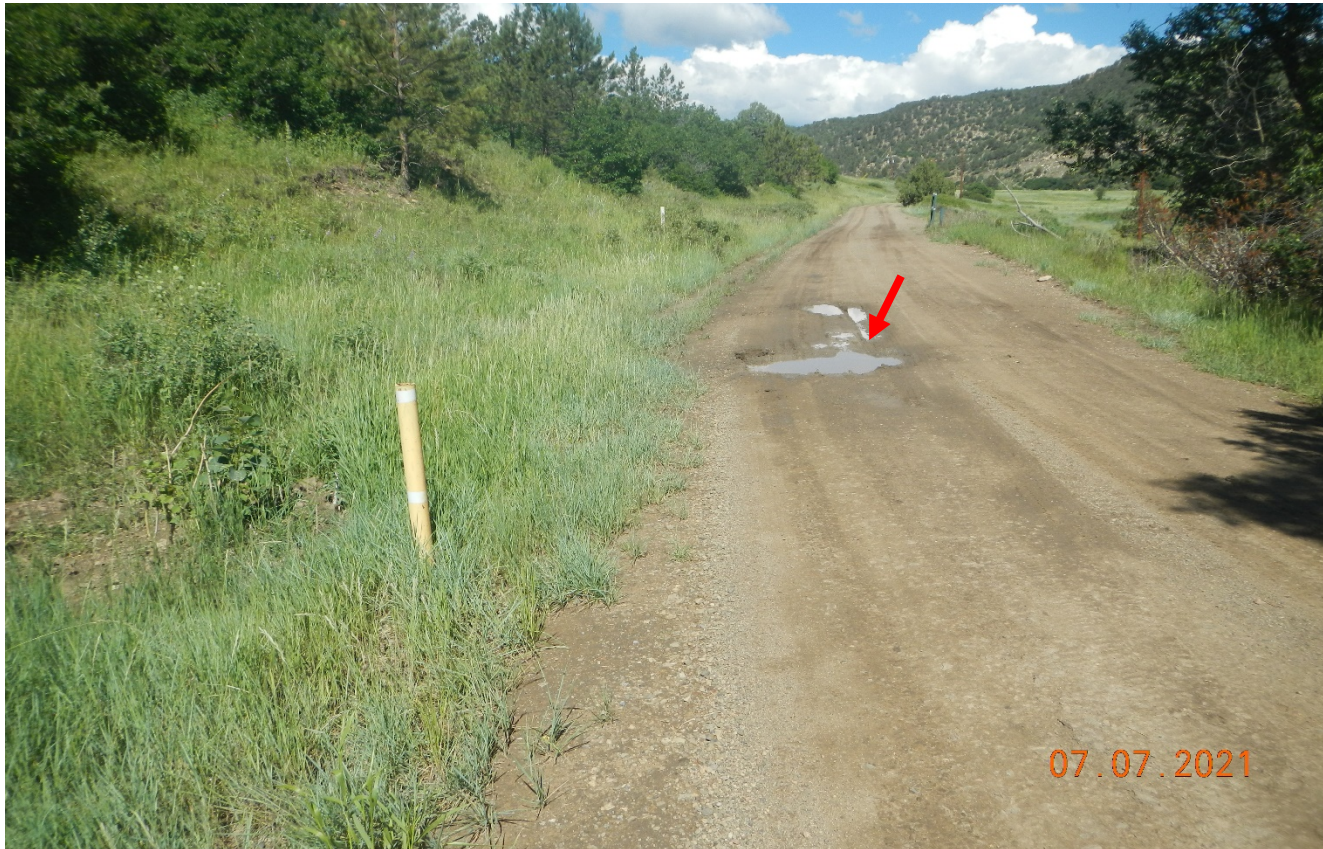
**Photo 3.** Additional grading will be needed to drain stormwater toward the culvert in this area. Stormwater is already accumulating on the road shown at red arrow.  
Lat/Long:37.06585,-104.93198.

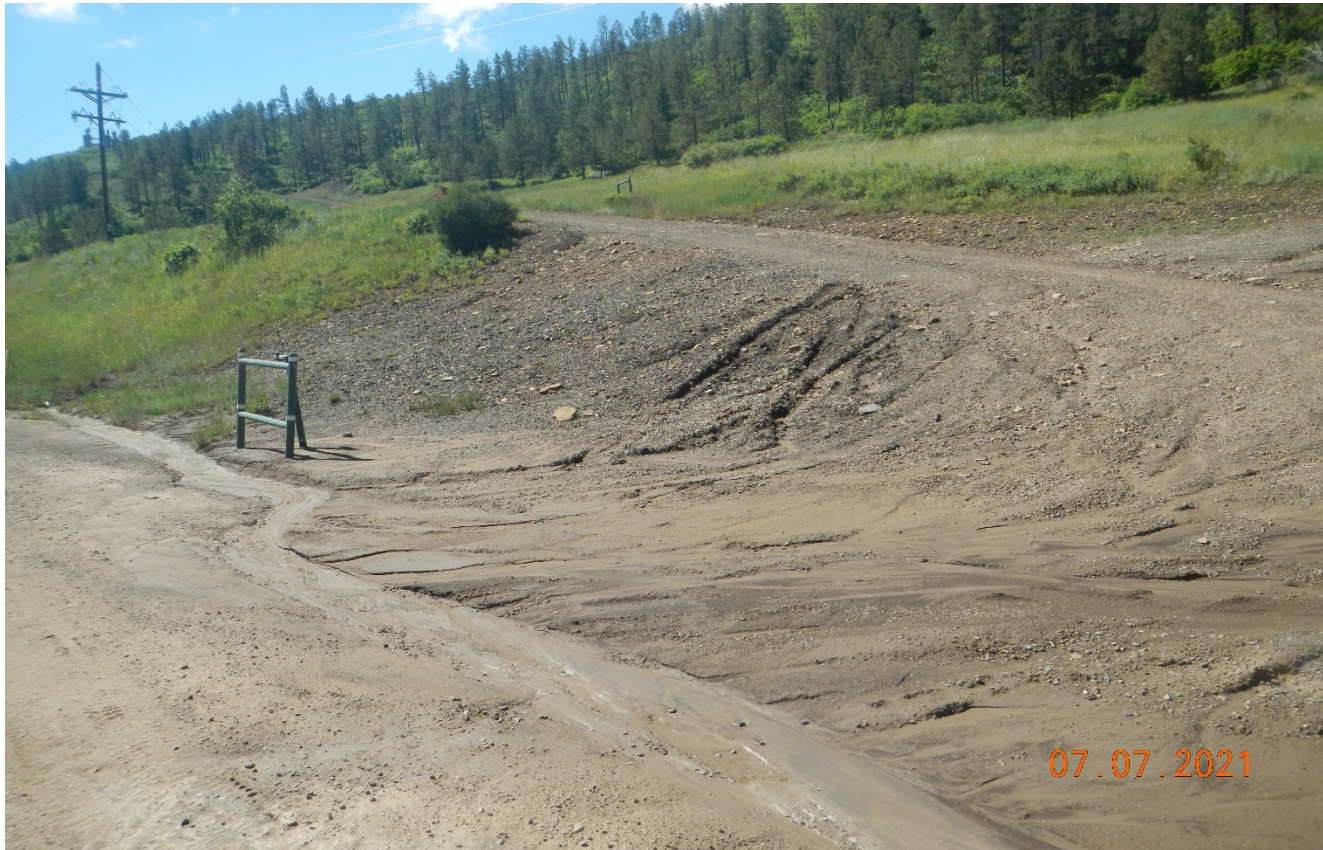
**Photo 4.** Facing southeast toward the access road. Stormwater is directed toward the culvert shown at red arrow. Sediment is already filling into this area which will require ongoing maintenance.

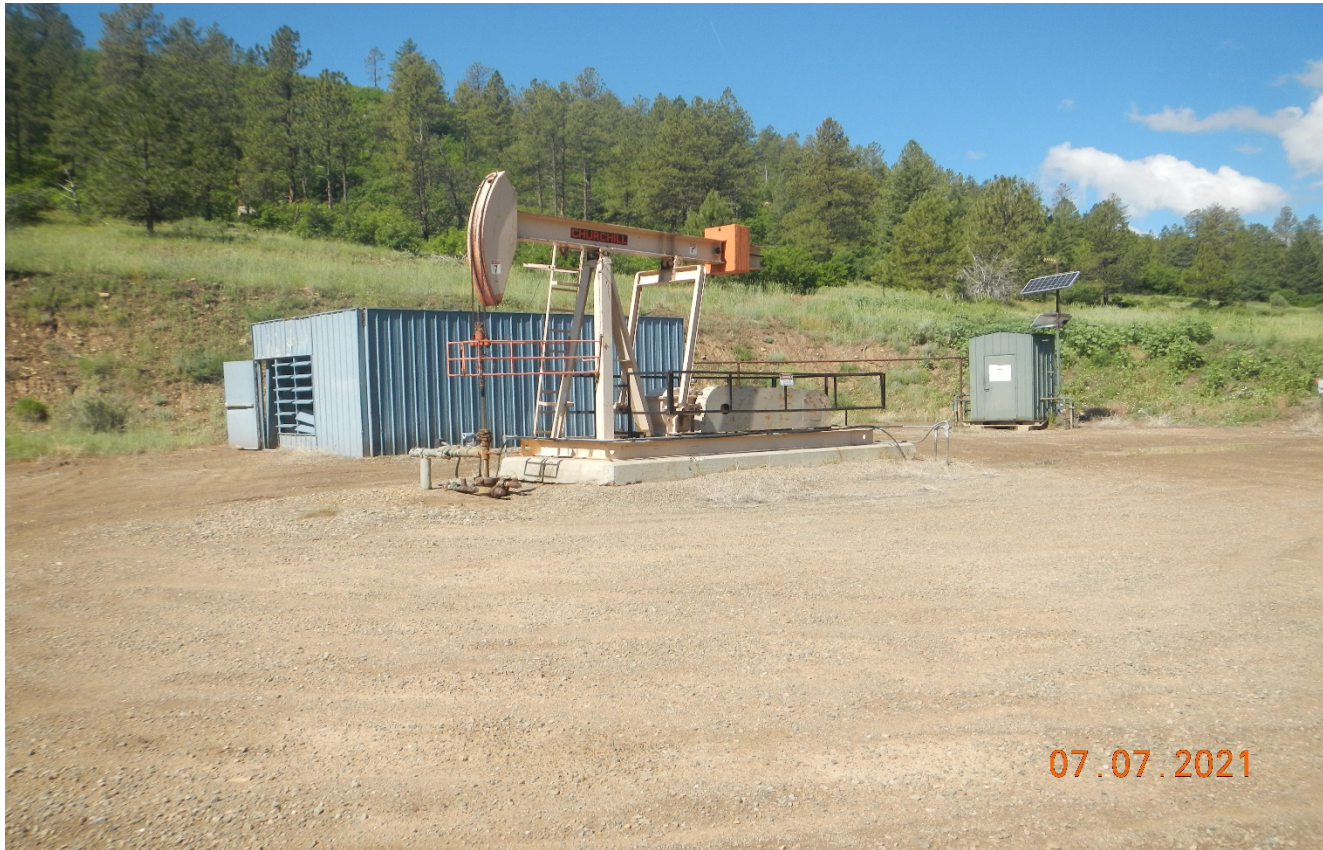
**Photo 5.** Facing toward the well site.
