Inspection Photos

API: 071-08927

Operator: OGRIS OPERATING LLC

Inspection Date: 7/7/2021

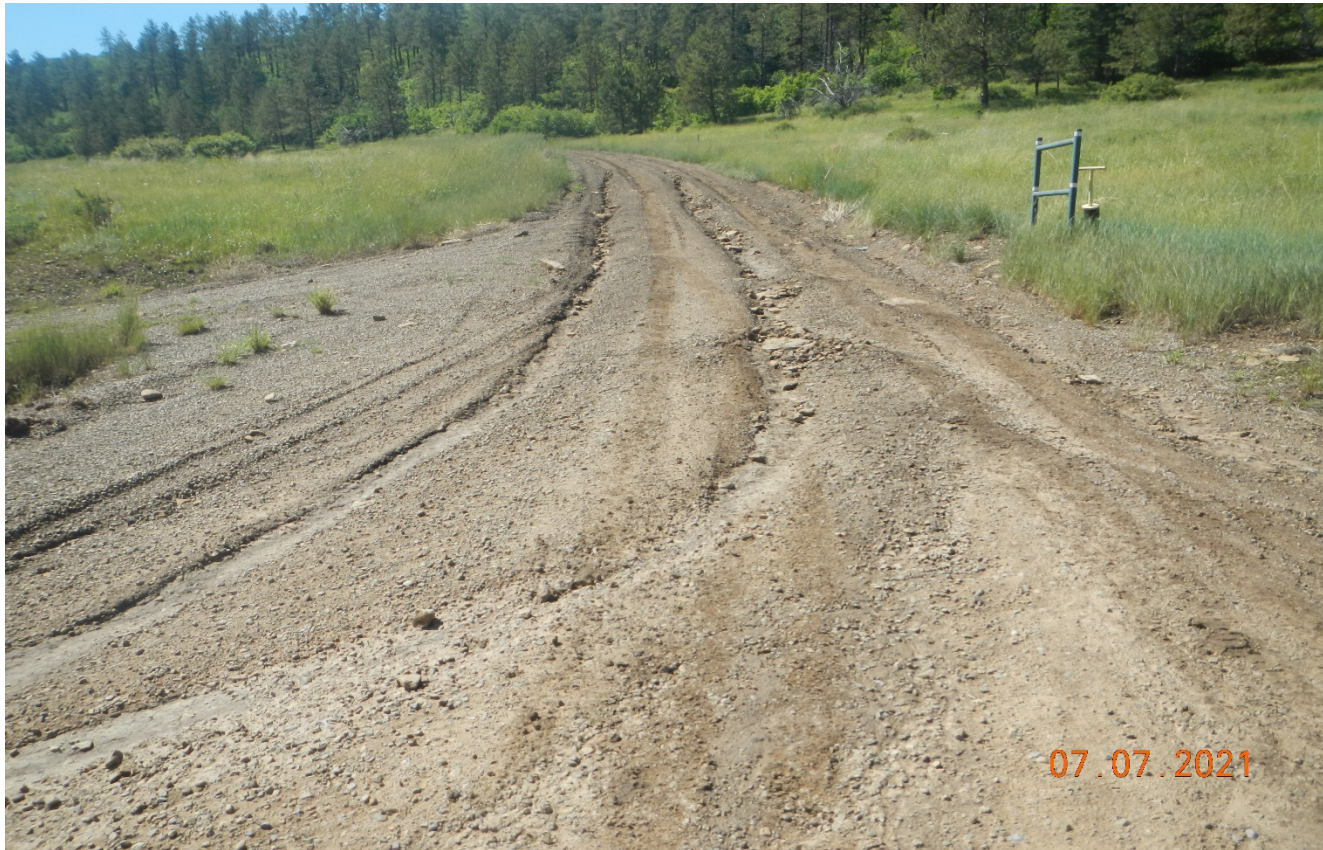
Photo 1. Facing southeast along the access road. The road is not stabilized and there are signs of erosion.

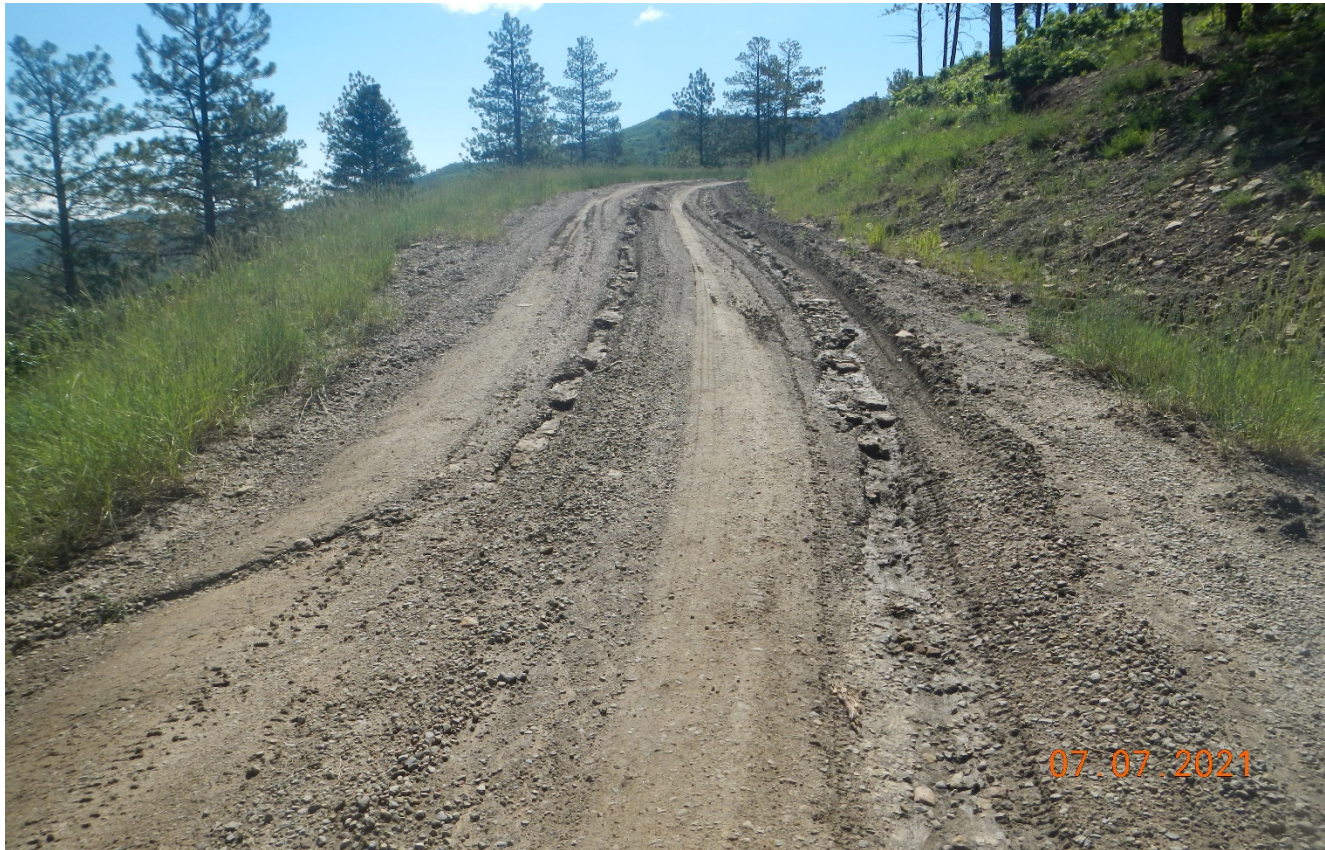
Photo 2. Facing southeast further along the access road. The road is not stabilized and there are signs of erosion and vehicle rutting.

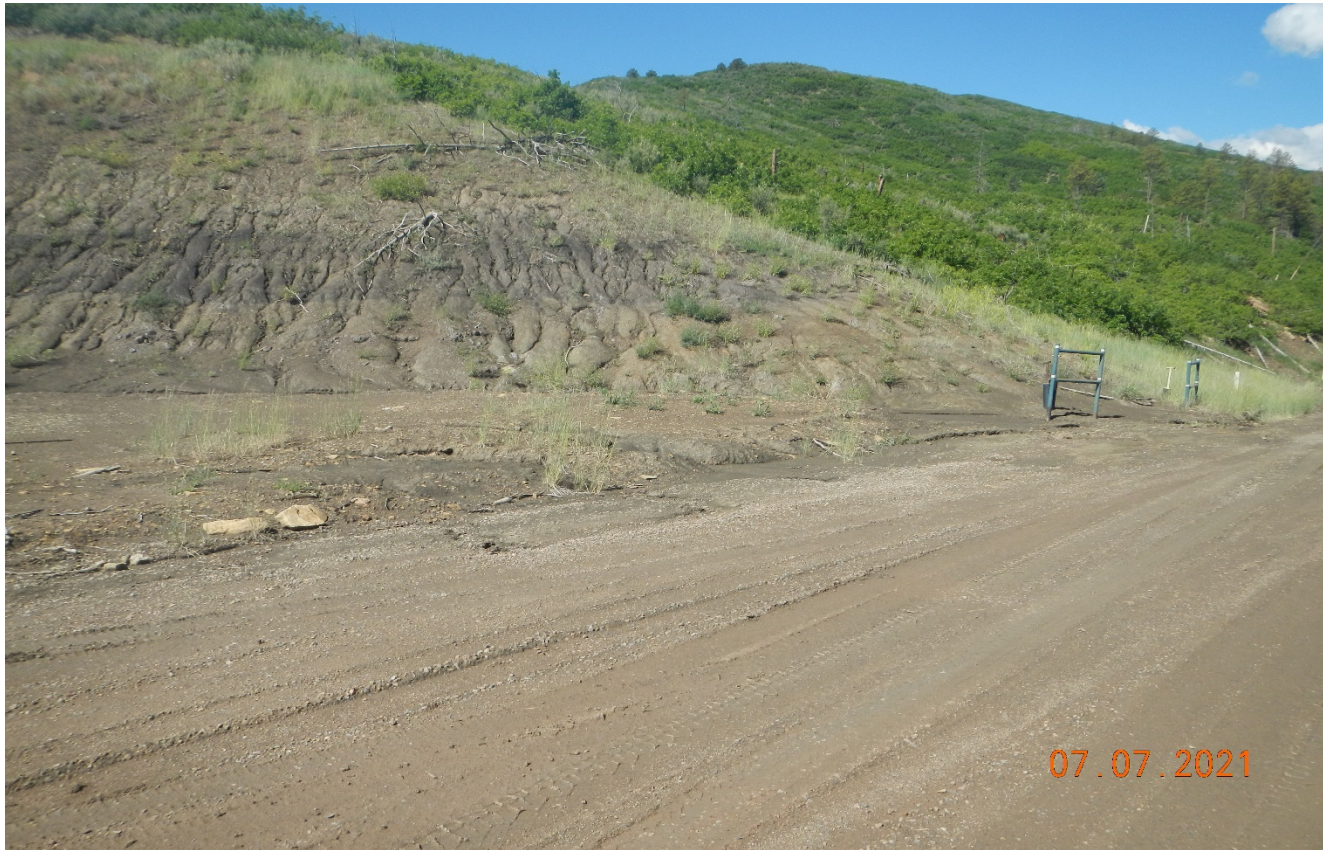
Photo 3. Facing southwest at the location. Erosion of the cut slope is directing sediment down towards the road. This area needs to be stabilized erosion controls are needed (e.g. sediment trap)

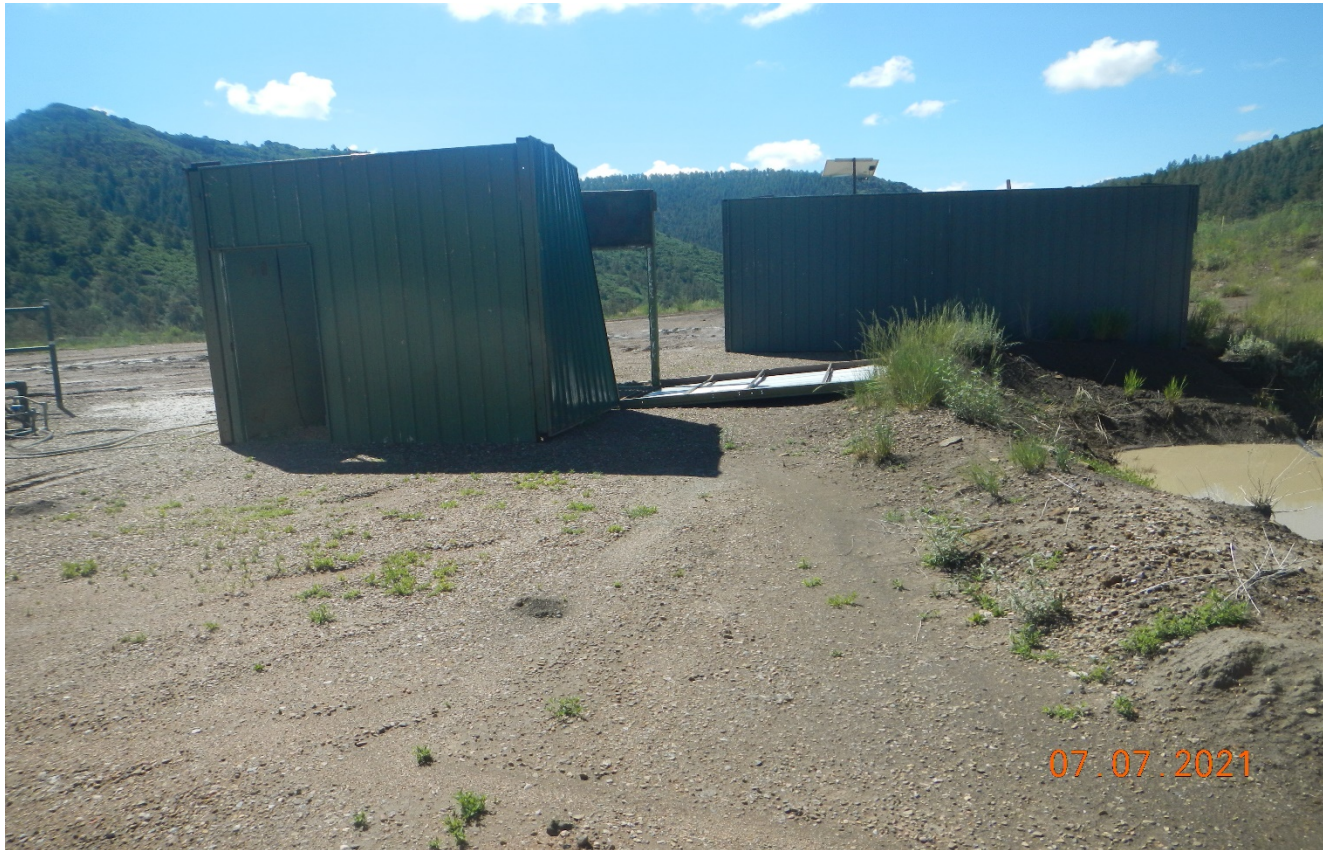
Photo 4. Facing toward the equipment. A panel is laying on the ground and needs to be re-installed.
