## Inspection Photos

Location Name: CAERUS PICEANCE LLC PUCKETT-67S97W /1NWSE

Location ID: 324311

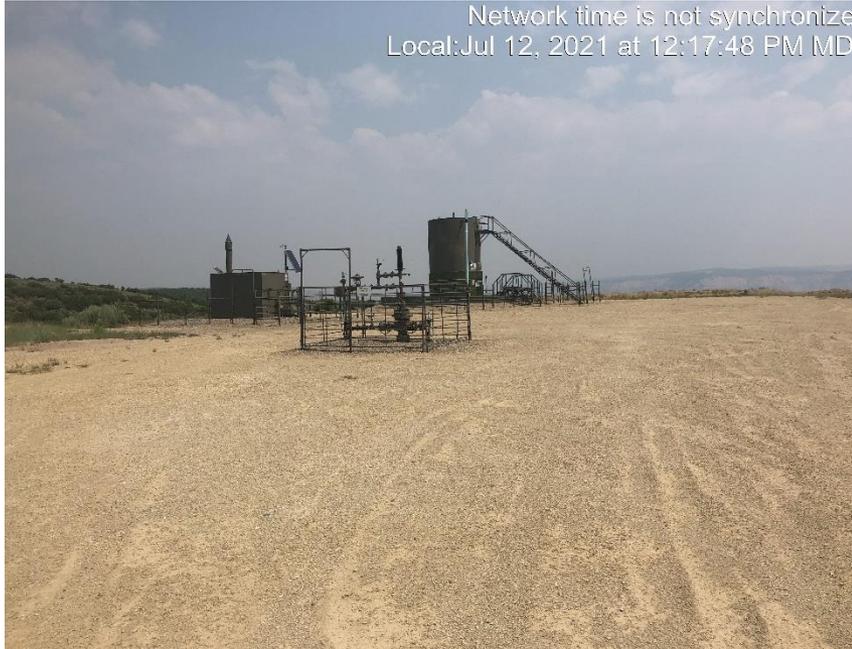
Photo #4382 from entrance to location.

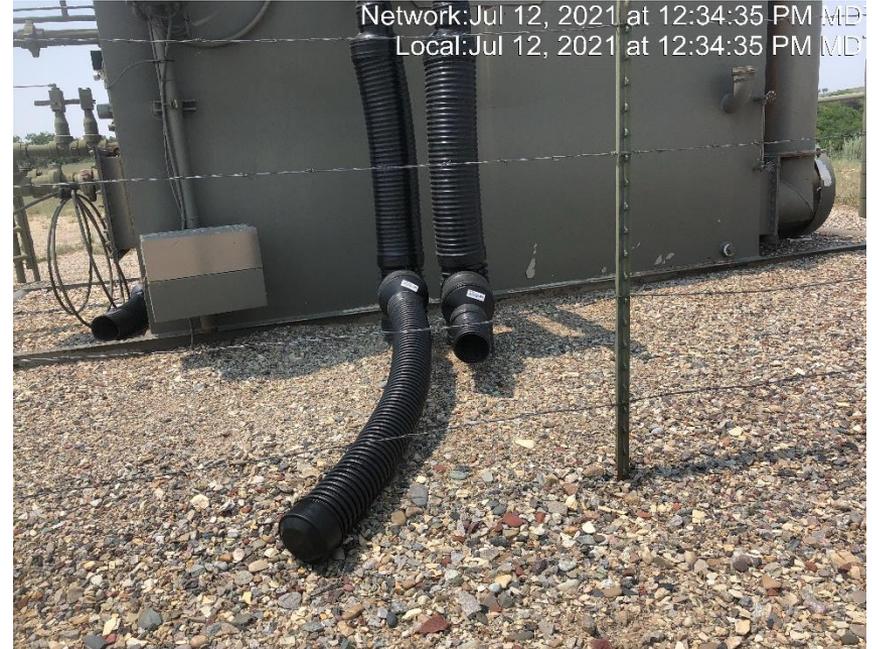
Photo #4383 Flow line heating insulation open ended and not capped.

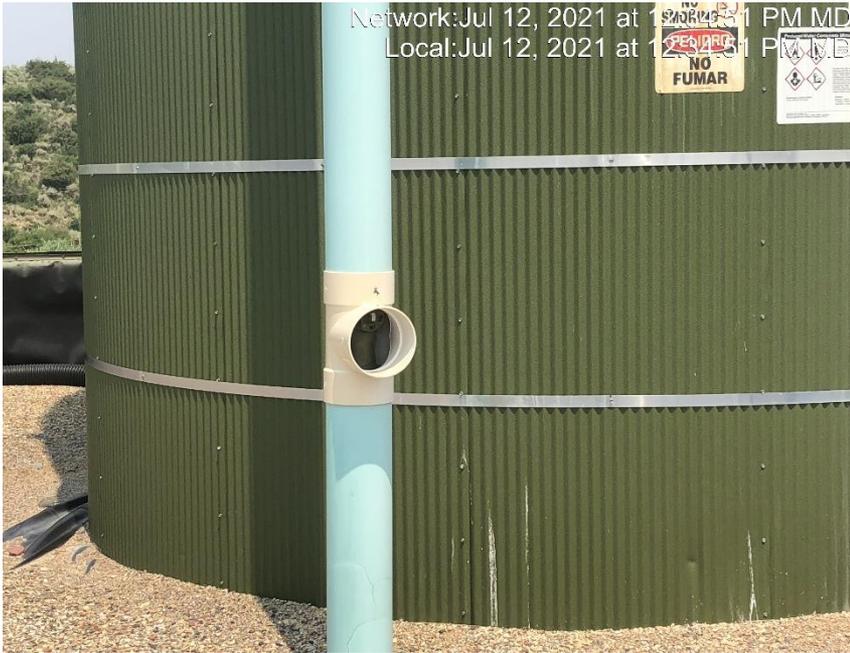
**Photo #4384 Flow line heating insulation open ended and not capped.**
