**Inspection Photos**  
**Location Name: CAERUS PICEANCE LLC P6-22-1 /**  
**Location ID: 324394**

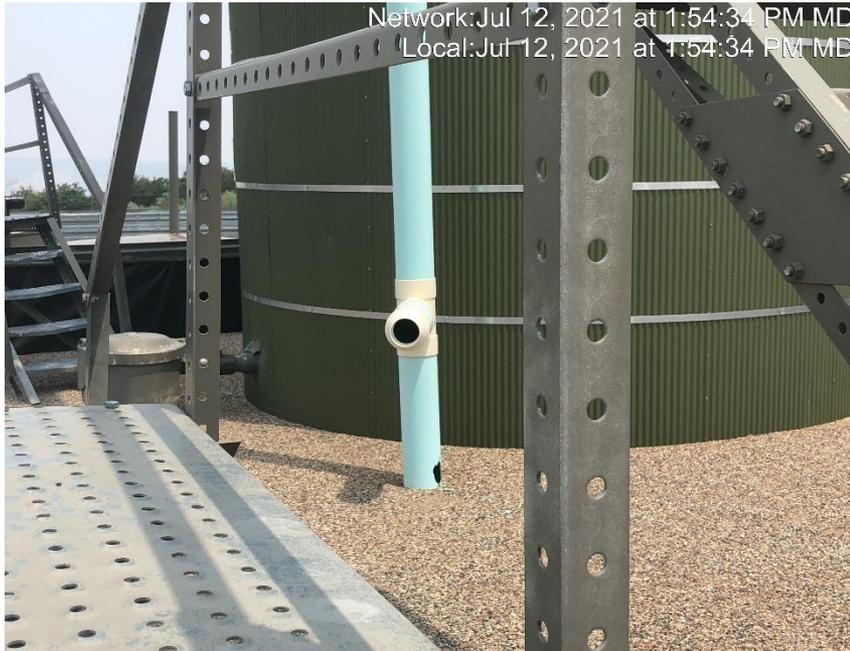
**Photo #4392 Flow line heating insulation open ended and not capped.**

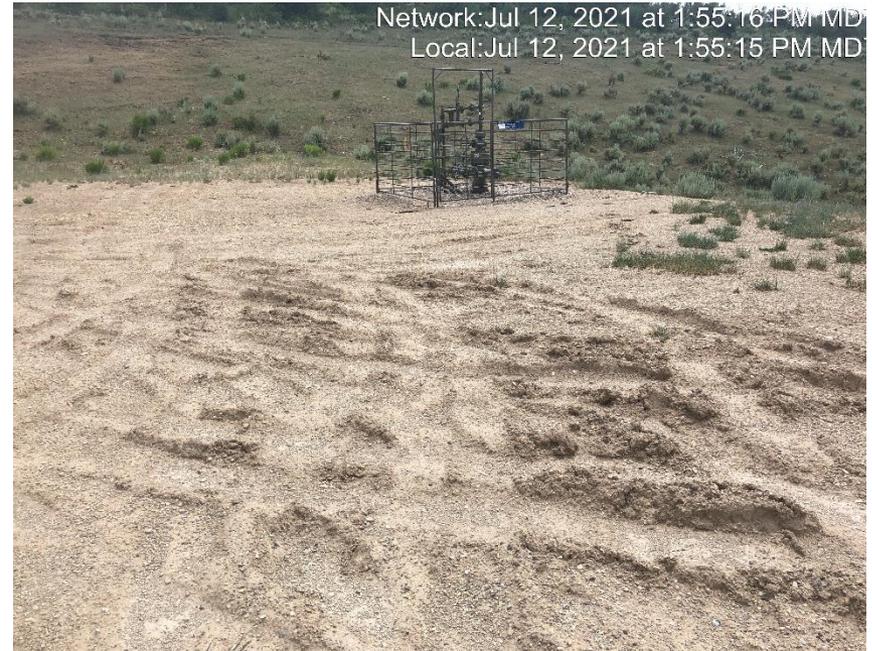
**Photo #4393 Location lacks stabilization.**

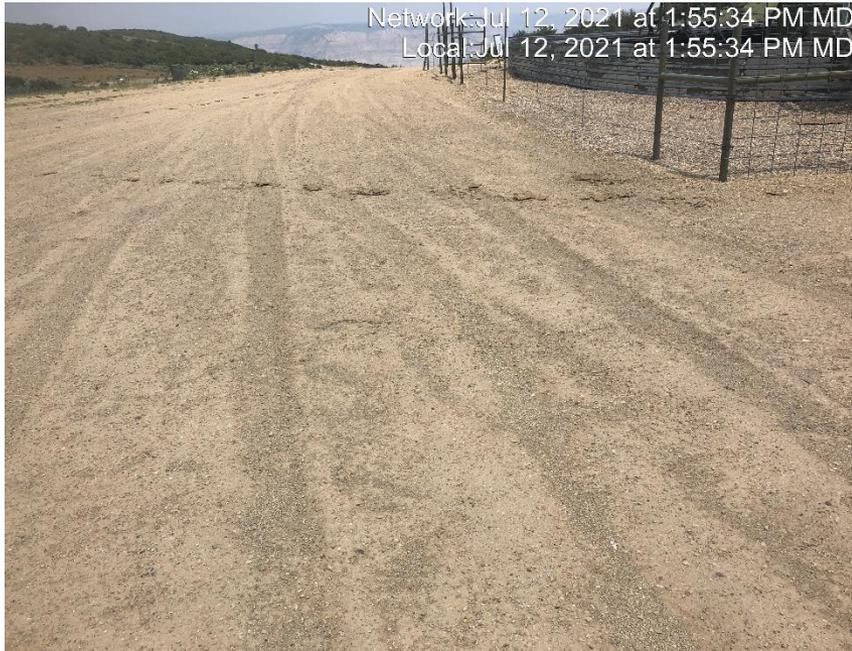
**Photo #4394 Location lacks stabilization.**

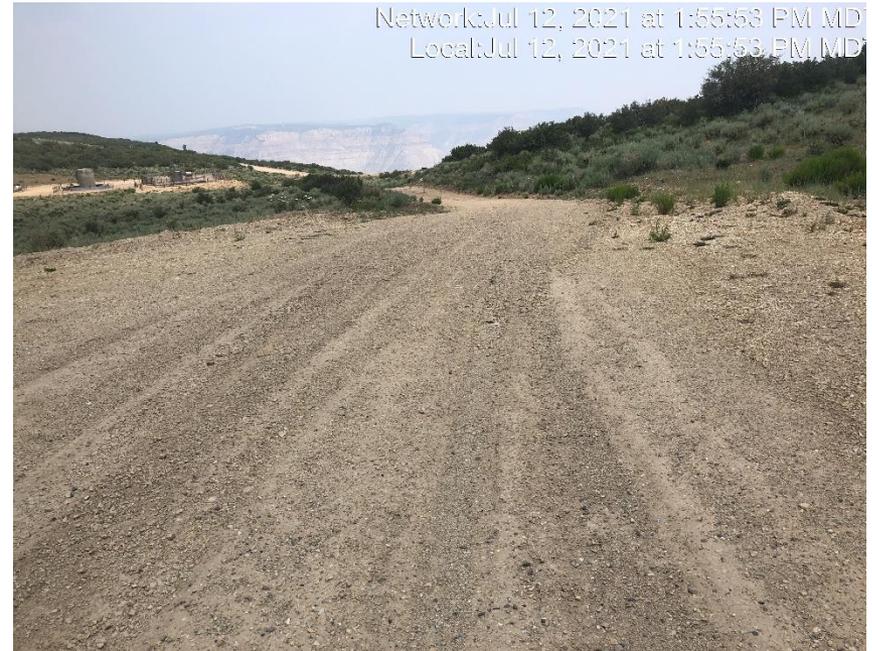
**Photo #4395 No form of tracking BMP located at the entrance to location.**
