Inspection Photos

Location Name: CAERUS PICEANCE LLC PUCKETT-67S97W /1NWN

Location ID: 324328

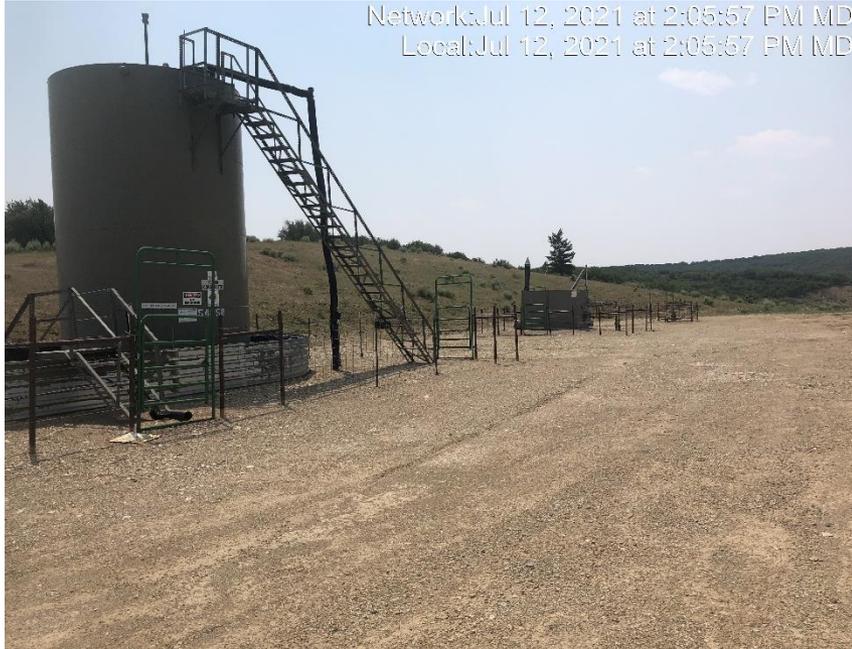
Photo #4398 from entrance to location.

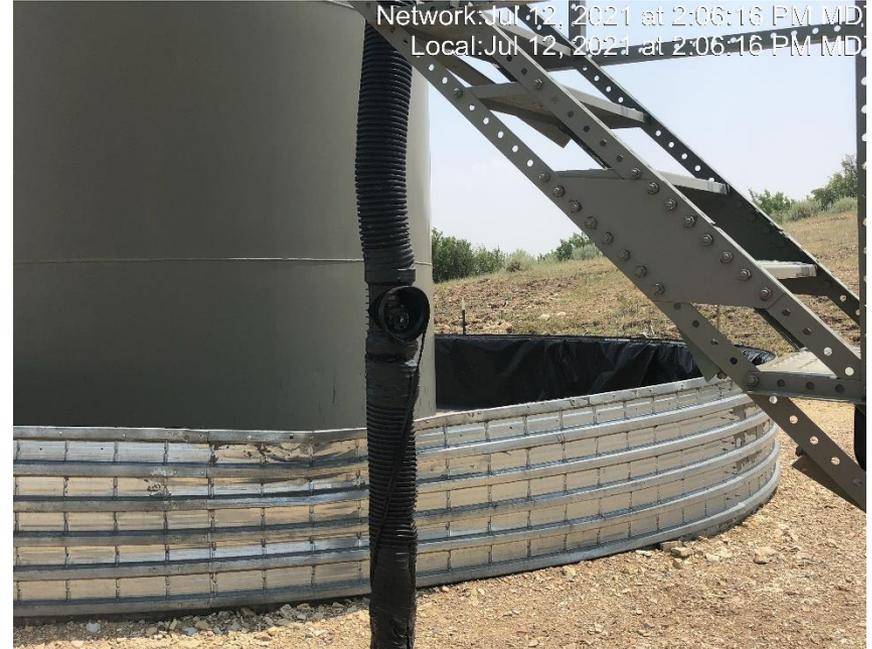
Photo #4399 heating insulation open ended and not capped.

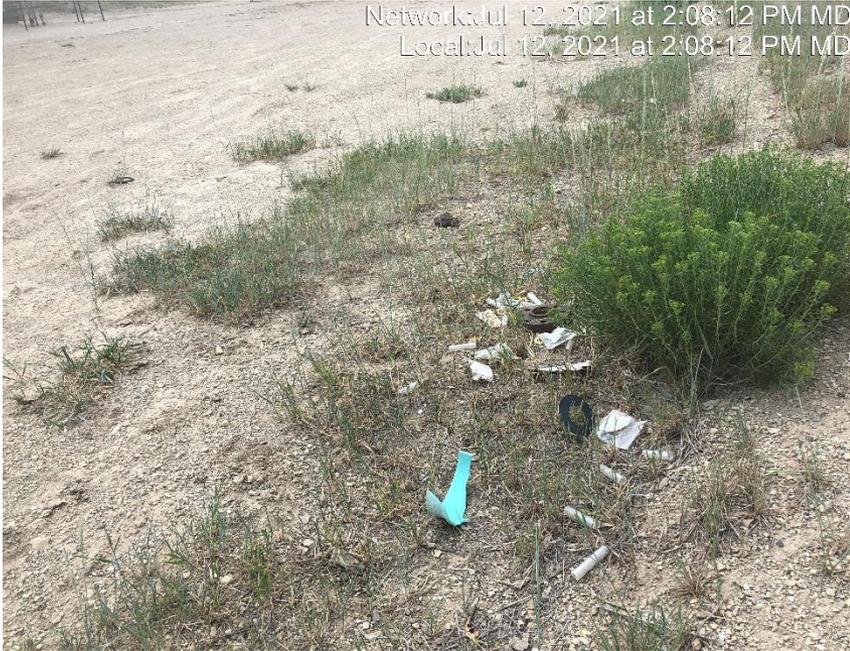
Photo #4403 Trash on location.

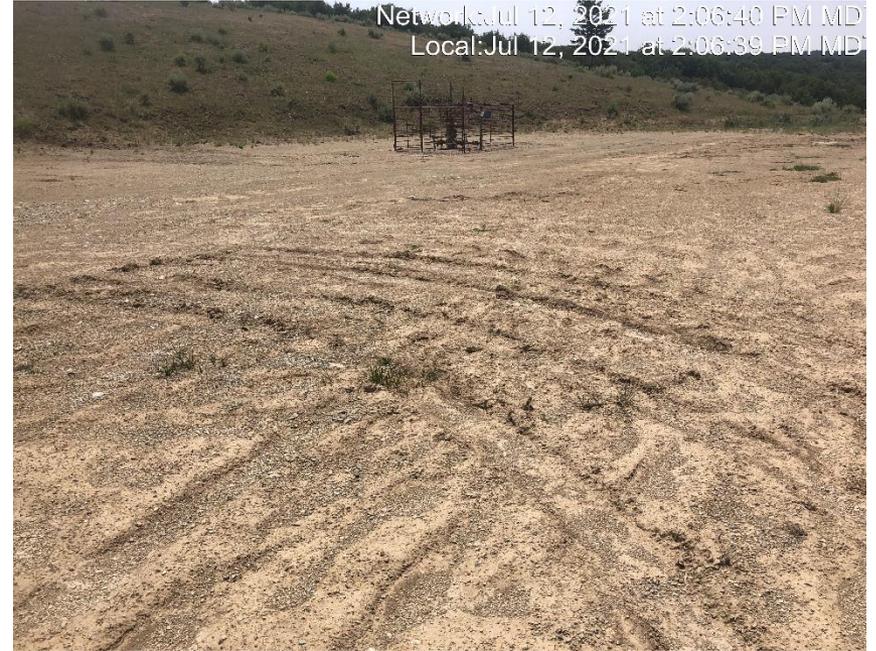
Photo #4400 Location lacks stabilization.

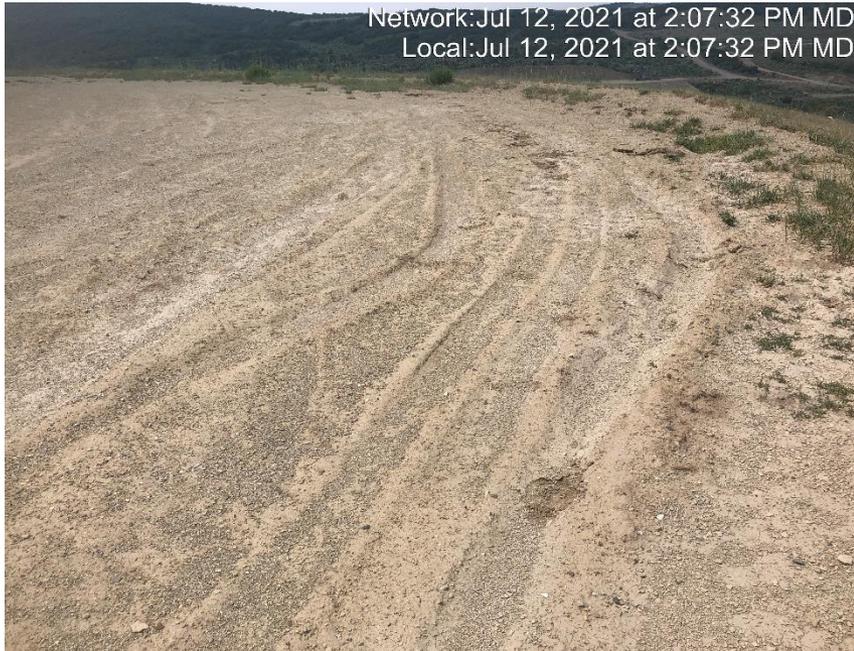
Photo #4401 Location lacks stabilization.

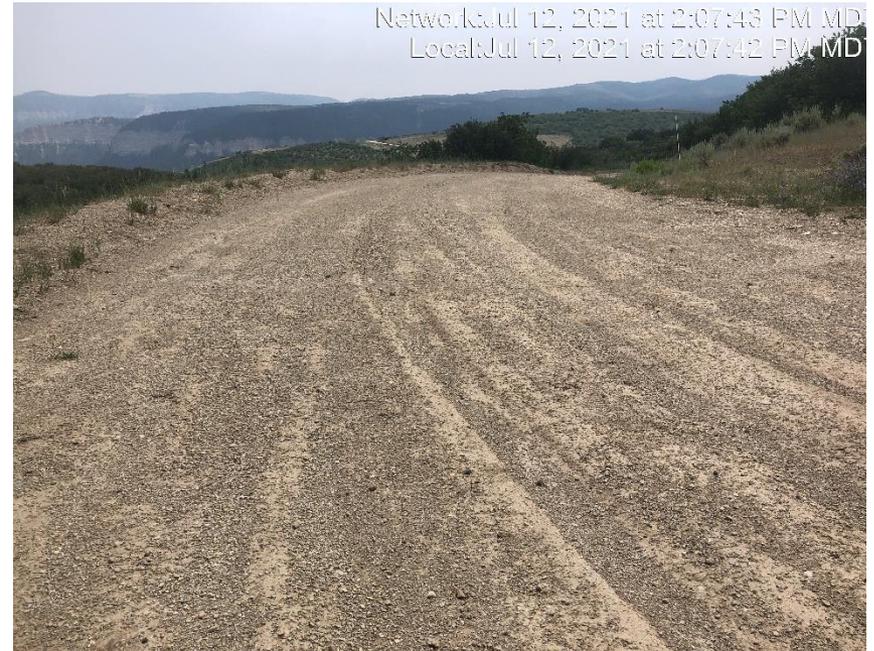
Photo #4402 No form of tracking BMP located at the entrance to location.
