**Inspection Photos
E. Stieber Consolidation
Spill ID 480275 (AC)**

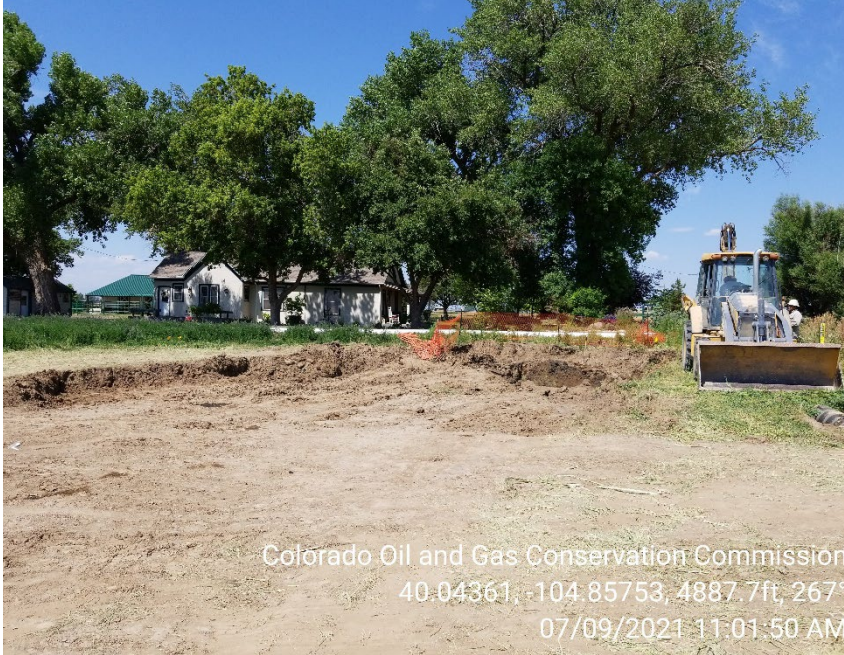
Photo 1 – Spill area 7/9. Excavation is open and surface soils surrounding excavation have been scraped.

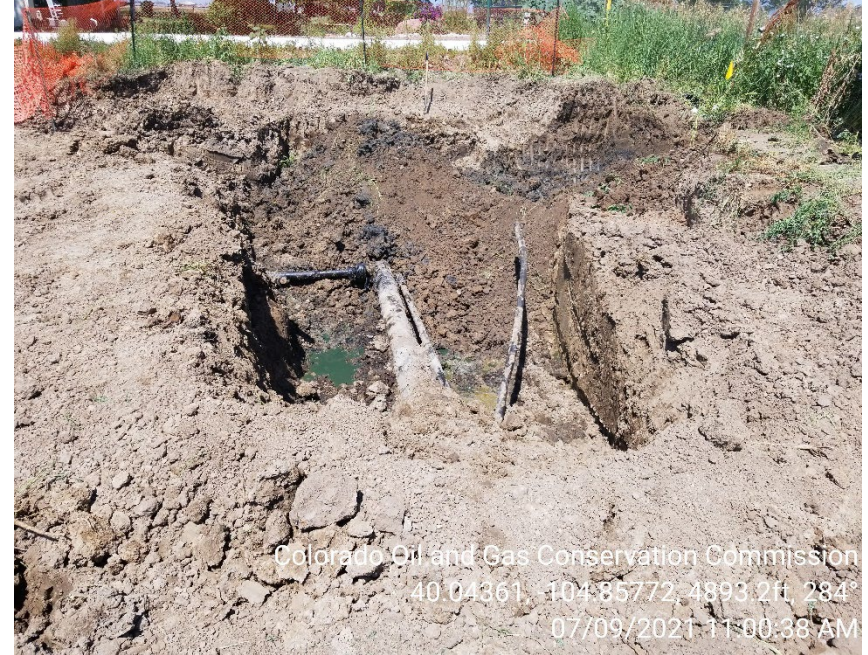
Photo 2 – Spill excavation 7/9. Impacts remain visible in-situ and free product is visible in excavation.

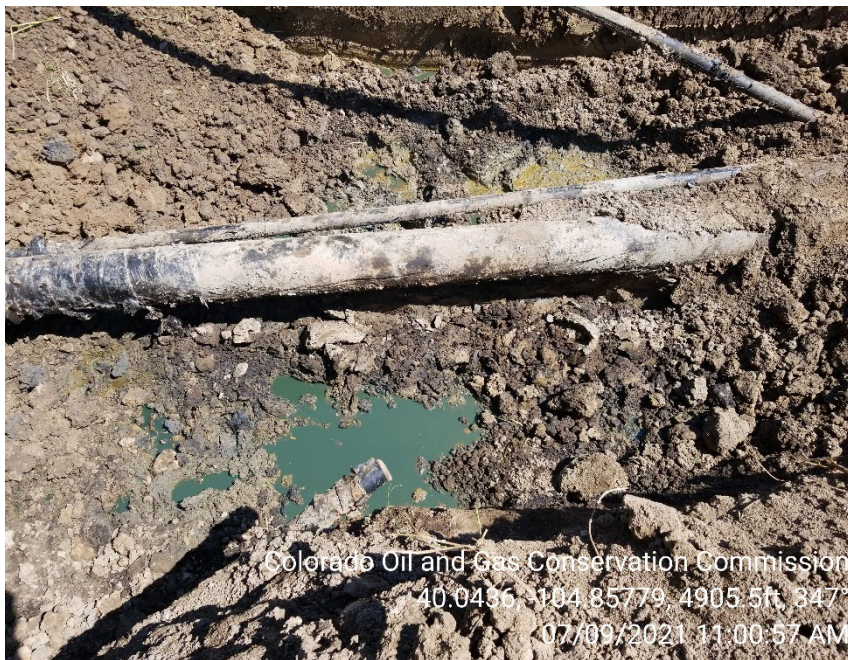
Photo 3 – Spill excavation 7/9; free product is visible in excavation.

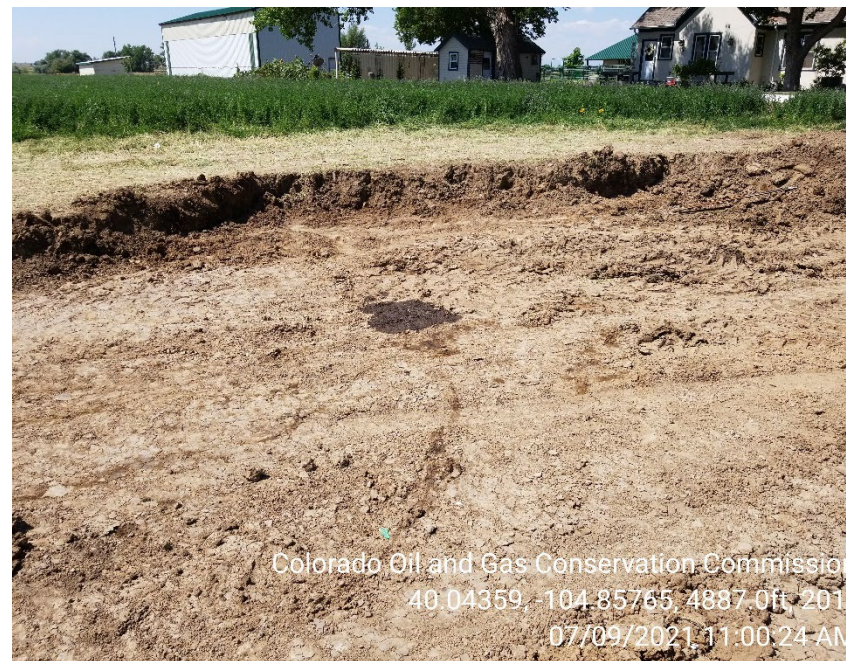
Photo 4 – Soil staining on surface in scraped area.

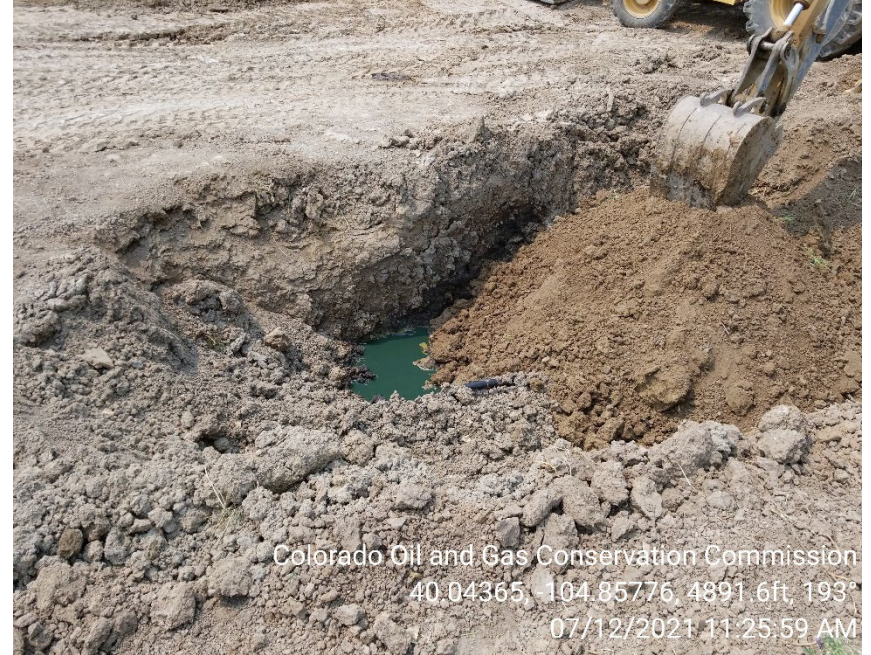
Photo 6 – Spill excavation 7/12; free product is visible in excavation and soil impacts remain in-situ.

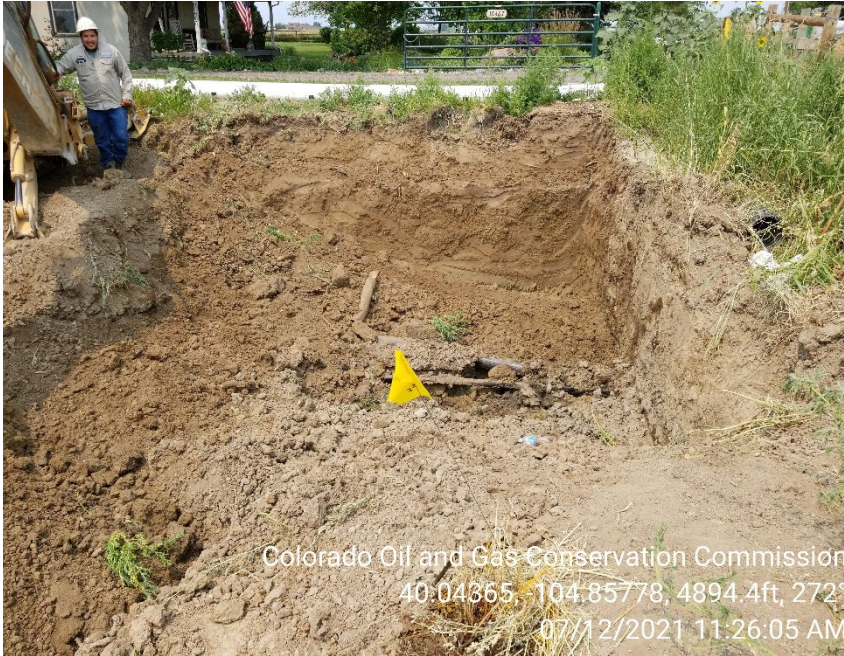
Photo 7 - Spill excavation 7/12; soil impacts remain in-situ.

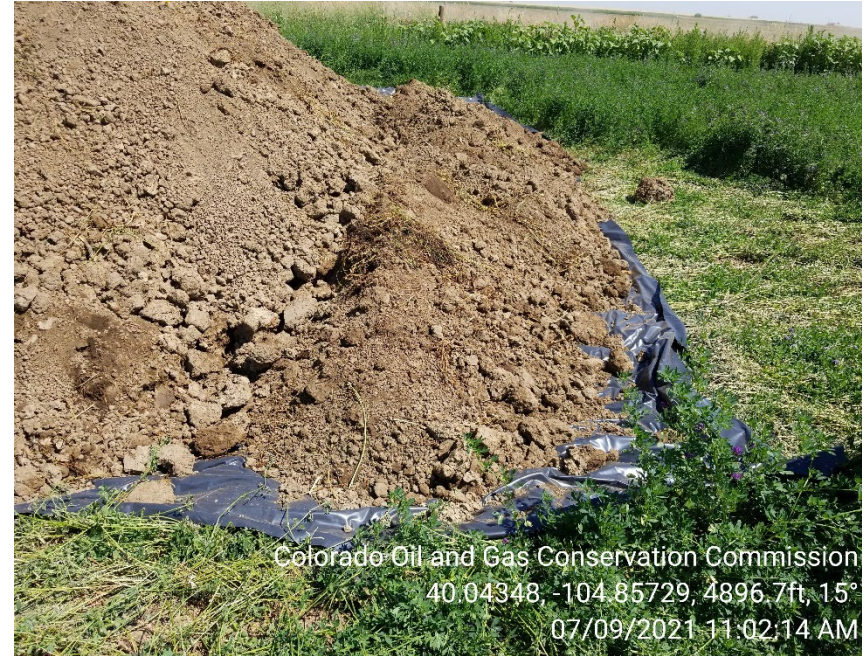
Photo 8 – Impacted soil being placed on plastic liner then transported off-site.
