Stormwater Inspection

Operator: COLORADO INTERSTATE GAS COMPANY LLC- 18600

Facility ID: 120785

Inspection Photos
Facility Name: Cheyenne Compressor Station
Facility ID: 120785

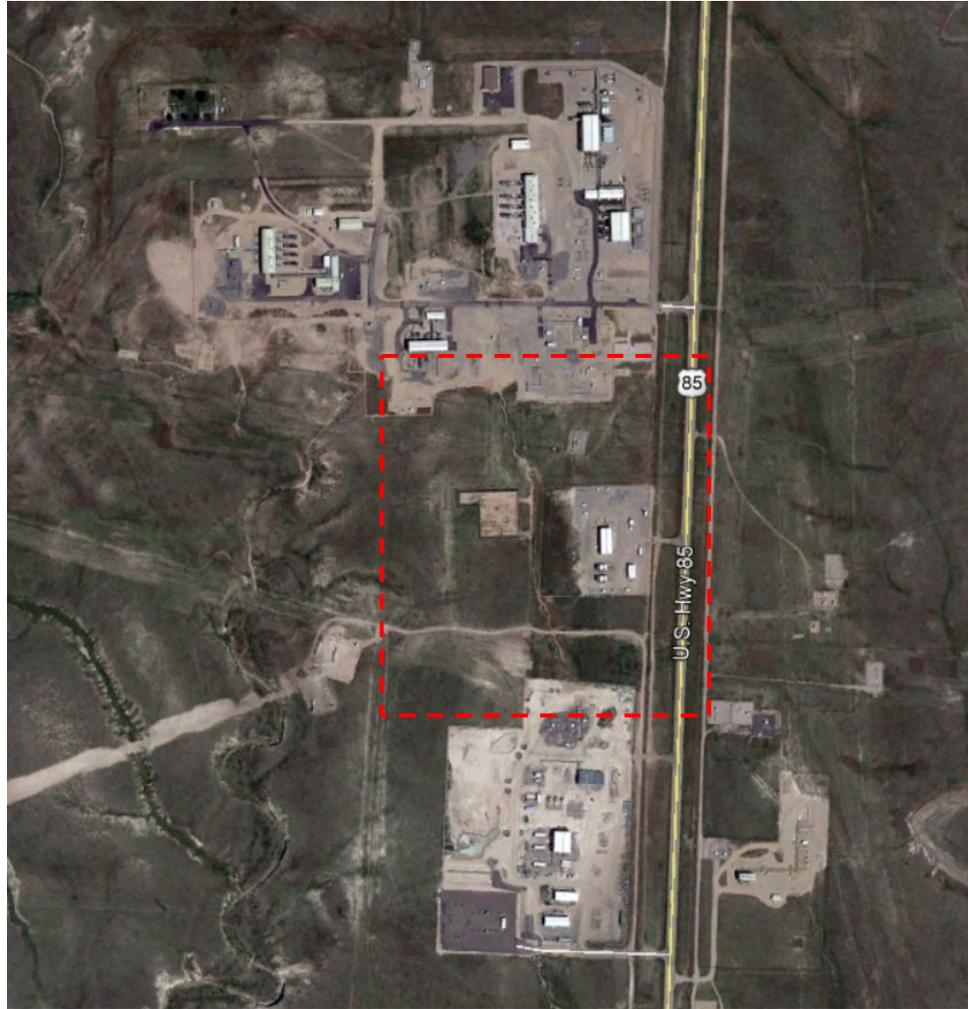
Photo 1. Google Earth aerial imagery illustrates the area of interest regarding stormwater erosion coming off the Cheyenne Compressor Station, which is impacting other down gradient surface owners. Photo 2 is a zoomed in (red box) aerial of the specific reach of stormwater erosion taken in 2019 and Photo 3 was taken in 1999.

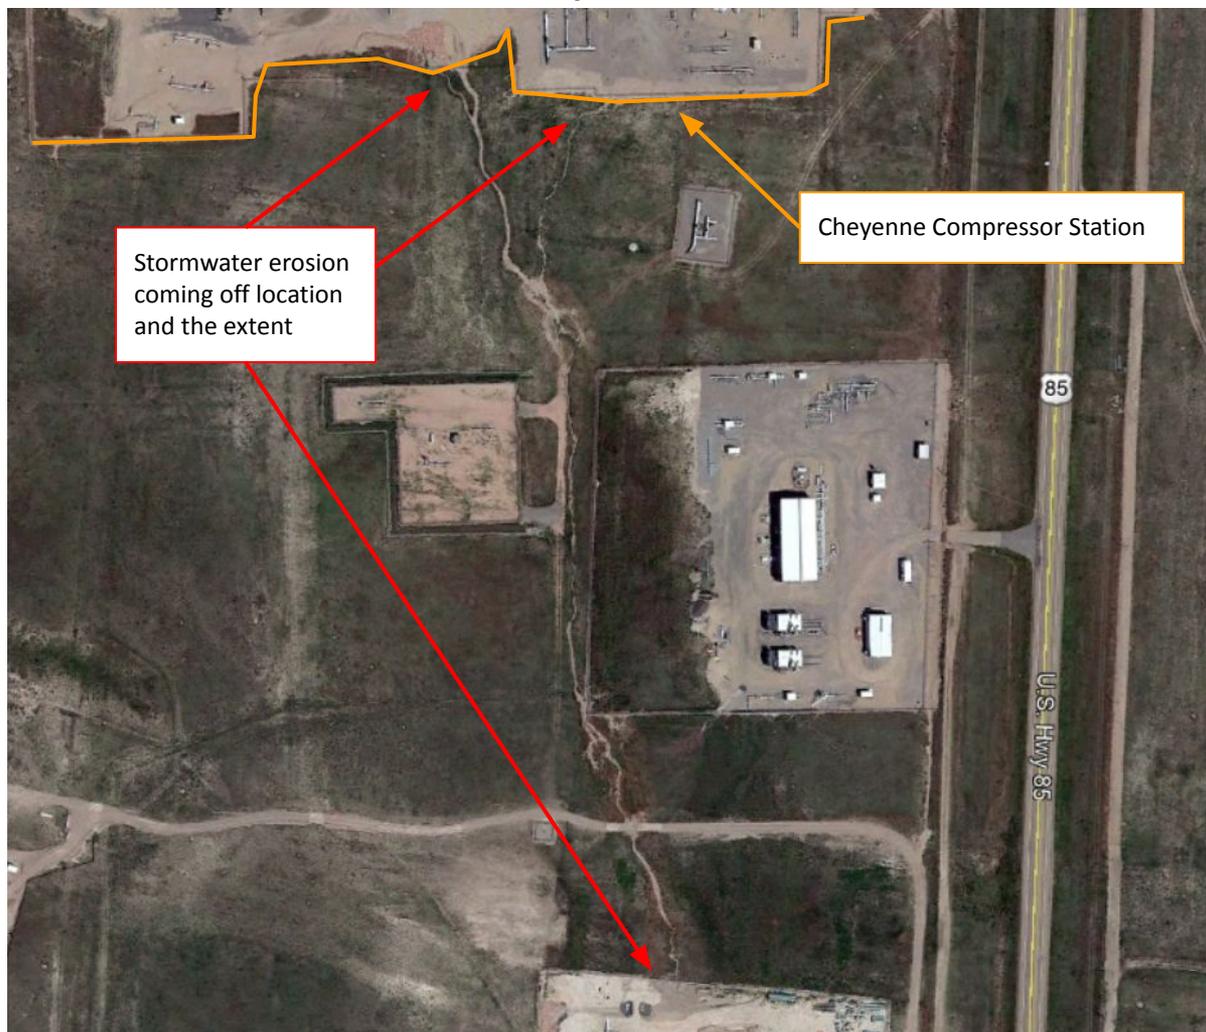
Photo 2. Zoomed in aerial imagery from 2019 illustrates stormwater erosion coming off the Cheyenne Compressor Station which is causing gully erosion off location and impacting downgradient surface owners.

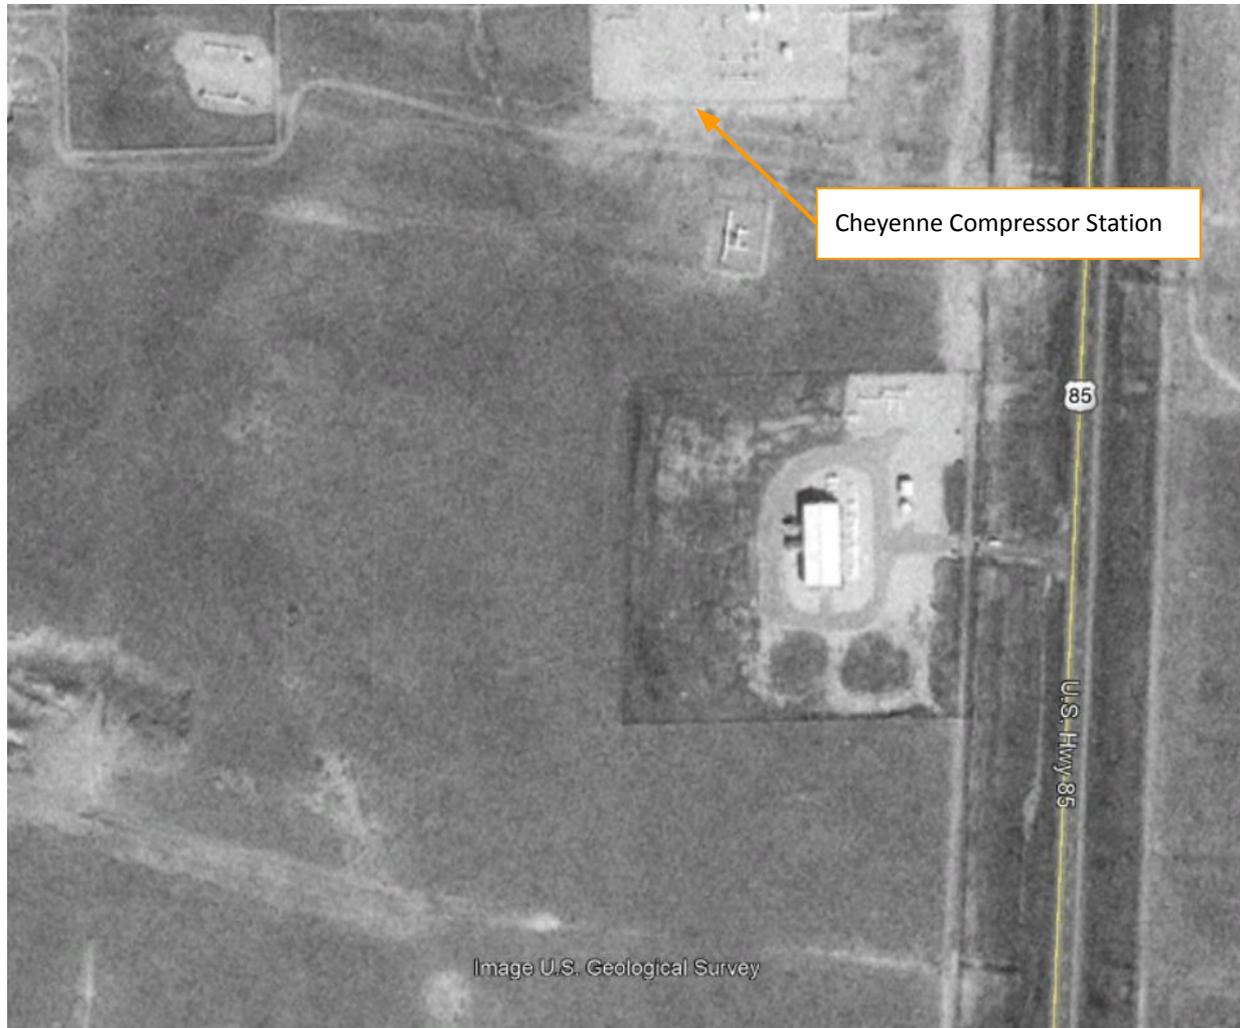
Photo 3. Zoomed in aerial imagery from 1999 illustrates there may have been a natural swale, but there was no incised channel. Overtime, due to stormwater runoff from the Cheyenne Compressor Station, it has caused gully erosion along the natural swale.

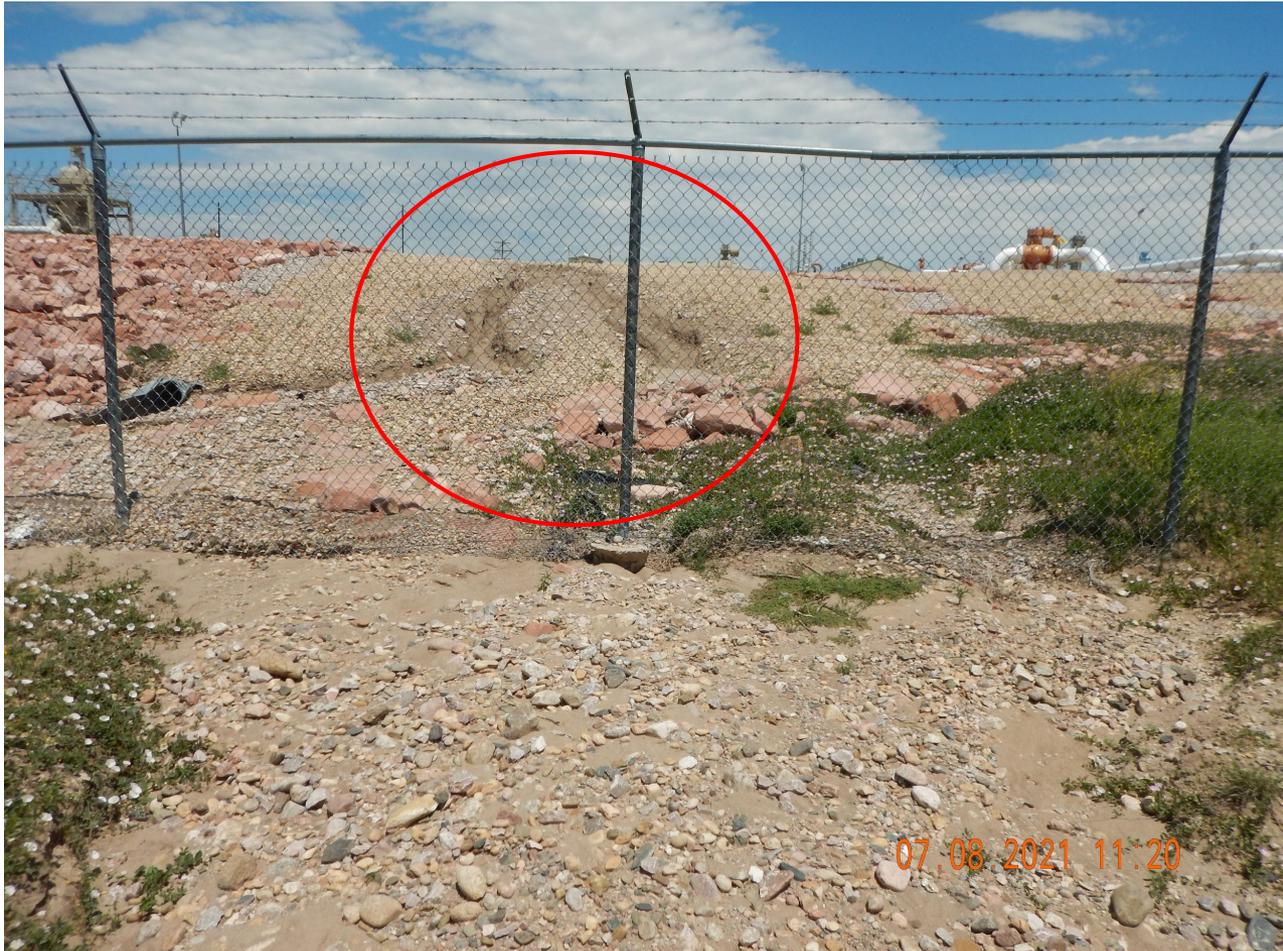
Photo 4. Photo taken from the southern Cheyenne Compressor Station, facing North. Photo illustrates unmanaged stormwater erosion coming off the location going around some adjacent rip-rap.

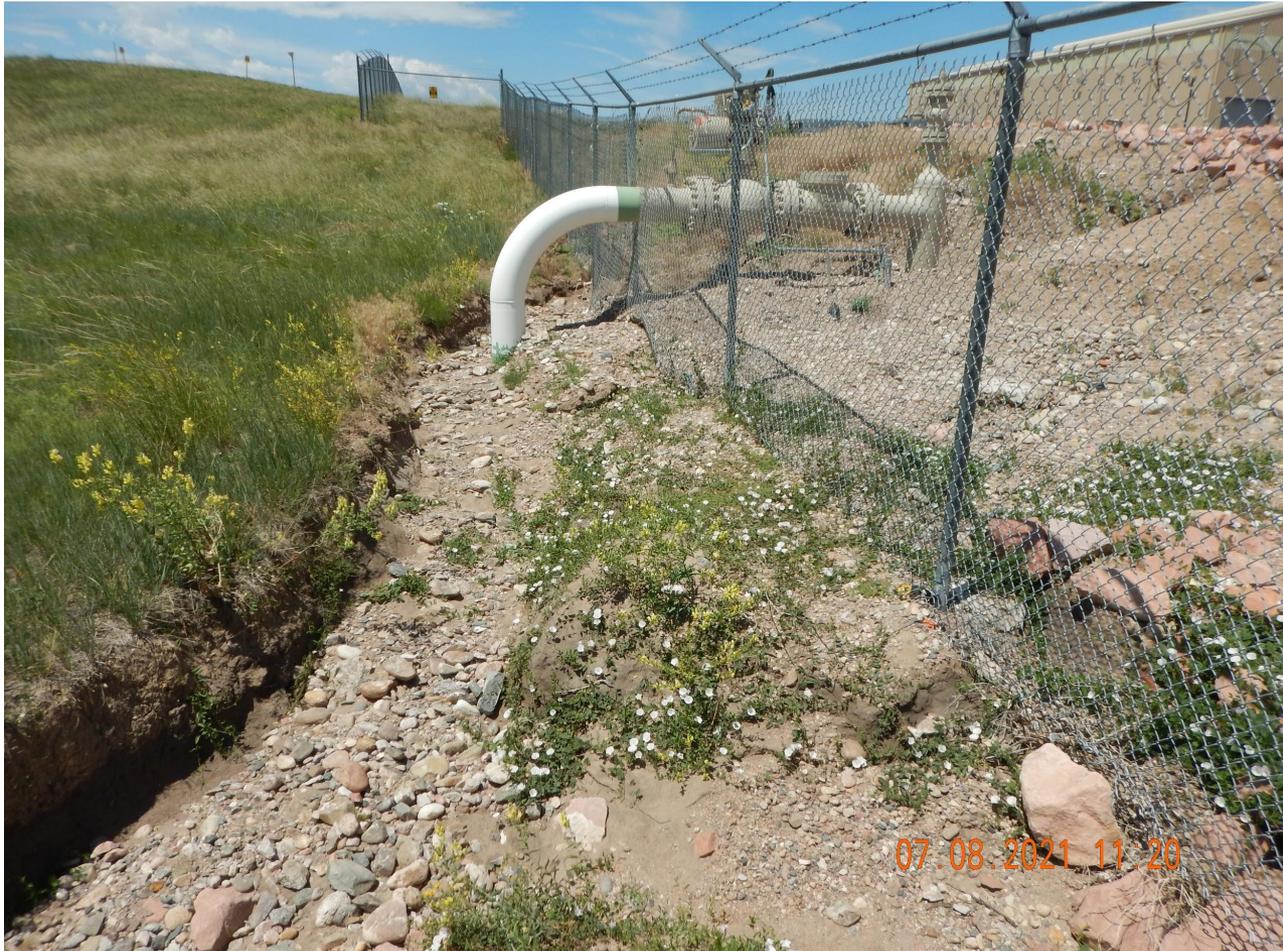
Photo 5. Photo taken from the southern Cheyenne Compressor Station, facing West. Photo illustrates unmanaged stormwater erosion coming off the location and causing gully erosion.

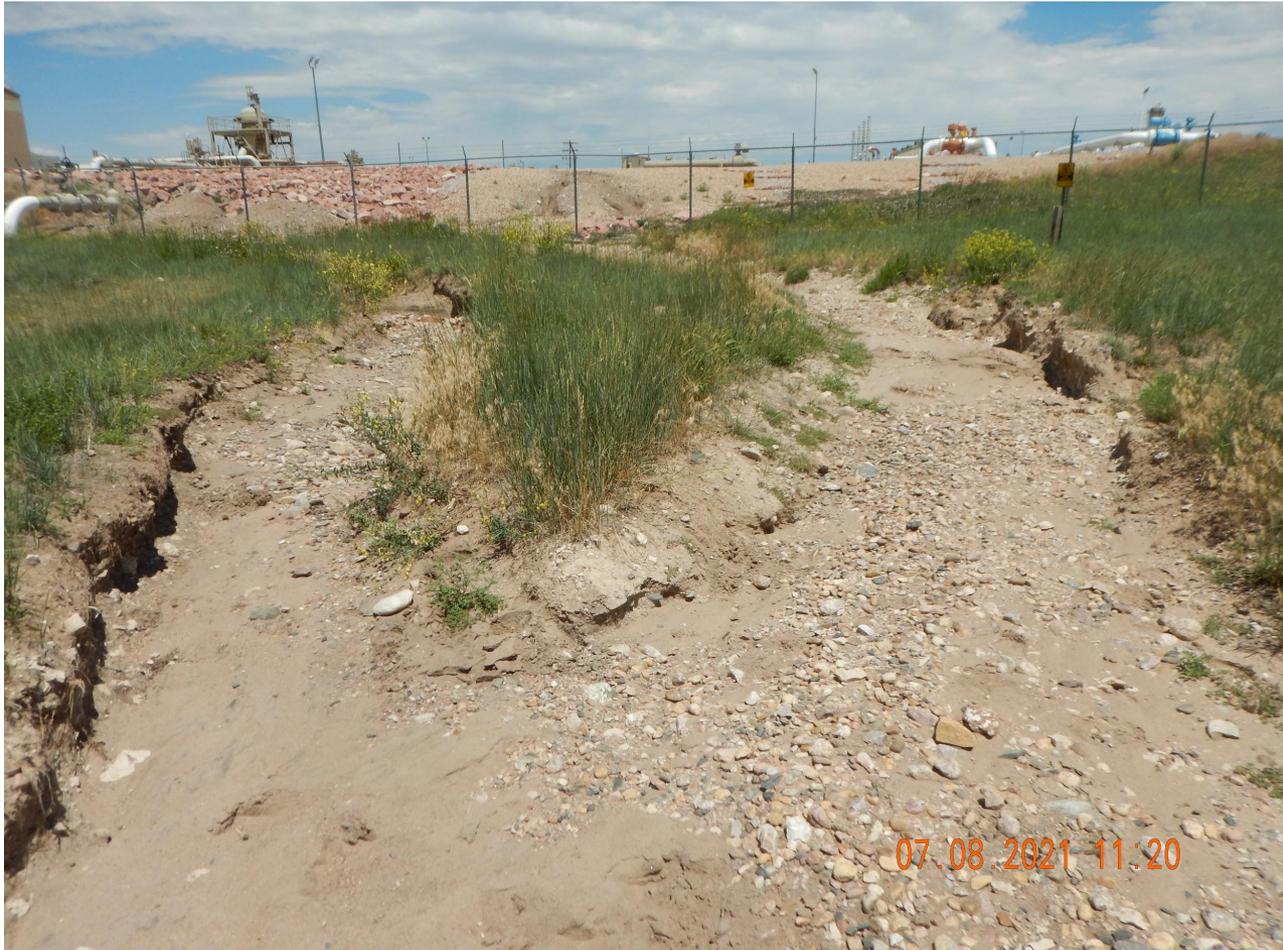
Photo 6. Photo taken south of the Cheyenne Compressor Station, facing North. Photo illustrates the stormwater erosion impacts coming off the location and causing gully erosion.

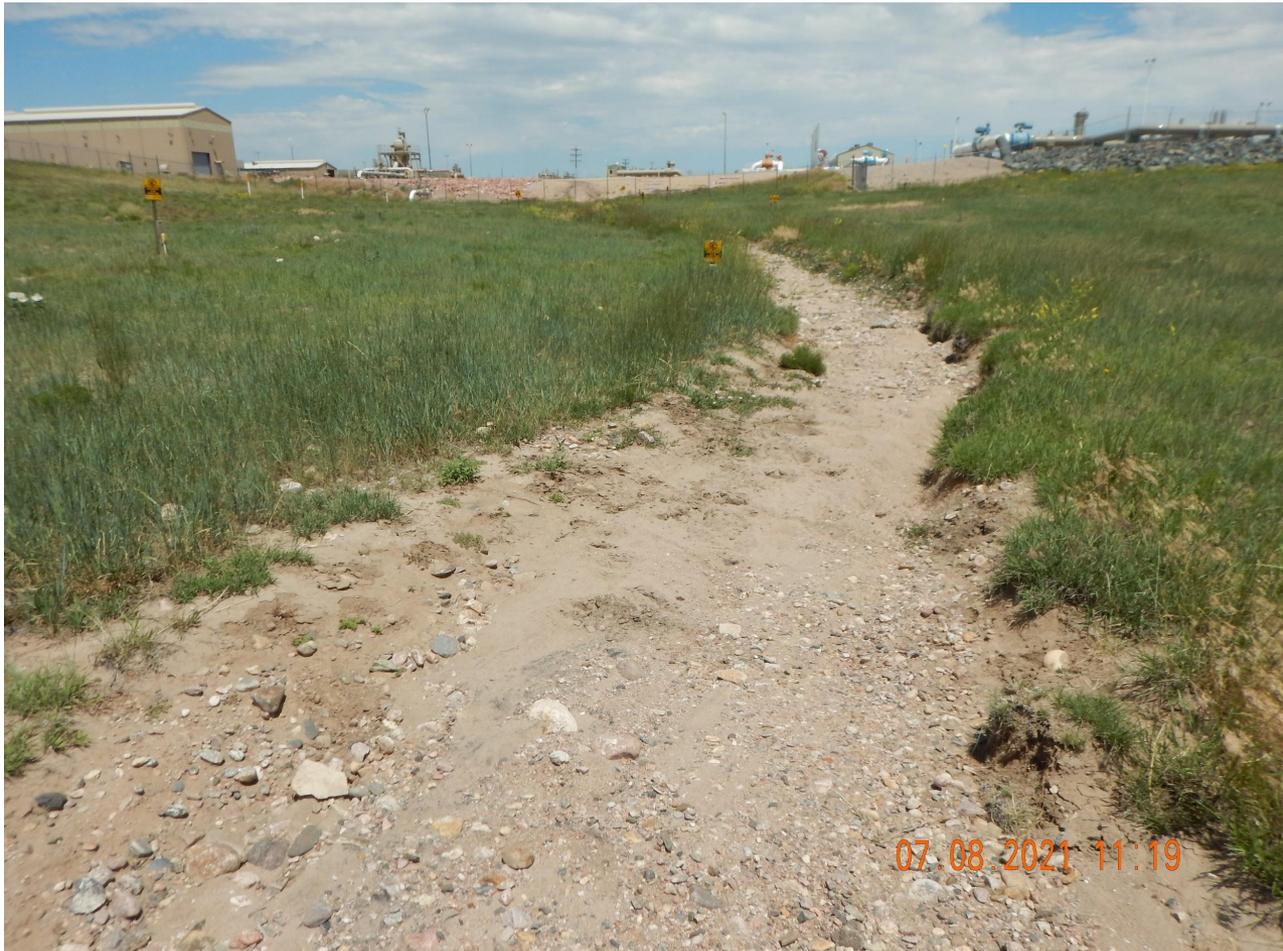
Photo 7. Photo taken south of the Cheyenne Compressor Station, facing North. See comments under Photo 6.

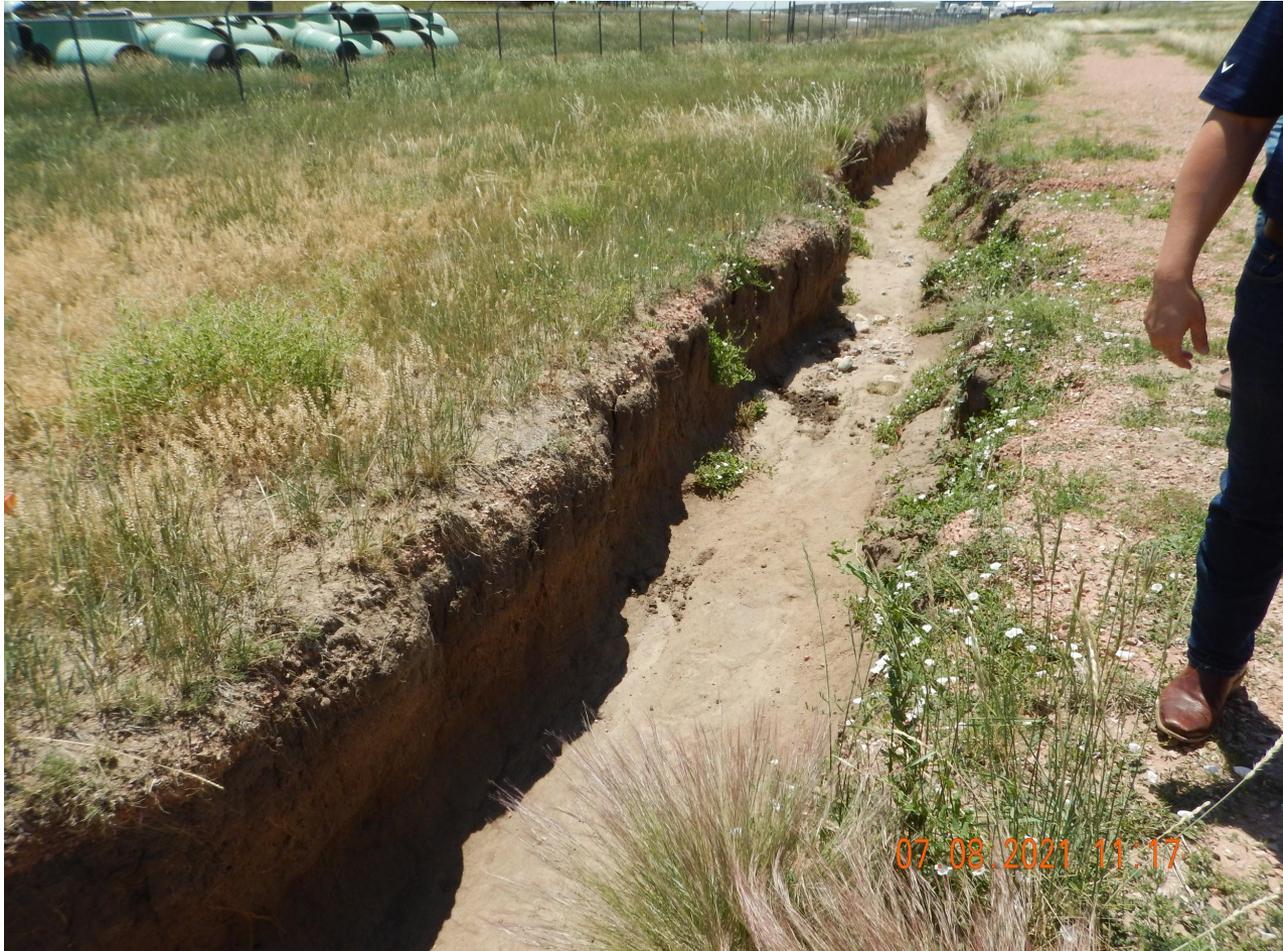
Photo 8. Photo taken from the southern property boundary of the Cheyenne Compressor Station, facing South. Photo illustrates the stormwater erosion impacts coming off the location and causing gully erosion and impacting the downgradient surface owners. This portion of the reach is a safety hazard for cattle operations and exposed buried lines from the adjacent facilities.

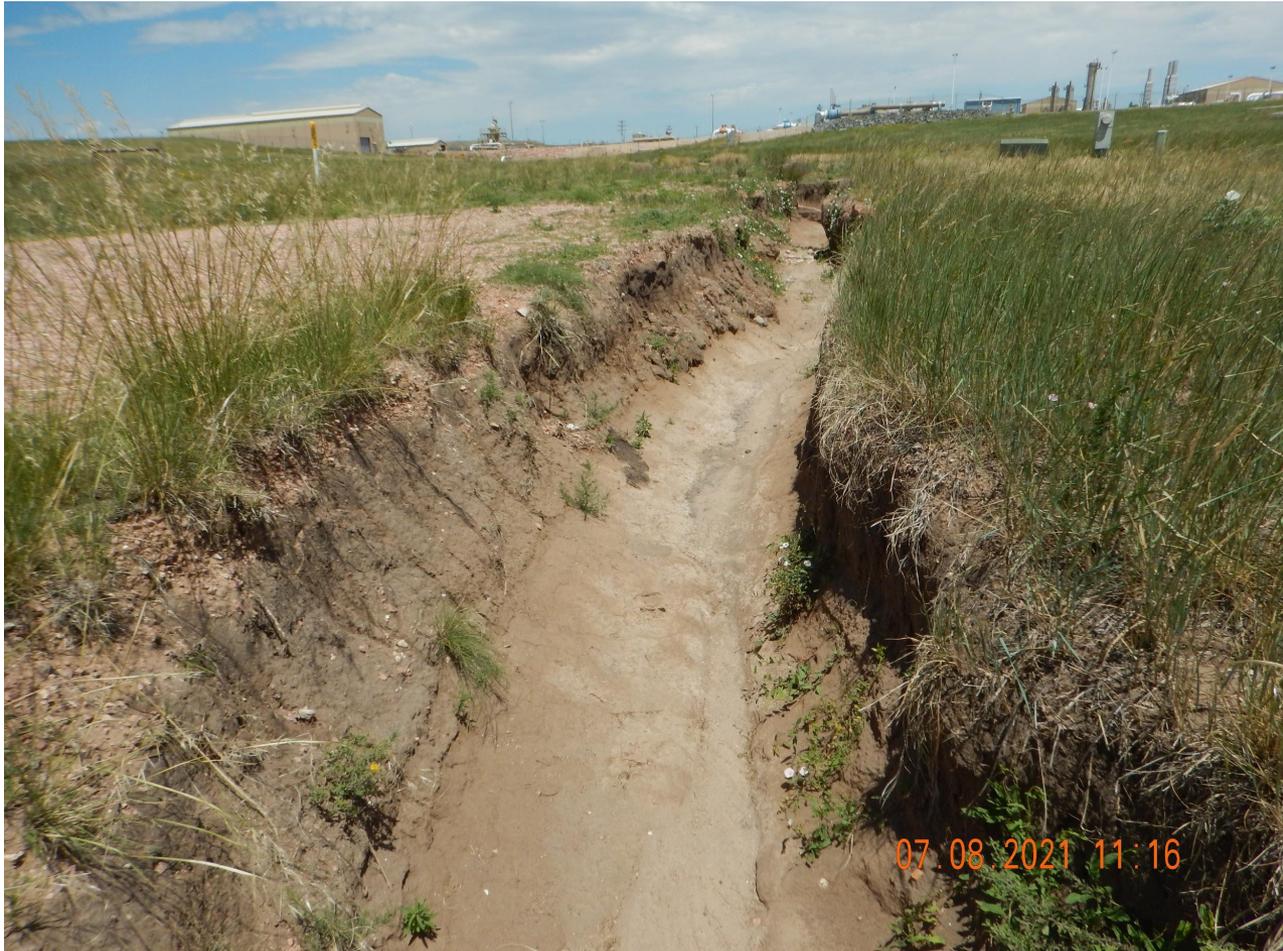
Photo 9. Photo taken from the southern property boundary of the Cheyenne Compressor Station, facing North. See comments under Photo 8.

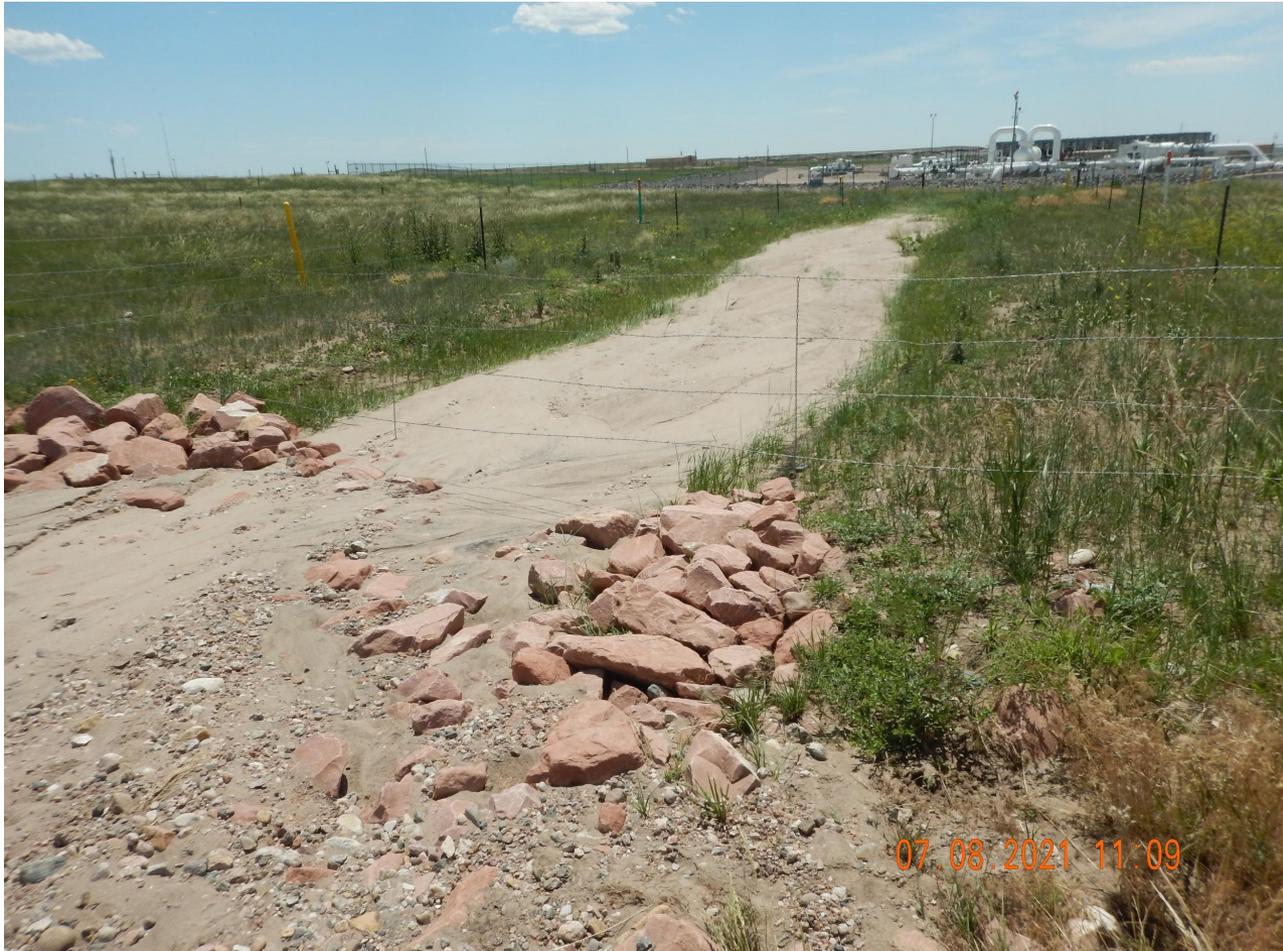
Photo 10. Photo taken from the southern reach of the stormwater erosion, facing South. Photo illustrates impacts to recent stormwater and reclamation work that has been impacted by unmanaged stormwater runoff from the Cheyenne Compressor Station.
