Inspection Photos
Operator: Simcoe
API: 067-07172
Date: 7/13/2021

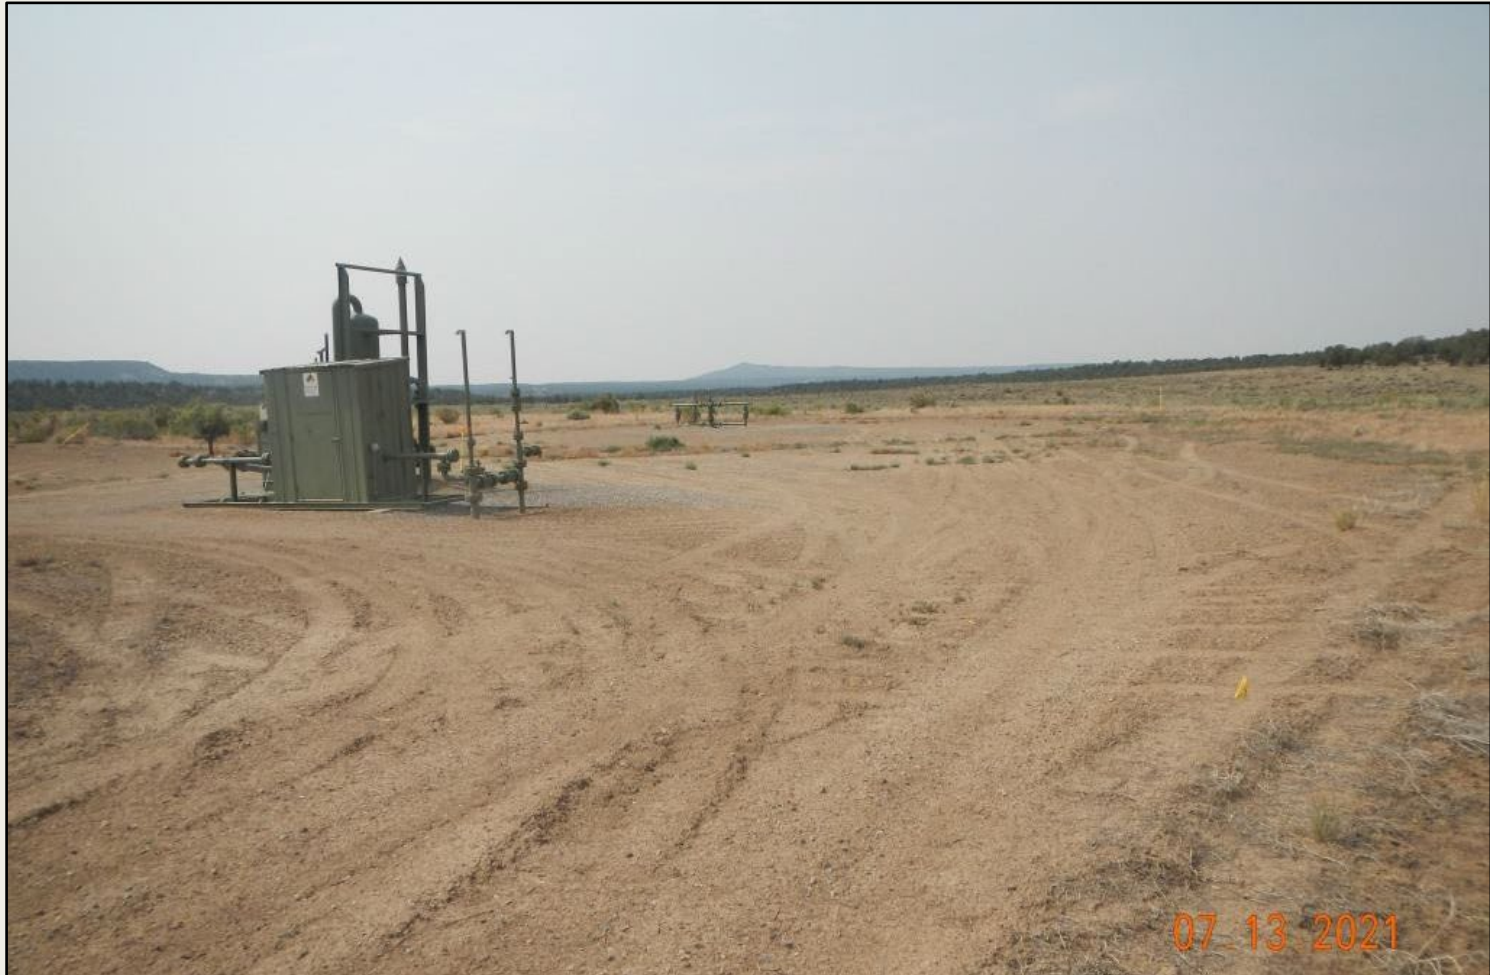
Photo 1. View the project area from the well pad entrance facing center.

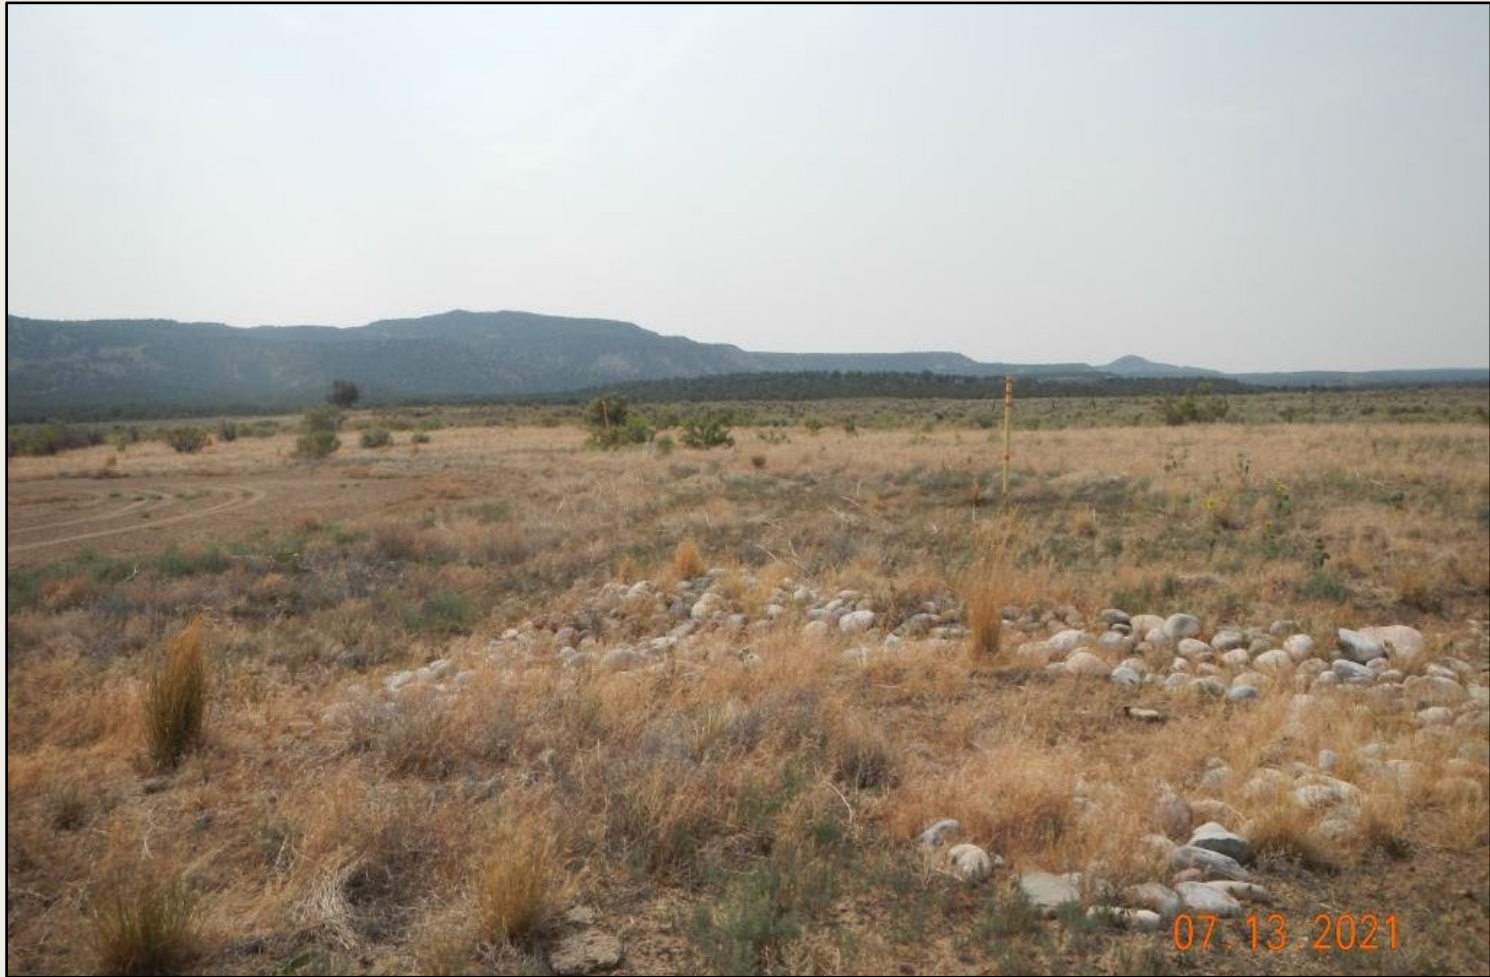
Photo 2. View of the western project area from the northwestern corner facing southward. Revegetation is progressing in portions with squirreltail and crested wheatgrass. Other portions remain sparse and weedy and need to be monitored.

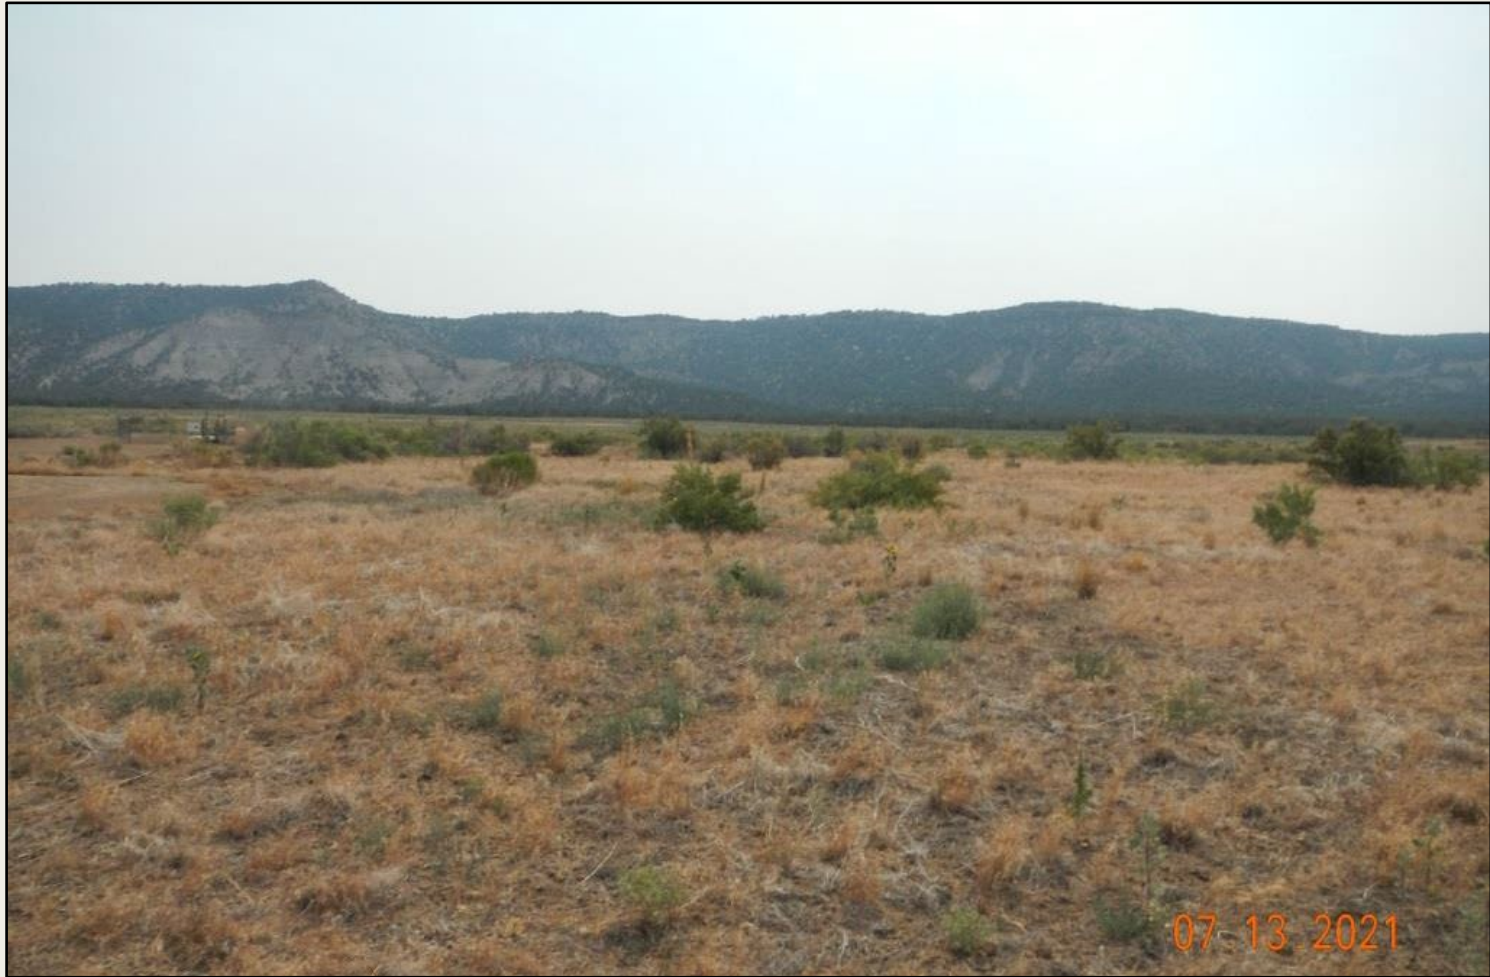
Photo 3. View the southern project area from the southwestern corner facing eastward.

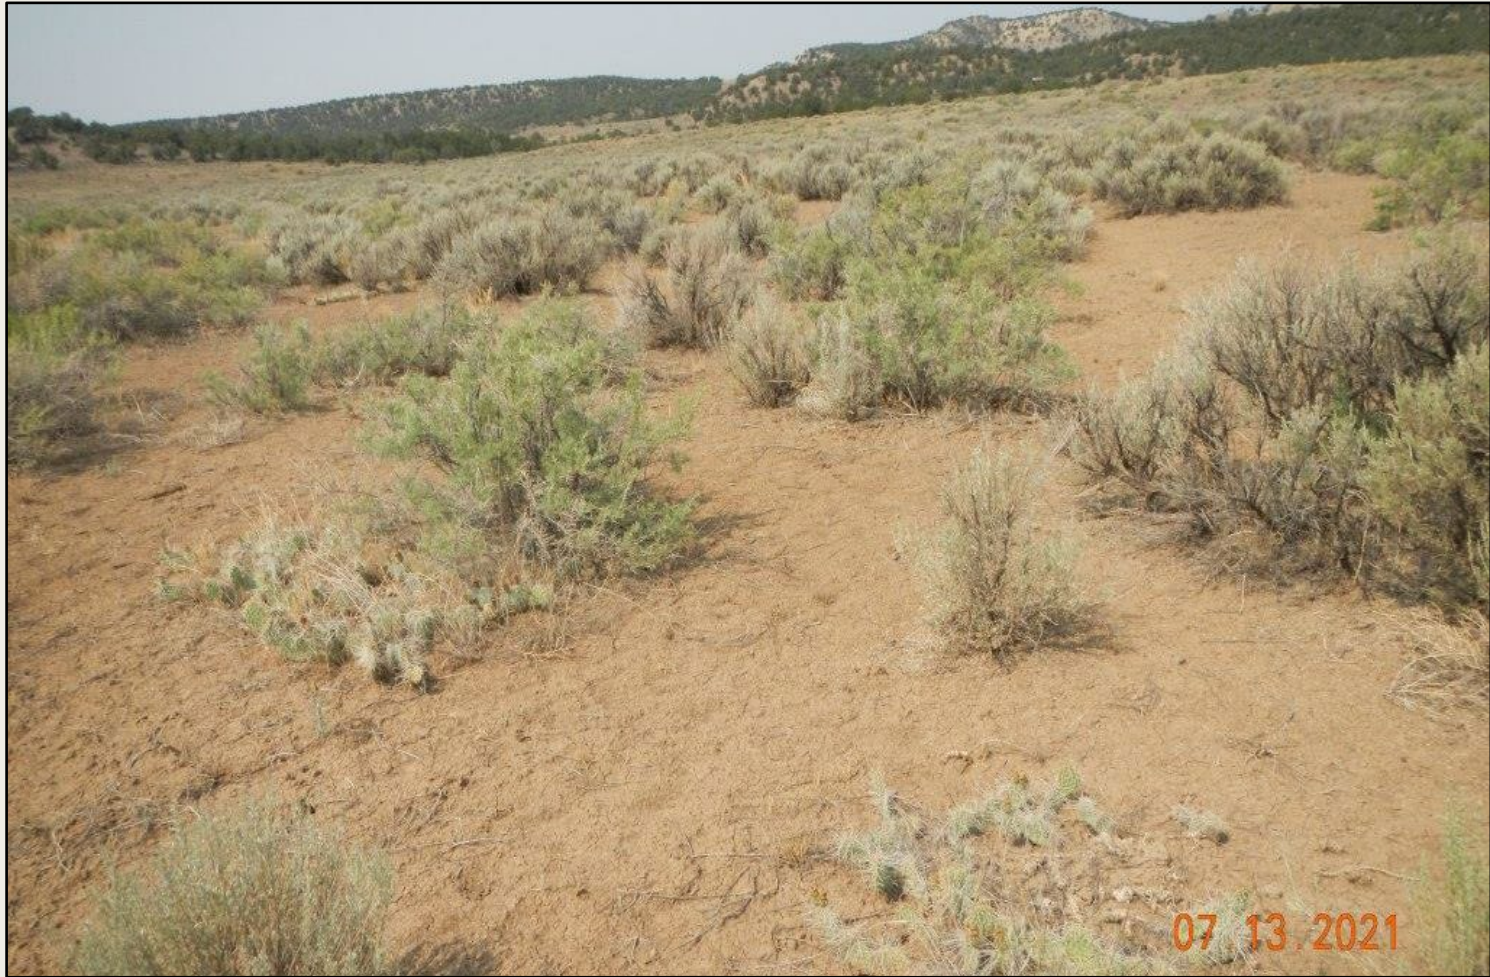
Photo 4. View the reference area comprised of sagebrush and greasewood shrubland with Indian ricegrass, squirreltail, prickly pear, fourwing saltbush, and purple threeawn.
