Inspection Photos  
Operator: Simcoe  
API: 067-05577  
Date: 7/13/2021

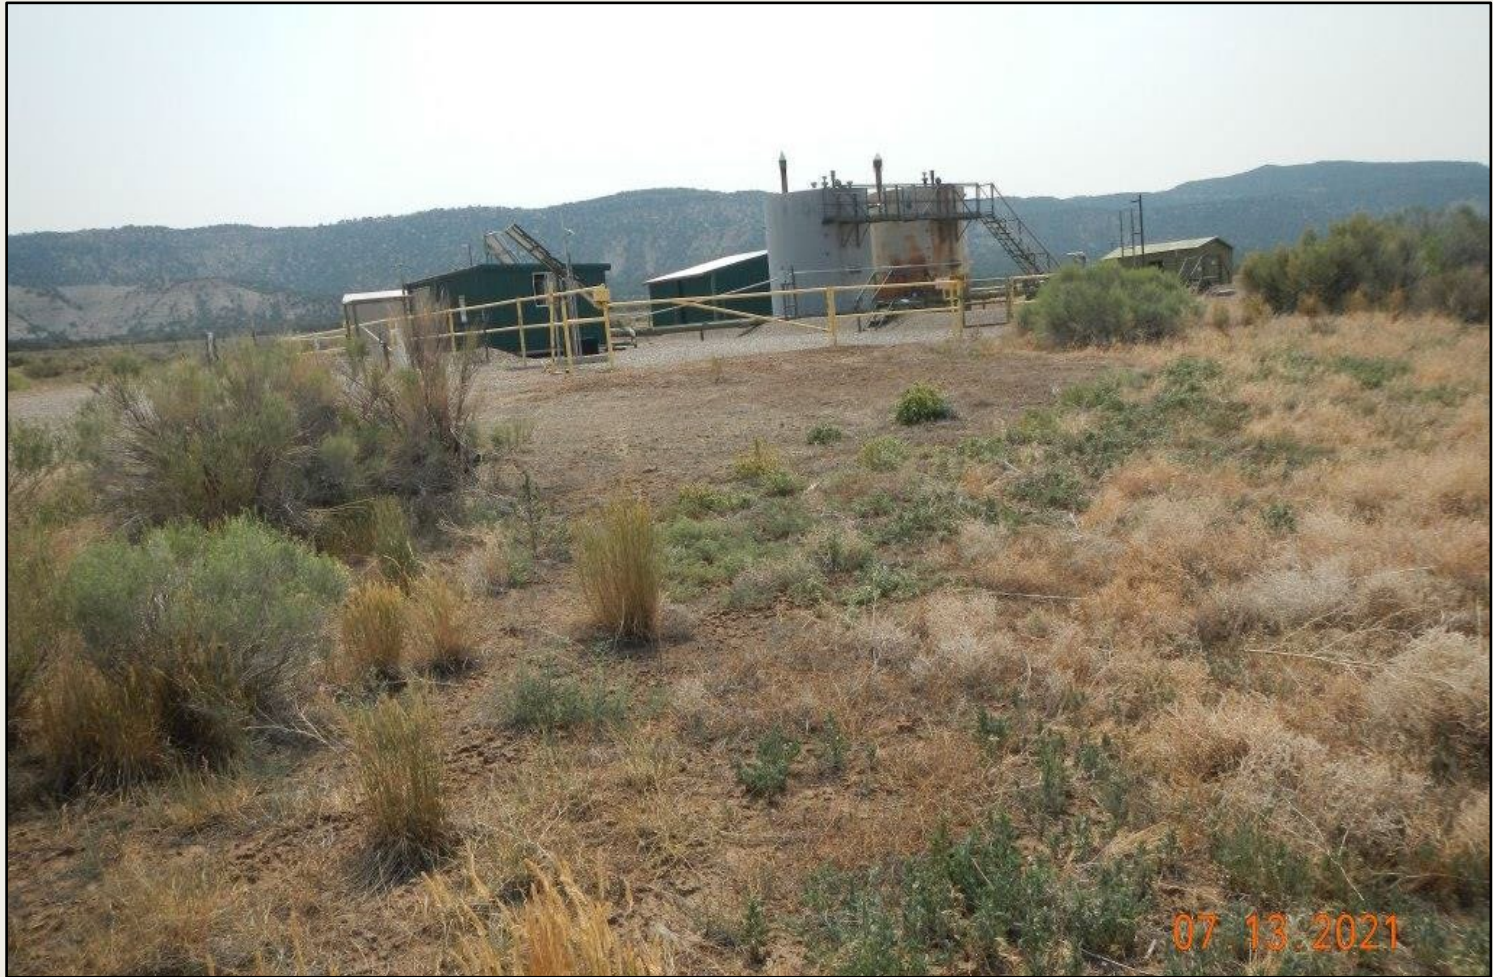
Photo 1. View the project area from the northwestern corner facing center.

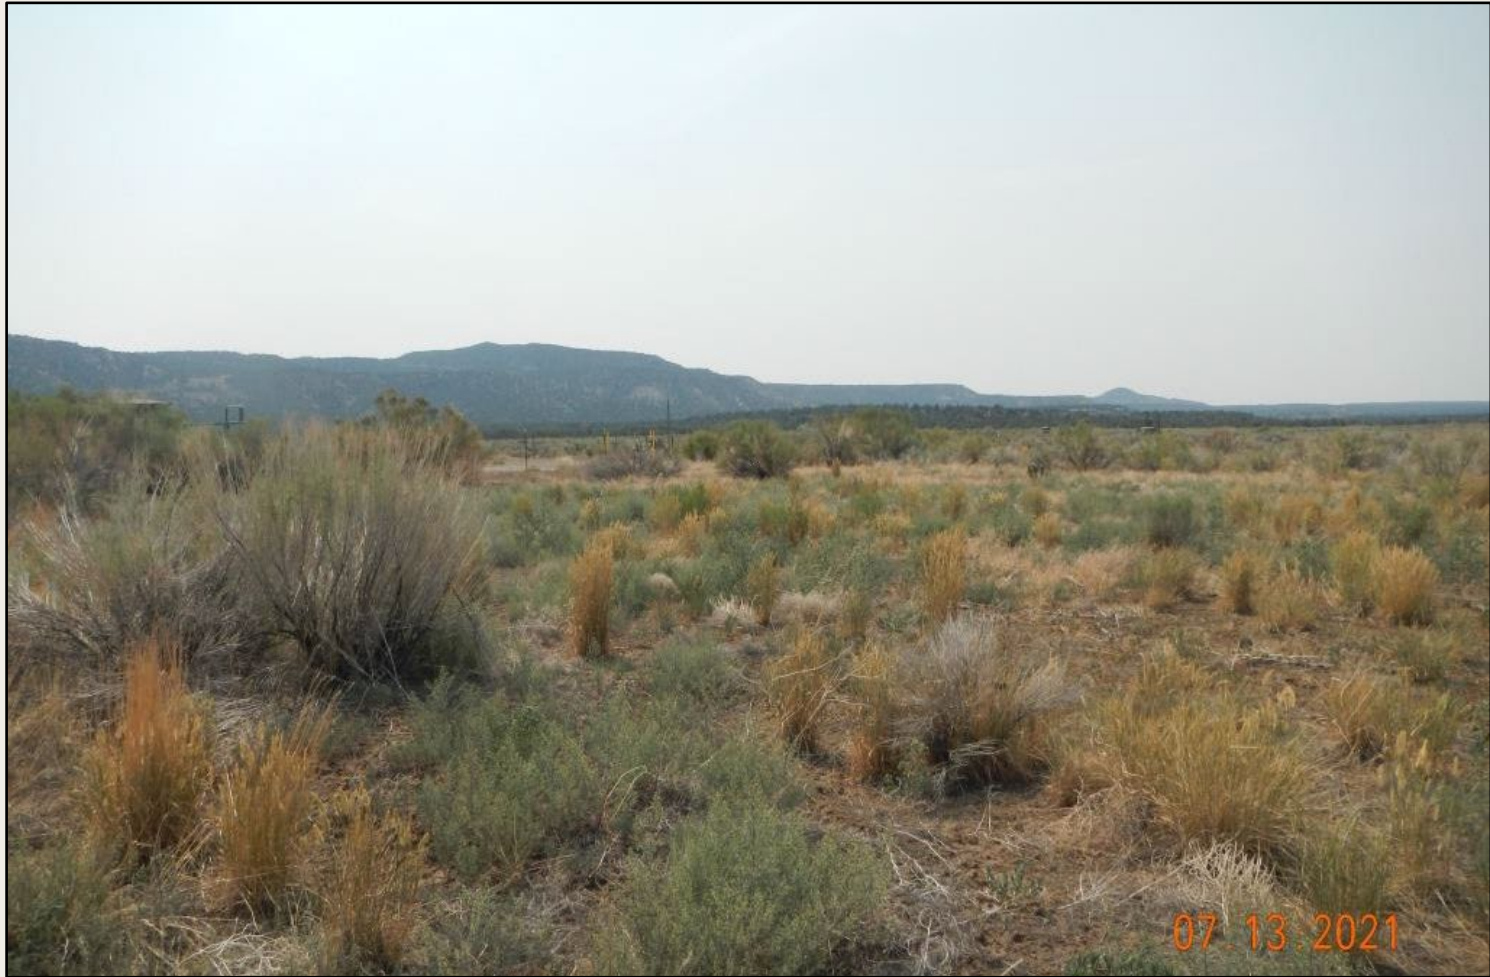
Photo 2. View of the western project area from the northwestern corner facing southward. Revegetation is progressing in portions with squirreltail, rubber rabbitbrush, and crested wheatgrass. Other portions remain sparse and weedy and need re-seeding

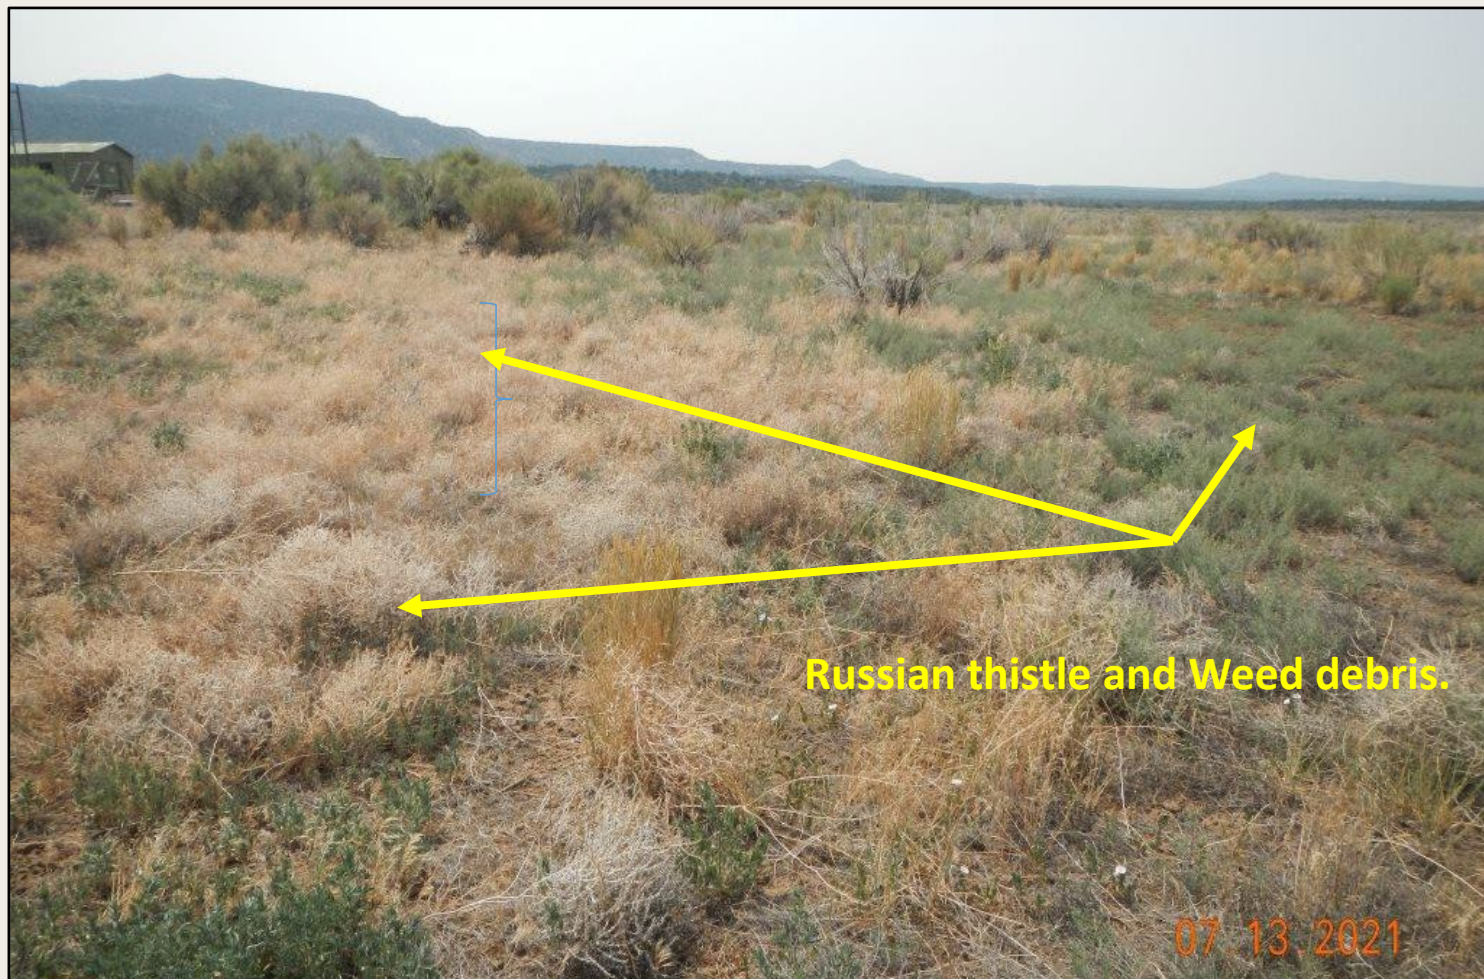
Photo 4. View of dense Russian thistle and debris within the western project area. Little desirable vegetation observed here. Weeds are obstructing desirable vegetation establishment.

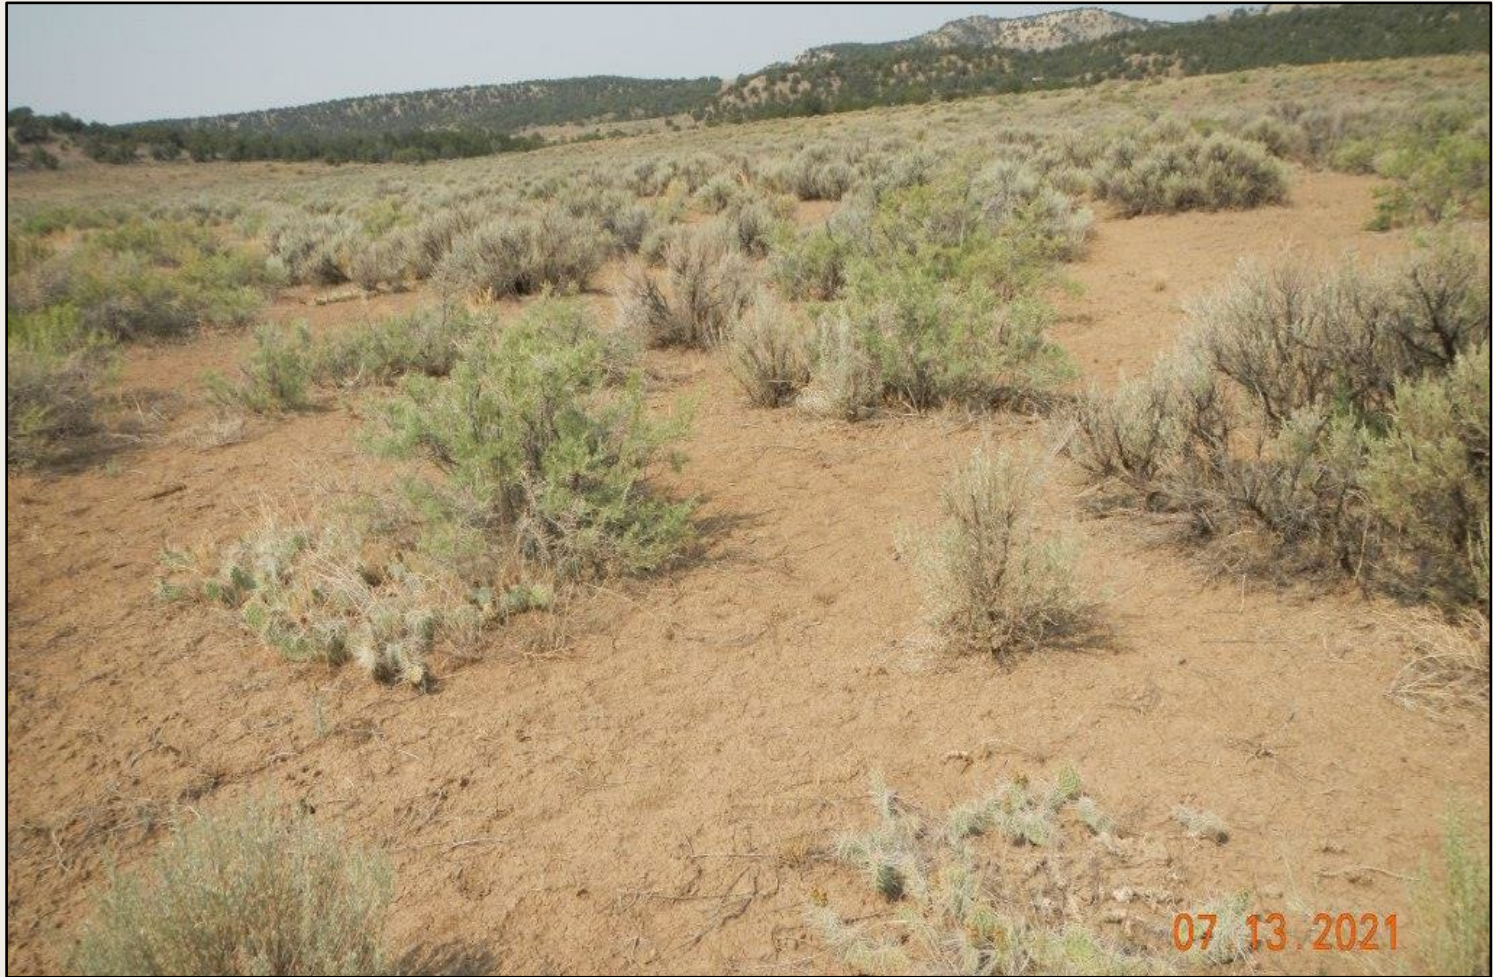
Photo 5. View the reference area comprised of pinyon and juniper woodland with understory of prickly pear, squirreltail, sagebrush, and gambel oak.
