Inspection Photos

Operator: Hilcorp Energy
API: 067-07583
Date: 7/13/2021

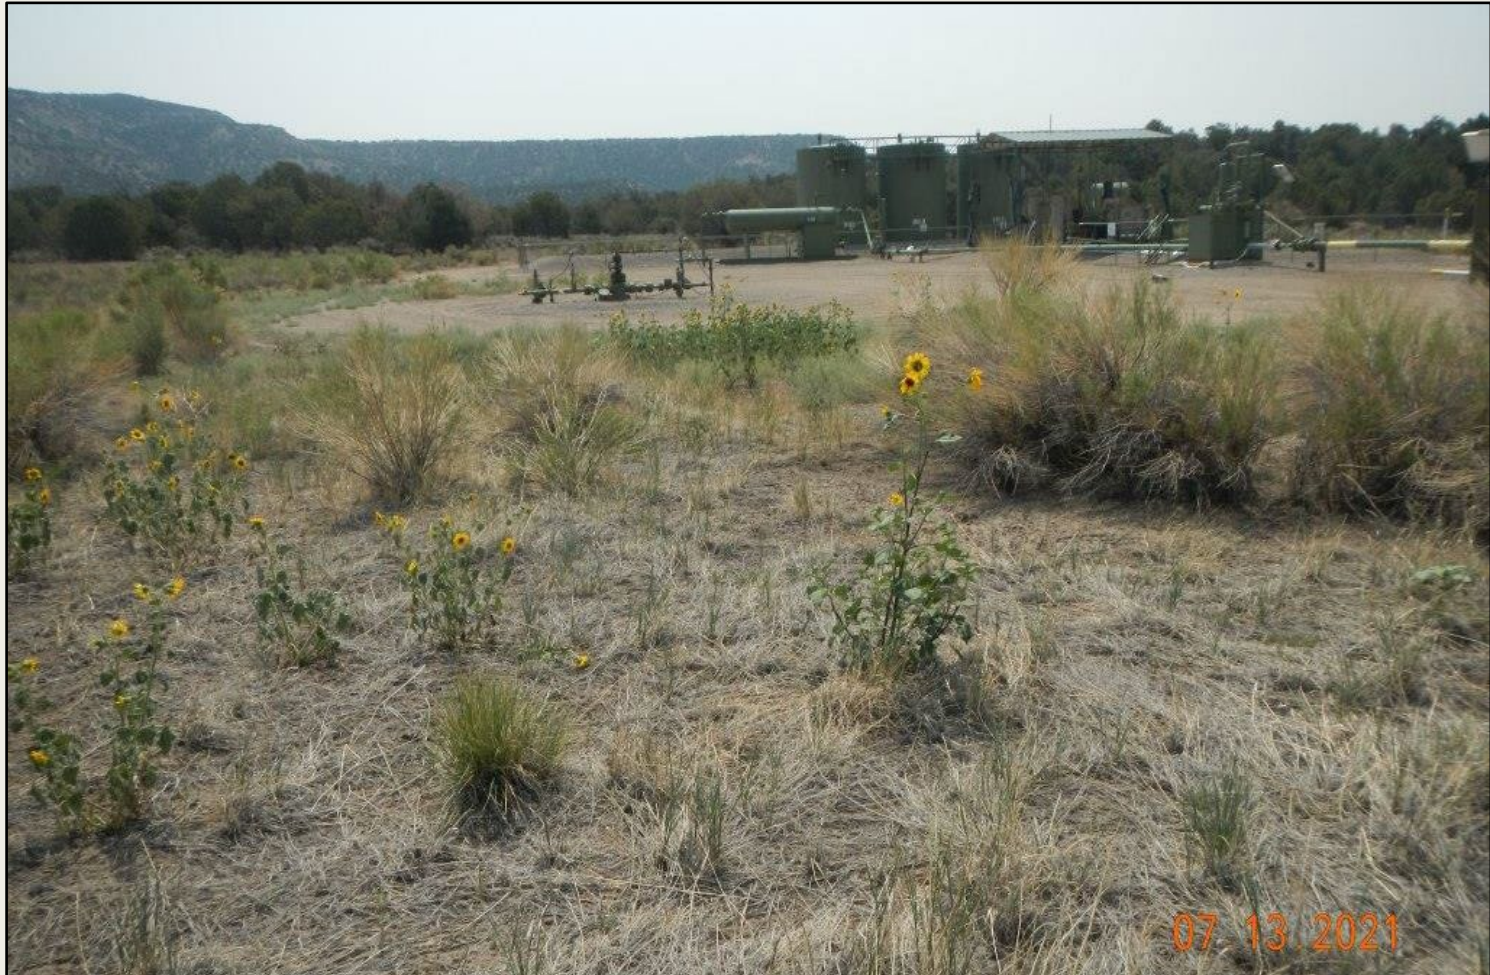
Photo 1. View the project area from the northwestern corner facing center.

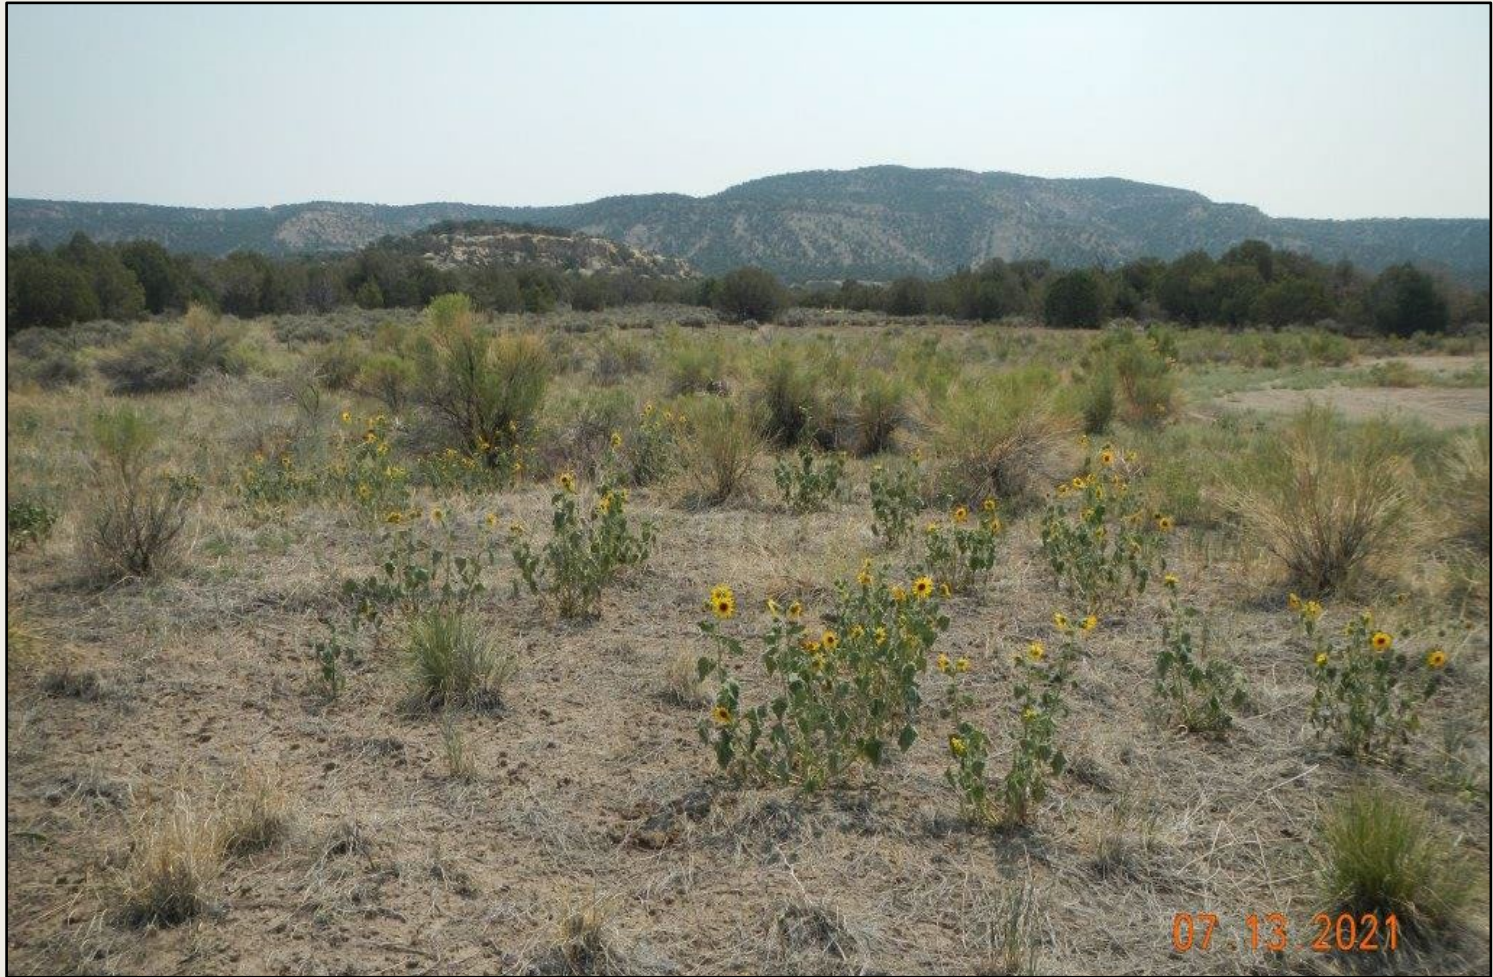
Photo 2. View of the northern project area from the northwestern corner facing eastward. Revegetation is progressing with western wheatgrass, crested wheatgrass, and rubber rabbitbrush.

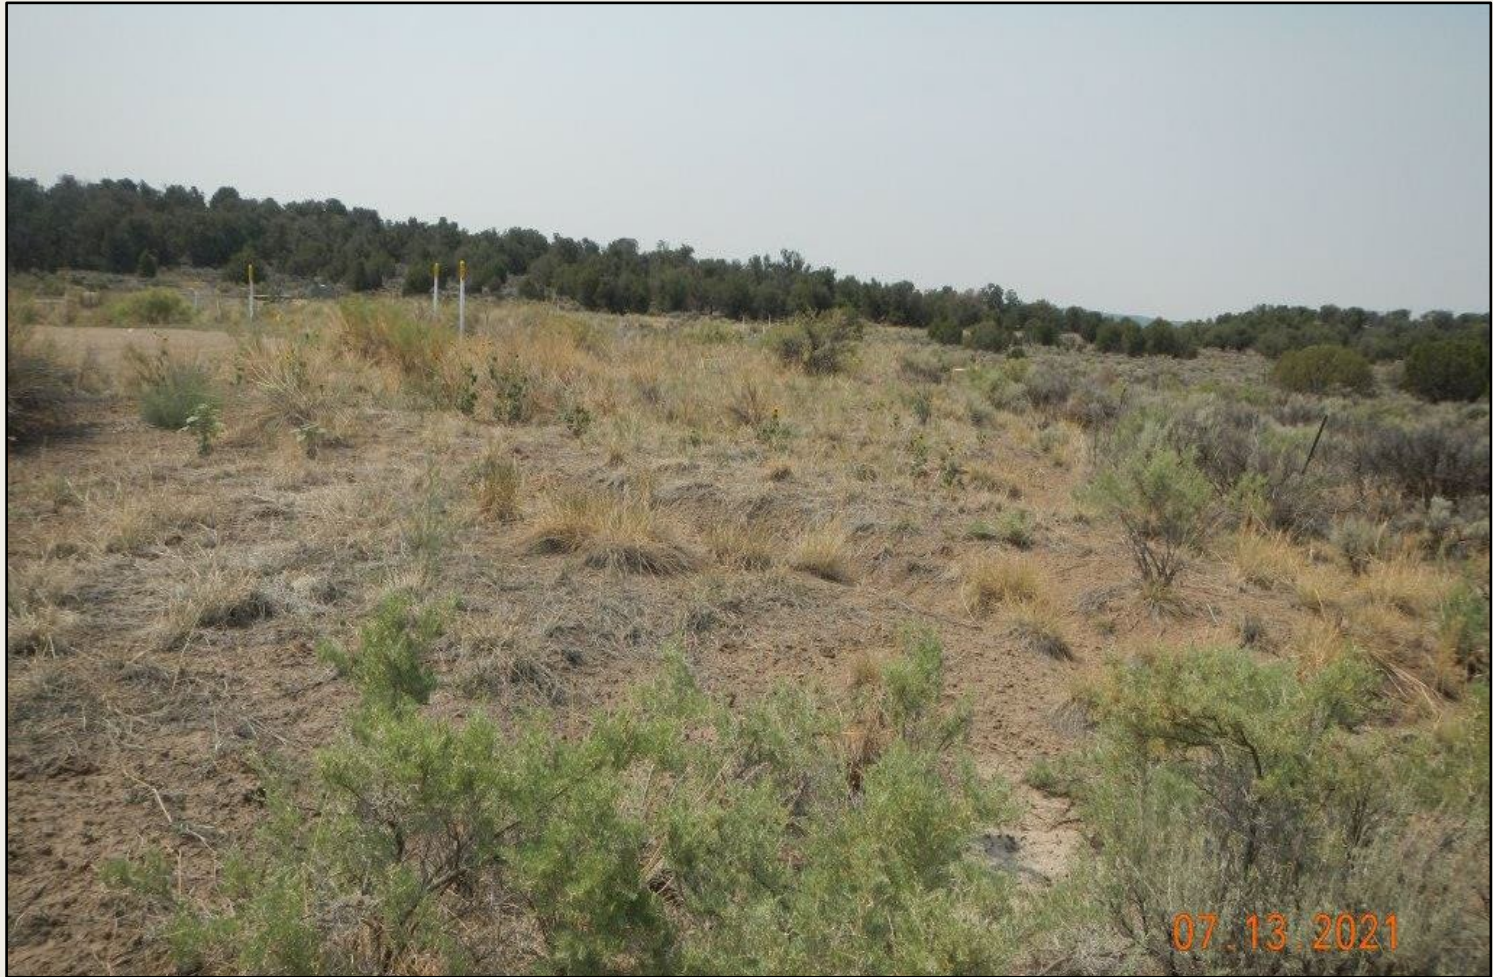
Photo 3. View of the western project area from the northwestern corner facing southward.

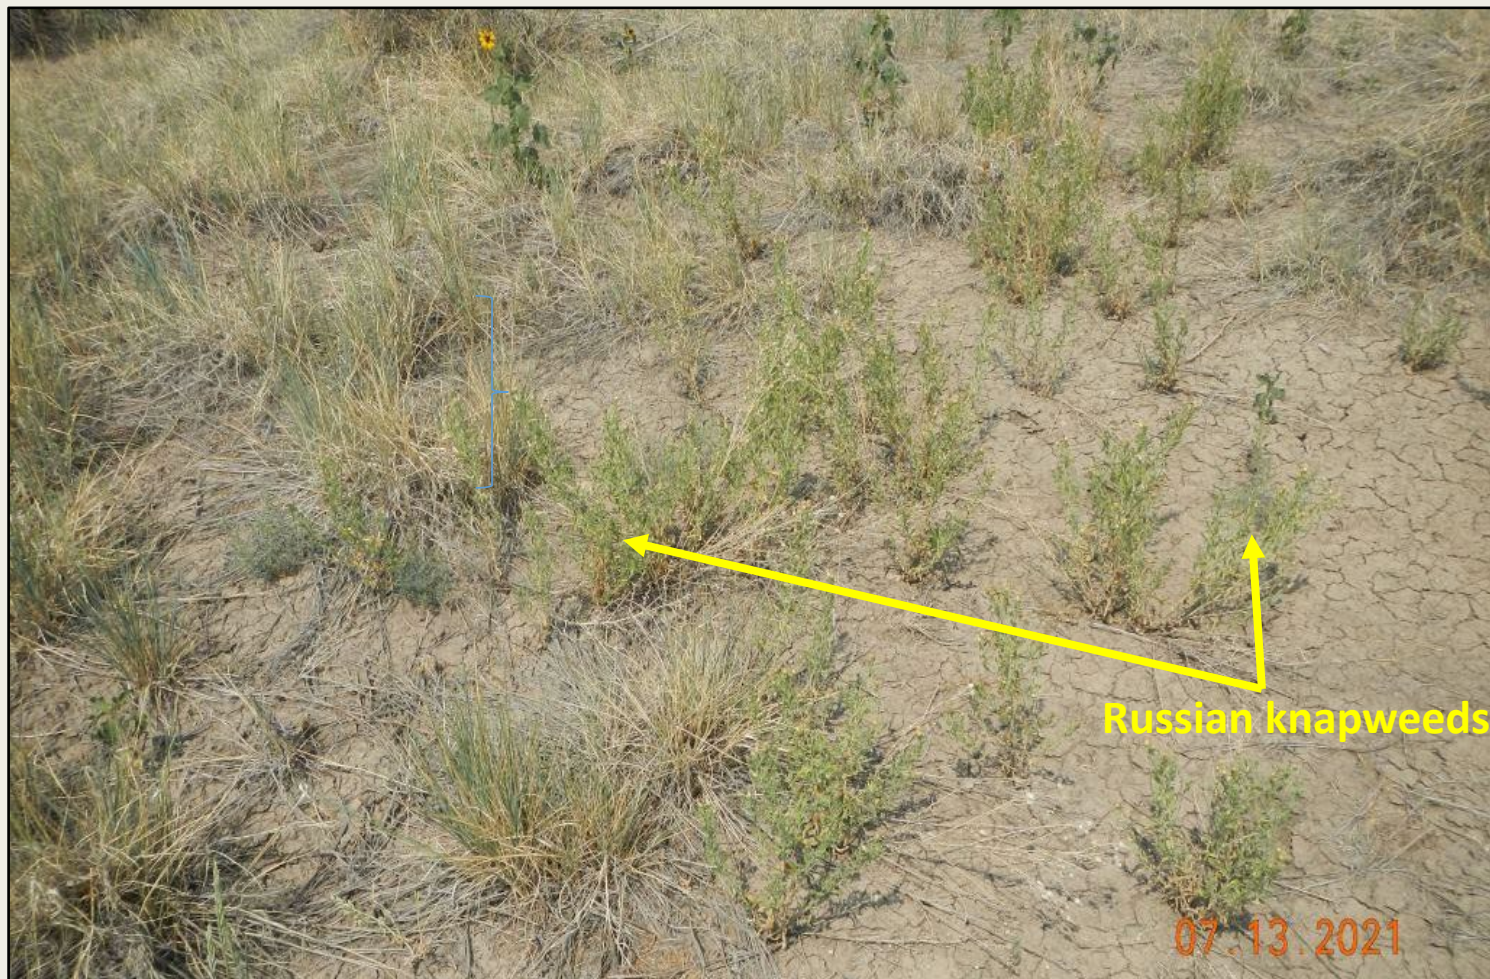
Photo 4. View of Russian knapweeds within the northwestern working area. Approximately 75 individuals observed.

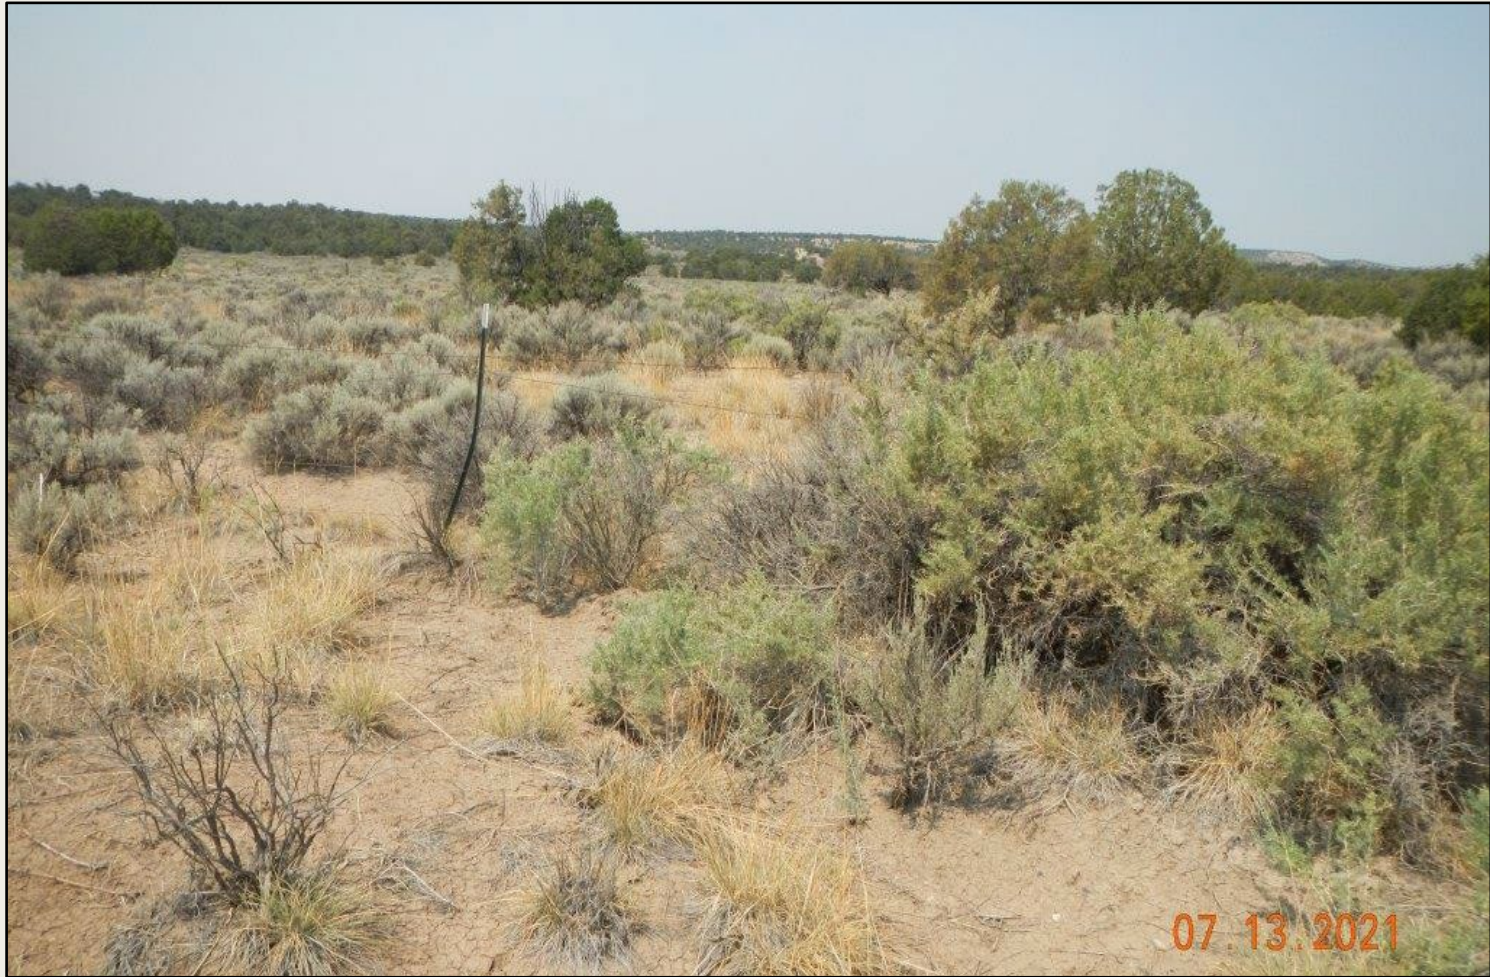
Photo 5. View the reference area comprised of sagebrush shrubland and pinyon/juniper woodland with understory of squirreltail, greasewood, and threadleaf sunflower.
