**UTAH GAS OP LTD DBA UTAH GAS CORP
DRAGON TRAIL UNIT-62S102W 26SWSE
Location # 314307**

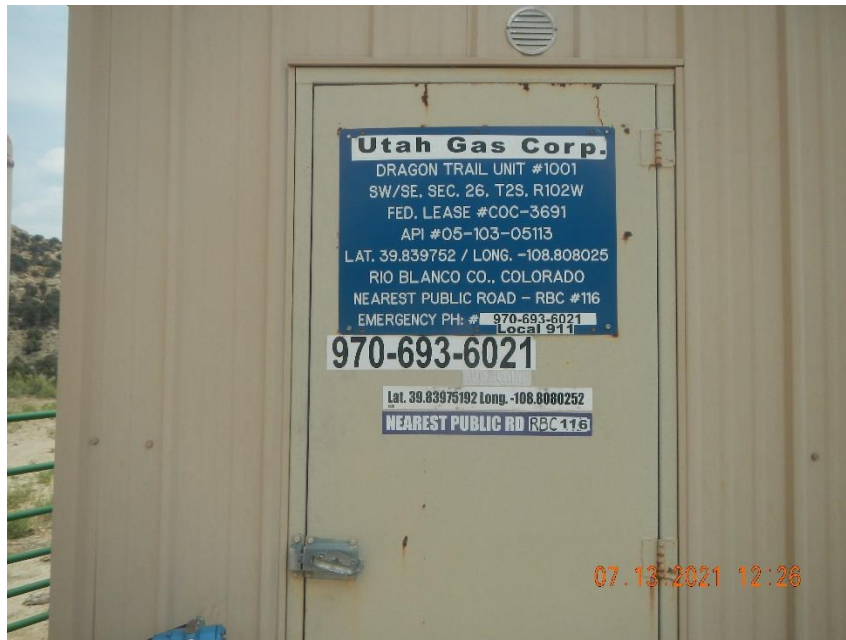
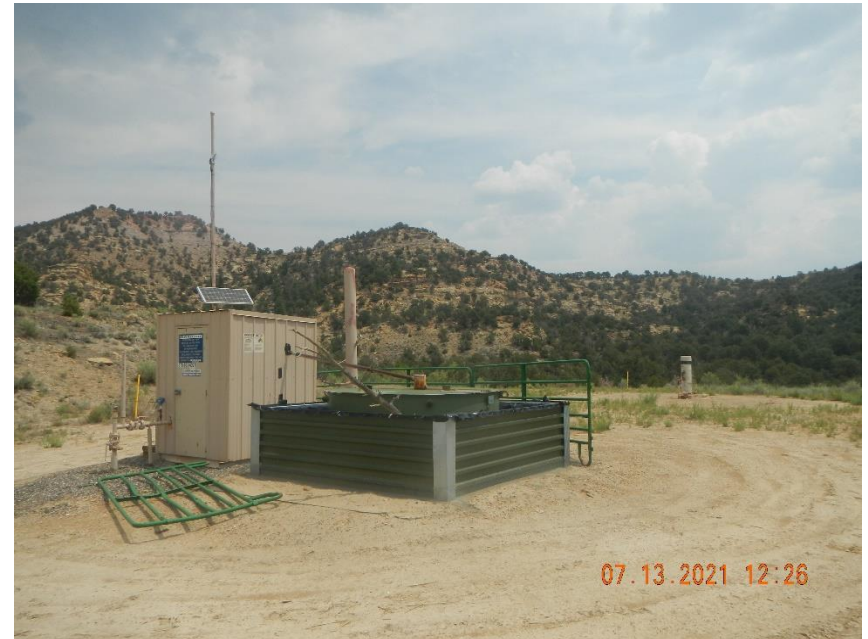
Weeds on location. No battery sign at tank battery.

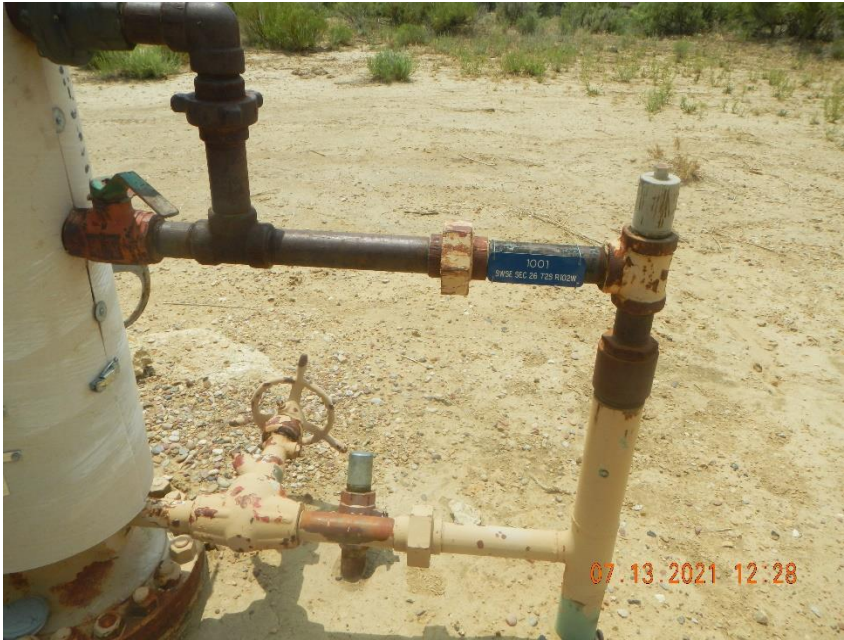
No api# on well tag/sign.

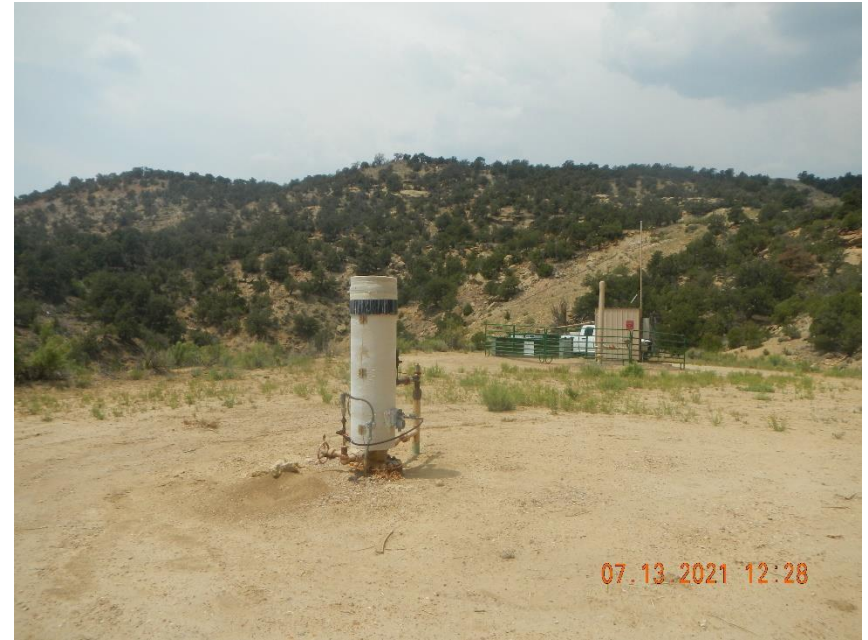
Weeds on location.

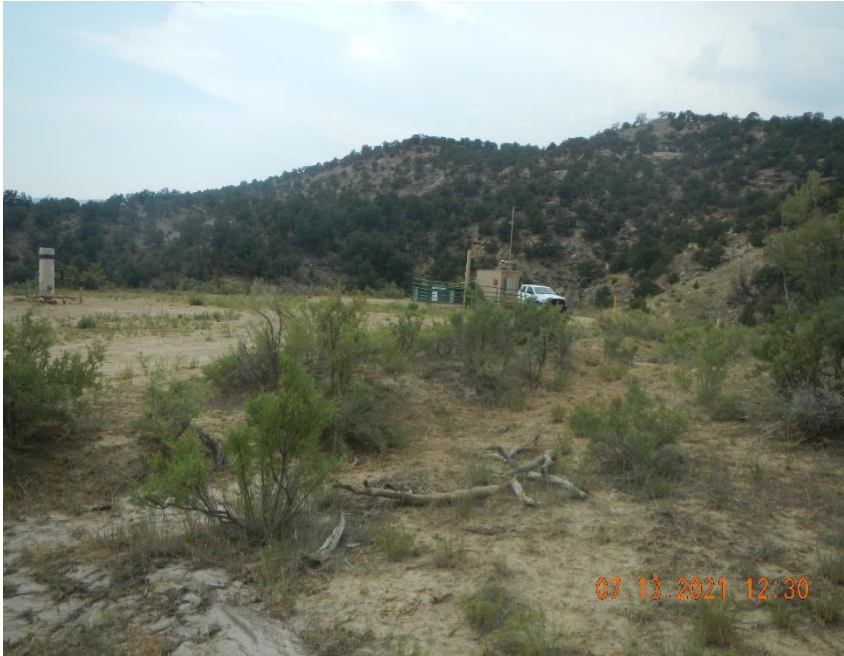
Sediment movement in location ditch.

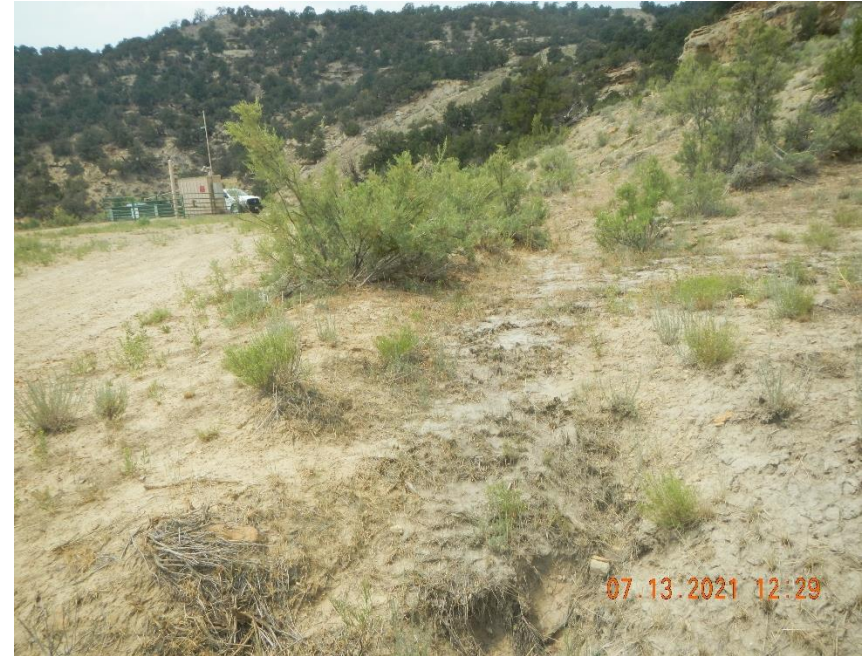
Sediment movement in location ditch.

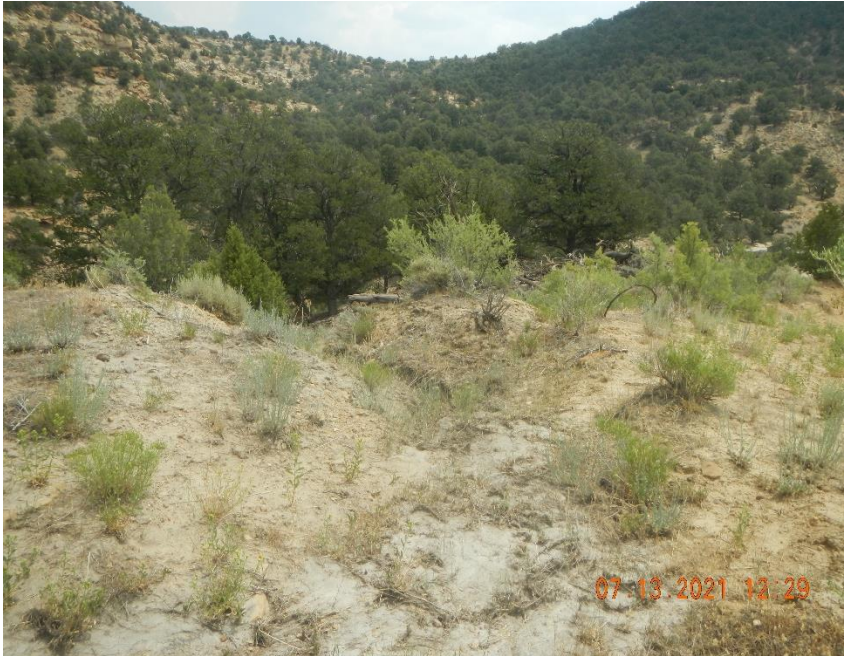
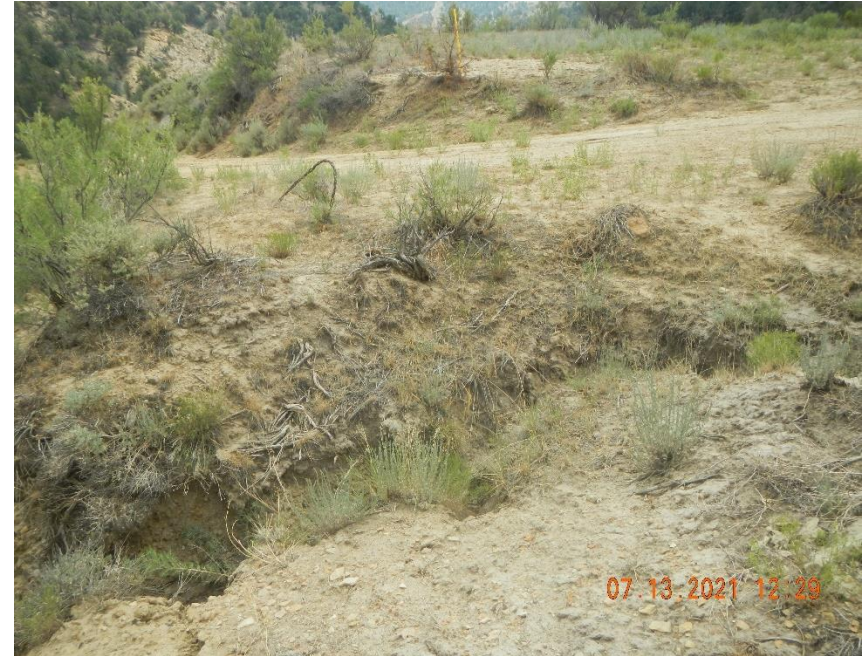
Erosion of hillside from storm water flow of location ditch.

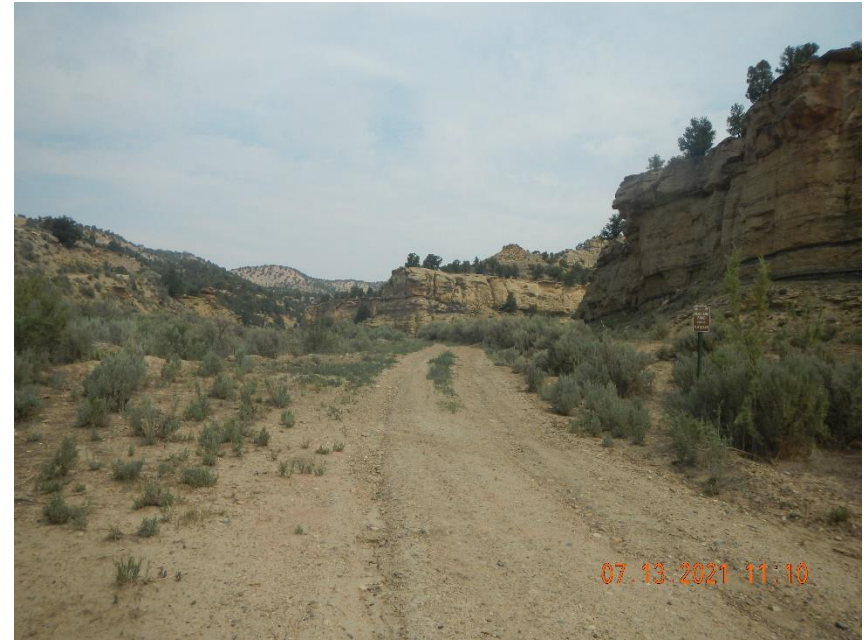
Erosion of road and movement of sediment.

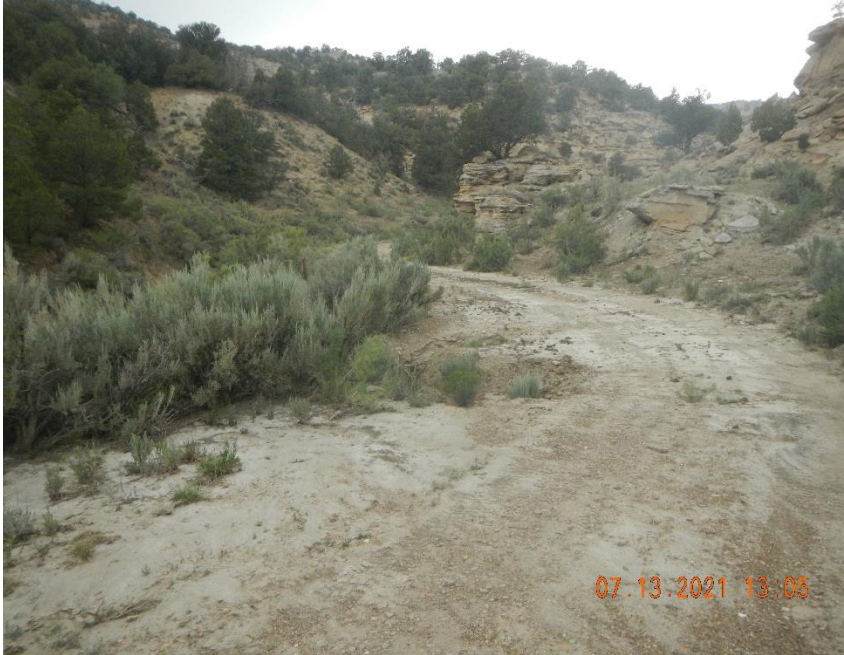
Road Access road is not maintained in a stable condition.

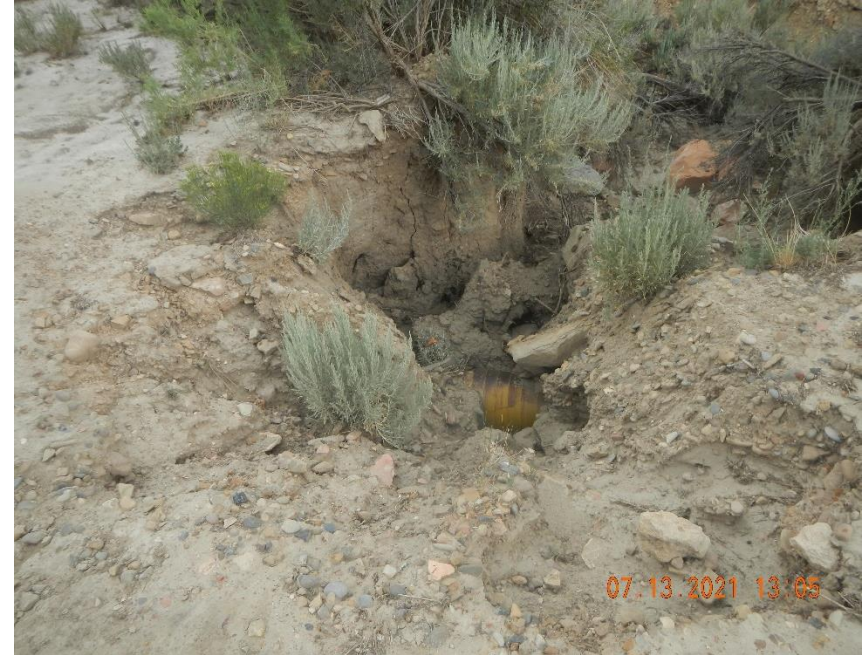
Shoulder of road is washing away and exposing gas line. 39.83447 108.80650

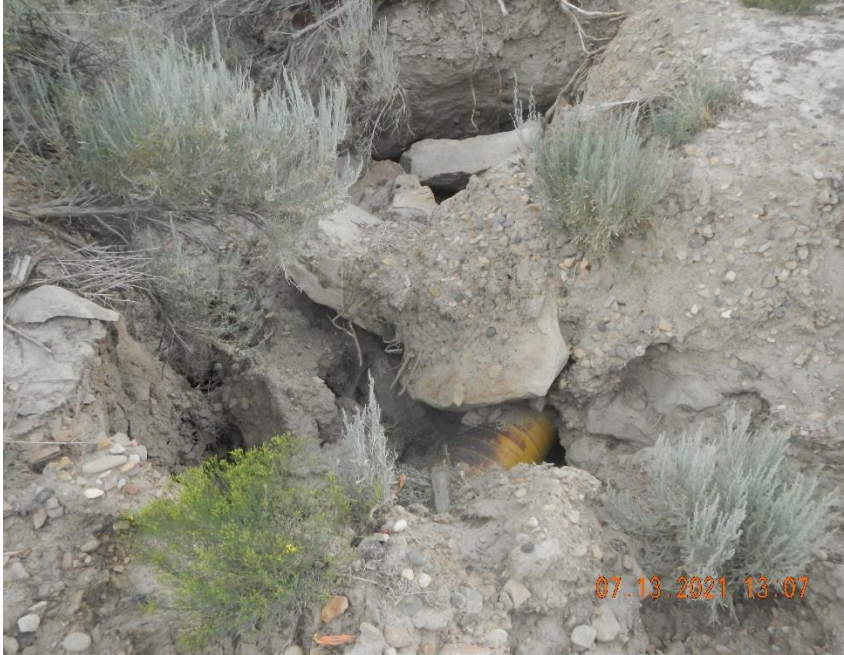
Exposed gas line.

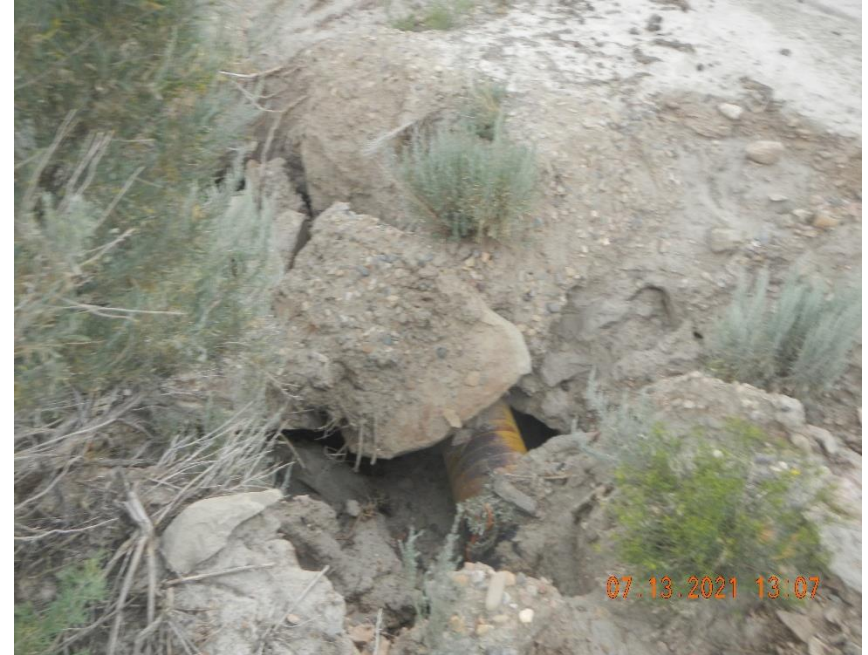
Exposed gas line.

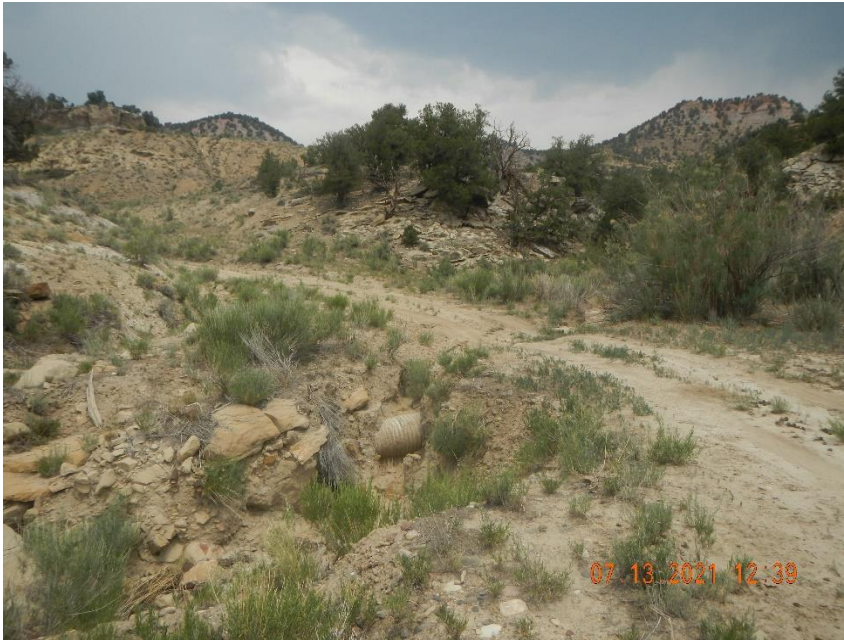
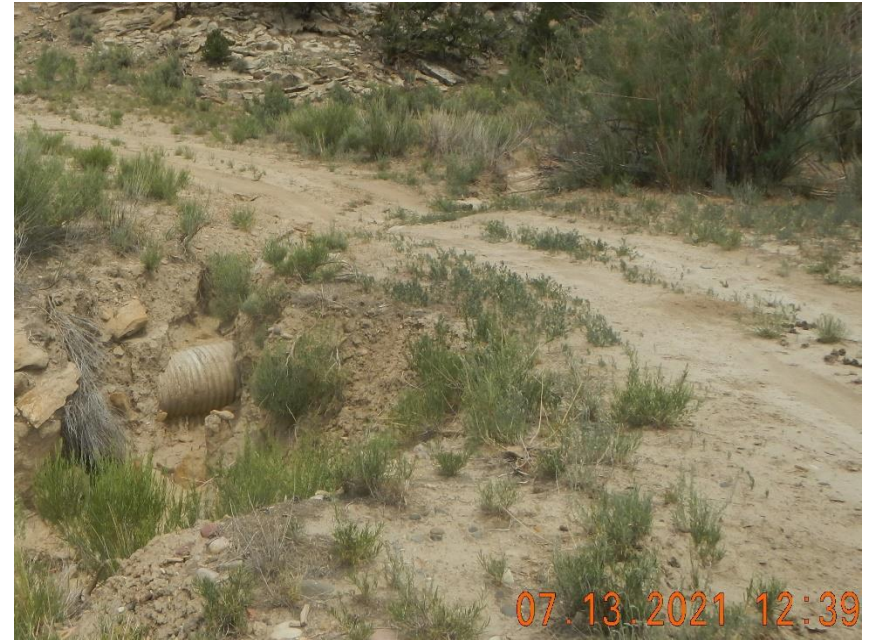
**Culvert running under road 39.83809, -108.80713.
No inlet or outlet found.**

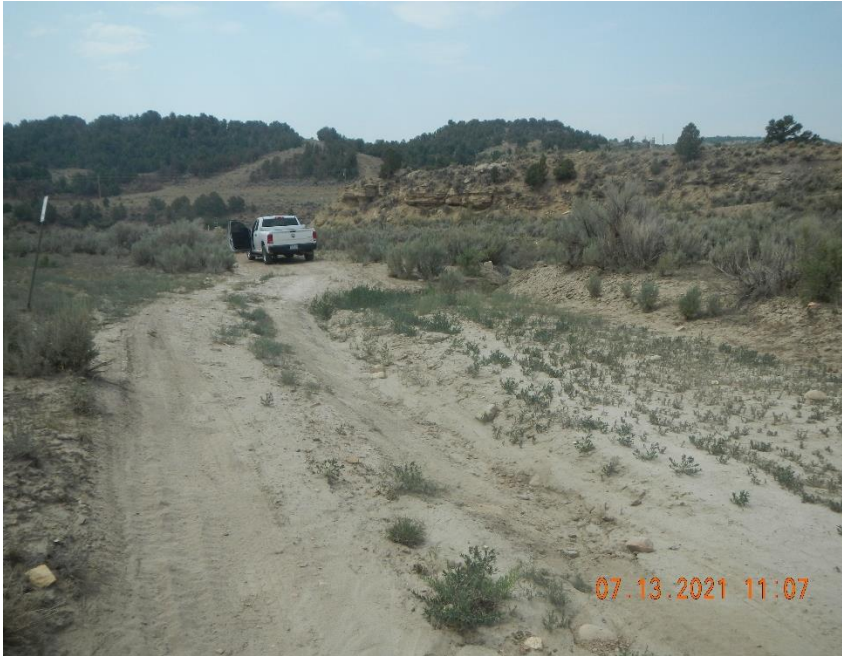
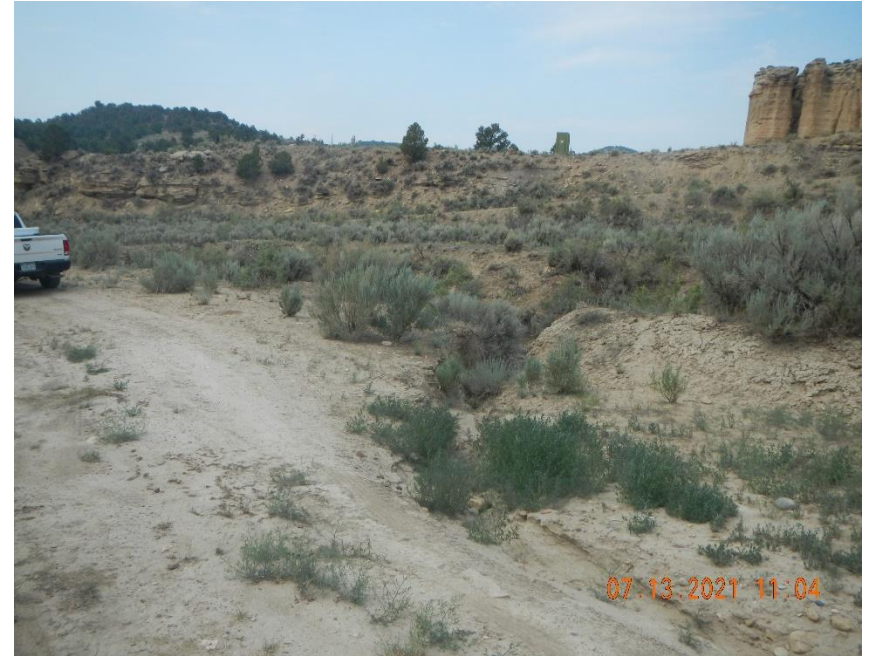
**Erosion rill crossing access road.
Weeds on access road.**

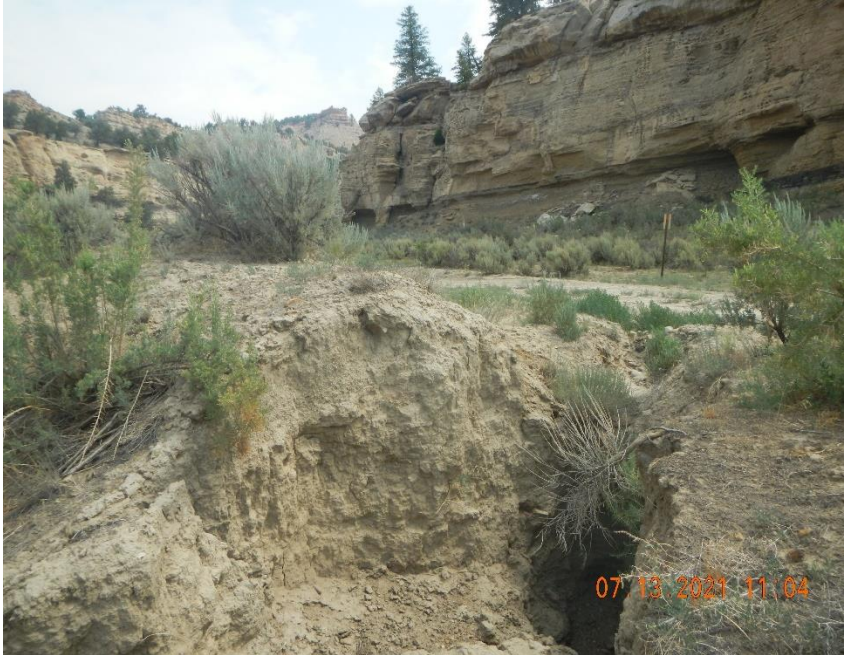
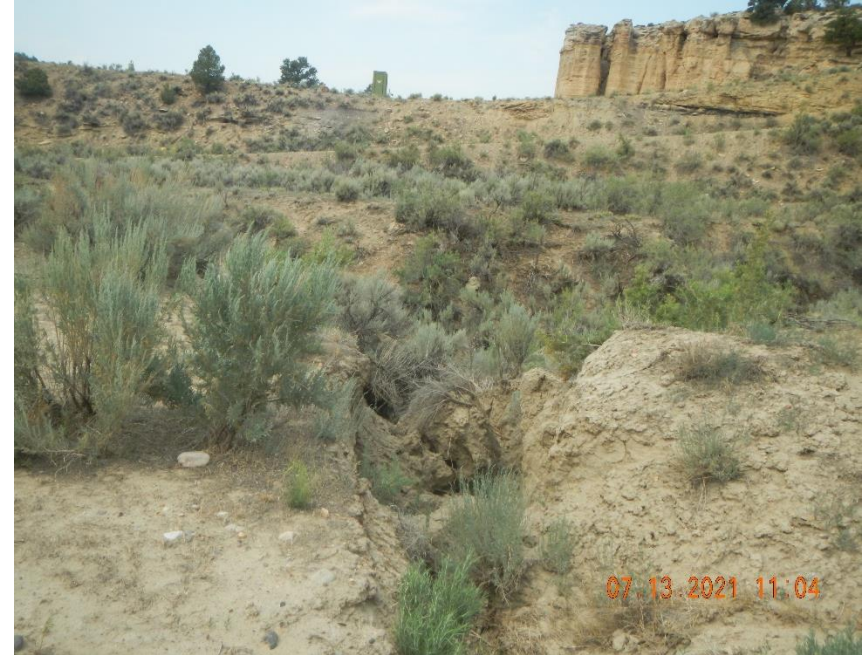
Wash out from erosion rill crossing access road.

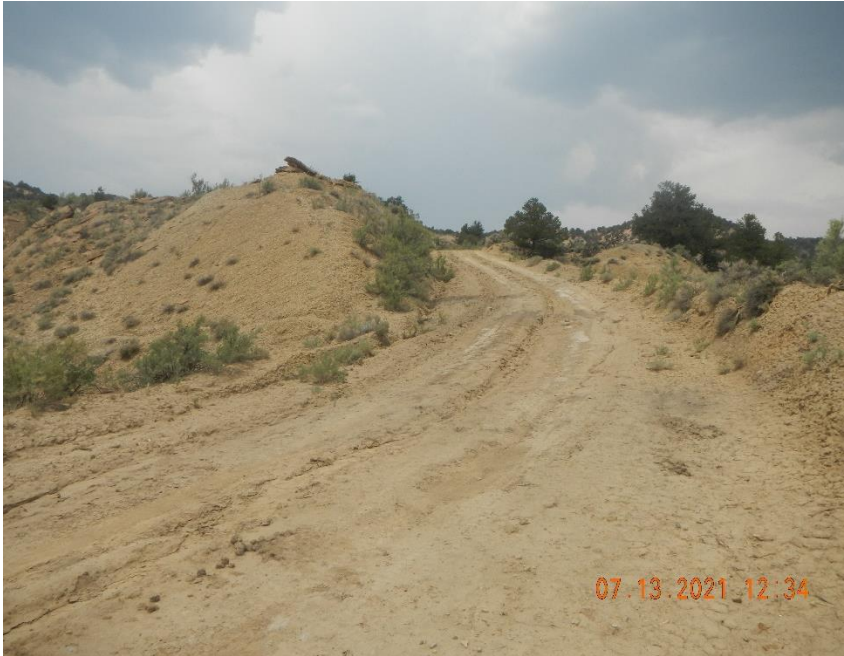
Erosion of road at the entrance of location.

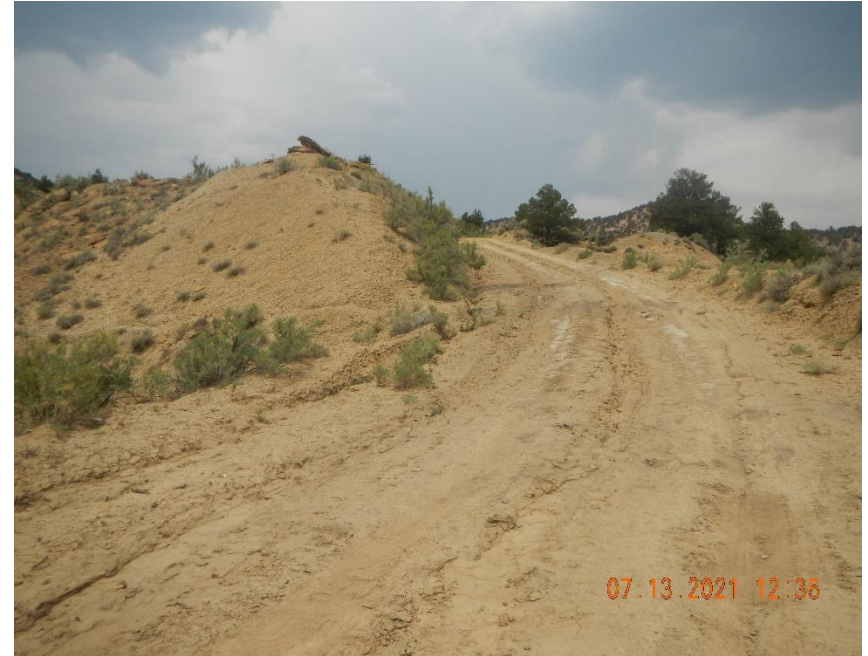
Access roads and BMPs not maintained in a stable condition.
