## Inspection Photos

Location Name: TEP ROCKY MOUNTAIN LLC BOSELY /GM 34-14

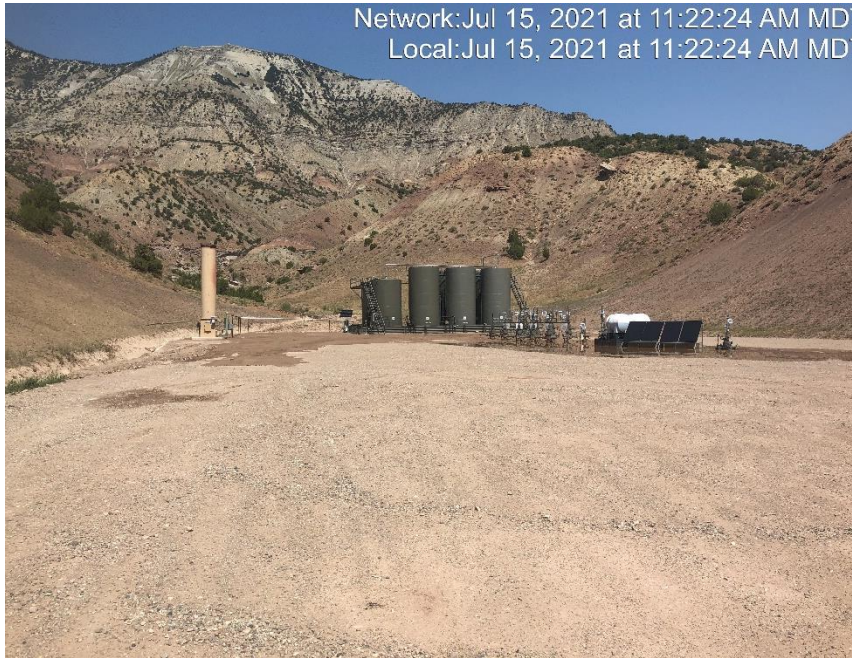
**Photo #4433 from entrance to location.**

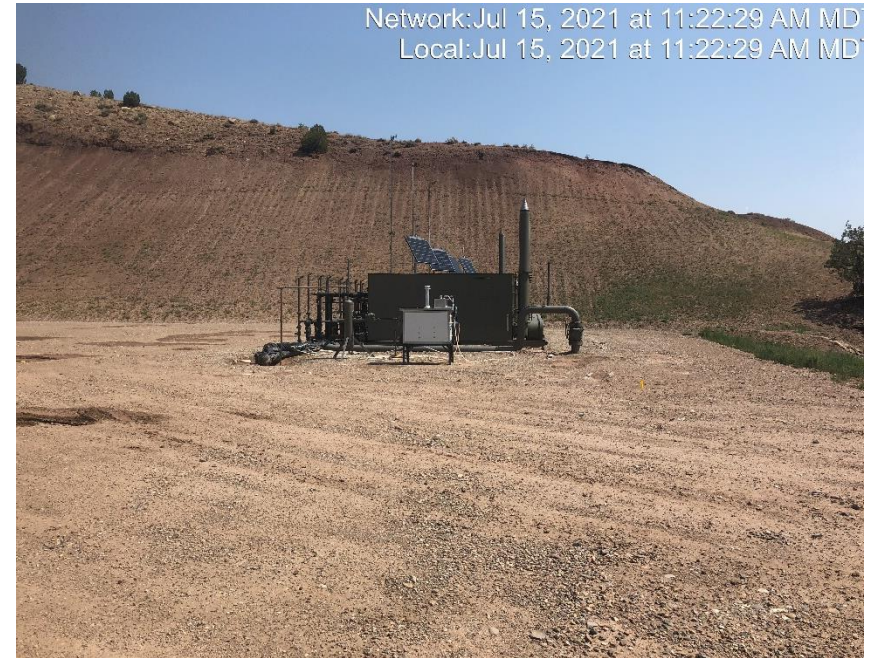
**Photo #4434 from entrance to location.**

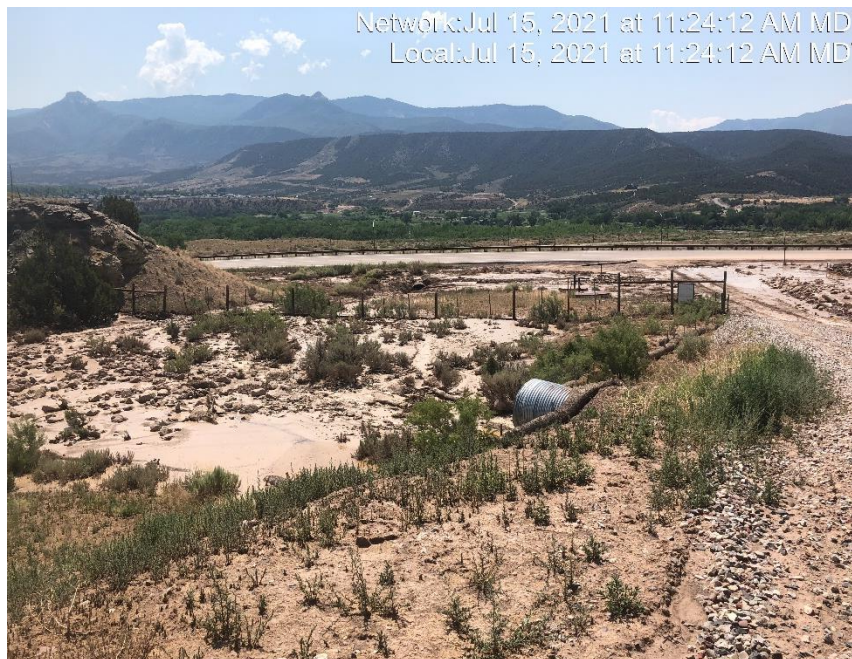
**Photo #4435 from entrance to location.**

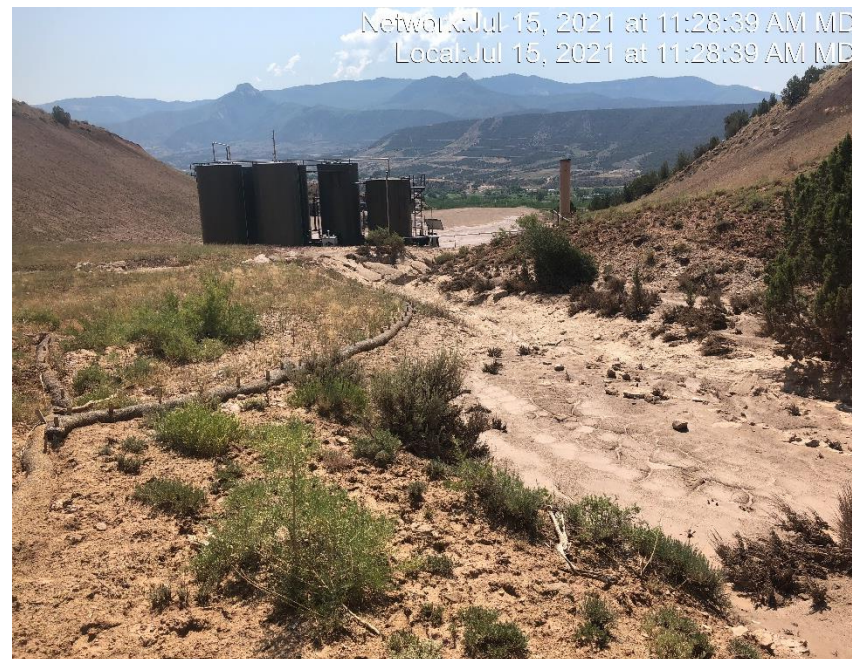
**Photo #4436 Drainage up stream of location.**

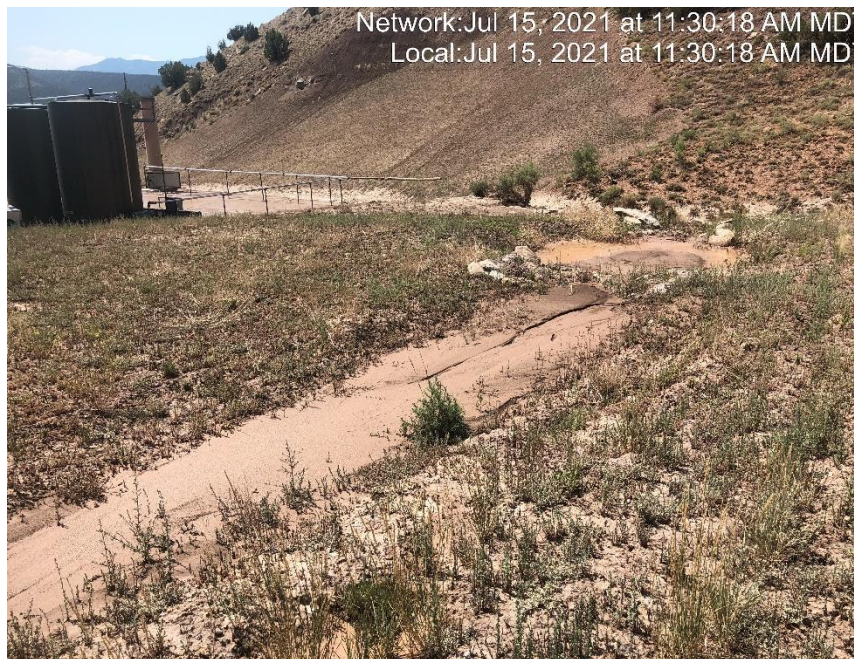
**Photo #4437 Sediment trap filled with sediment.**

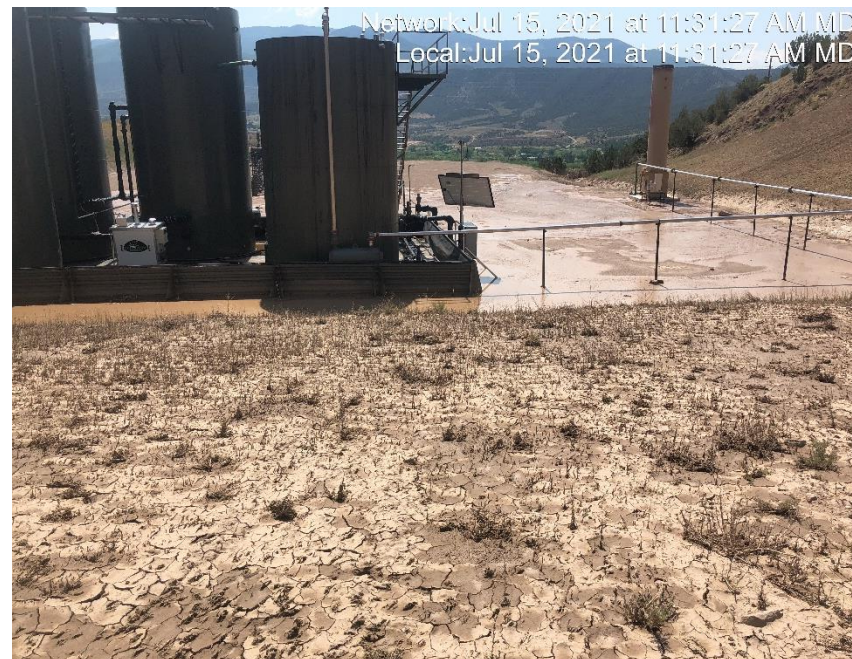
**Photo #4438 Cut slope behind tank battery.**

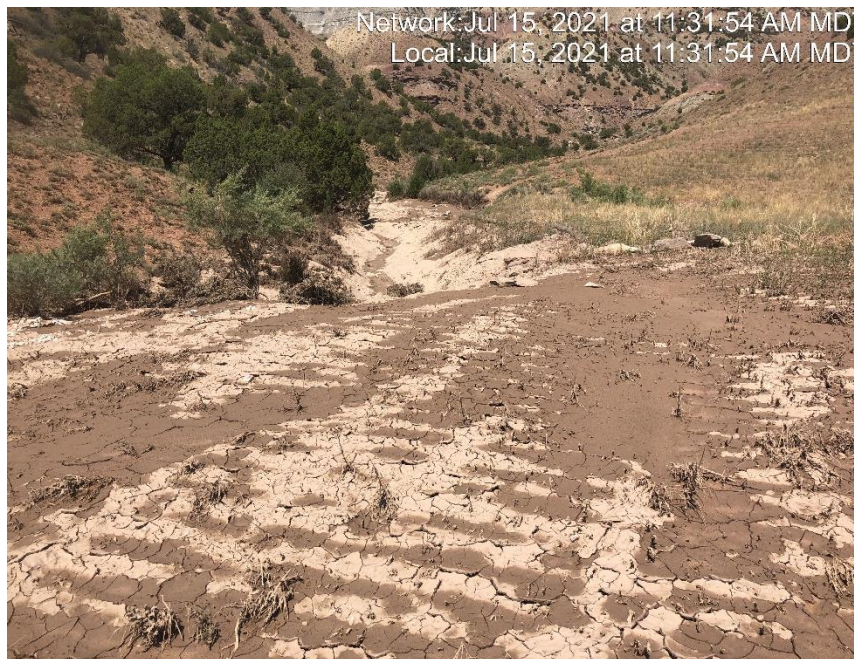
**Photo #4439** drainage up stream of location.

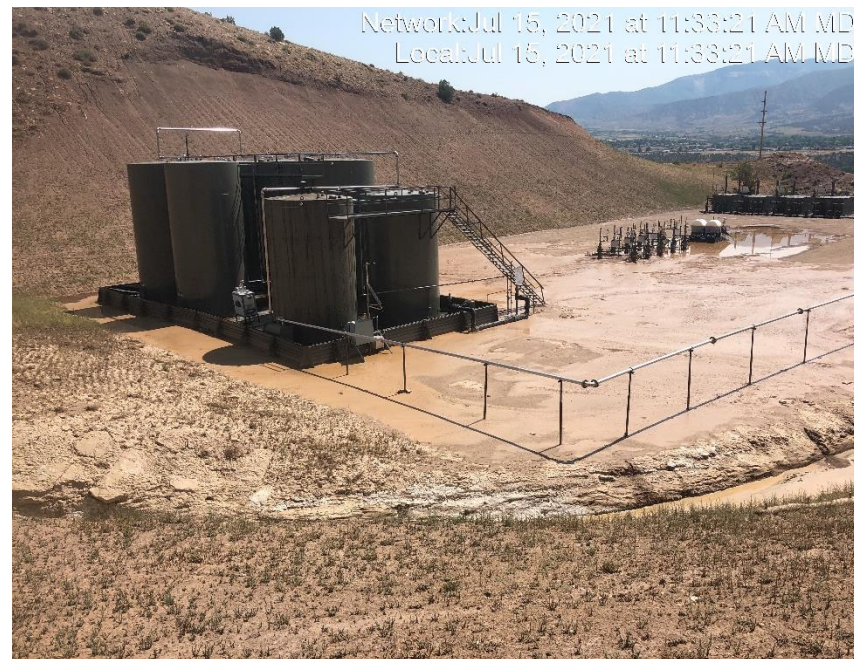
**Photo #4440** Sediment encroaching on production equipment.

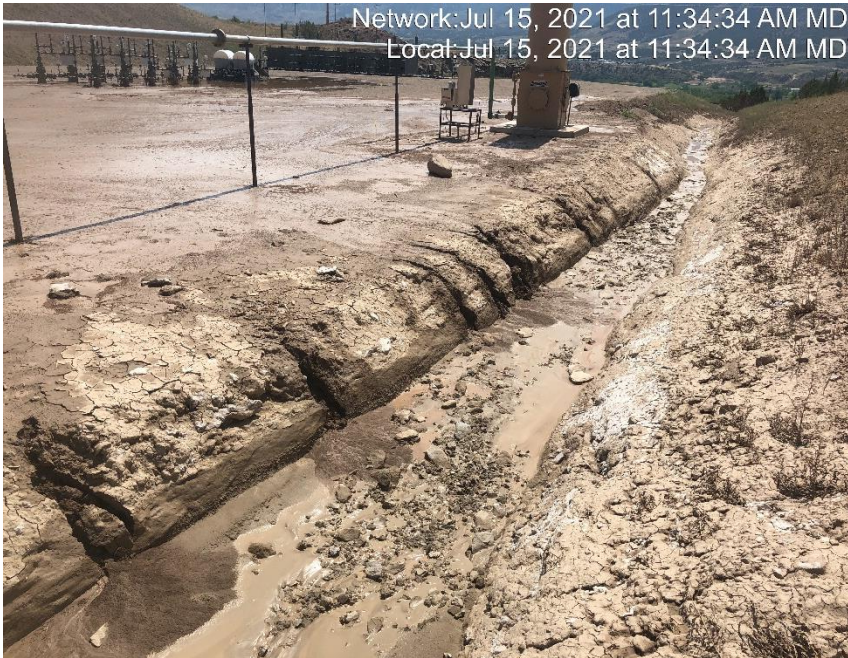
Photo #4441 Ditch on West side of location shows signs of subsidence.

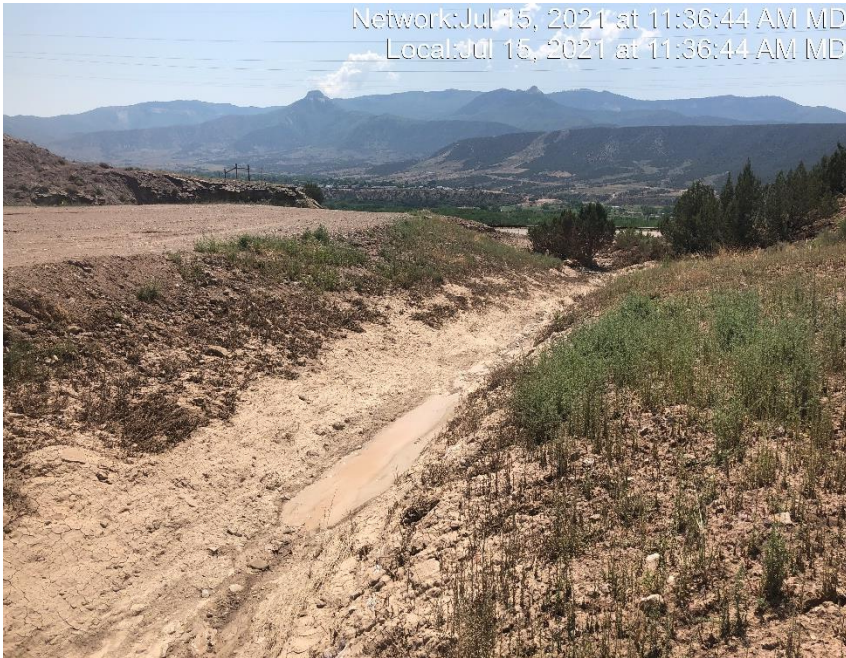
**Photo #443 Ditch on West edge of location.**

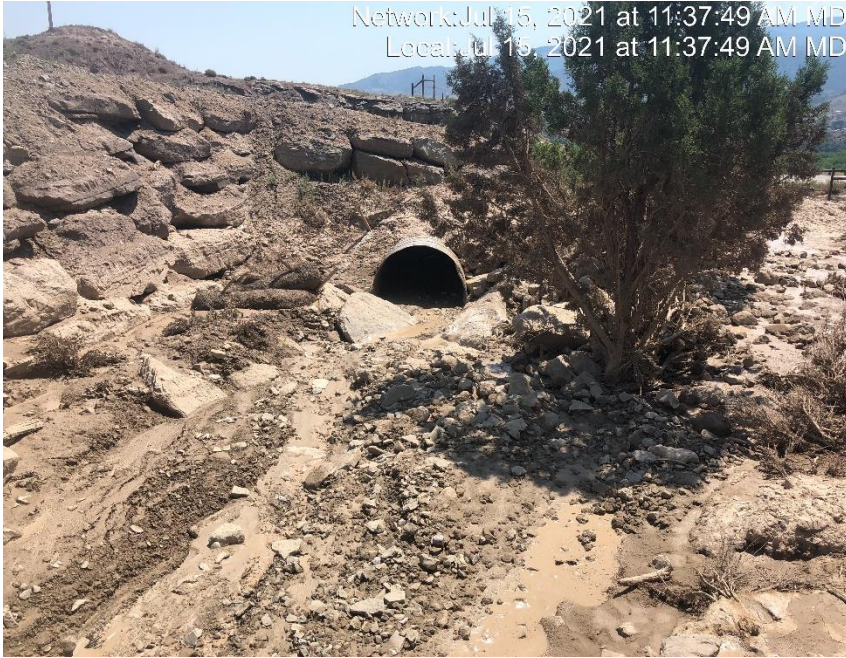
**Photo #4445 Inlet to culvert in access road.**

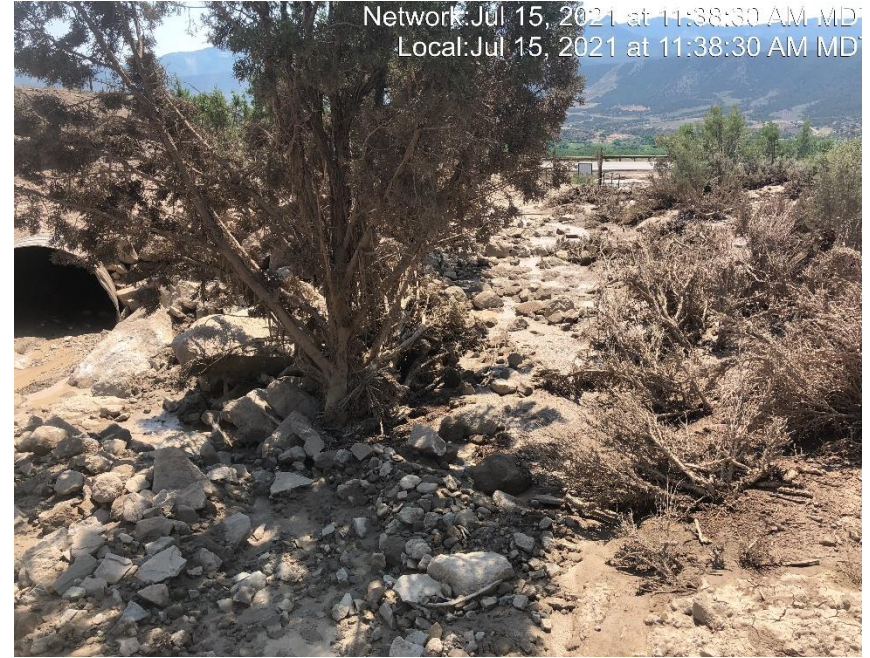
**Photo #4446 Storm water diverted to the right of culvert once the culverts capacity was exceeded.**

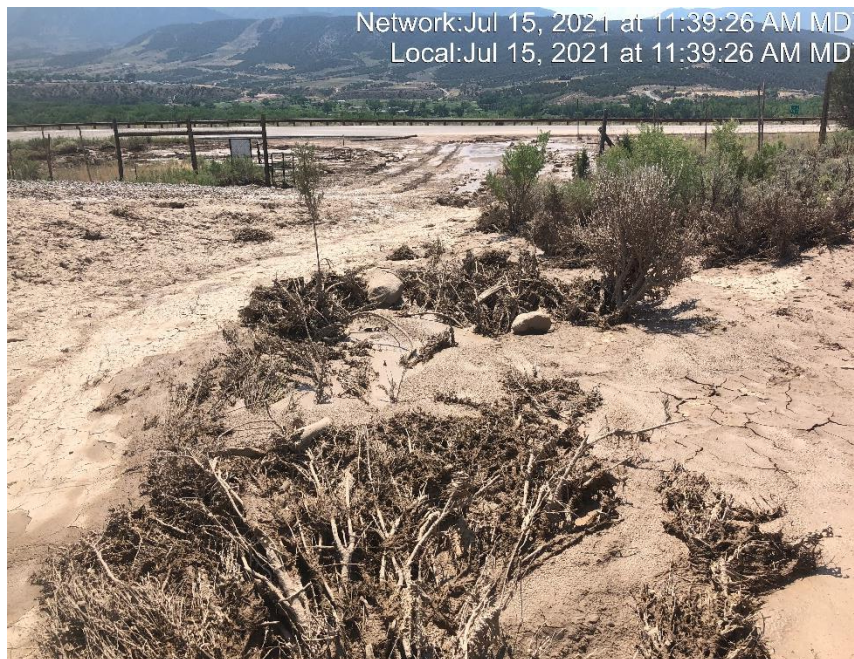
**Photo #4447 Sediment and debris from the diverted path.**

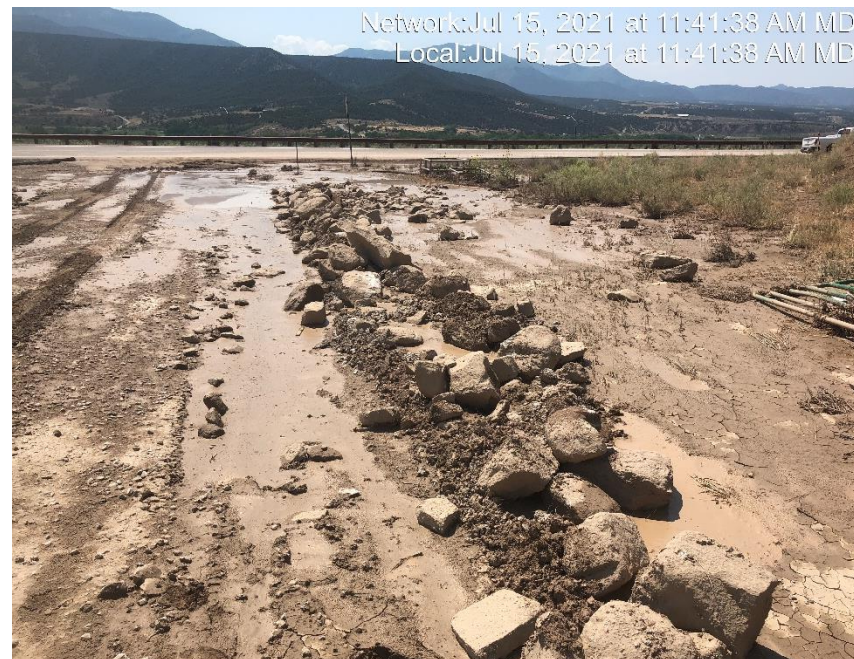
**Photo #4449 Sediment and debris that carried on to HWY 6.**

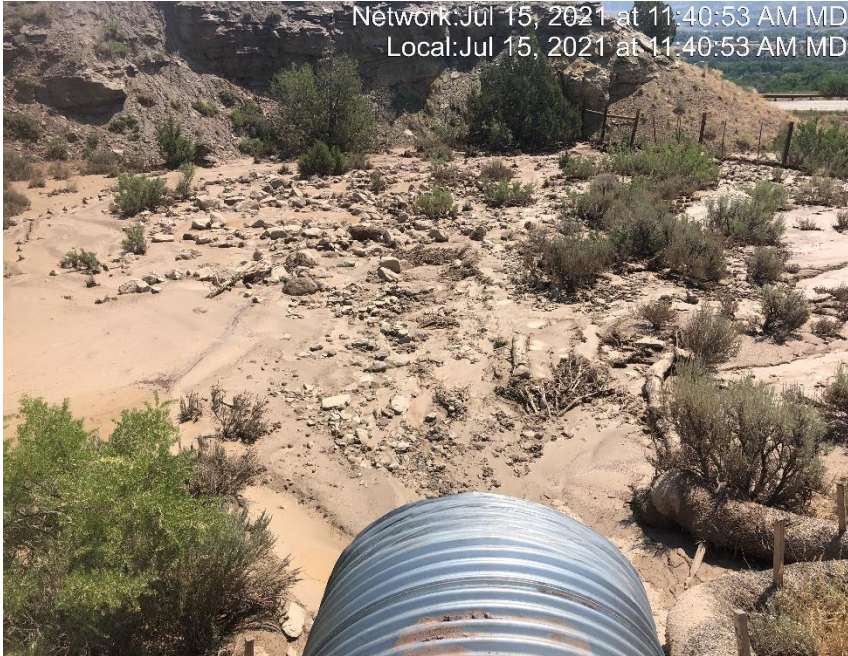
**Photo #4448 Outlet of culvert in access road.**

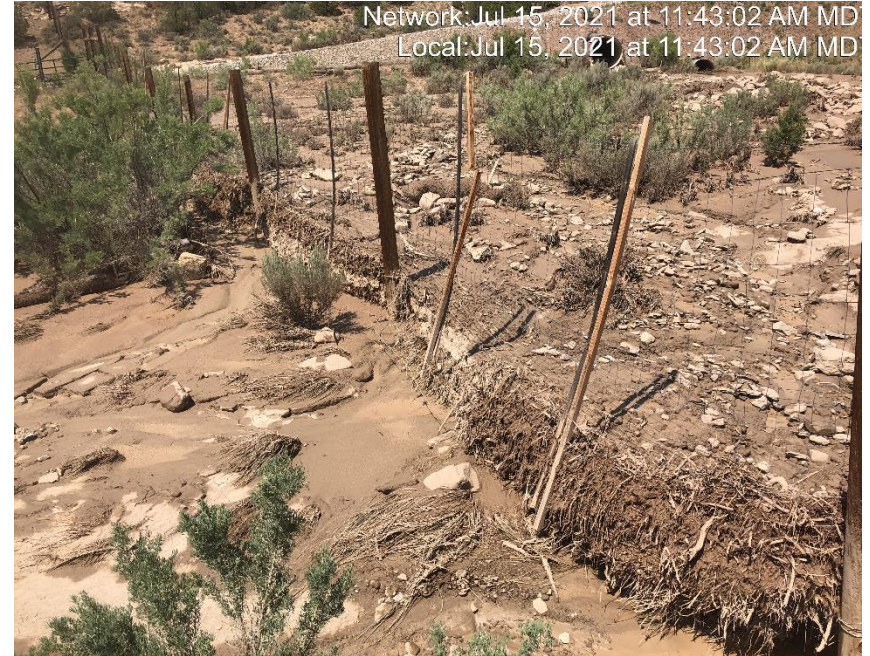
**Photo #4450 Sediment and debris in game fence.**

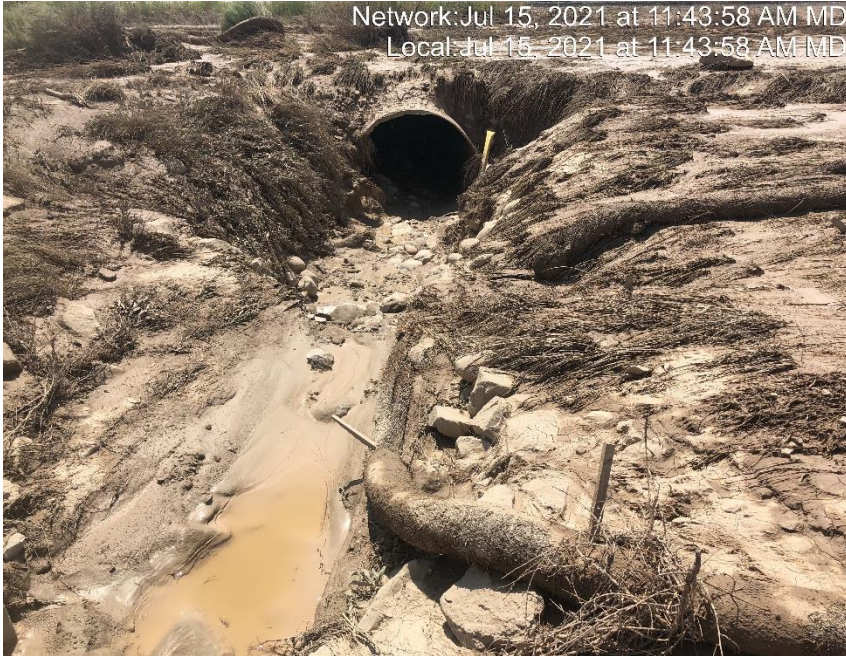
**Photo #4451 Inlet of culvert that runs under HWY 6.**

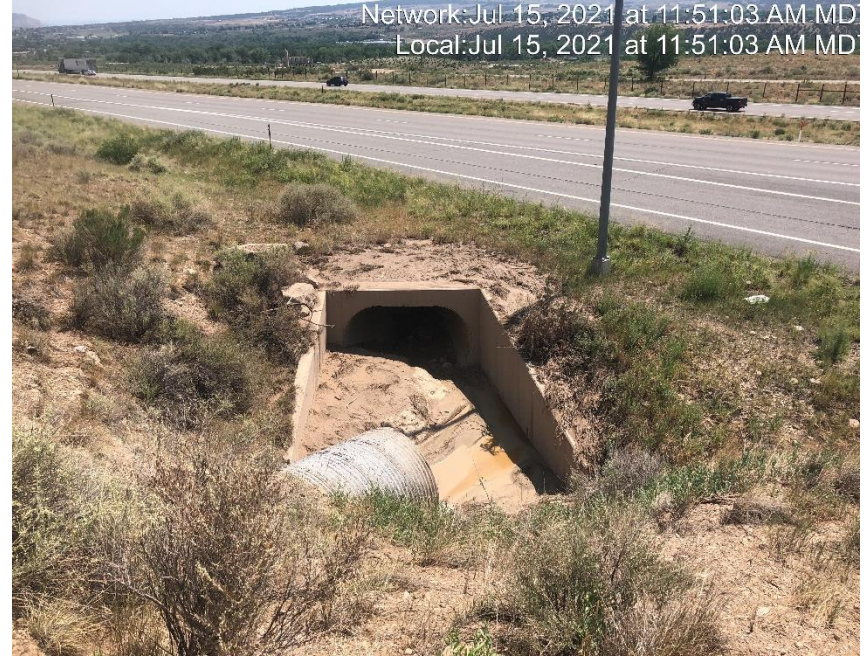
**Photo #4459 outlet of culvert under HWY 6 and inlet of culvert that runs under I-70 and into the Colorado River.**

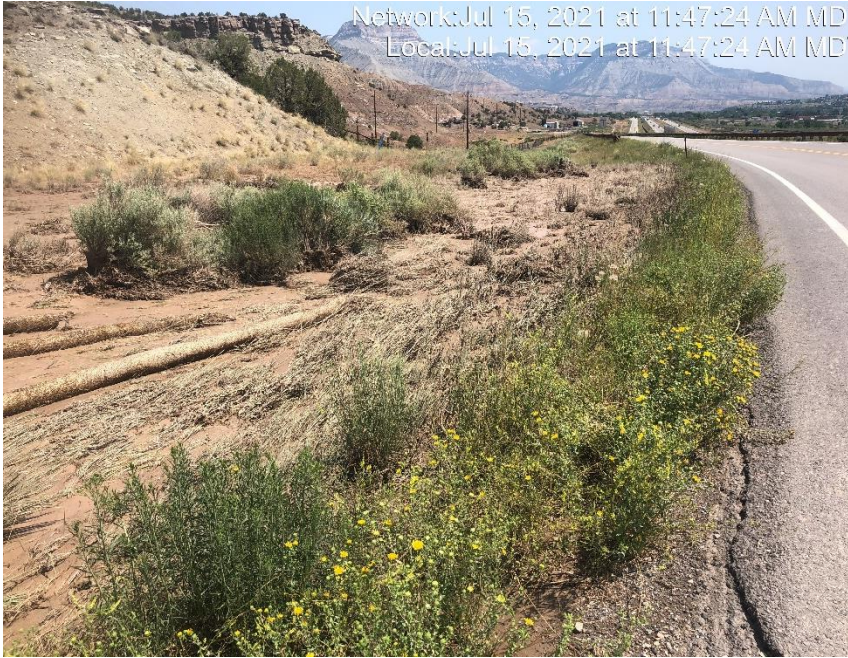
**Photo #4456 Diverted path of storm water once the culvert under HWY 6 was over run.**

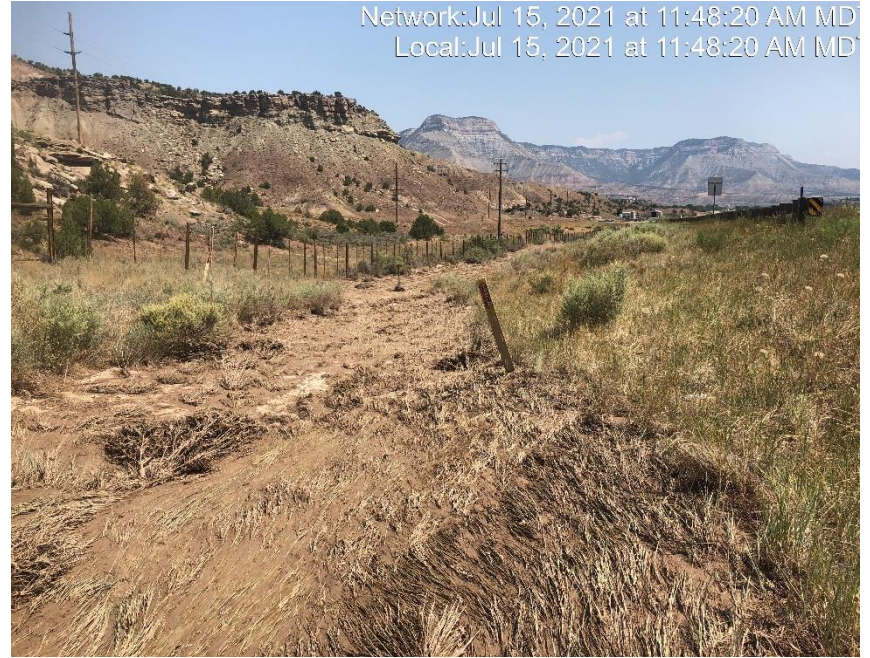
**Photo #4457 Storm water and debris carried down pipe line right of way.**

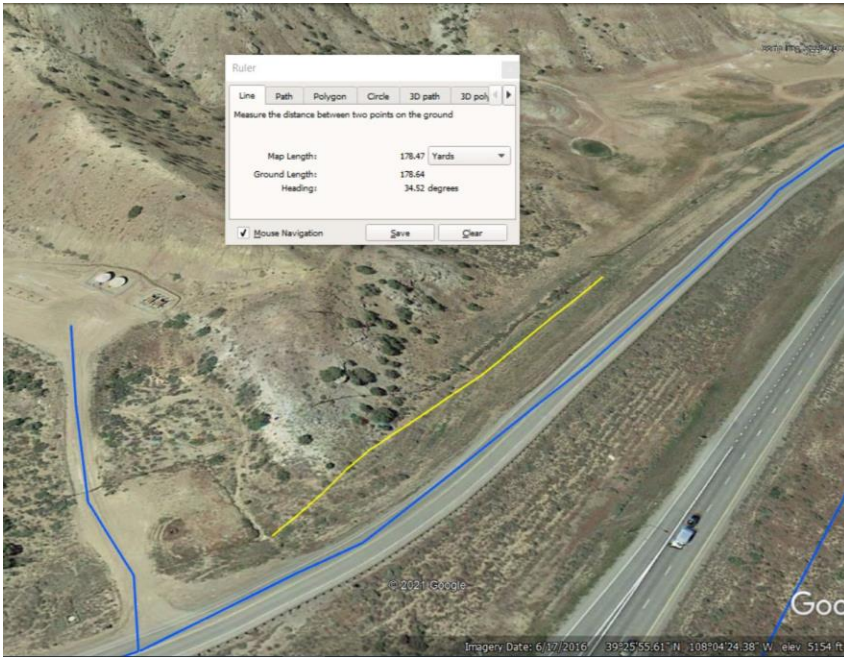
**Storm water carried debris for approximately 180 yards down pipeline right of way.**

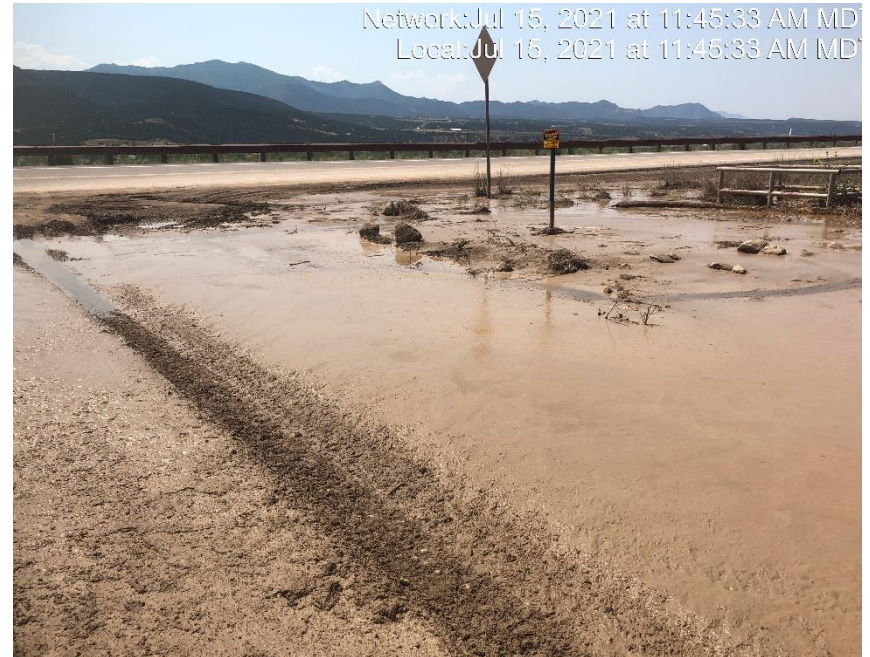
**Photo #4453 Debris appears to have been removed from HWY 6.**

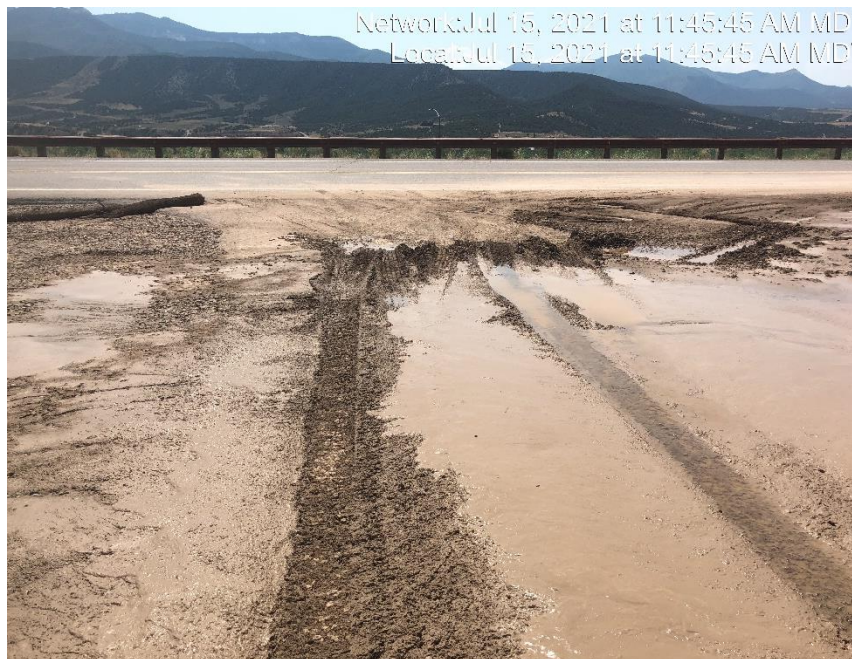
**Photo #4454 No form of tracking BMP has been implemented.**

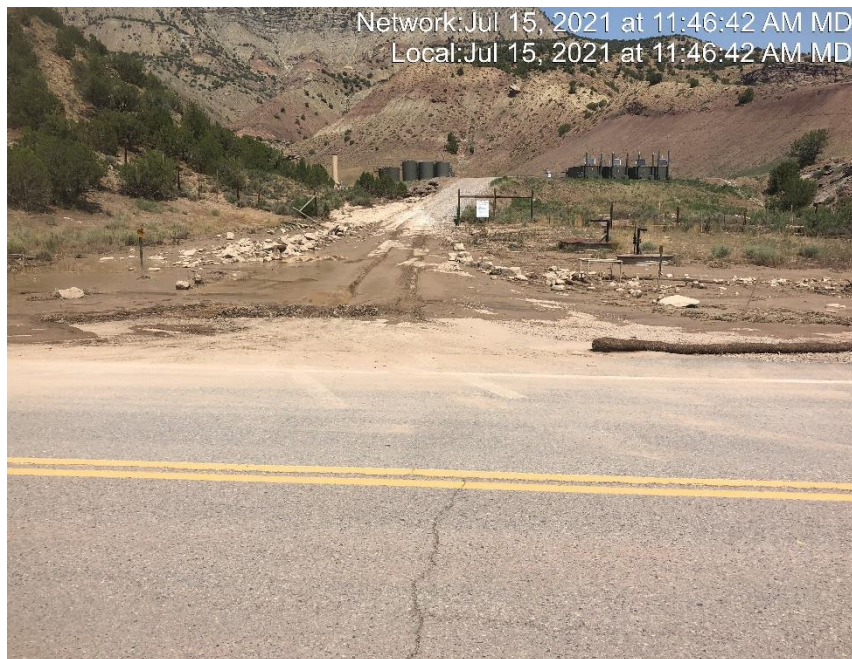
**Photo #4455 No form of tracking BMP implemented.**
