Inspection Photos

Location Name: CAERUS PICEANCE LLC HYRUP-68S96W /2NWSE

Location ID: 334158

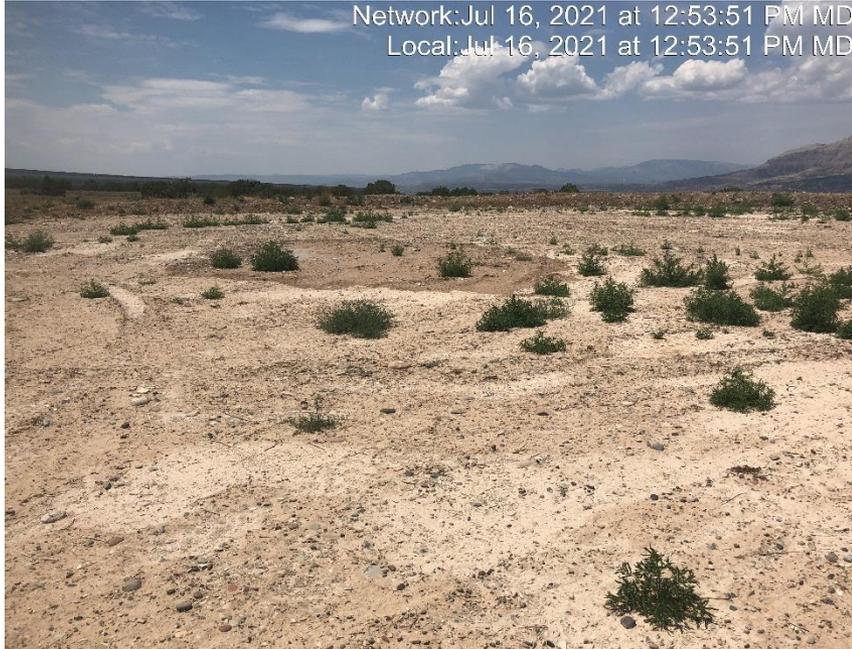
Photo #4472 Multiple places with undesirable plant species.

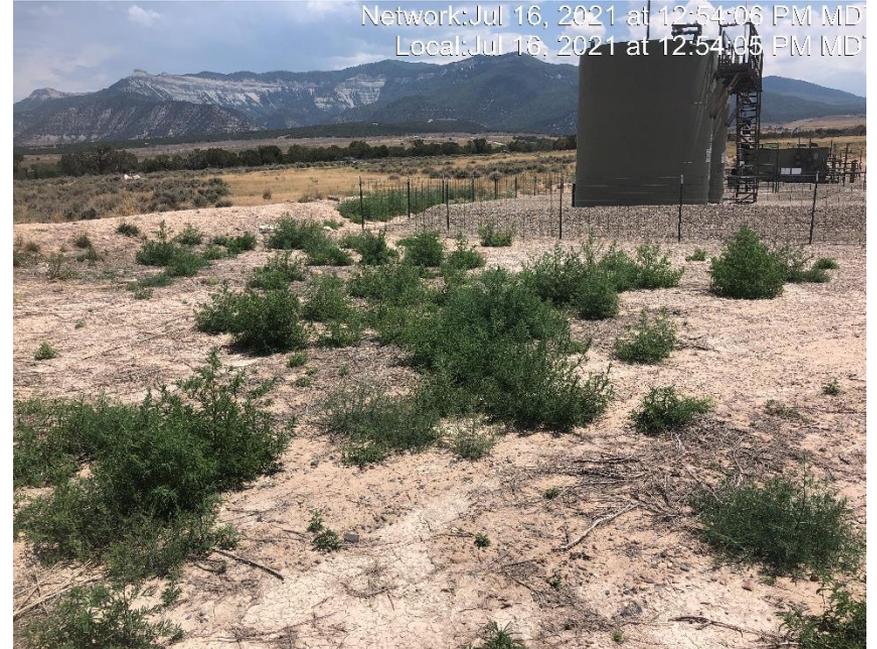
Photo #4473 Multiple places with undesirable plant species.

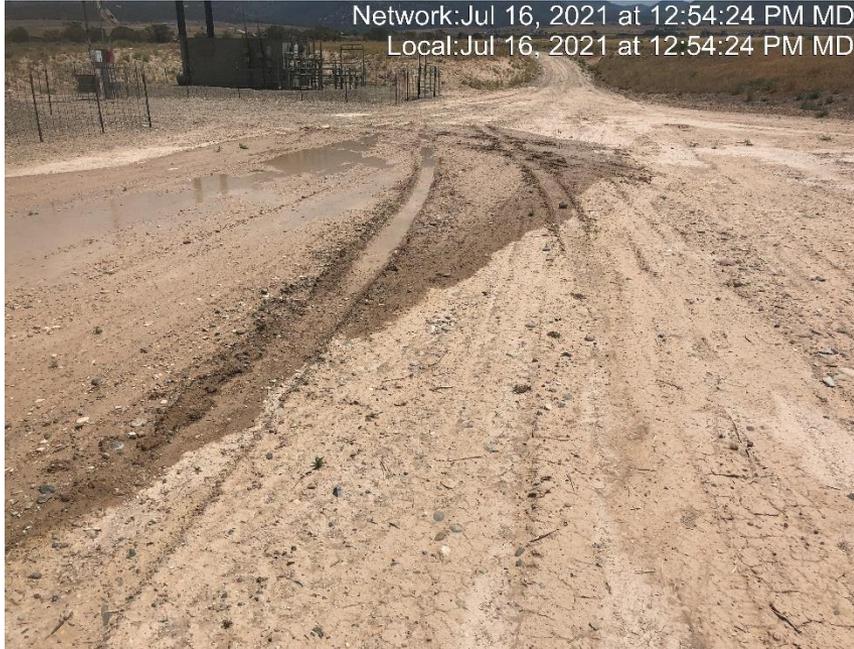
Photo #4474 Location lacks stabilization.

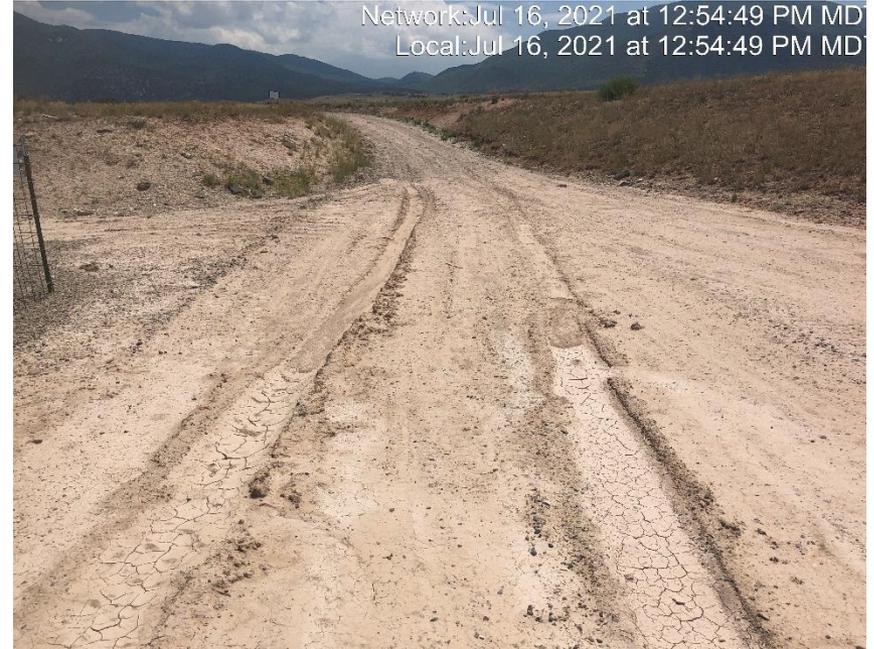
Photo #4475 No form of tracking BMP located at entrance to location.
