Inspection Photos

Location Name: CAERUS PICEANCE LLC MURRAY-68S96W /1SESW

Location ID: 334086

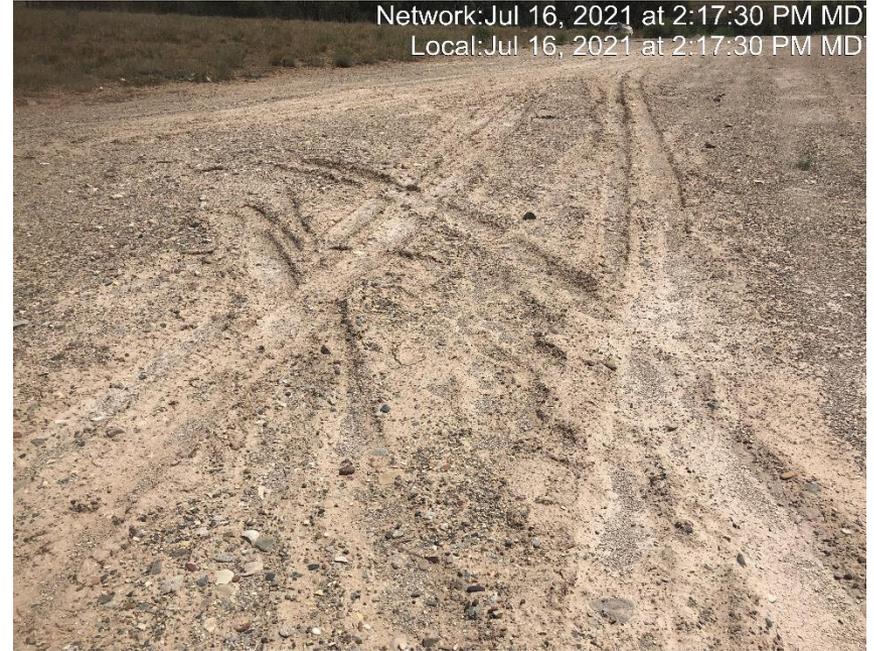
Photo #4483 Location lacks stabilization.

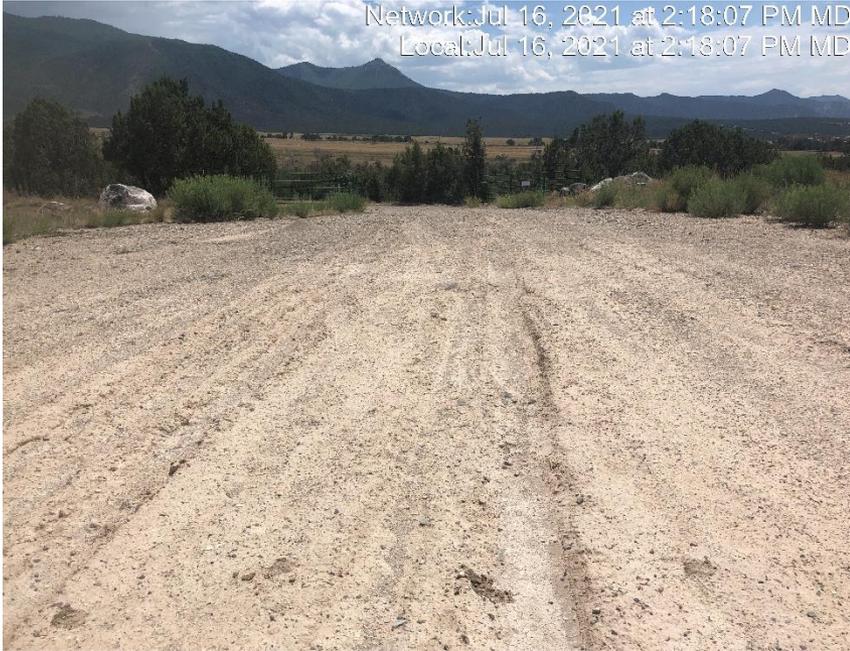
Photo #4484 location lacks stabilization.

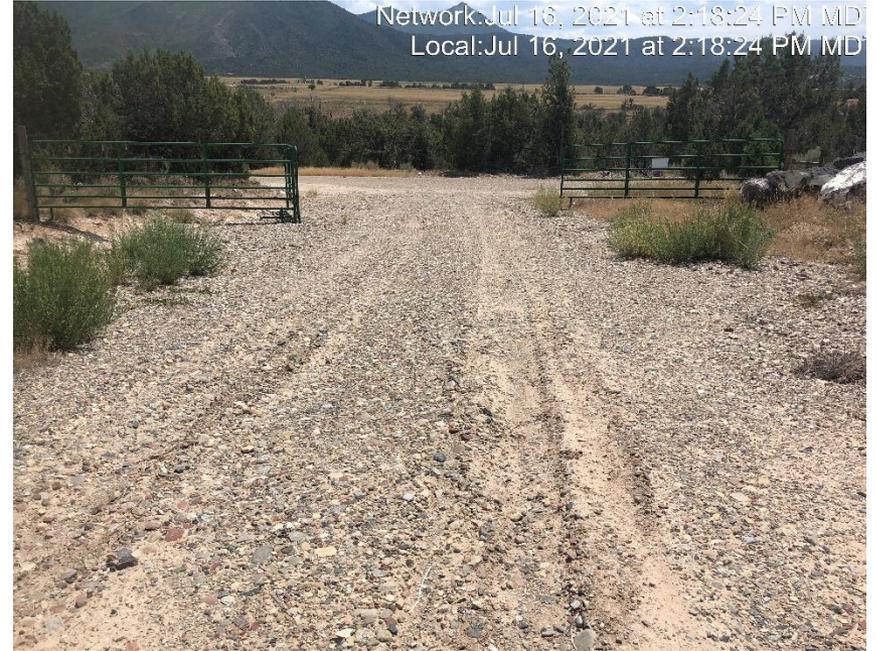
Photo #4485 No form of tracking BMP located at entrance to location.
