# Inspection Photos

API: 071-06339

Operator: OGRIS OPERATING LLC

Inspection Date: 7/7/2021

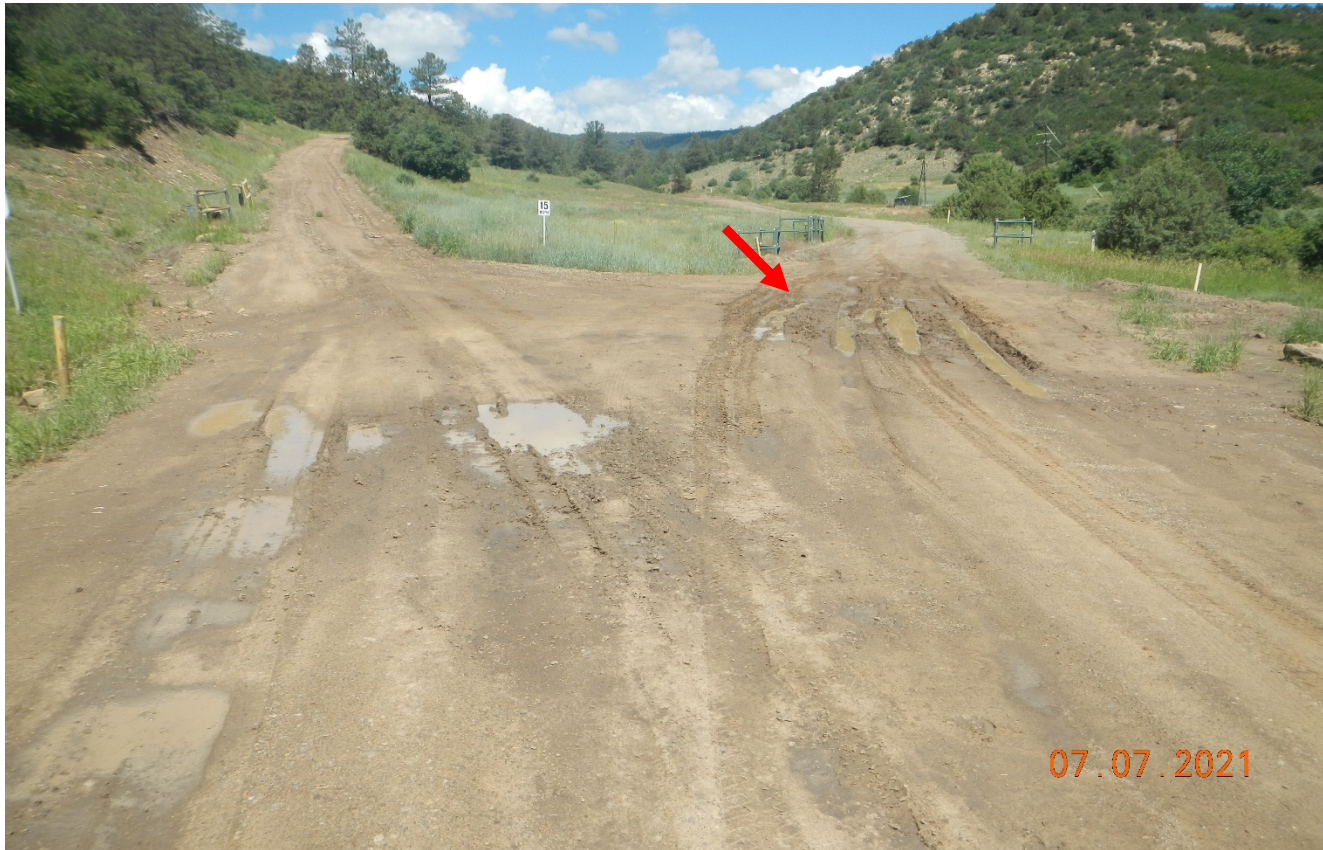
**Photo 1.** Facing northwest along the main access road. Sediment is being deposited onto the road shown at red arrow.

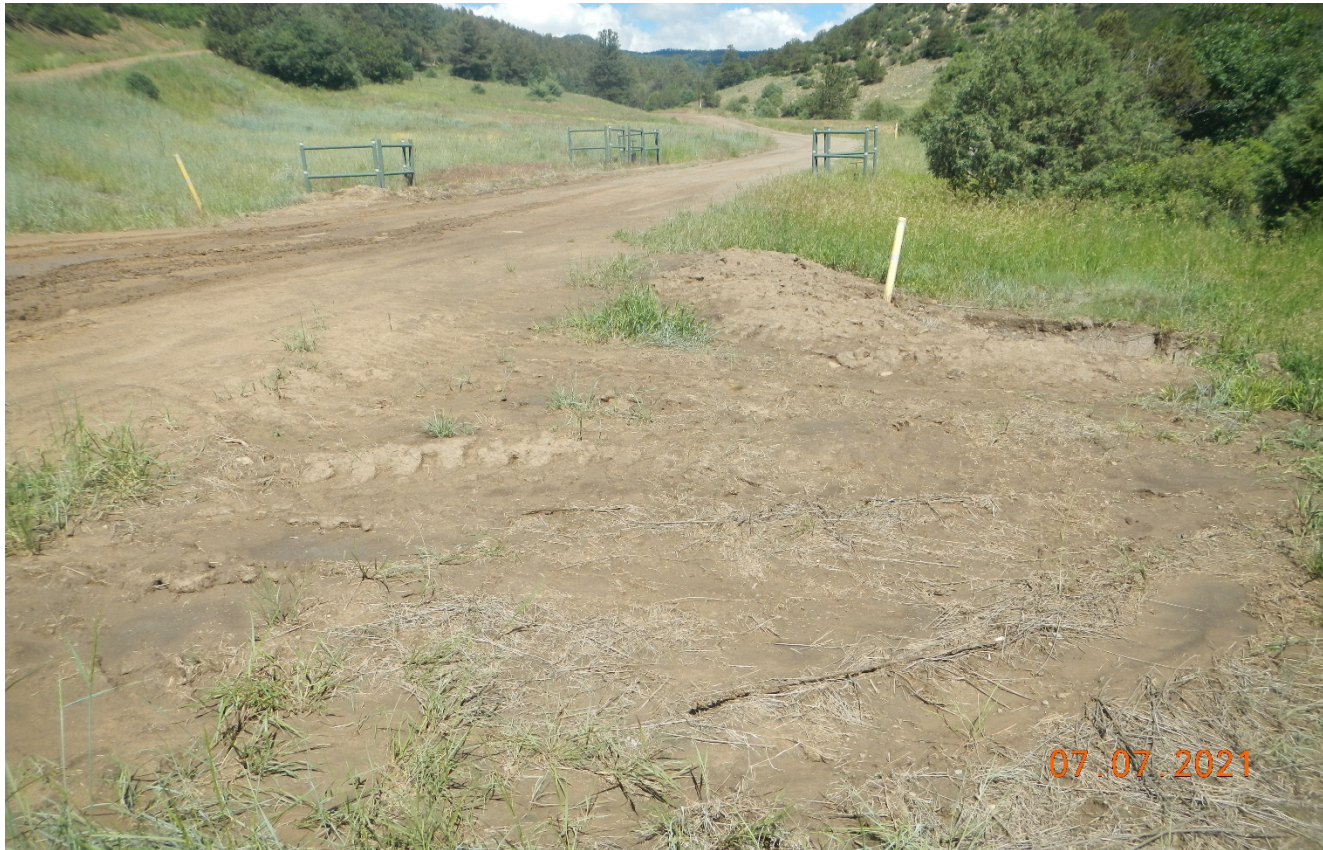
**Photo 2.** There is vehicle disturbance off the side of the road. The disturbance needs to be reclaimed. It appears the culvert was recently excavated at the outlet but may still be filled in with sediment.

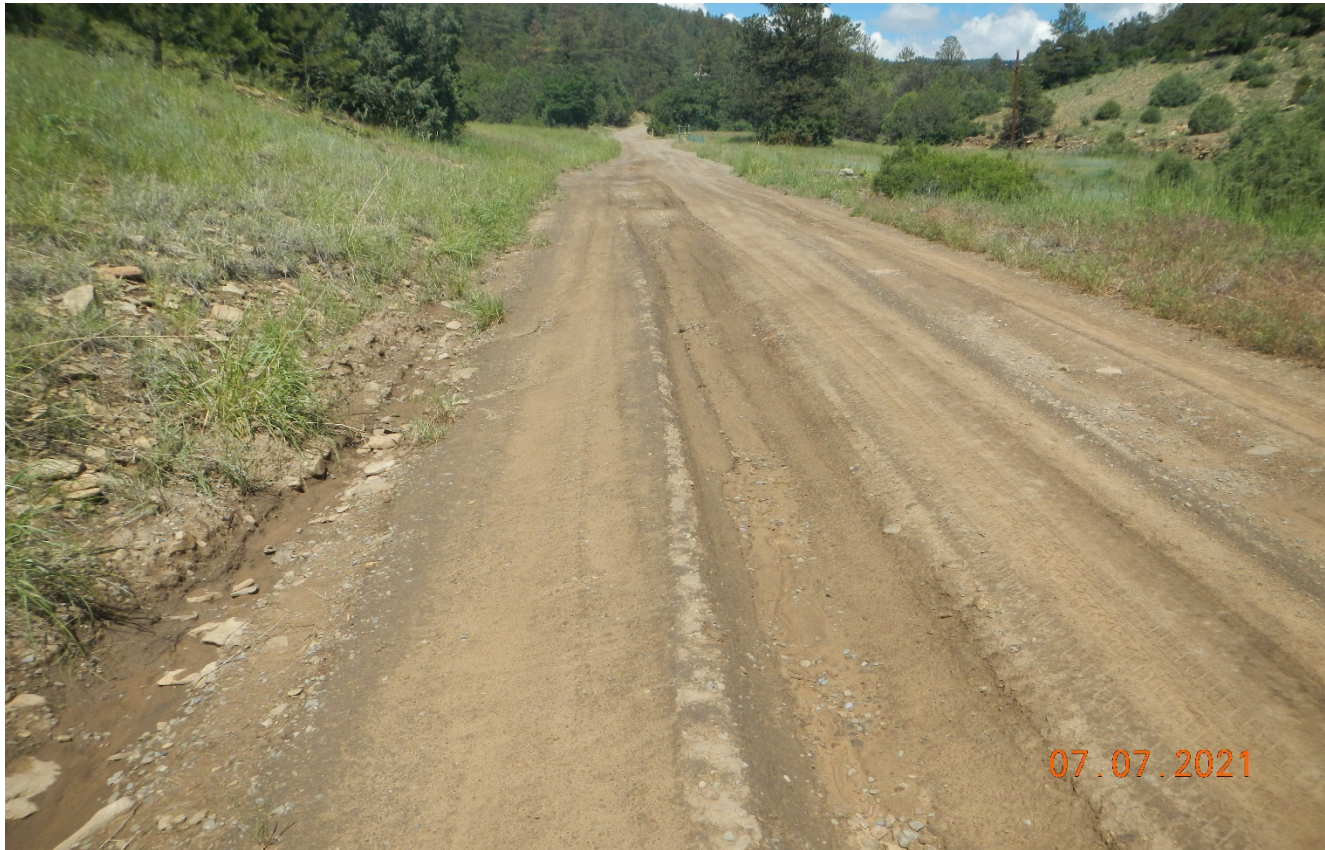
**Photo 3.** There is vehicle rutting along the main road. Areas of rutting need to be stabilized.
