# Inspection Photos

API: 071-07414

Operator: OGRIS OPERATING LLC

Inspection Date: 7/7/2021

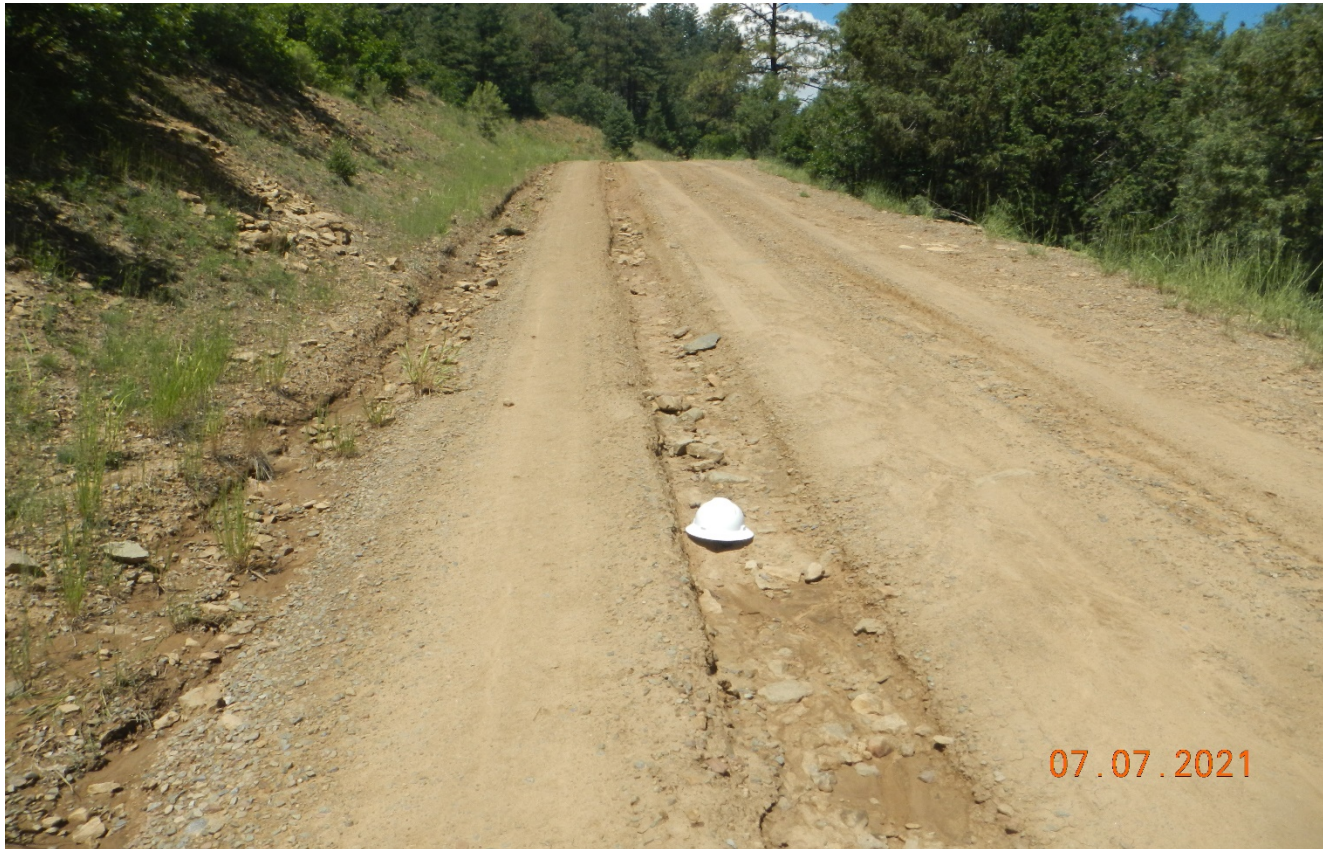
**Photo 1.** There is vehicle rutting and erosion along the road. The white hard hat is placed in the vehicle rut for scale.

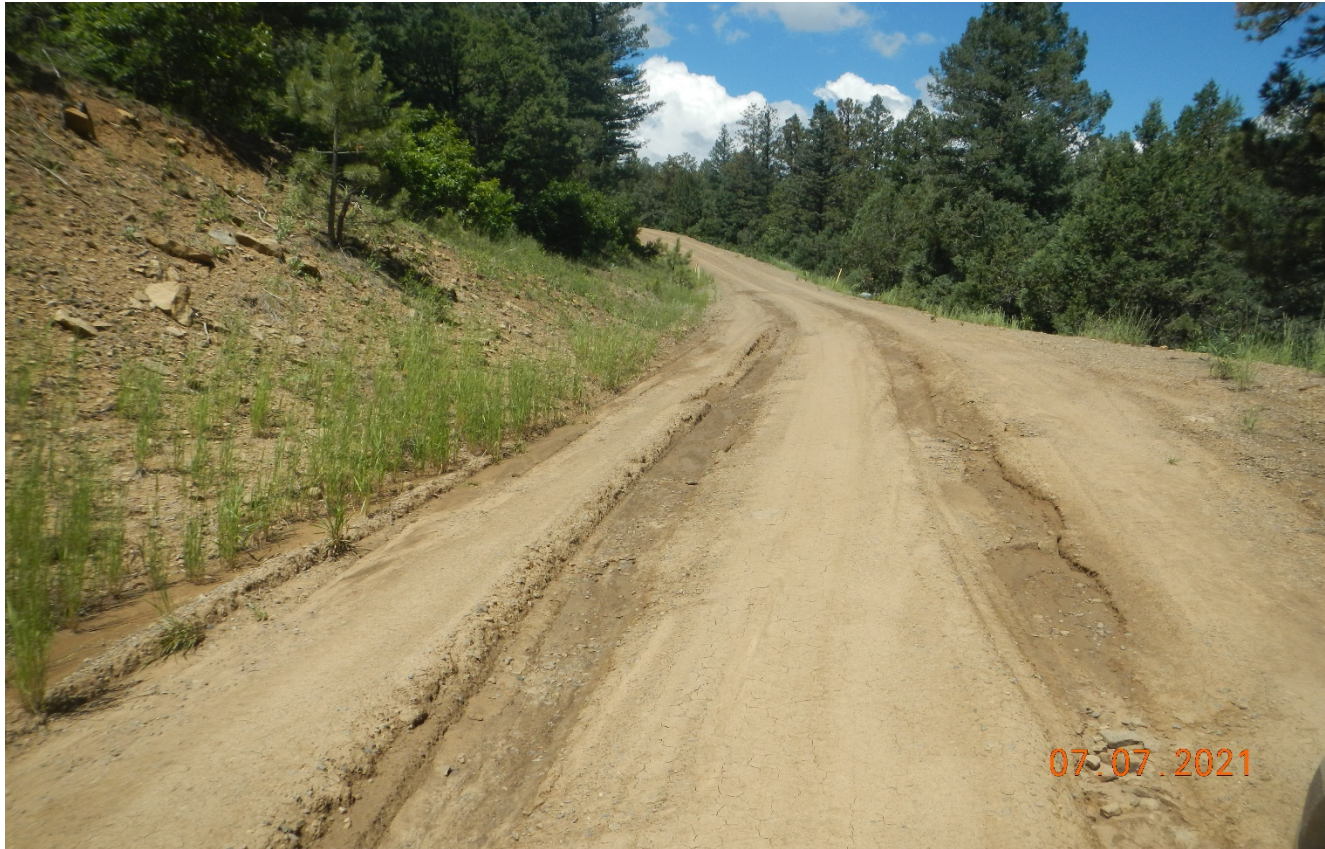
**Photo 2.** There is vehicle rutting and erosion along the road. Previous corrective action was not performed.

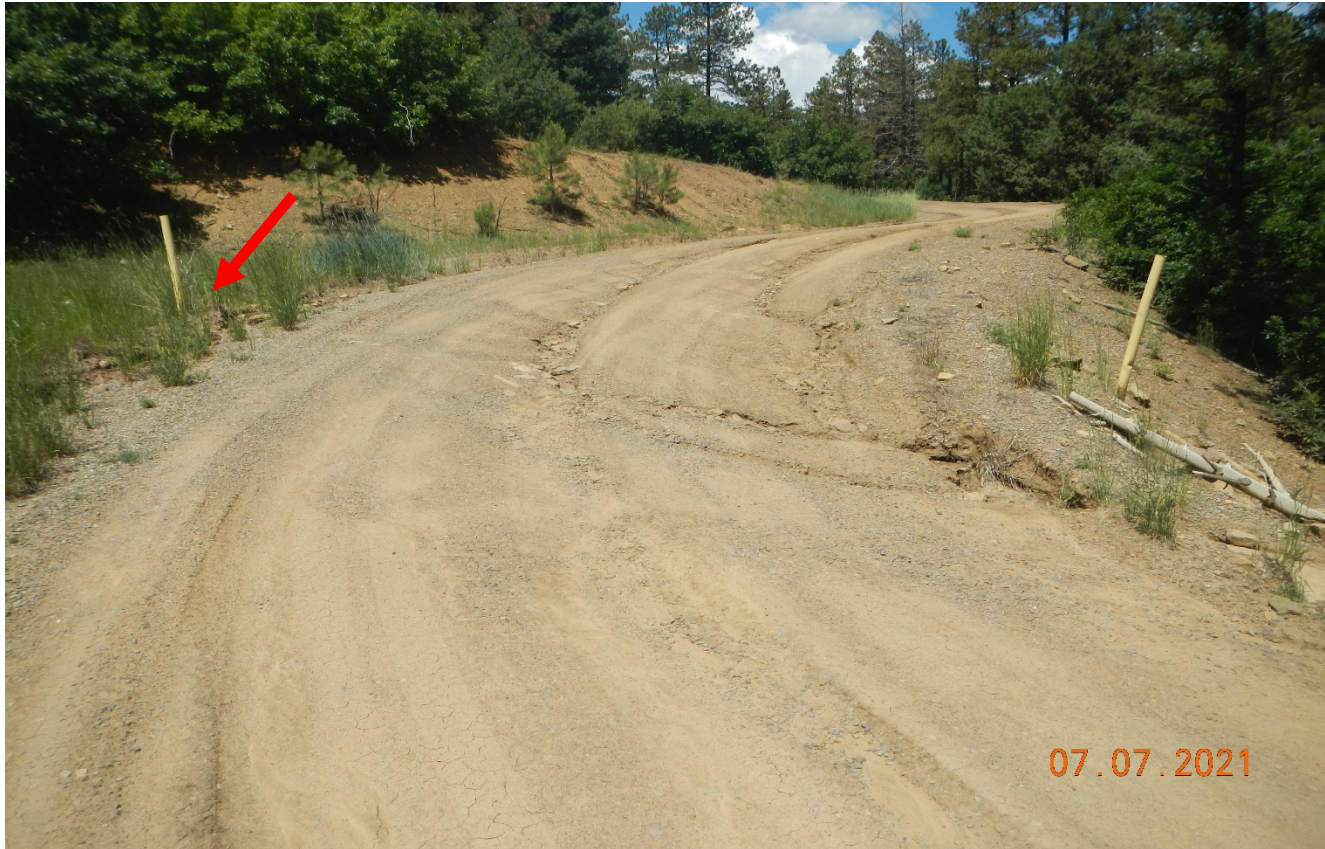
**Photo 3.** Stormwater is not being diverted toward the culvert (red arrow) and is flowing across the road causing erosion.

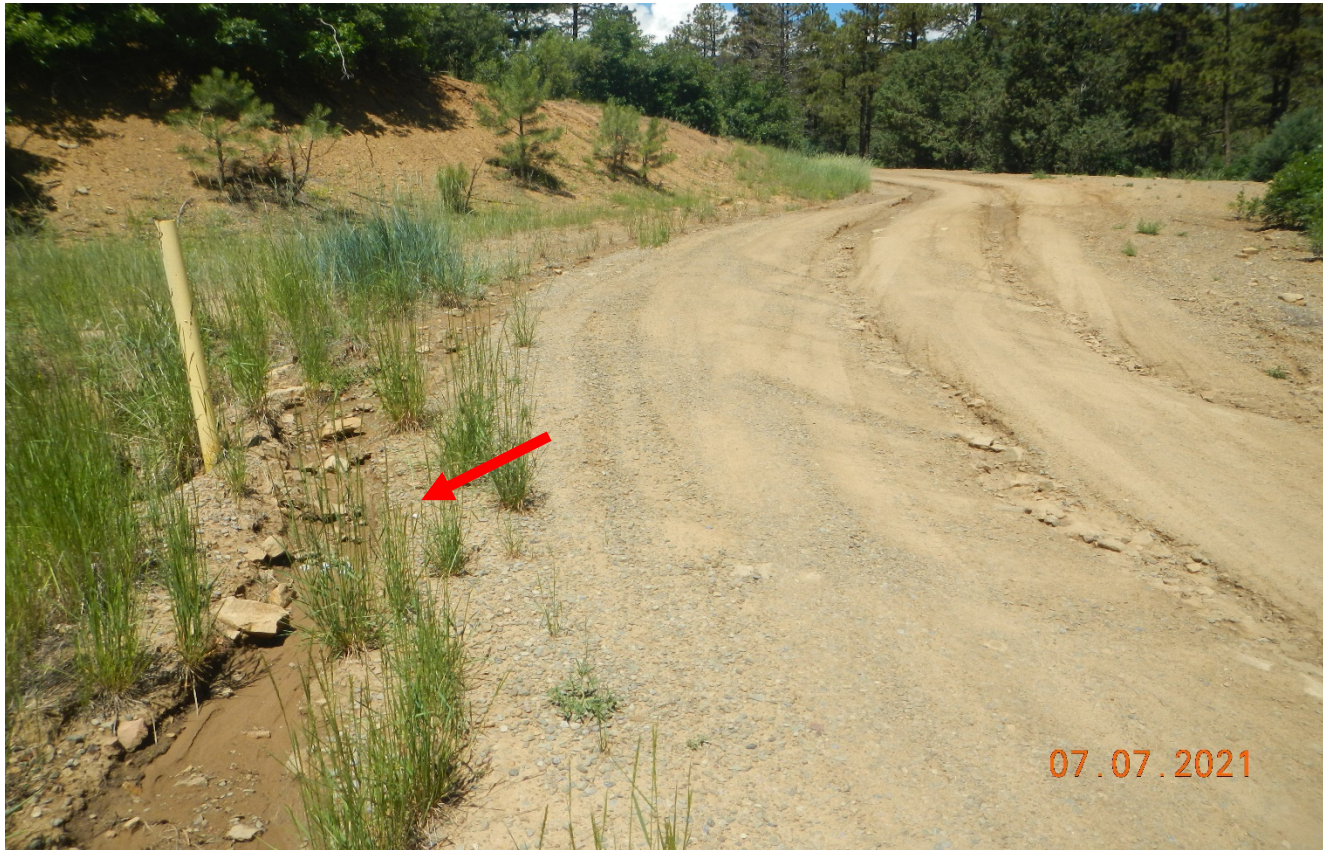
**Photo 4.** This is the same culvert shown in previous photo which stormwater not properly diverted to the culvert causing erosion.

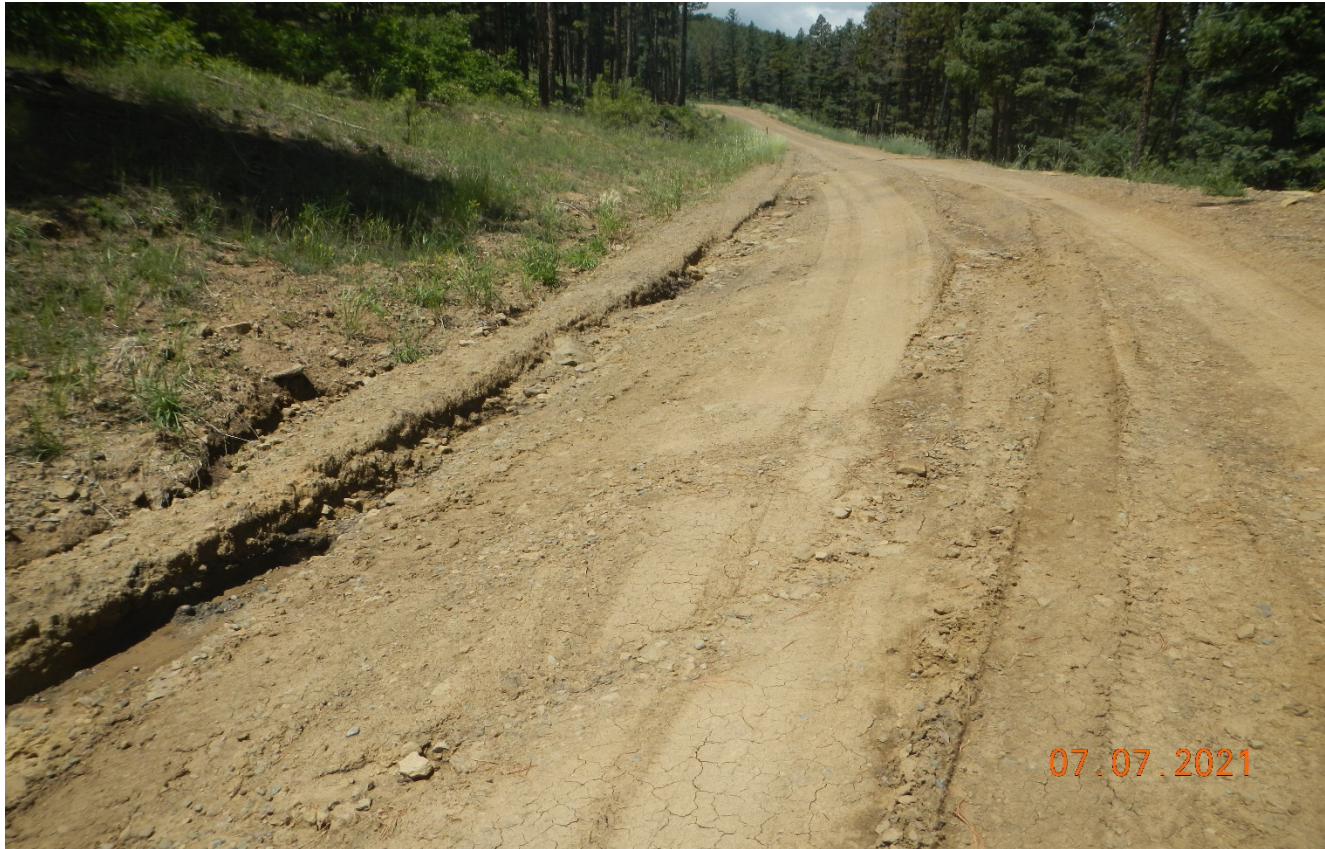
**Photo 5.** There is vehicle rutting occurring along the road which will only worsen if not repaired. The roads need to be maintained. Previous corrective action was not performed.
