## Inspection Photos

Spill/Release Name: Esperanza 8-6 (4" Off location)

Location ID: 334511 & Spill/Release ID: 480228

Inspection Date: July 1, 2021

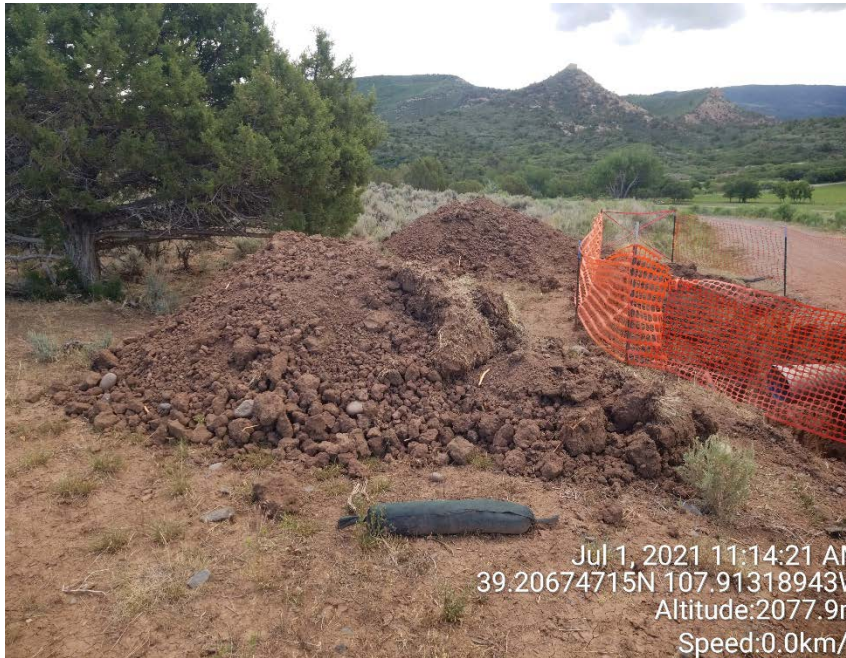
**Excavation (right, west side) and the two stockpiles of potentially impacted material (left side, east of the excavation).**

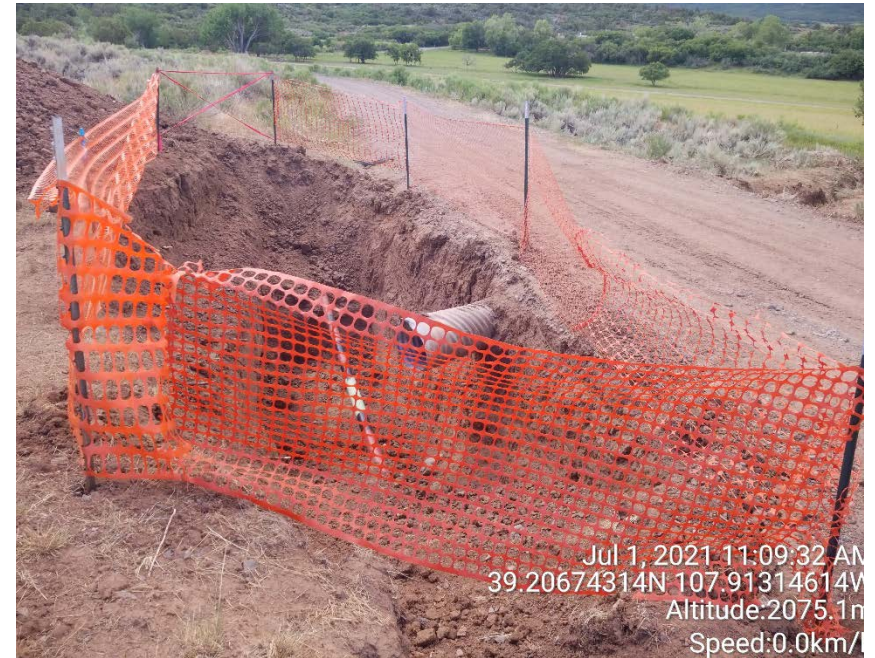
**Excavation containing 4" gathering line and a culvert that runs underneath the road and to the surface water feature located to the west of the excavation.**

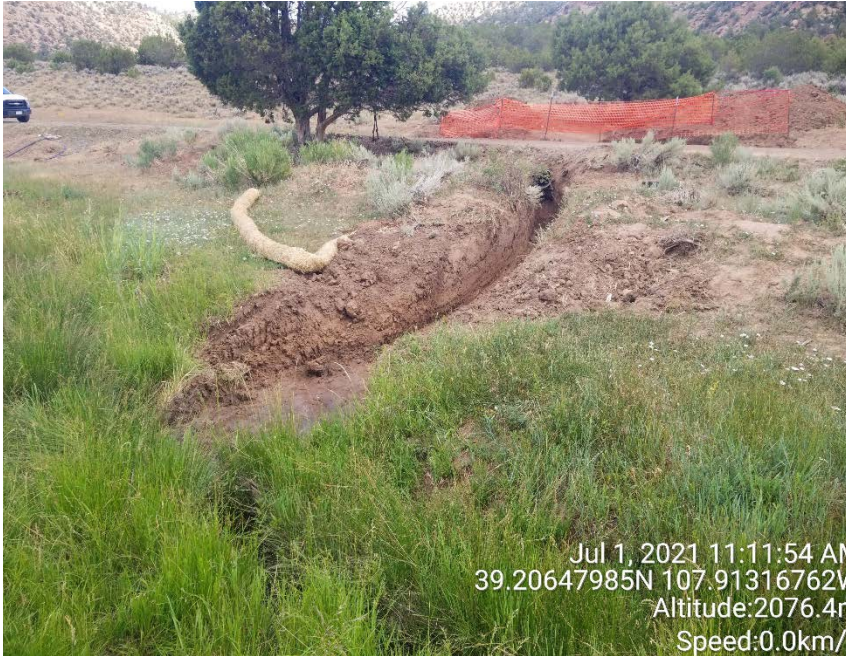
**View of where the culvert exits the west side of the road and flows through a drainage and into the surface water feature. Note the excavated area within the culvert drainage.**

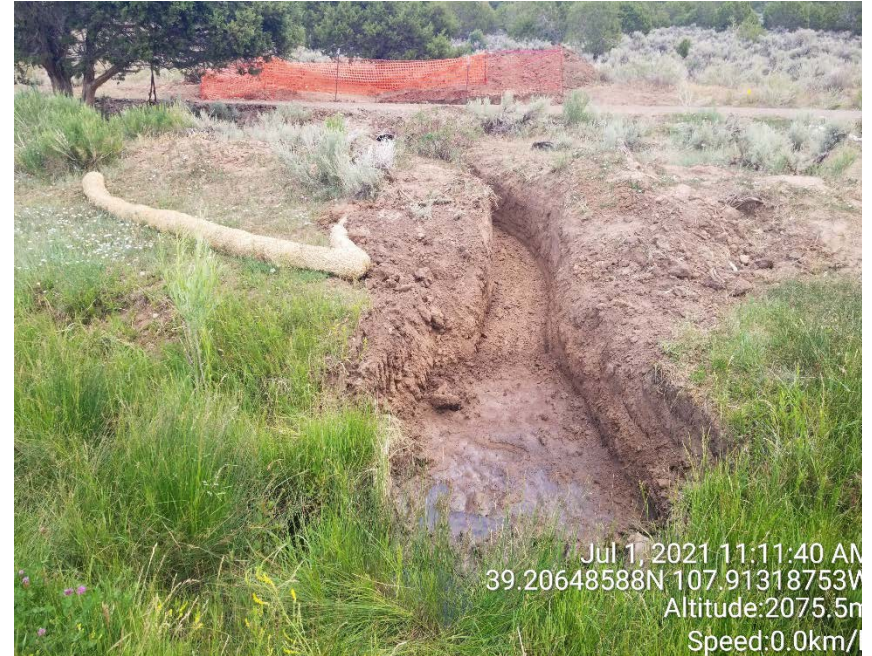
**Area where the culvert drainage intersects the surface water feature. Note the excavated area within the culvert drainage.**

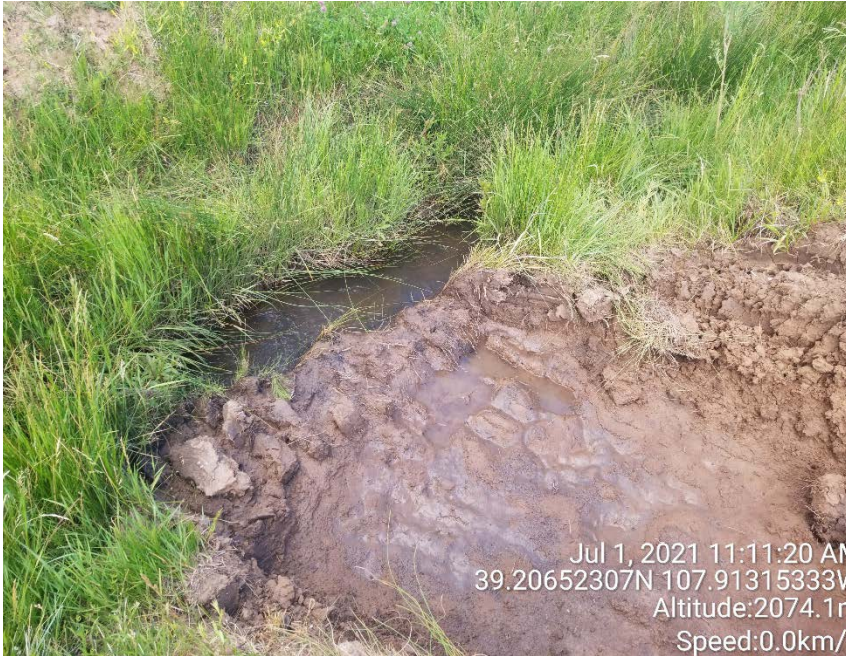
**Close up of where the culvert drainage intersects the surface water feature. Note the excavated area within the culvert drainage.**

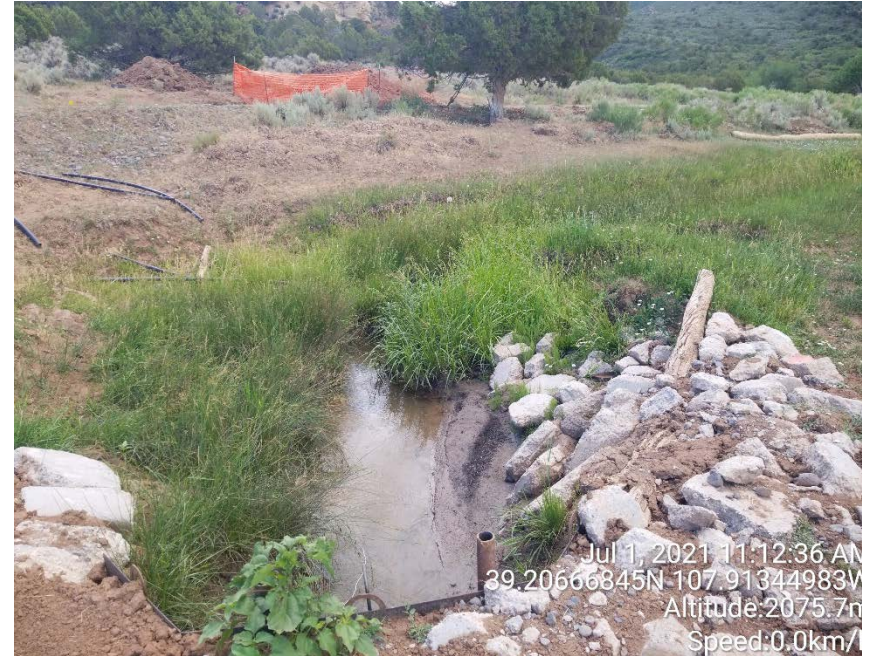
**Surface water feature with the excavation in the background (orange fence).**
