Inspection Photos
Location Name: MDM 33-14
Location ID: 331806

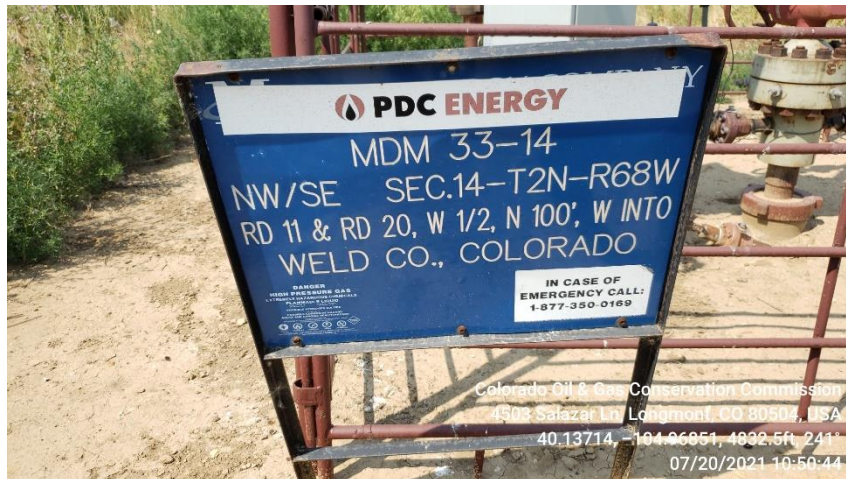
Photo 1 WH sign

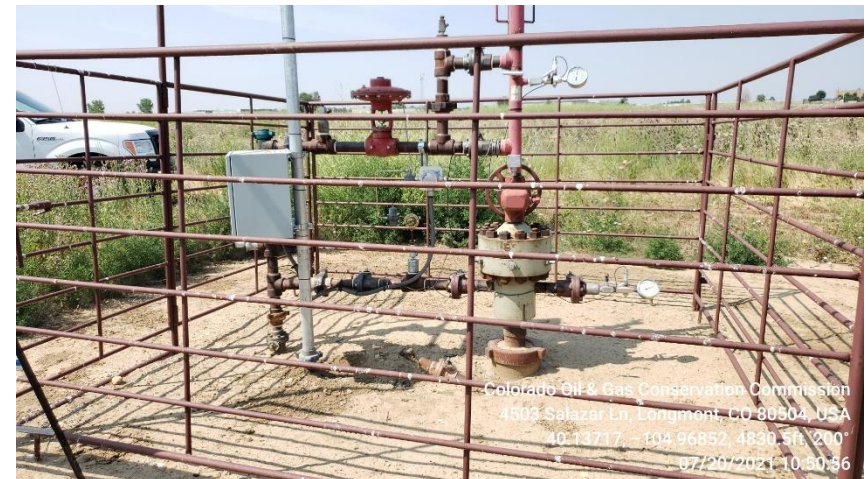
Photo 2 WH

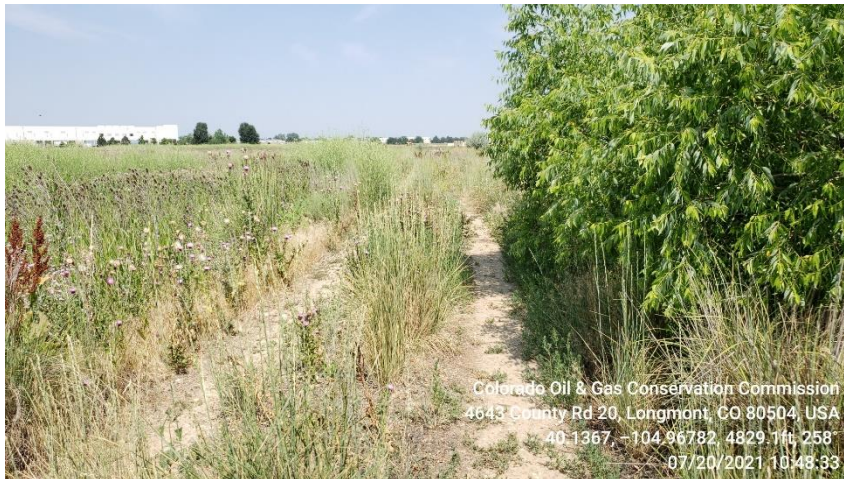
Photo 3 Weeds overgrown along access road

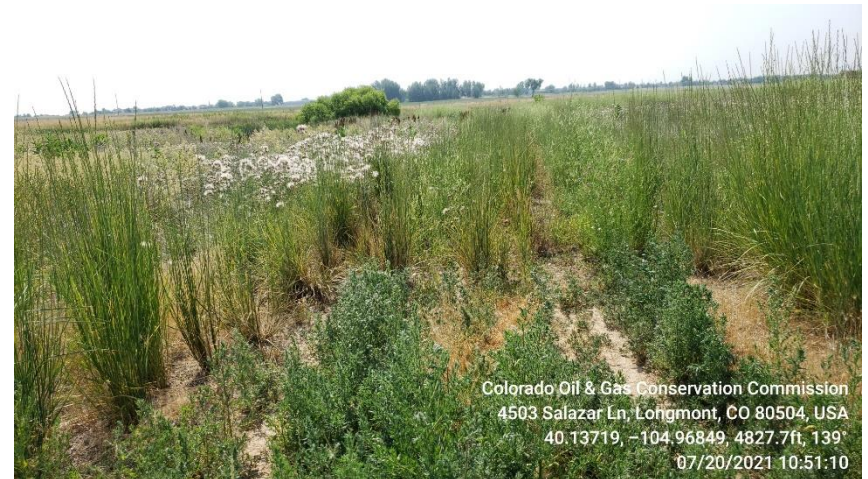
Photo 4 Weeds overgrown along access road

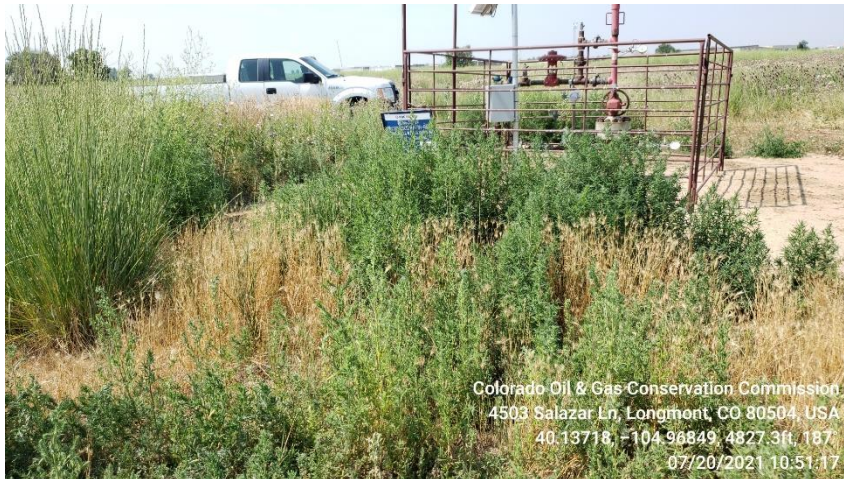
Photo 5 Weeds overgrown around location ROW

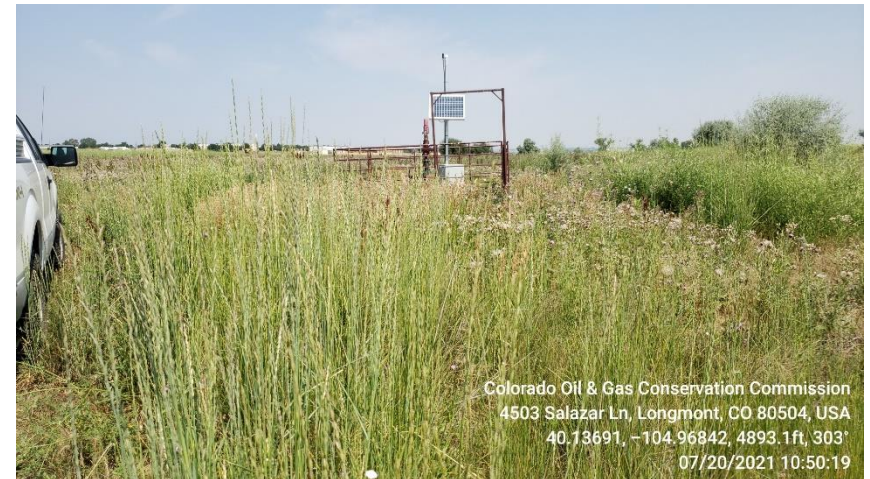
Photo 6 Weeds overgrown around location ROW

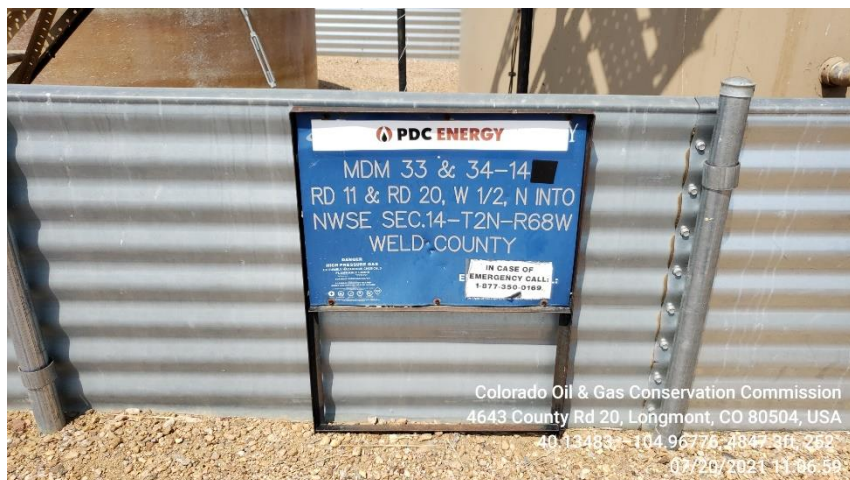
Photo 7 TB sign

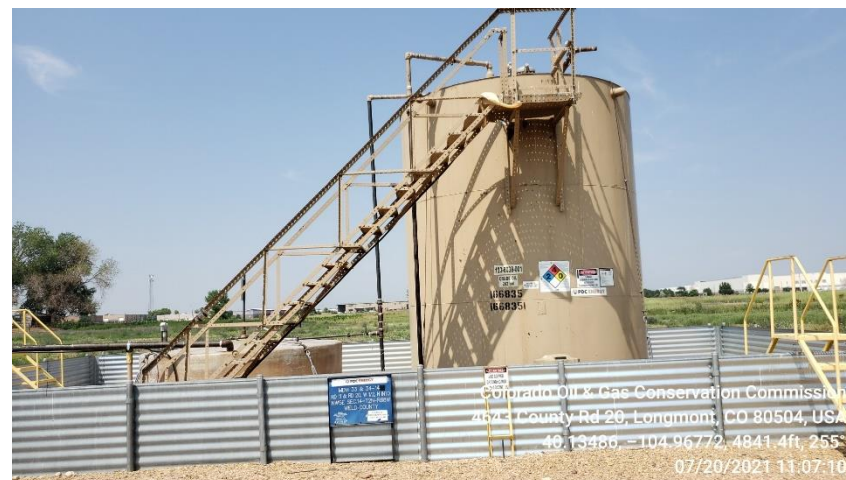
Photo 8 TB

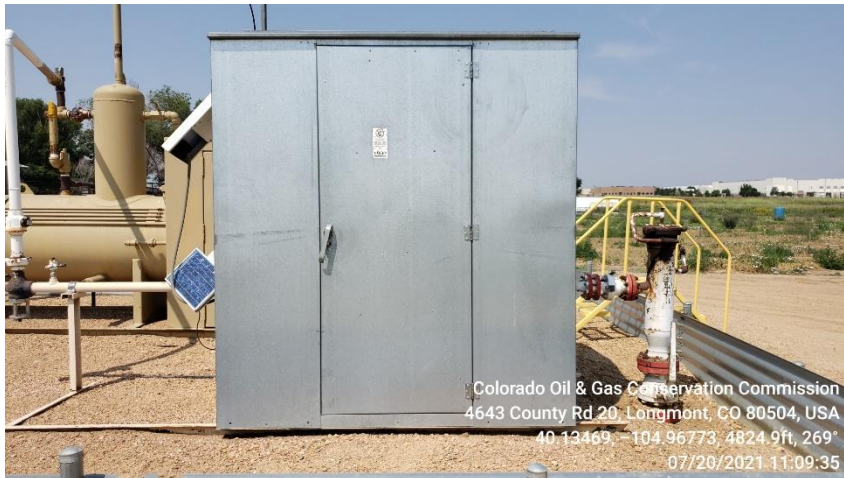
Photo 9 Gas Meter Run

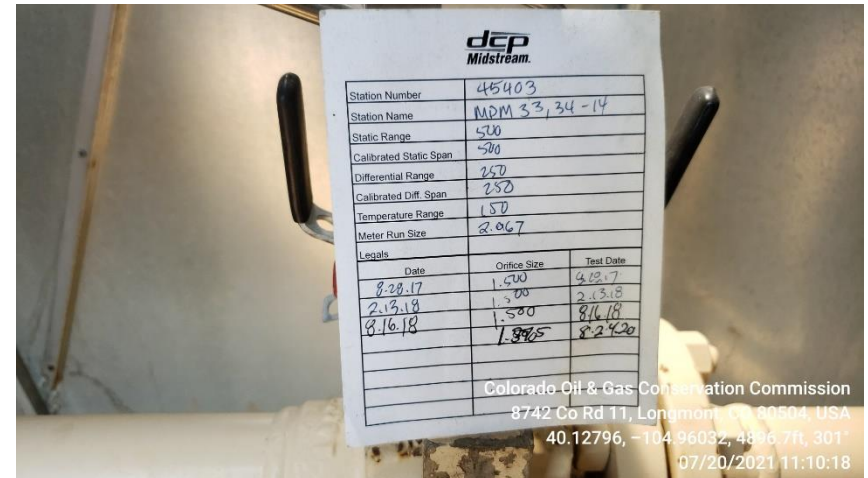
Photo 10 Card in meter house indicates calibration is not current.

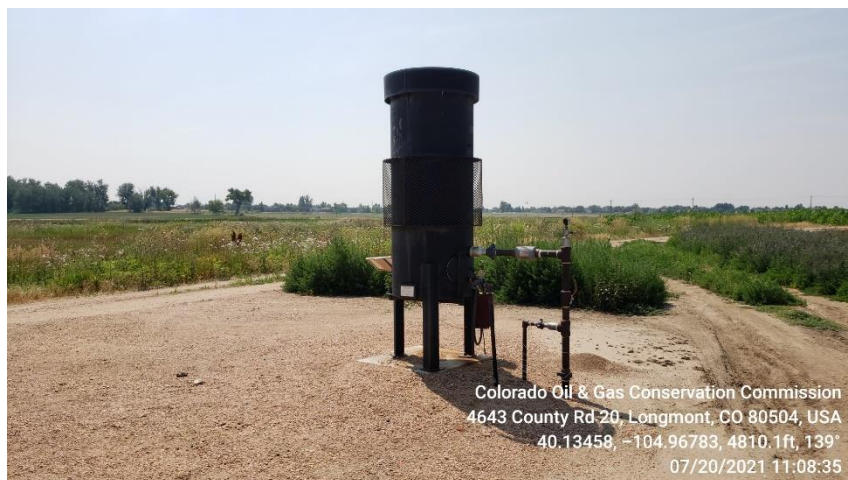
Photo 11 ECD

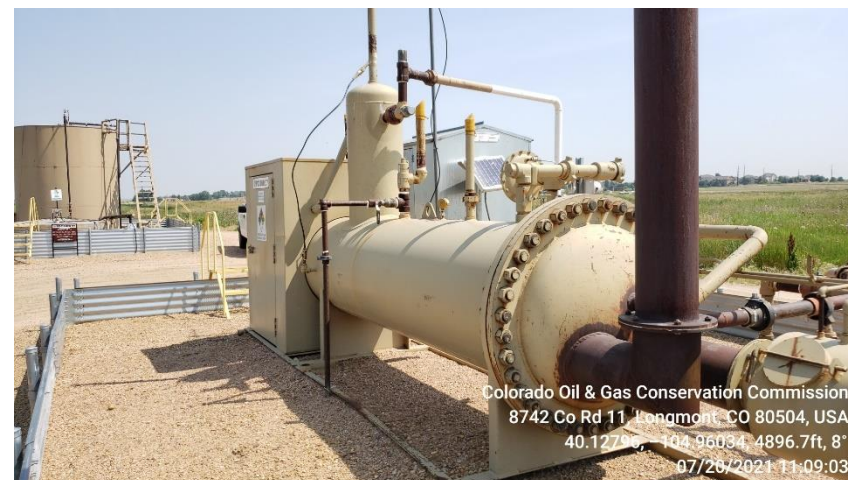
Photo 12 Horizontal Heated Separator
