Inspection Photos
Location Name: Elkhorn Company B6
Location ID: 318598

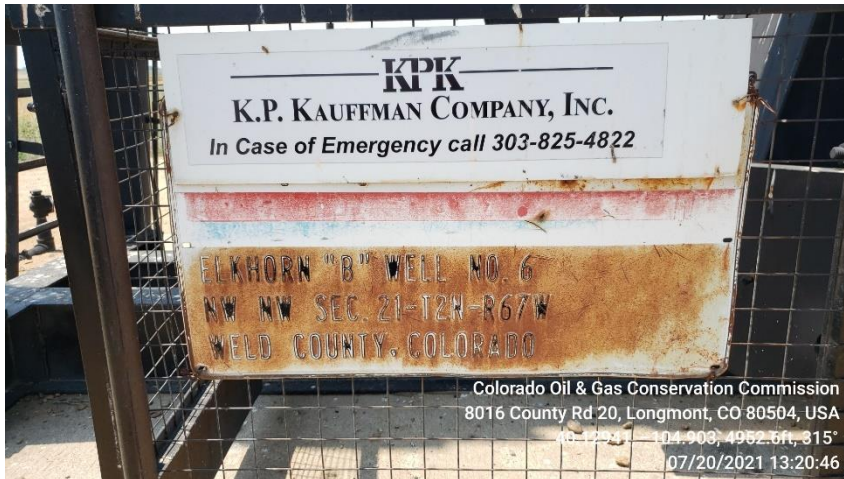
Photo 1 WH sign

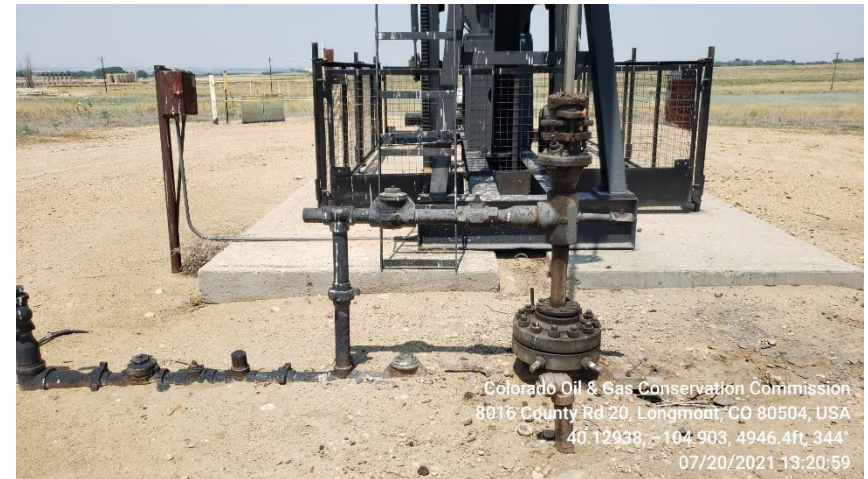
Photo 2 WH

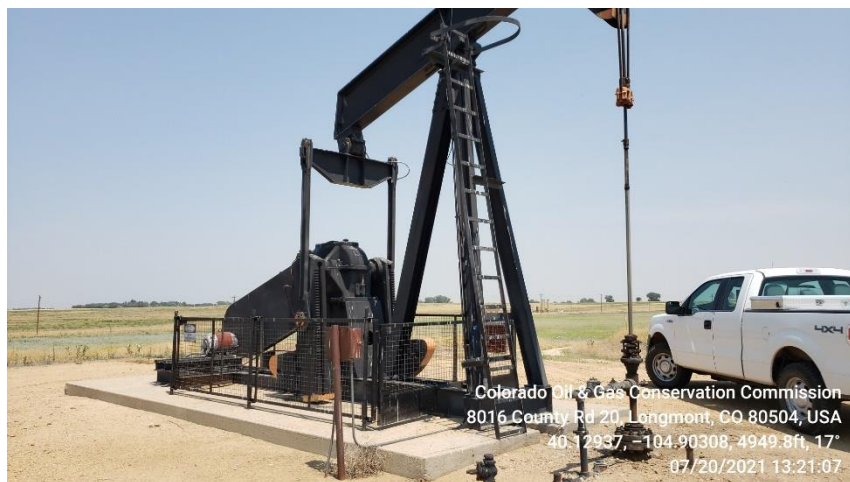
Photo 3 Pump Jack

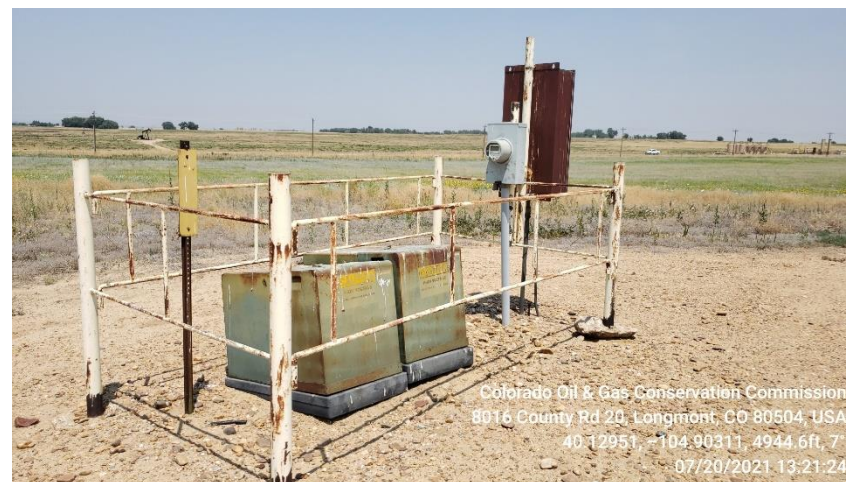
Photo 4 Ancillary Equipment

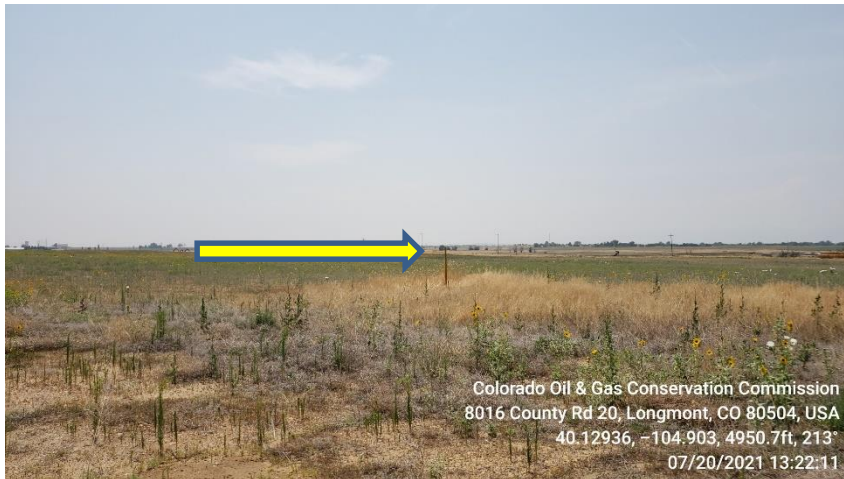
Photo 5 weeds growing around location ROW and dead man anchors

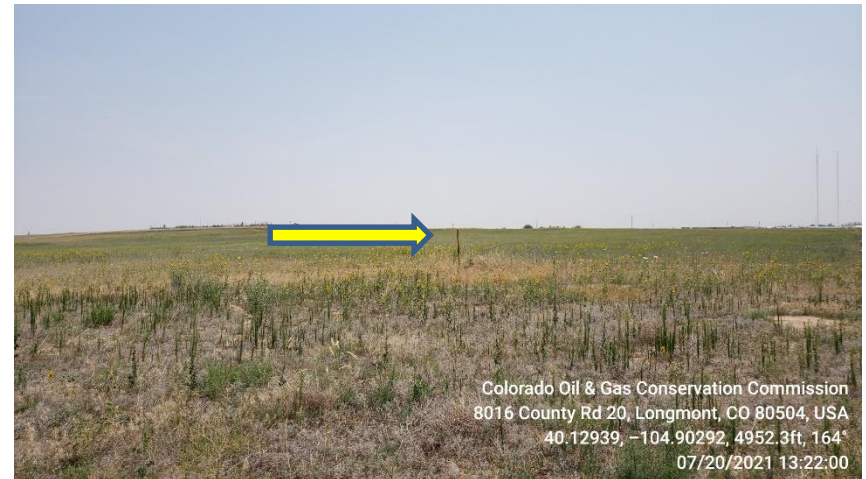
Photo 6 weeds growing around location ROW and dead man anchors

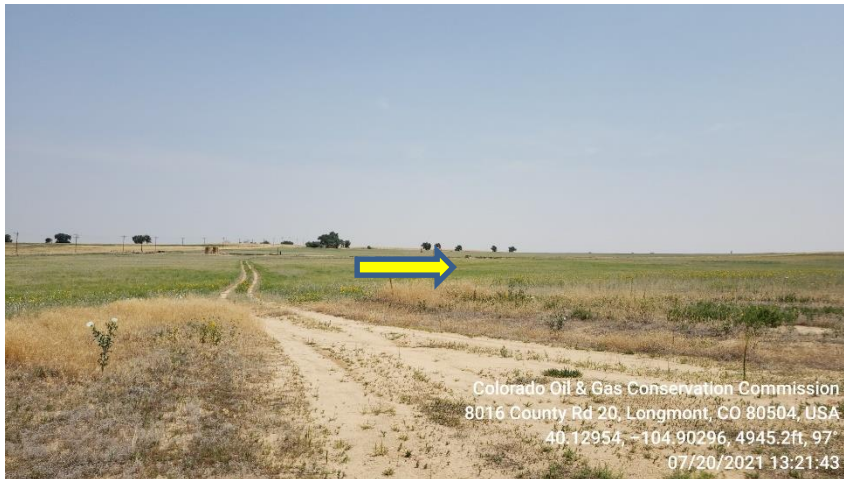
Photo 7 weeds growing around location ROW and dead man anchors

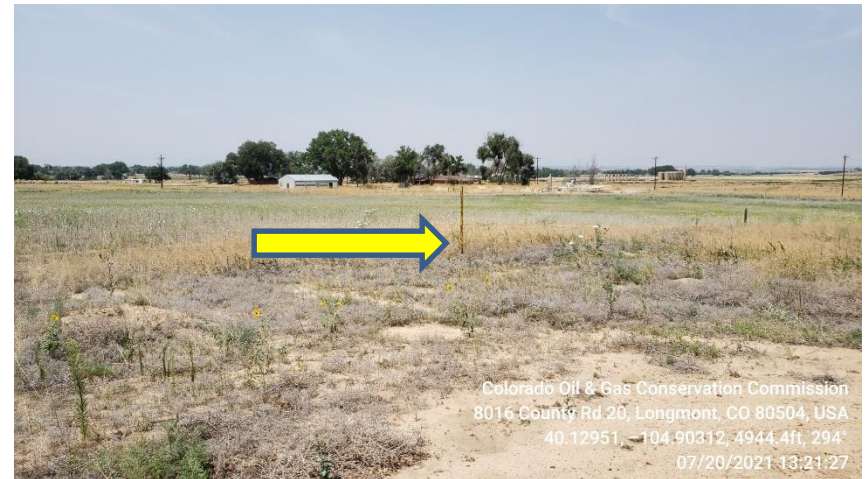
Photo 8 weeds growing around location ROW and dead man anchors

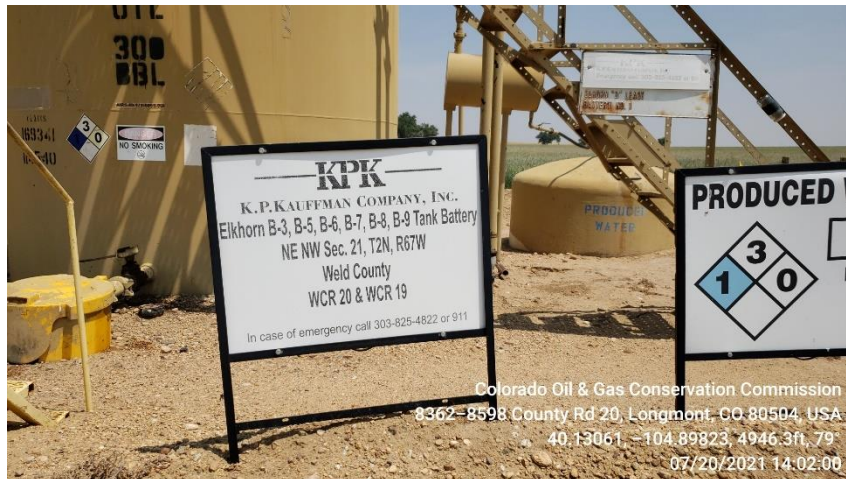
Photo 9 TB sign

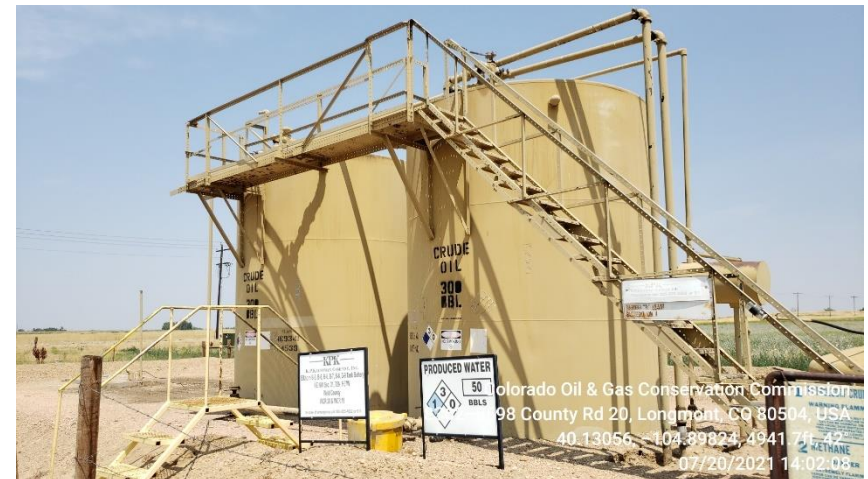
Photo 10 TB

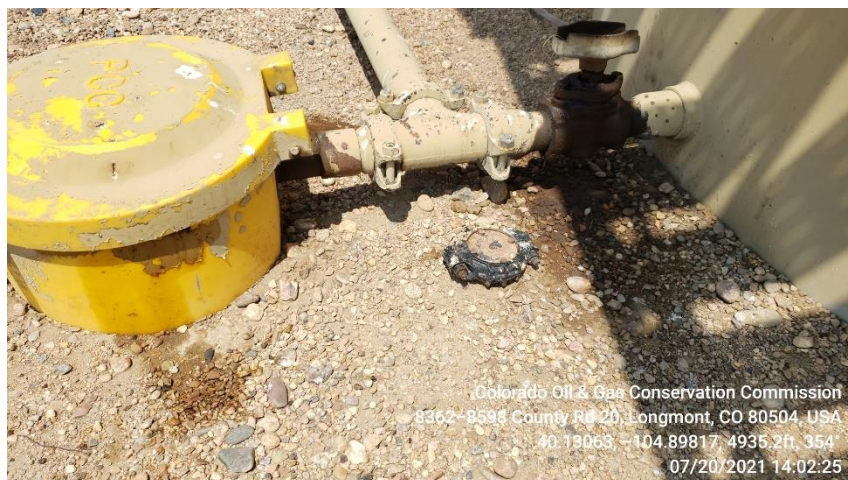
Photo 11 Stained soil by valve

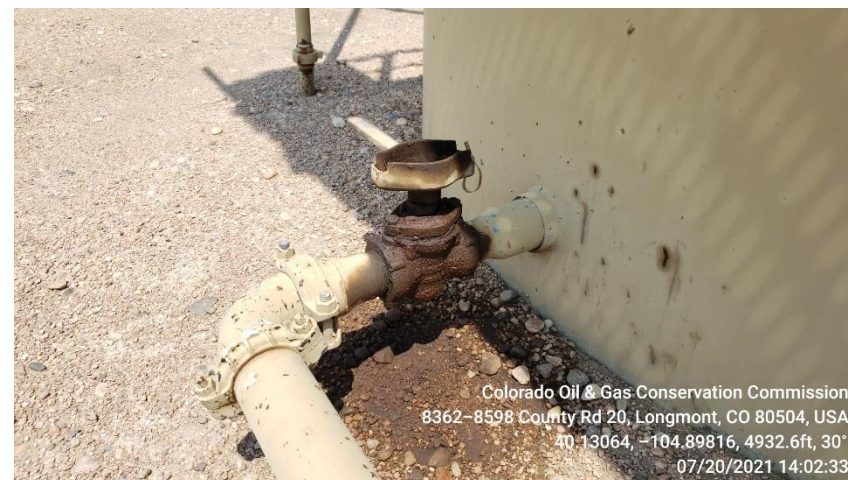
Photo 12 Stained soil by valve

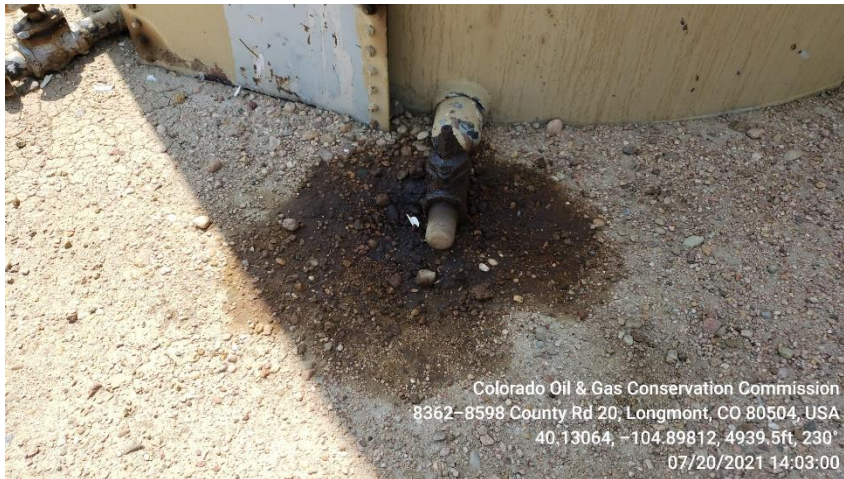
Photo 13 Stained soil by valve

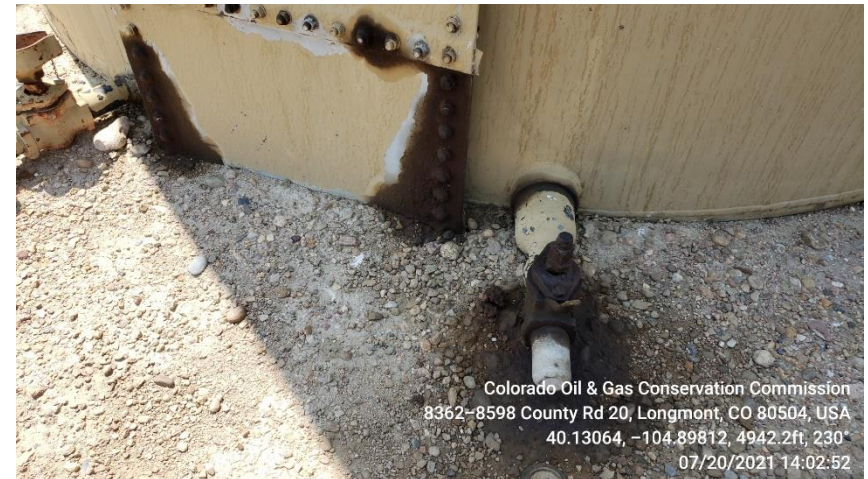
Photo 14 Stained soil by valve

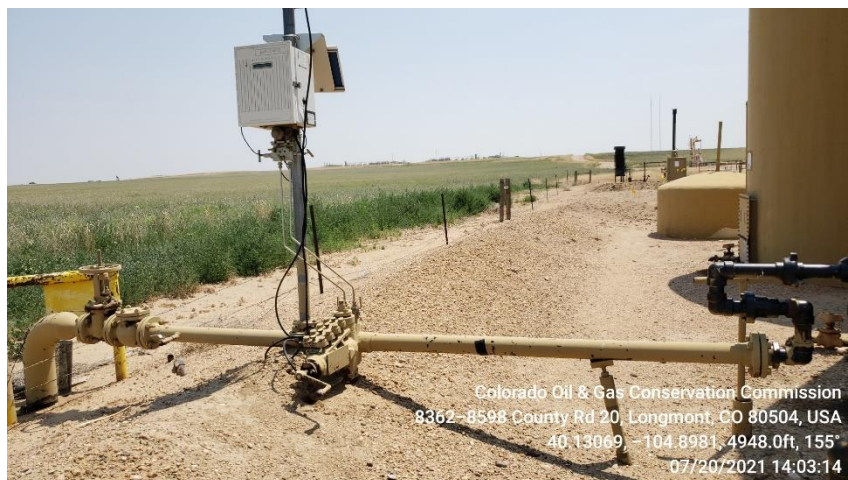
Photo 15 Gas Meter Run

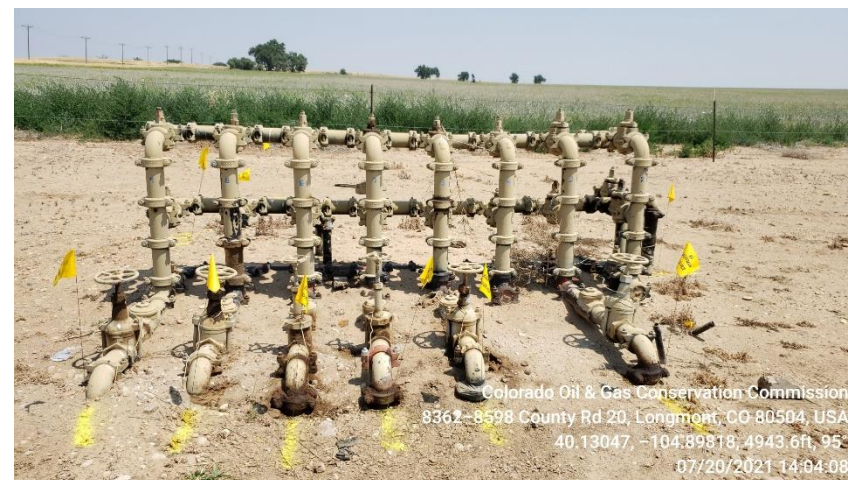
Photo 16 Flow line manifold

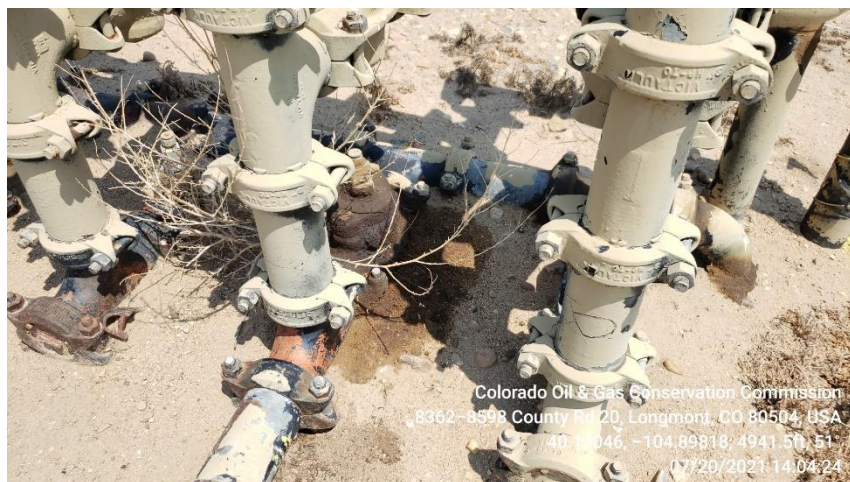
Photo 17 Stained soil by the Flow line manifold

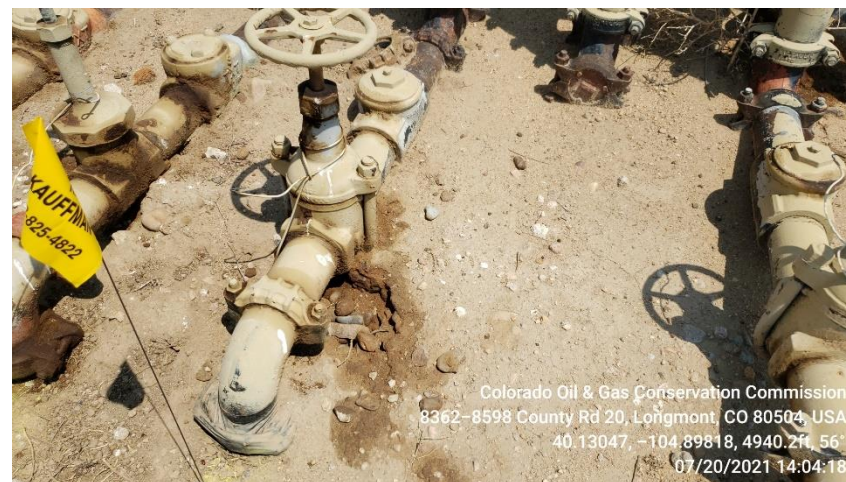
Photo 18 Stained soil by the Flow line manifold

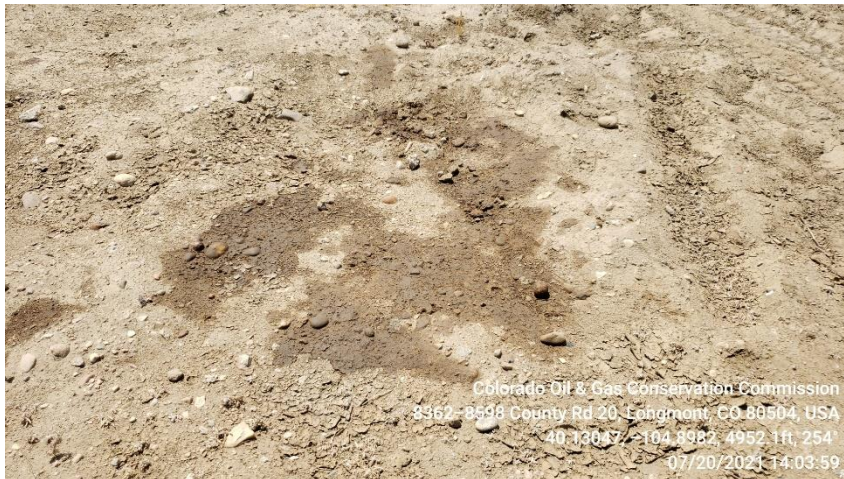
Photo 19 Stained soil by the Flow line manifold

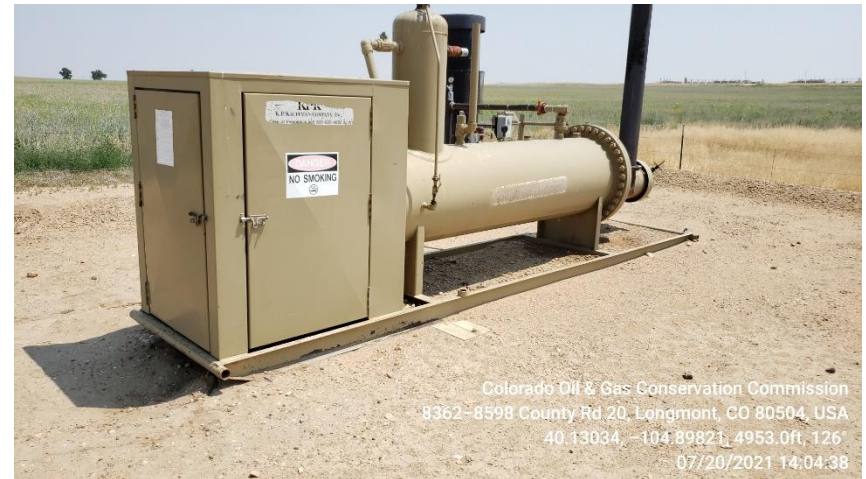
Photo 20 Horizontal Heated Separator

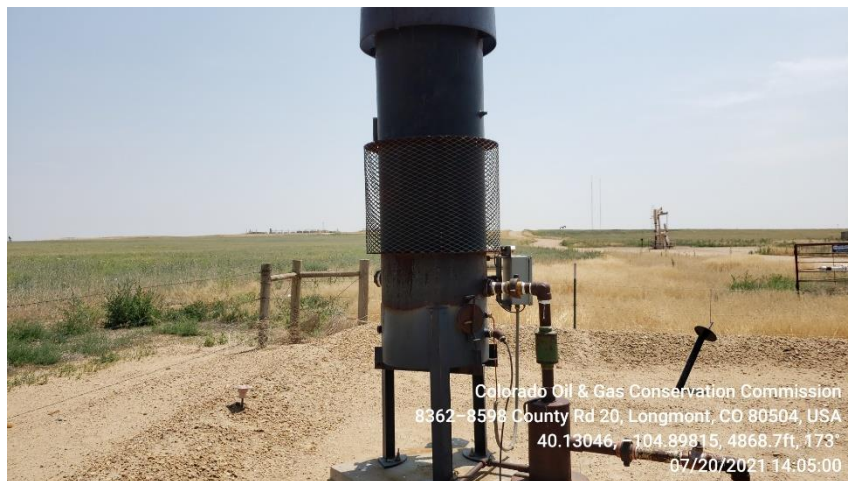
Photo 21 ECD
