# Inspection Photos

API: 017-07727

Operator: HIGH PLAINS ENERGY LLC

Inspection Date: 7/12/2021

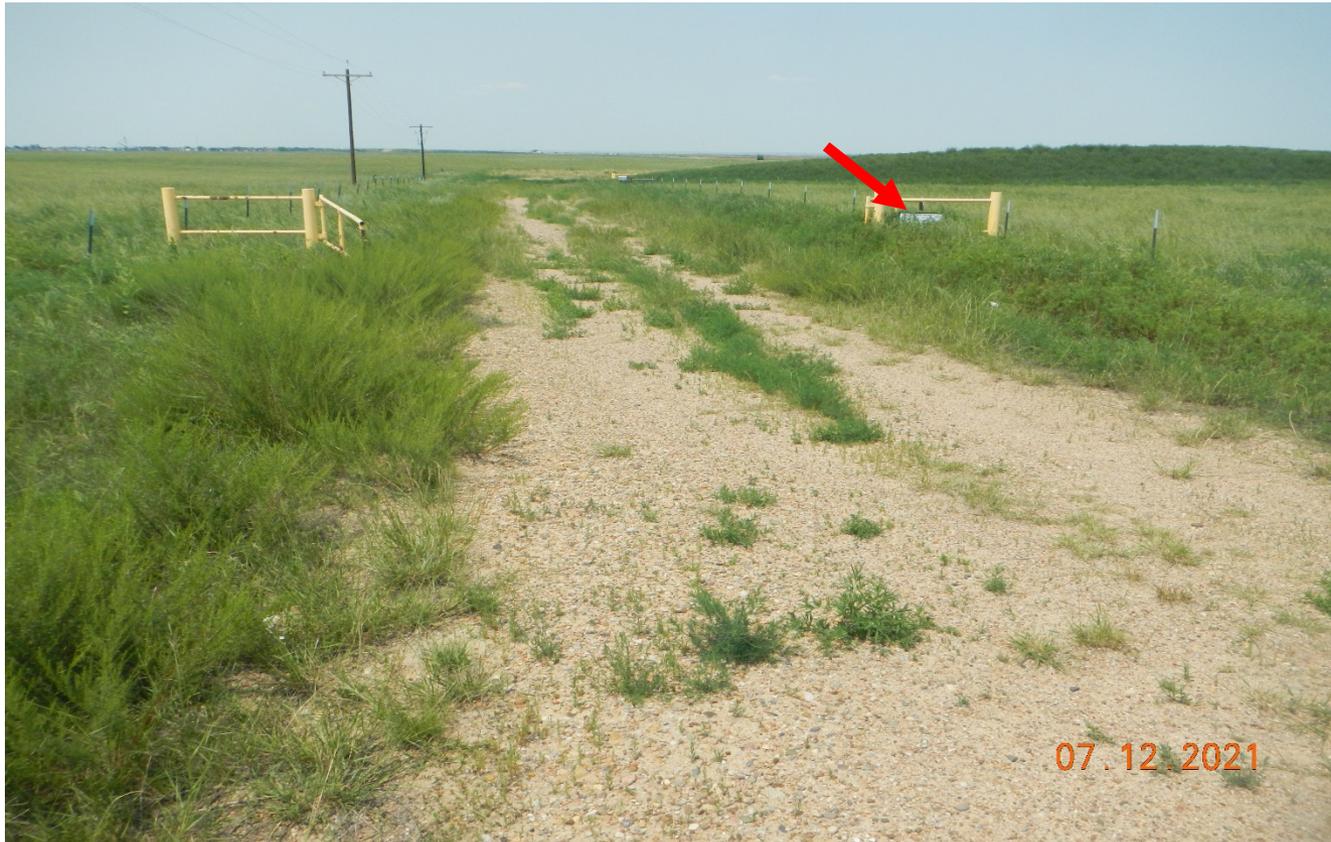
**Photo 1.** Facing north along the access road toward the location. Location sign is posted next to access road but is covered with weed growth.

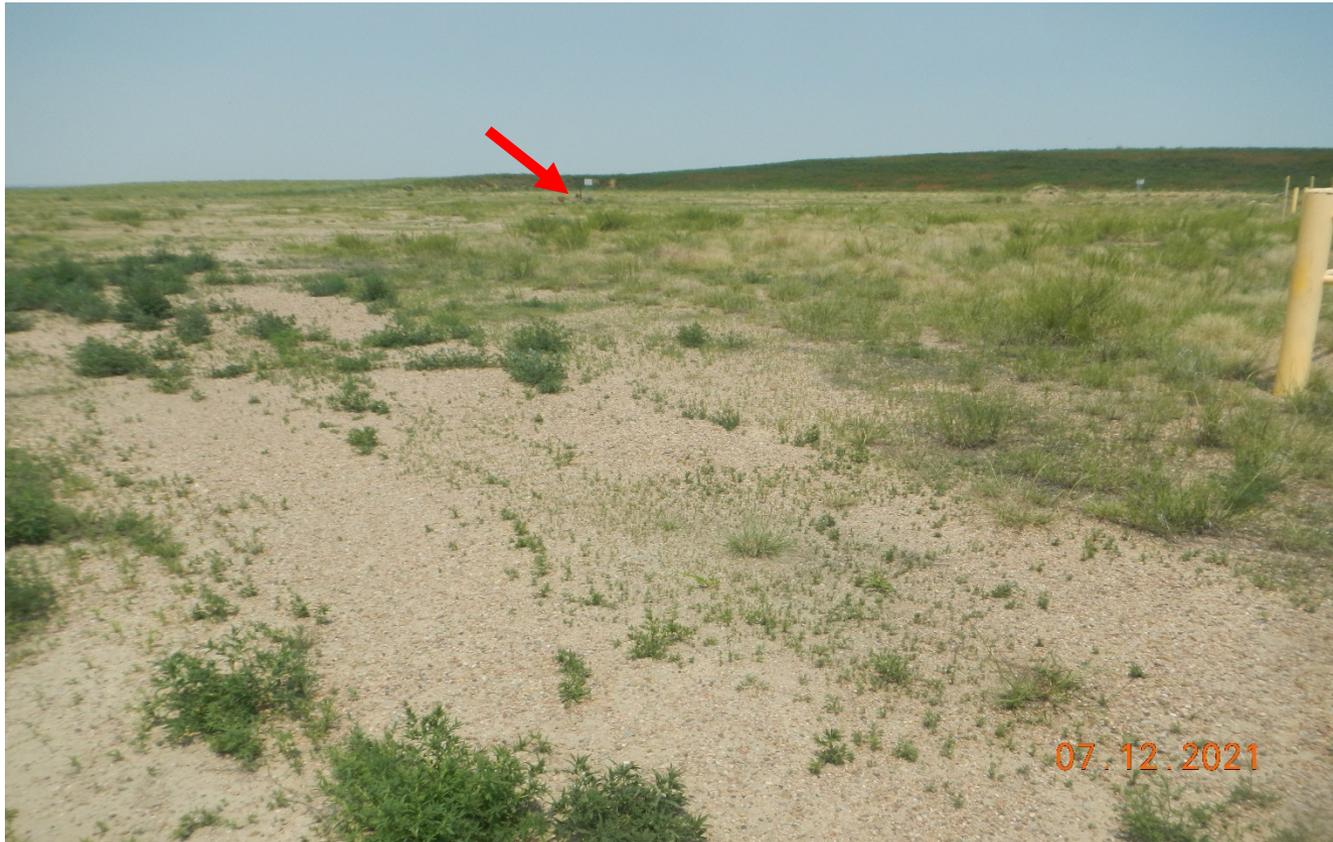
**Photo 2.** Facing northeast at the location. Wellhead is at center of location shown at red arrow.

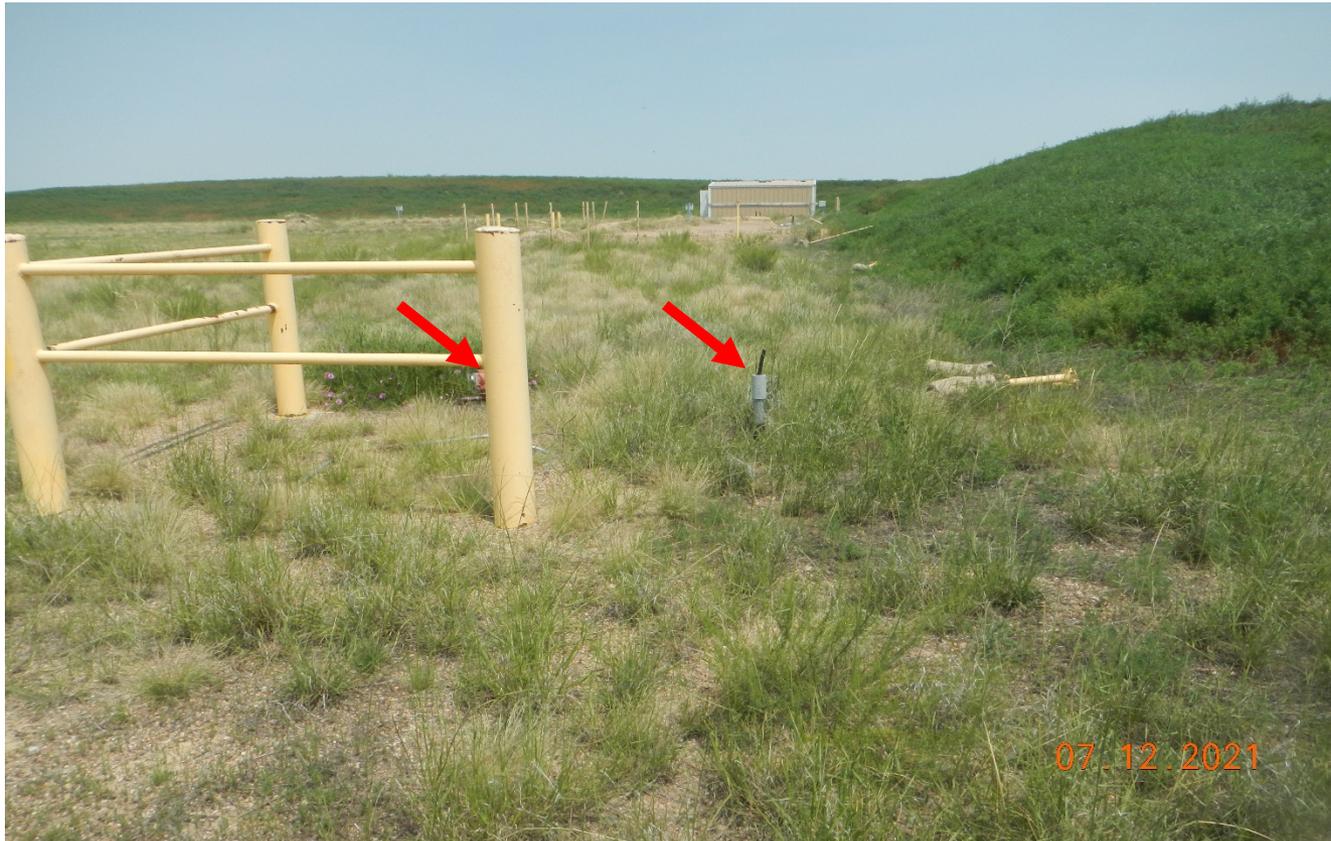
**Photo 3.** Facing east toward the location. There are unused pipe risers shown at red arrow.

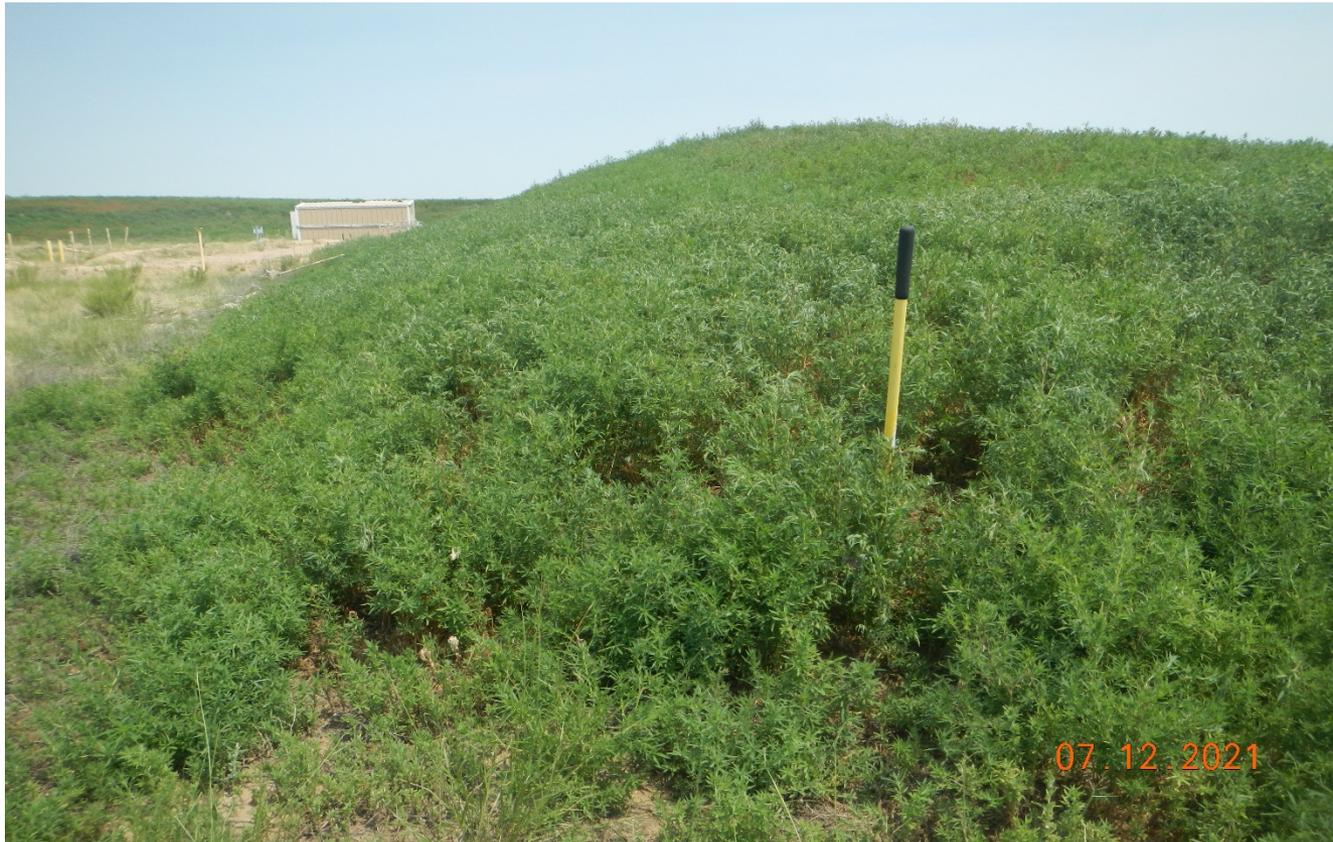
**Photo 4.** Facing east along the stockpiled soil. The stockpiled soil has not been replaced and recontoured. There are undesirable weeds (Kochia sp.) throughout the stockpiled soil . The shovel (4.5 ft.) indicates growth of weeds along the soil piles.

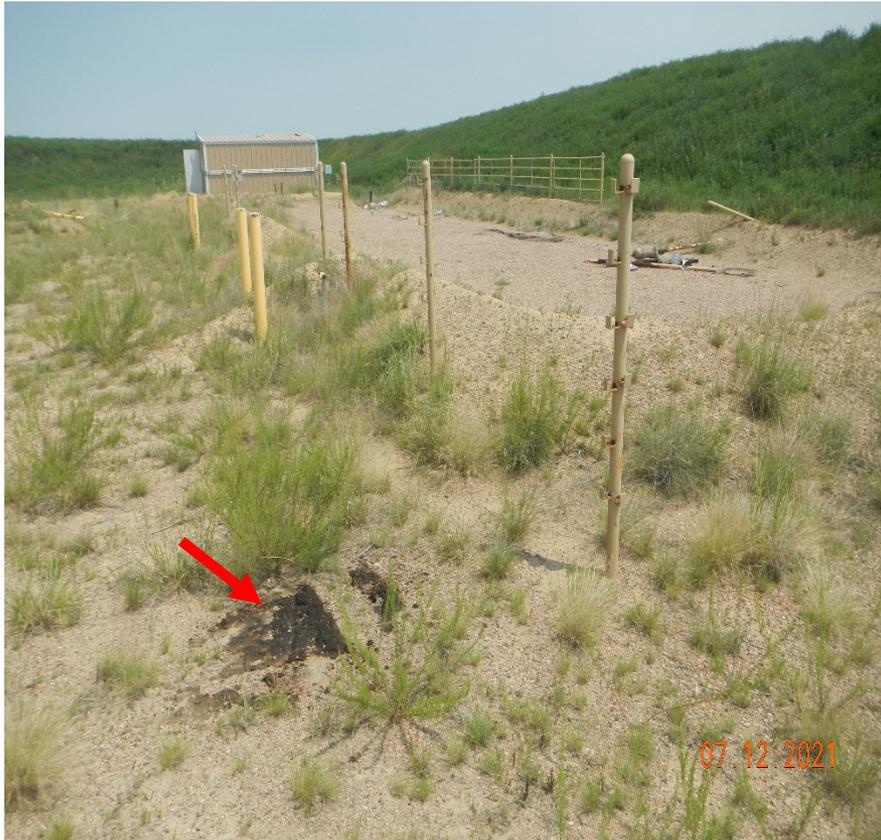
**Photo 5.** There is tank berms that remains and unused fence posts. There is oily waste shown at red arrow.

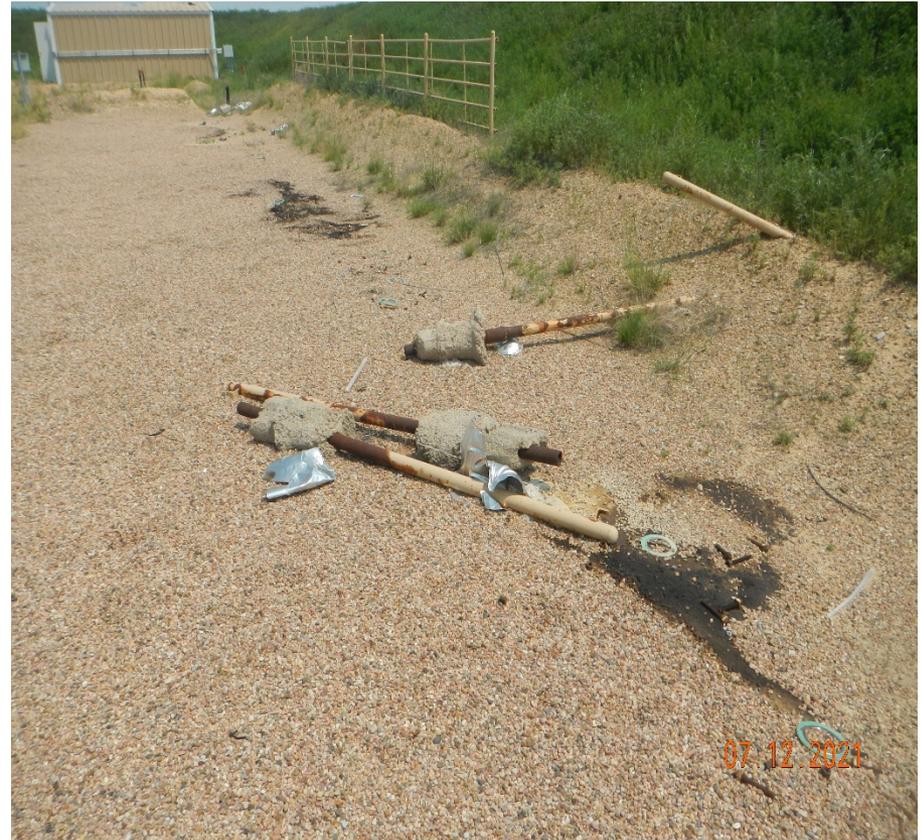
**Photo 6.** There is oily waste observed inside the berm area shown in previous photo.

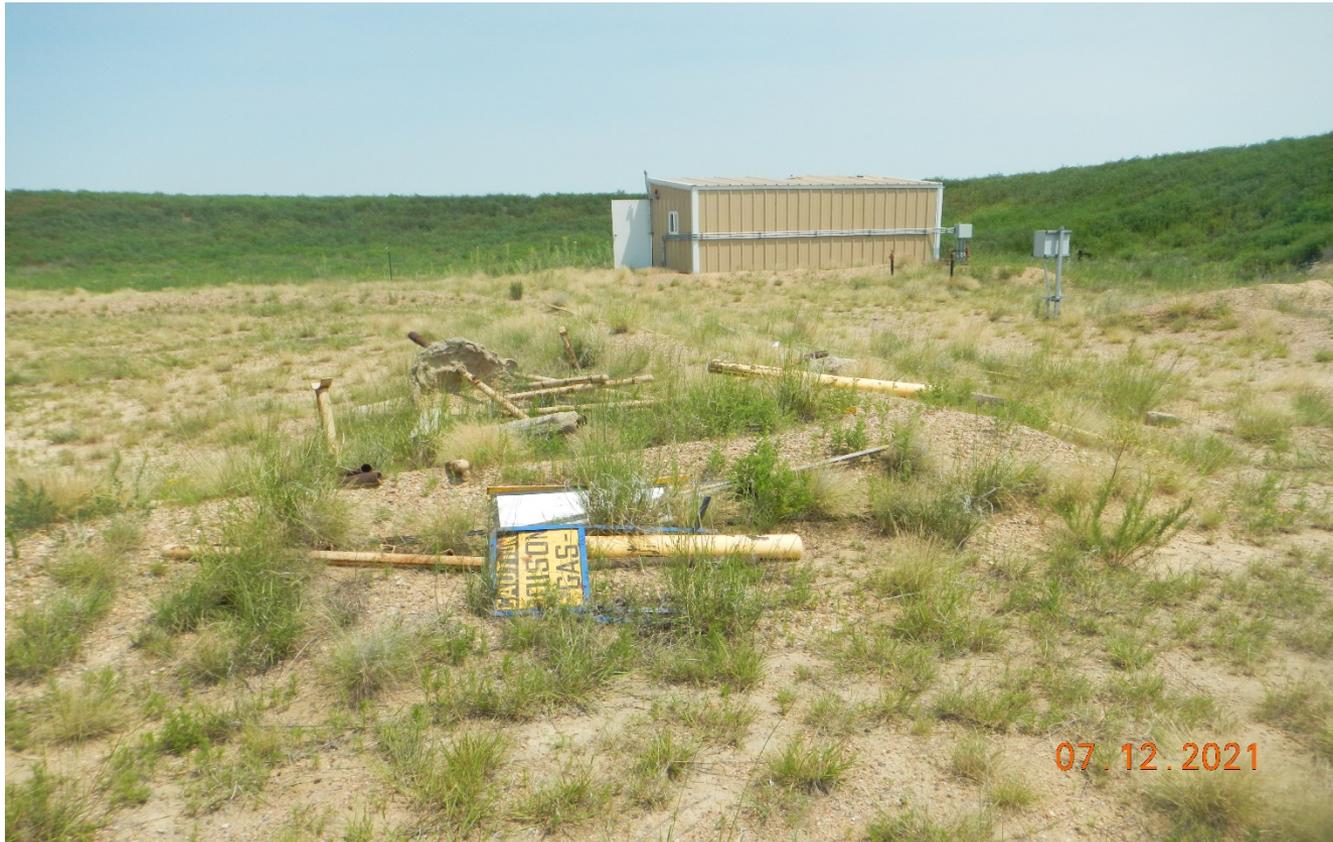
**Photo 7.** There is various unused equipment and debris laying on the ground. There is a berm that remains in this area.

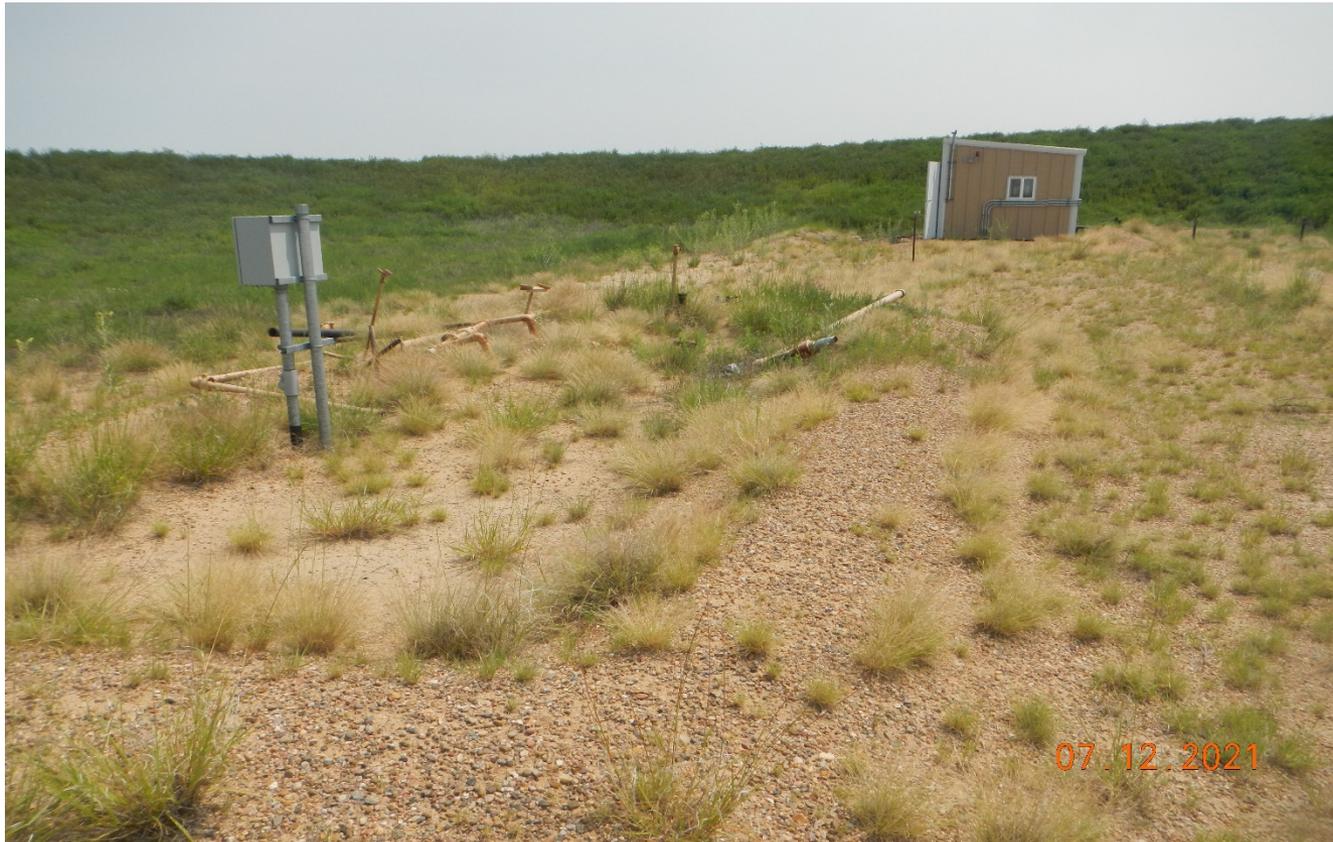
**Photo 8.** Facing southeast toward the location. There are multiple berm areas, unused equipment, debris, electrical equipment, and storage shed in disrepair.

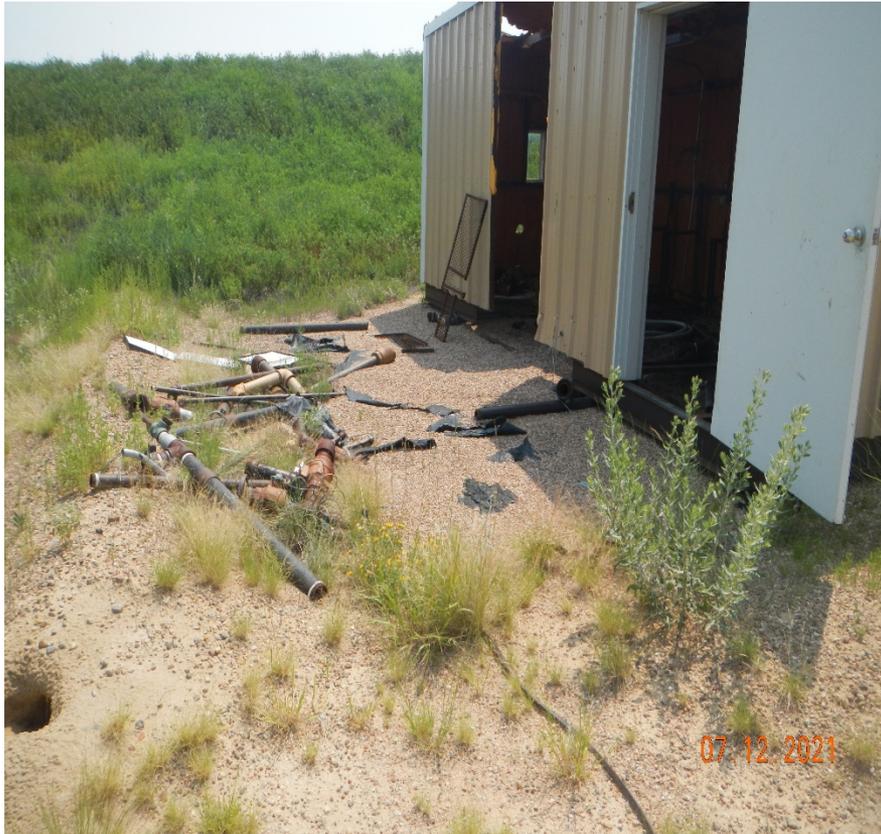
**Photo 9.** There is a shed in disrepair at the southeast side of the location. Various unused equipment remains near the shed.

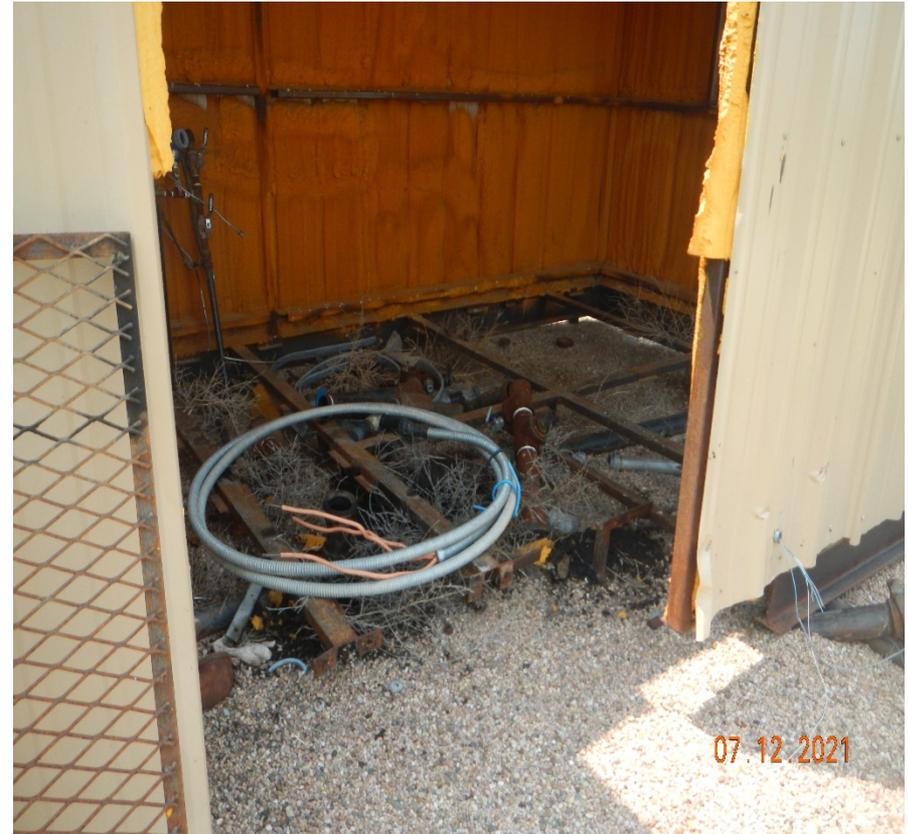
**Photo 10.** View of inside the shed. There is various piping risers, and supplies inside the shed.

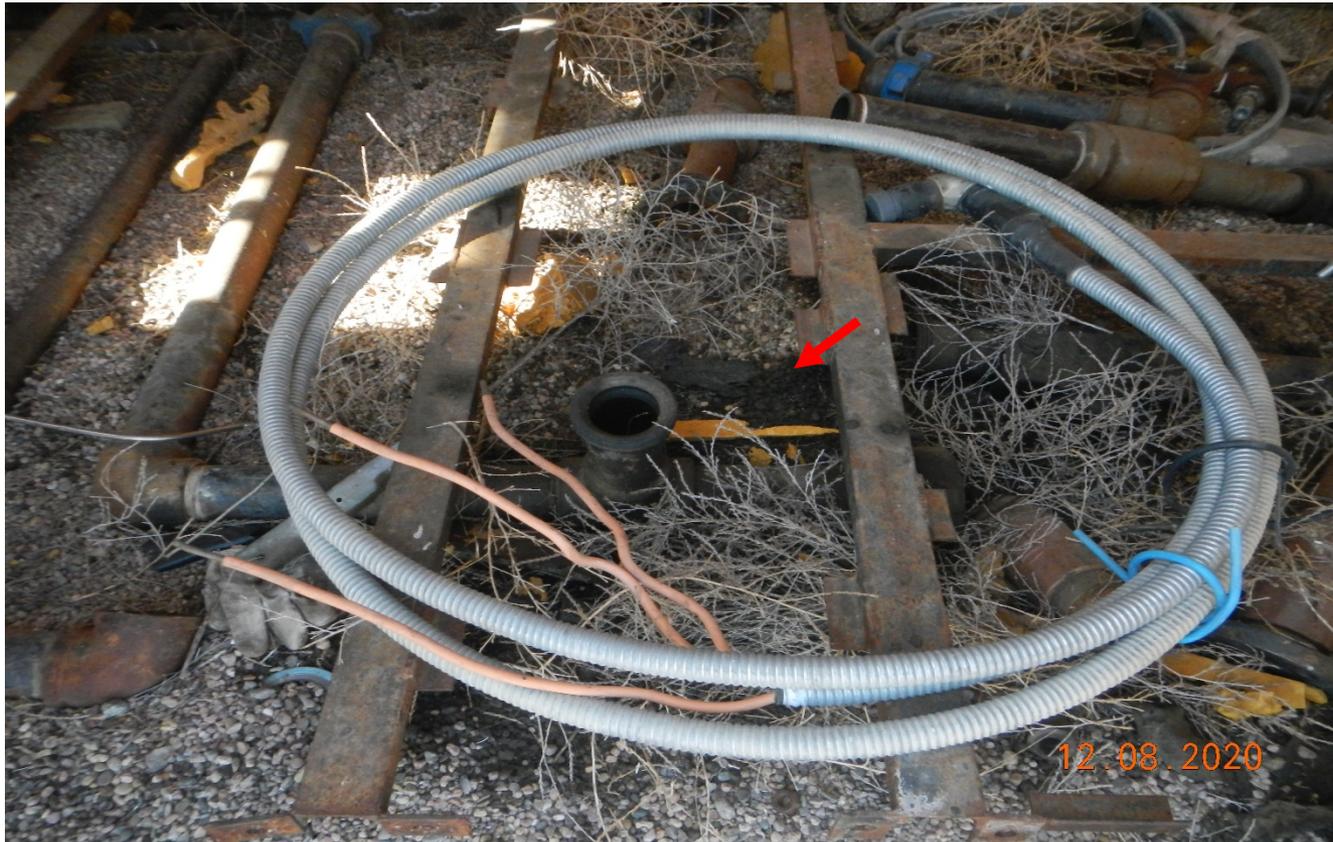
**Photo 11.** There are oil stained soils inside the shed.

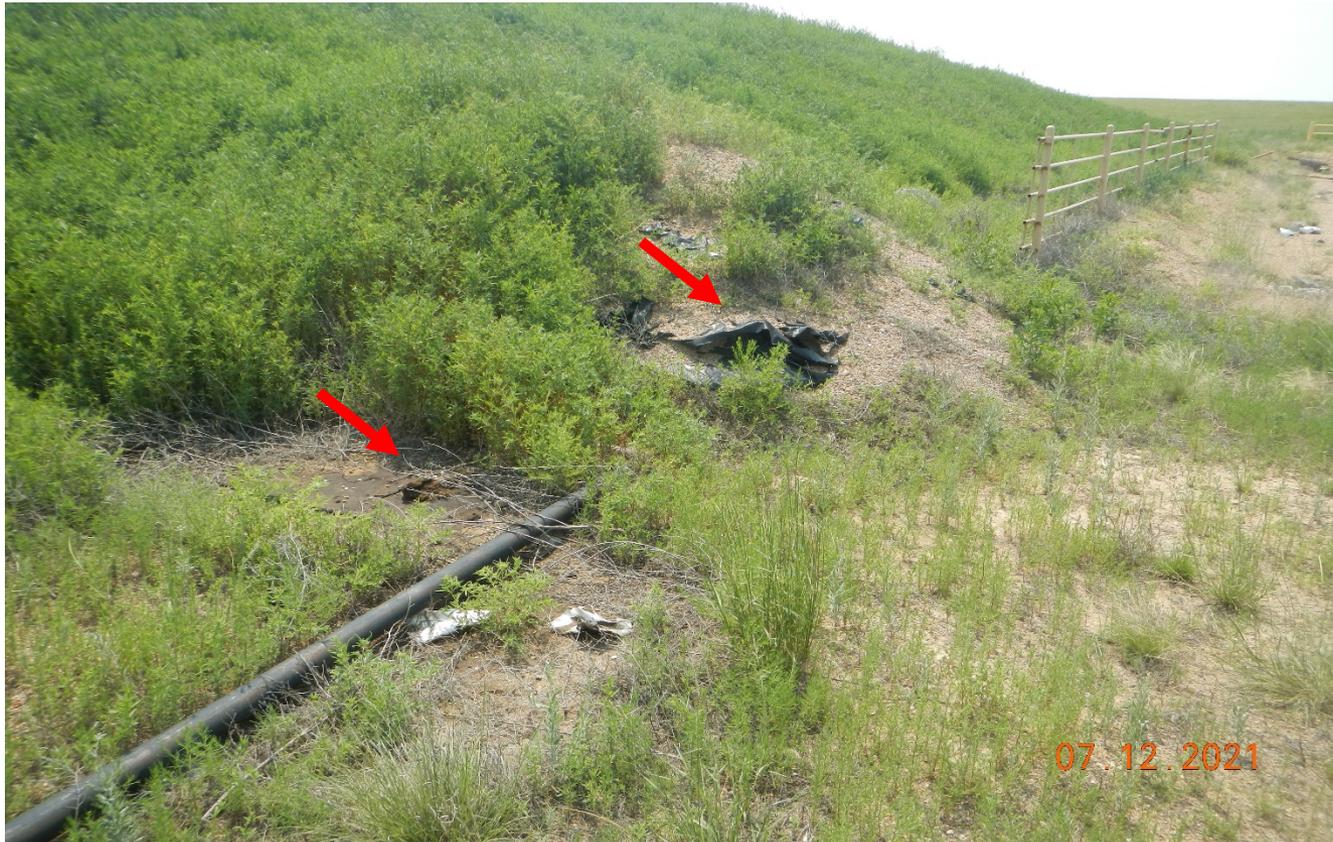
**Photo 12.** Facing southwest along the soil pile which is cover with undesirable weeds (Kochia). There is also a pile liner debris and oil stained soil shown at red arrow.

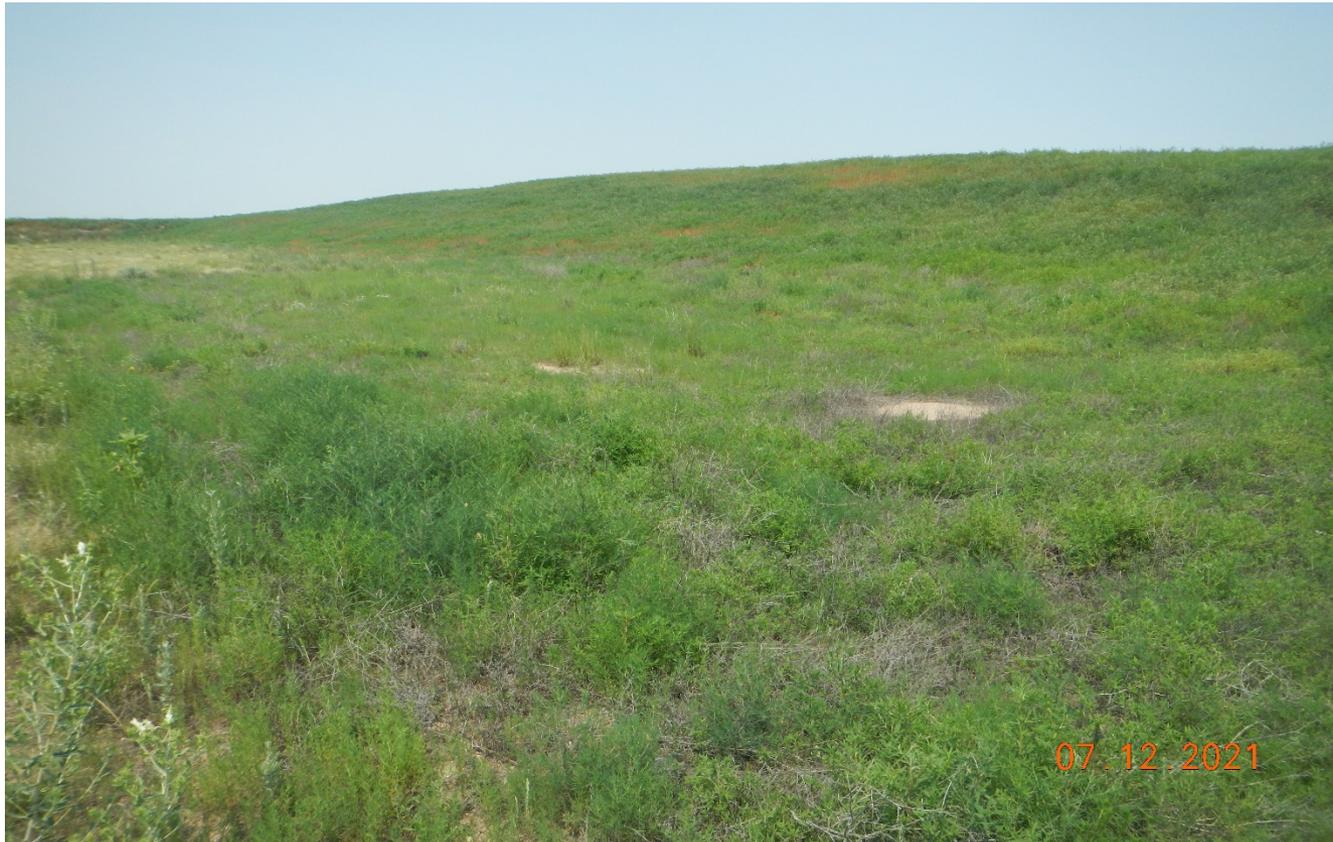
**Photo 13.** Facing northeast toward the east side of the pad. There are undesirable weeds (*Kochia* sp.) throughout the stockpiled soil.

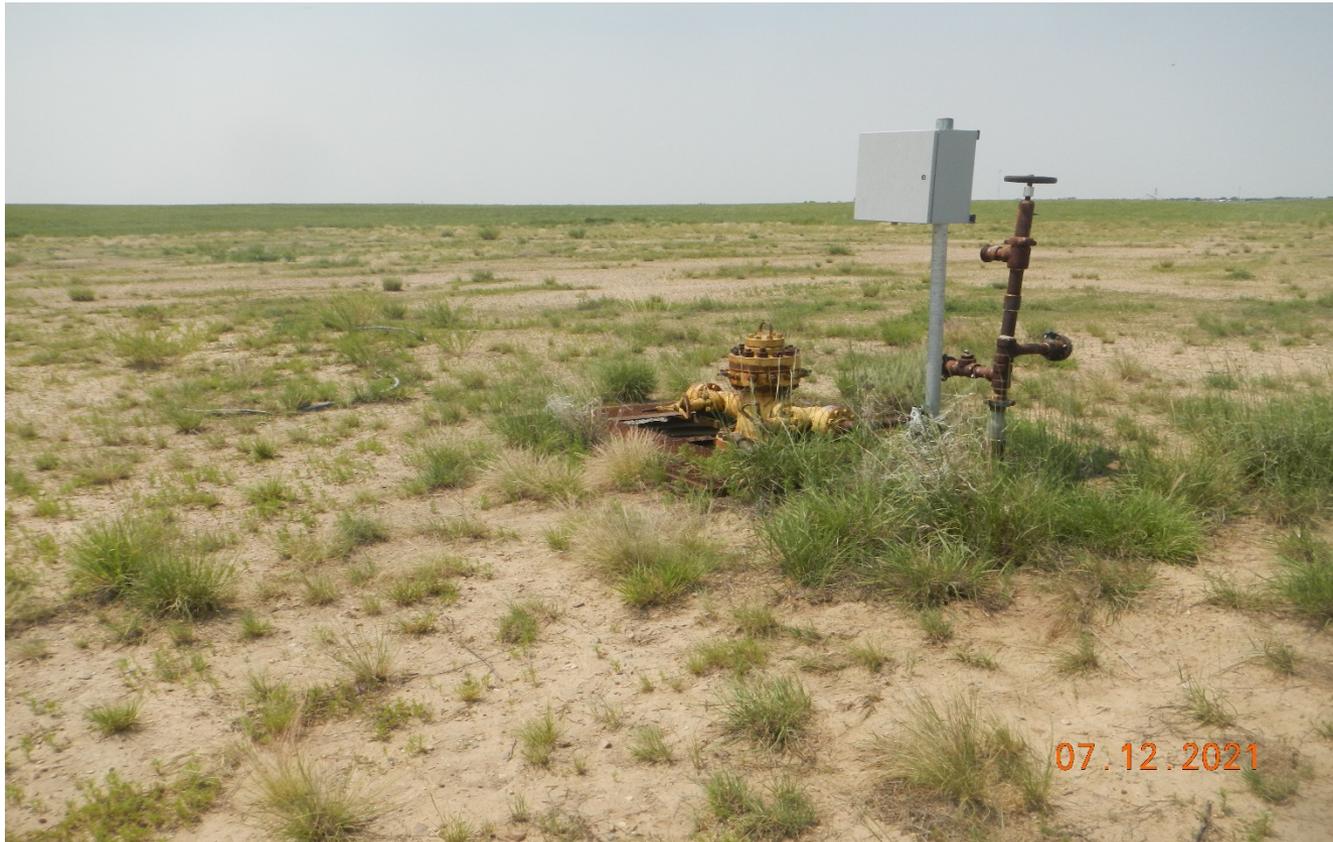
**Photo 14.** Facing toward the wellhead at the center of the location.

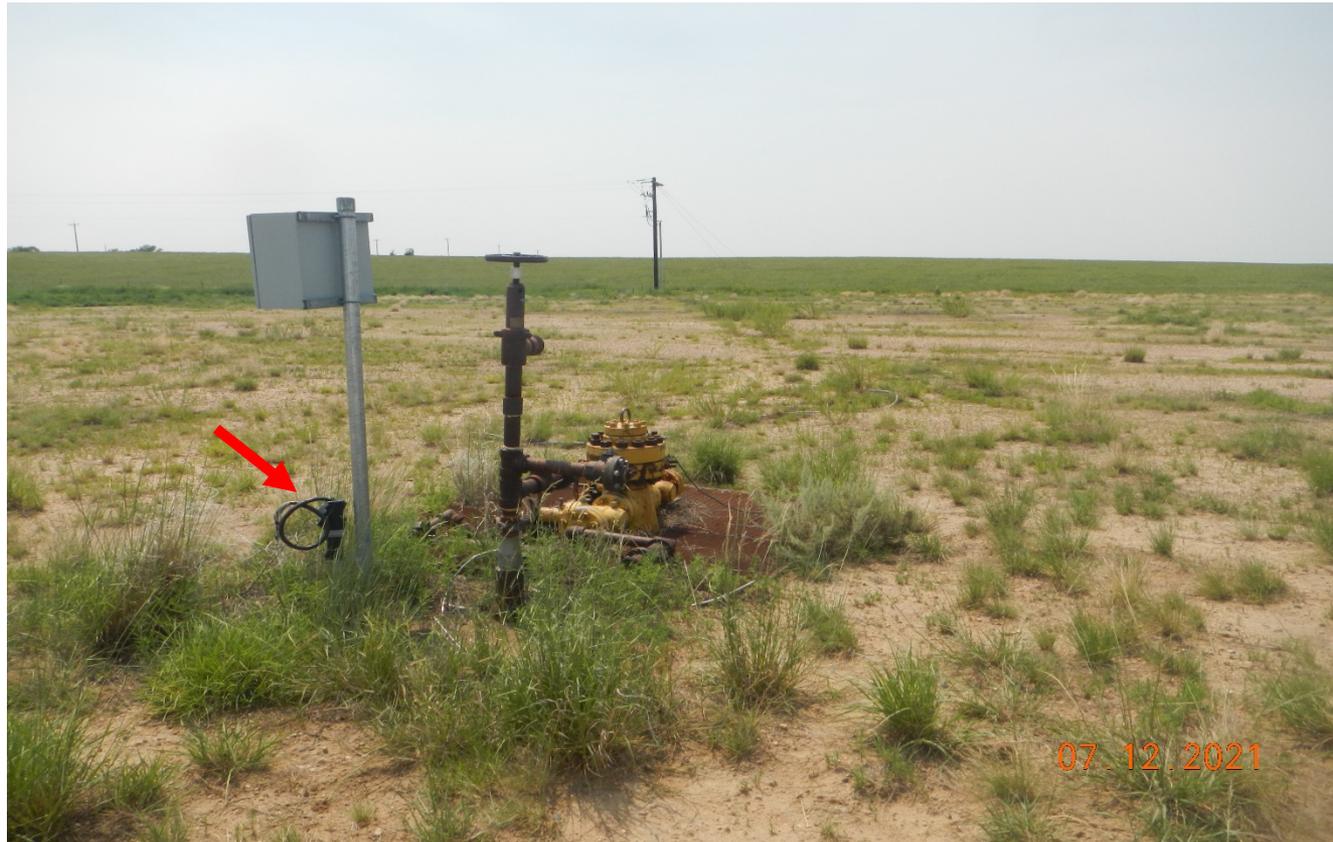
**Photo 15.** There is electrical wires extending out of the ground near the wellhead.

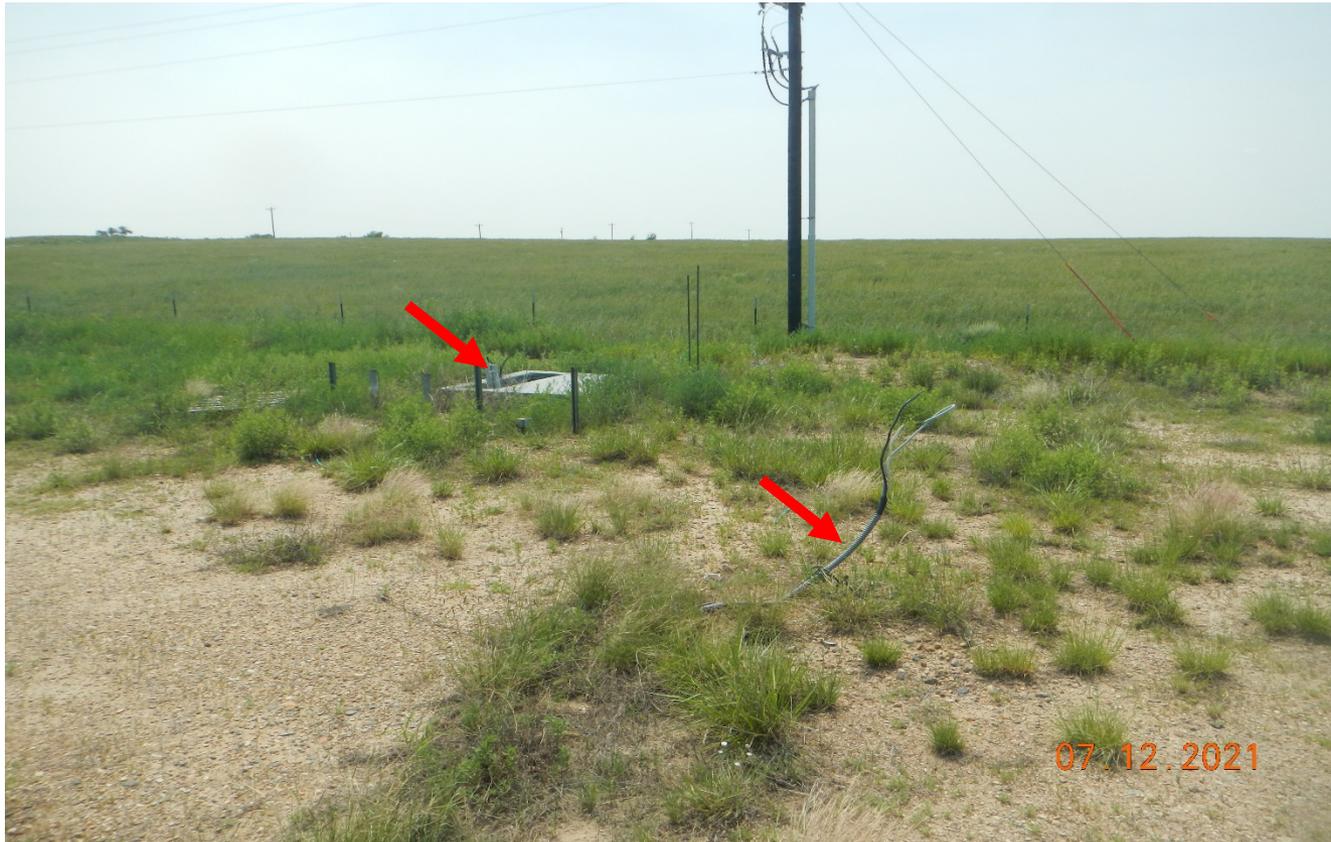
**Photo 16.** Facing toward west side of the location. There is electrical wiring extending out of the ground in this area. There is a cellar with exposed electrical wiring inside.

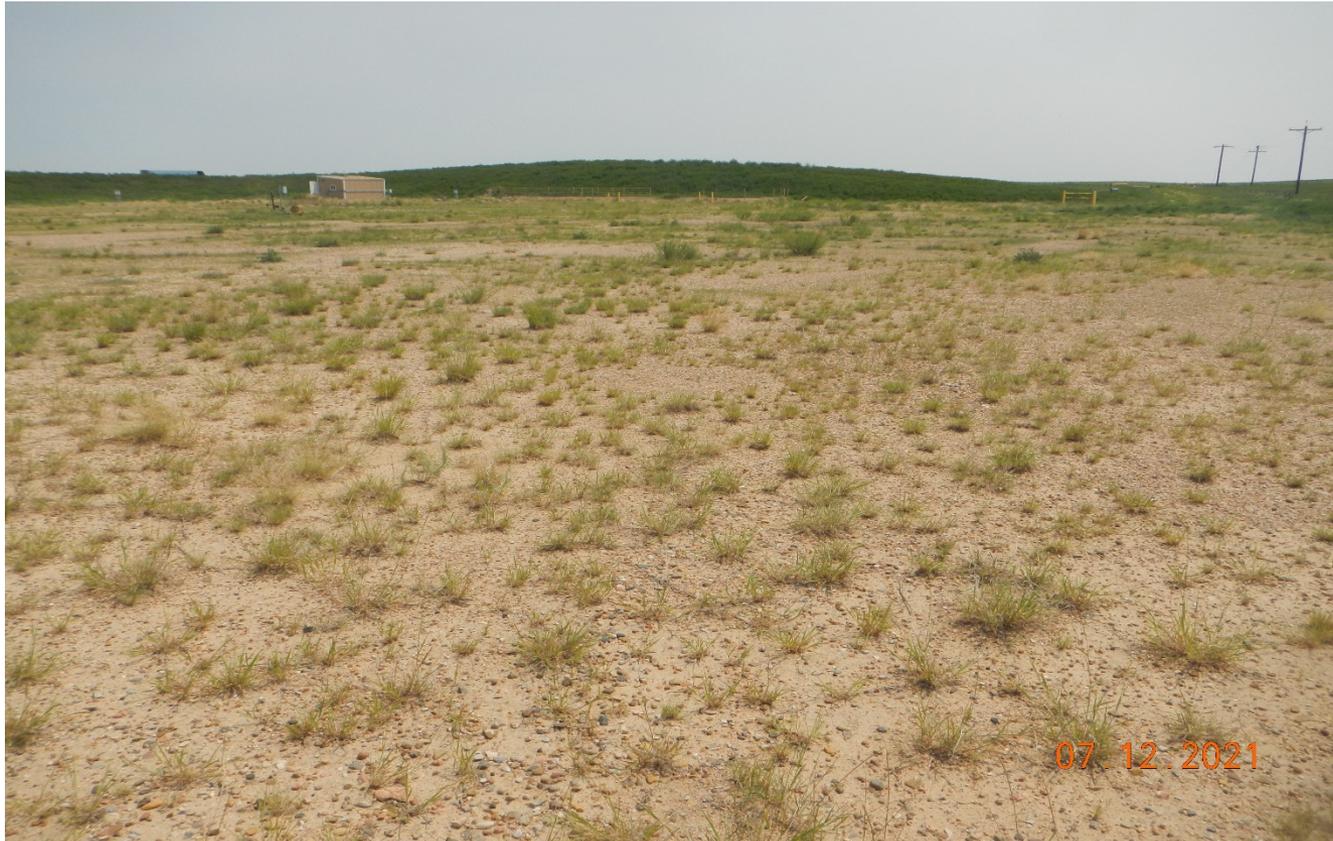
**Photo 17.** Facing southeast toward the location Interim reclamation has not been performed. Unused areas of the location have not been reclaimed.

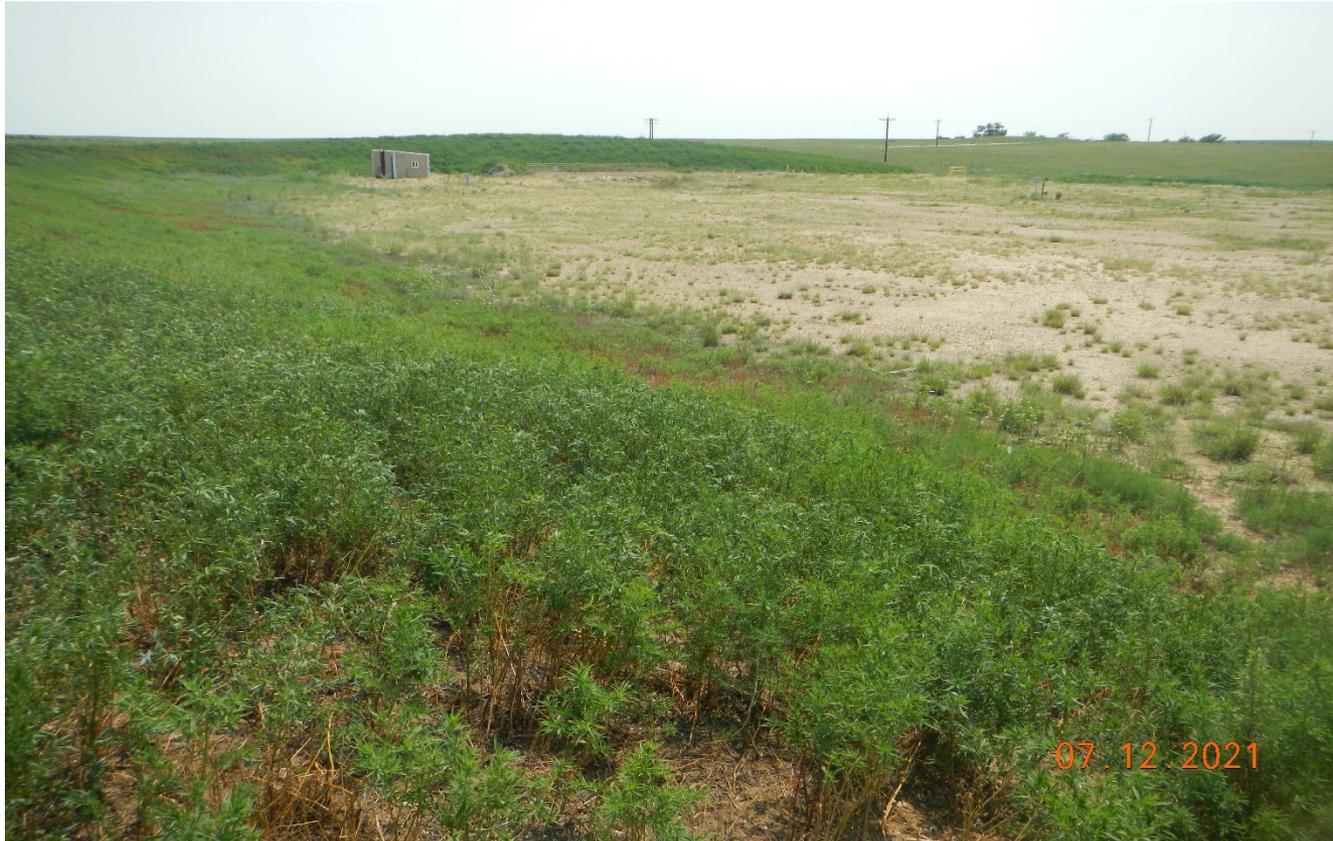
**Photo 18.** Northeast corner of the location facing southwest. Unused areas of the location have not been reclaimed.
