Inspection Photos
Location Name: Our Diane 31-27
Location ID: 328043

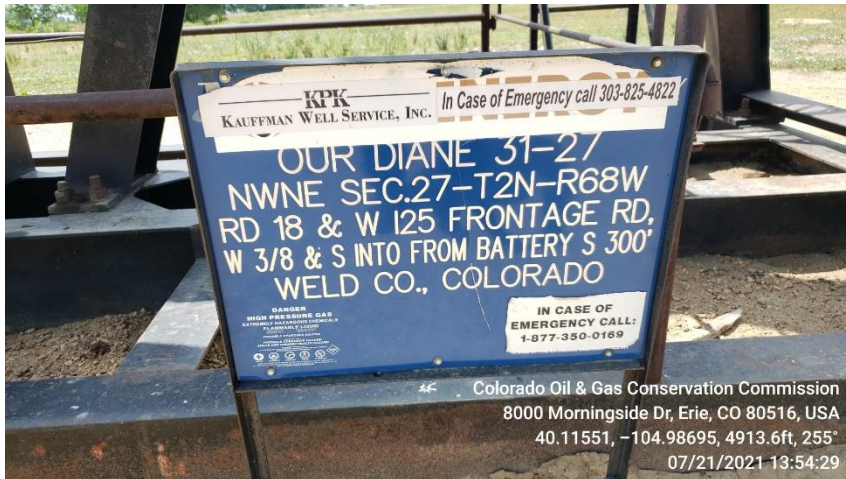
Photo 1 WH sign

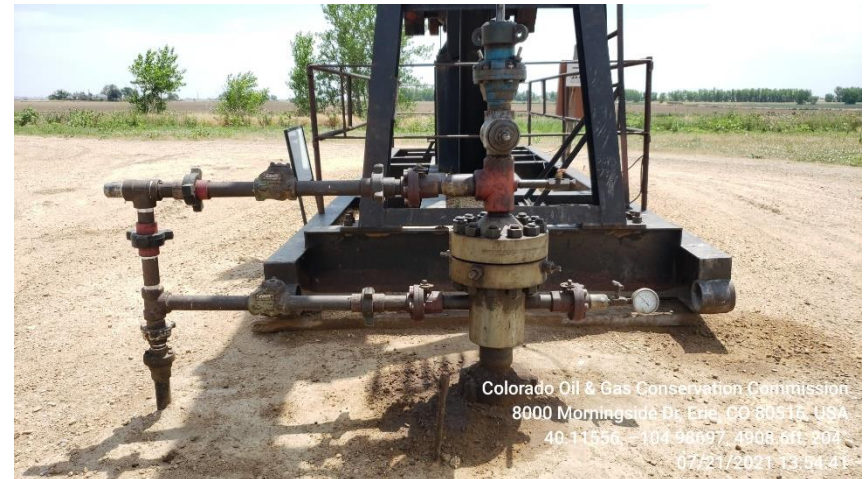
Photo 2 WH

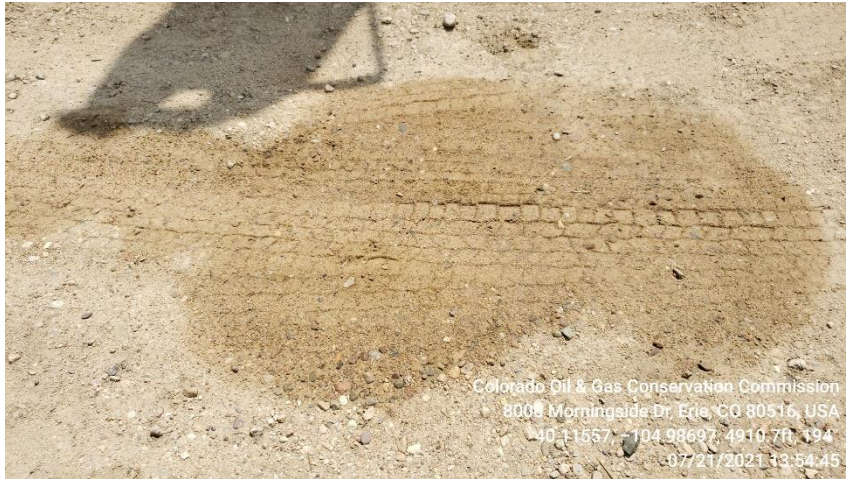
Photo 3 Stained soil near WH

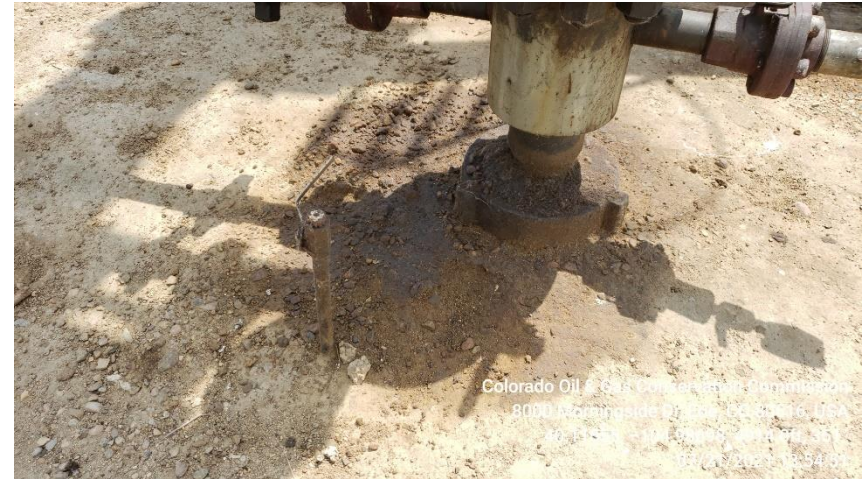
Photo 4 Stained soil around WH

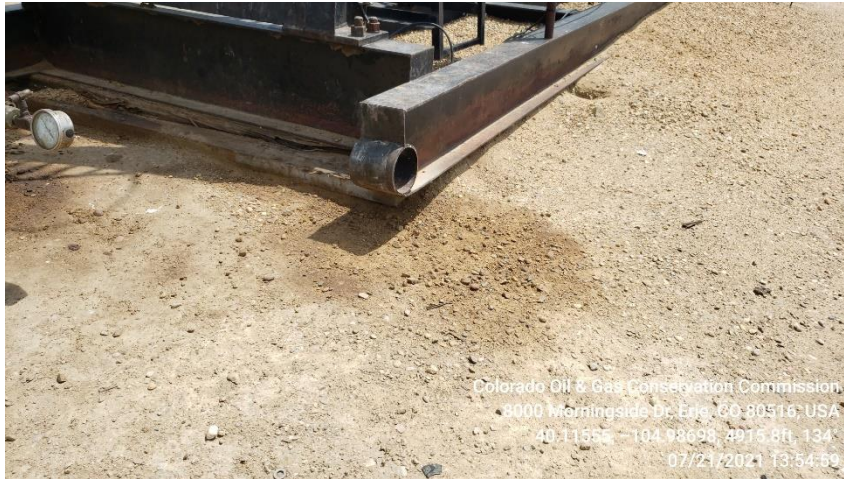
Photo 5 Stained soil near WH at Pump Jack base

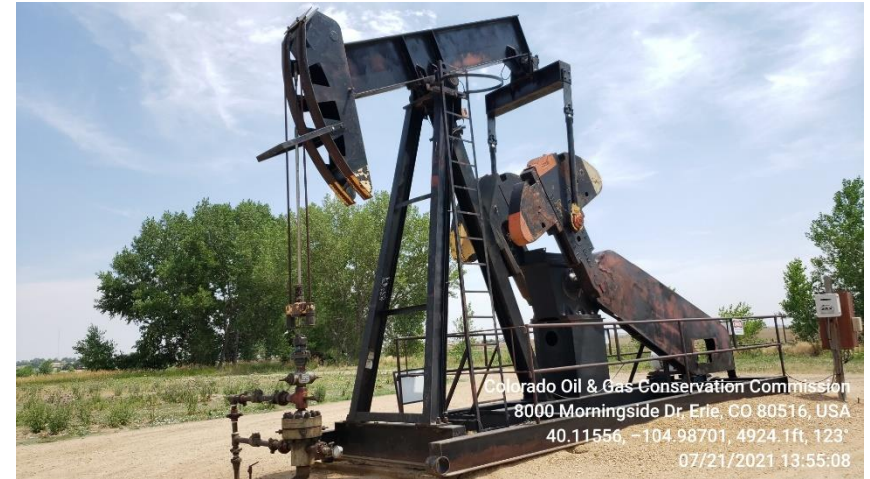
Photo 6 Pump Jack

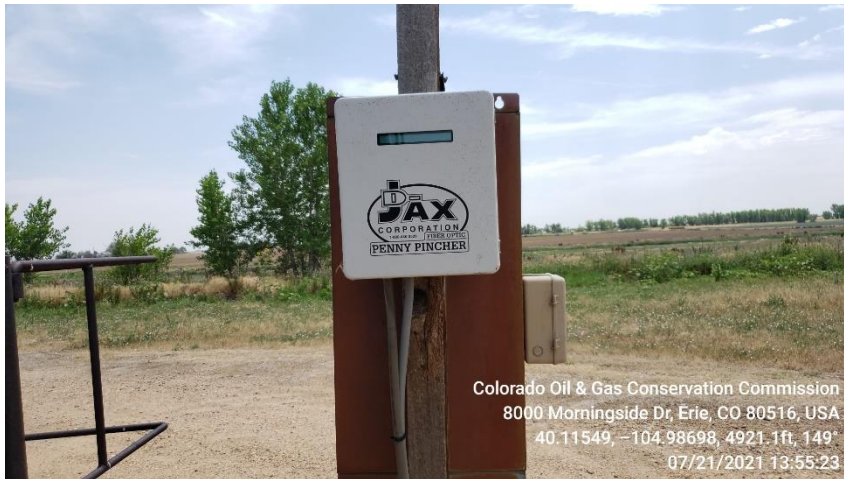
Photo 7 electric panel, fiber optic box

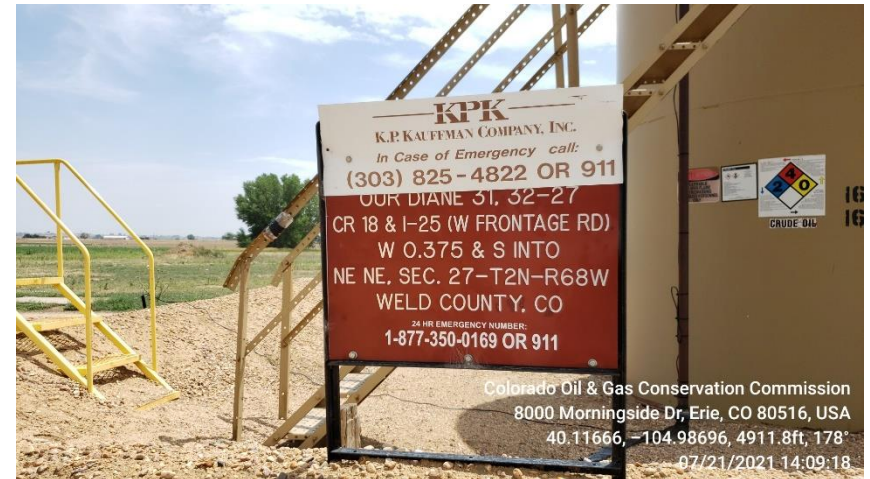
Photo 8 TB sign

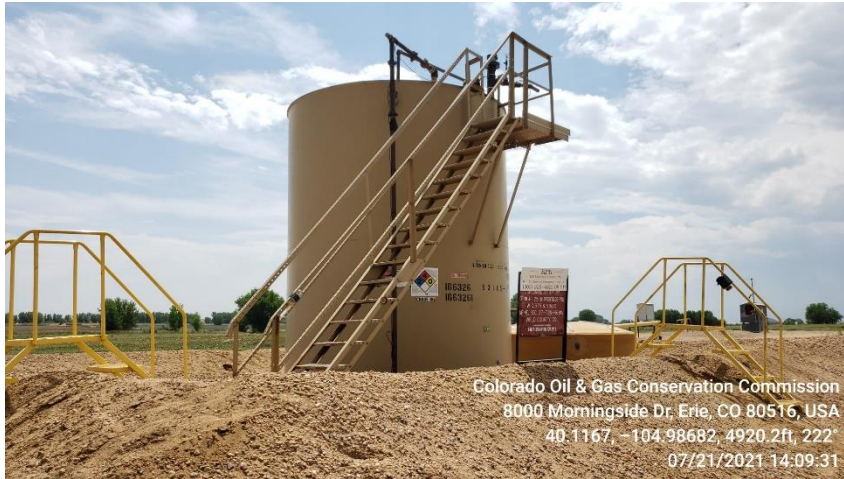
Photo 9 TB

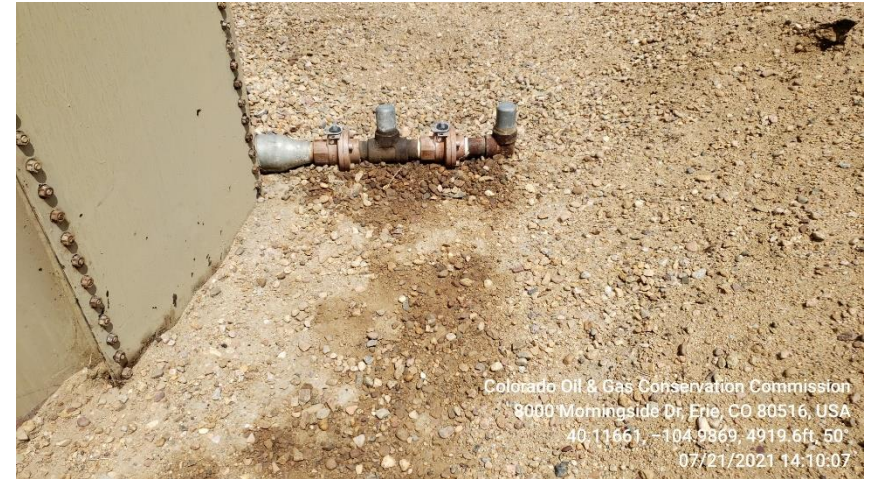
Photo 10 stained soil by valve on south side of crude tank

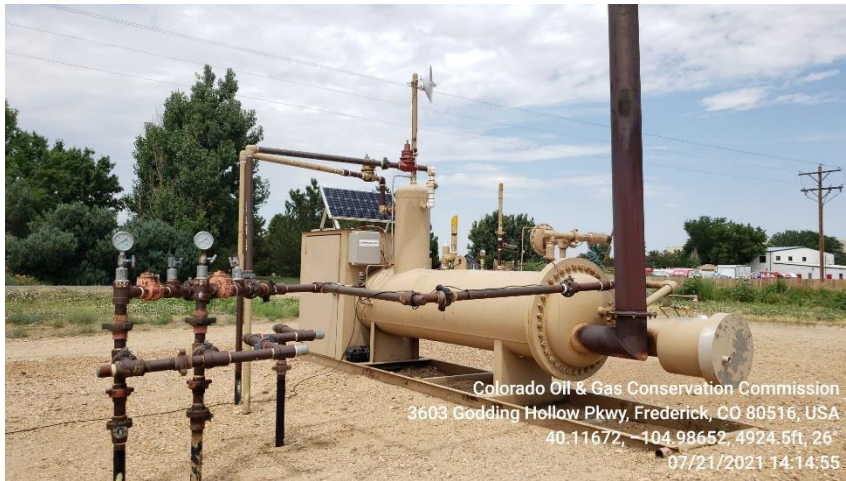
Photo 11 Horizontal Heated Separator

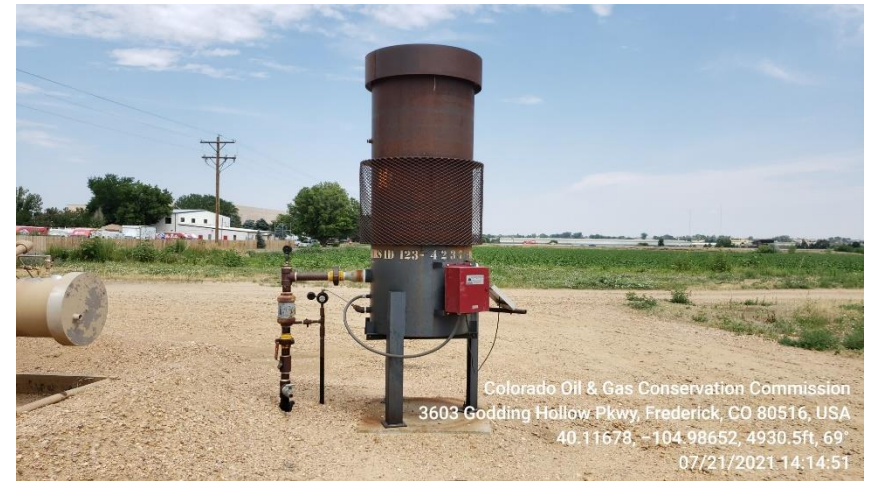
Photo 12 ECD

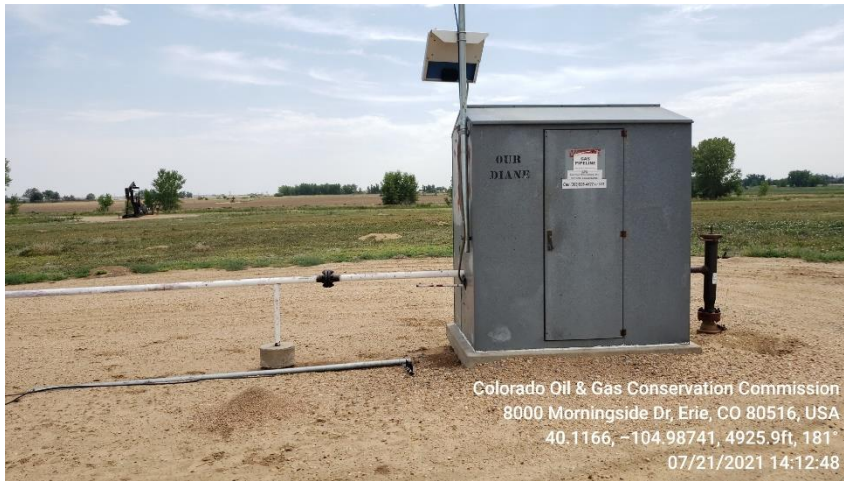
Photo 13 Gas Meter Run

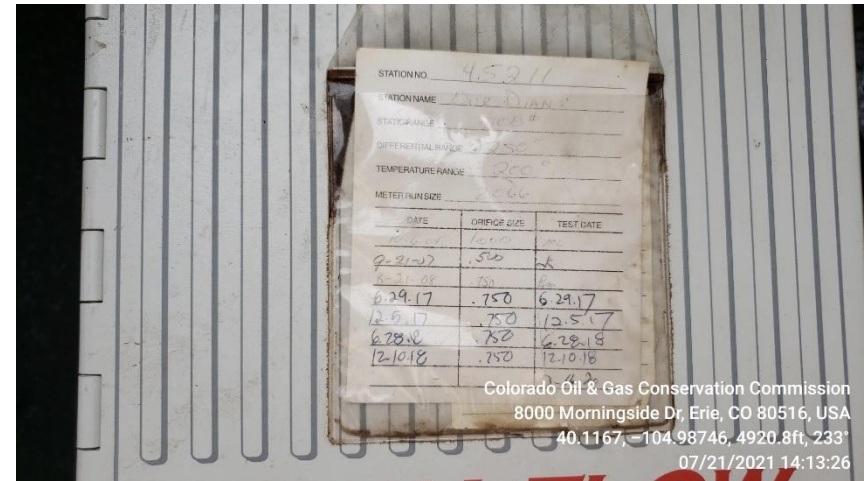
Photo 14 Card in meter house indicates that calibration is not current

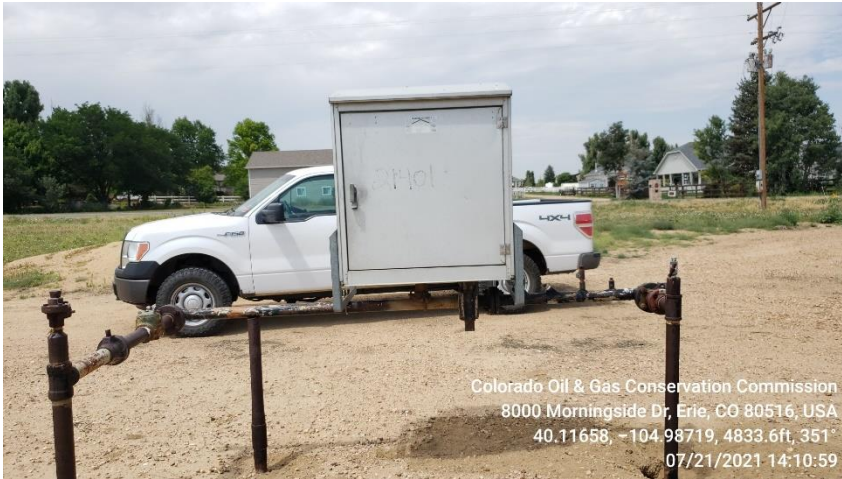
Photo 15 Gas Meter Run

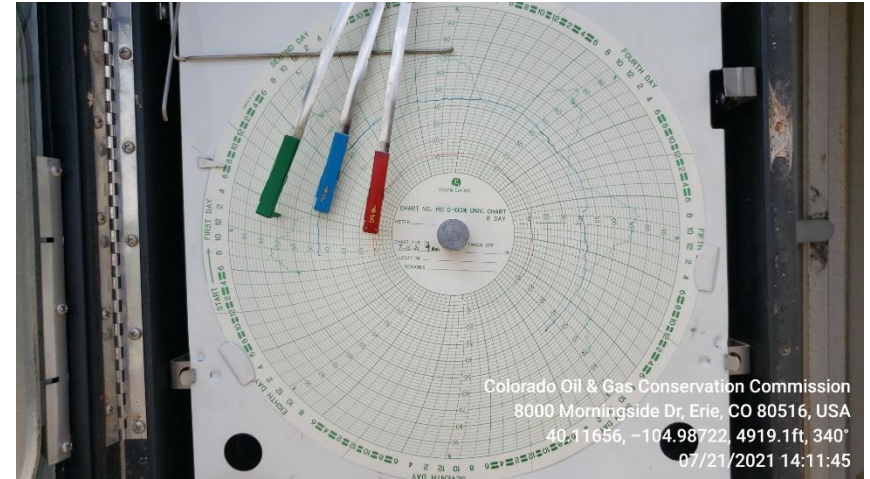
Photo 16 Chart in meter box is current from 7-16-2021

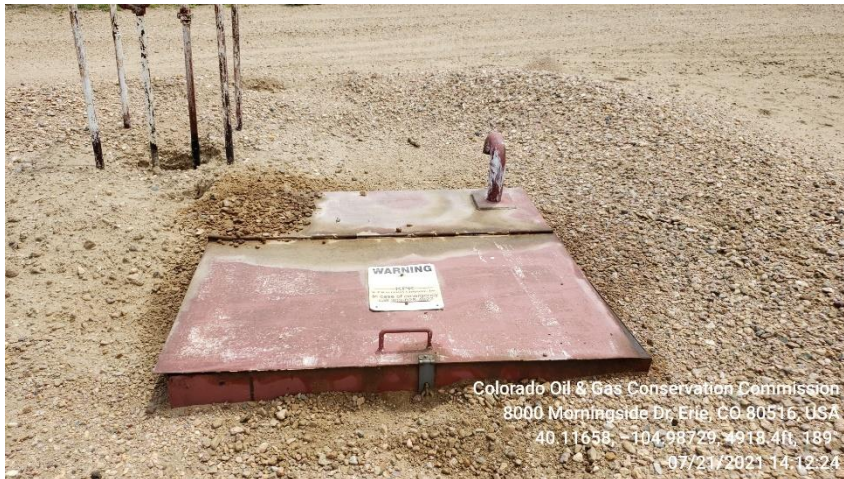
Photo 17 Stained soil around a Locked Cellar
