Inspection Photos
Location Name: Pace Connelly 3
Location ID: 318508

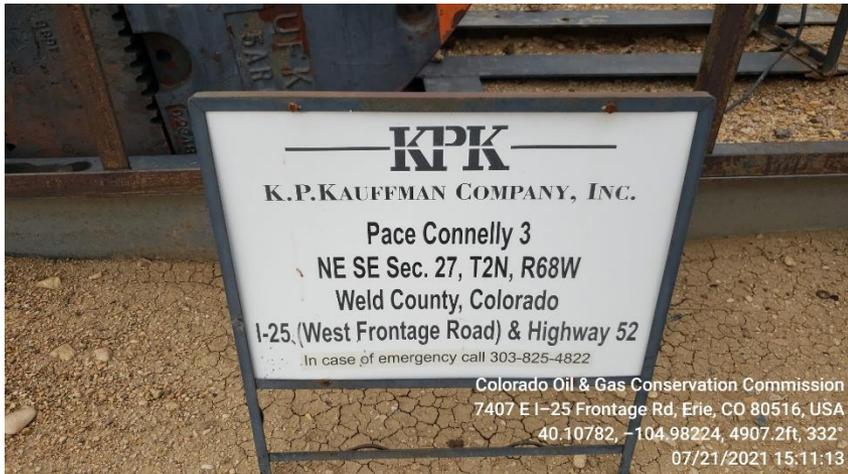
Photo 1 WH sign

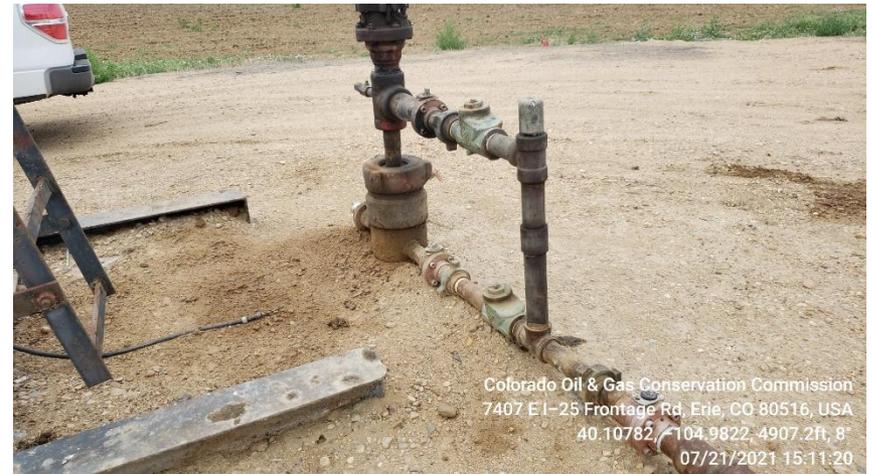
Photo 2 Stained soil around WH

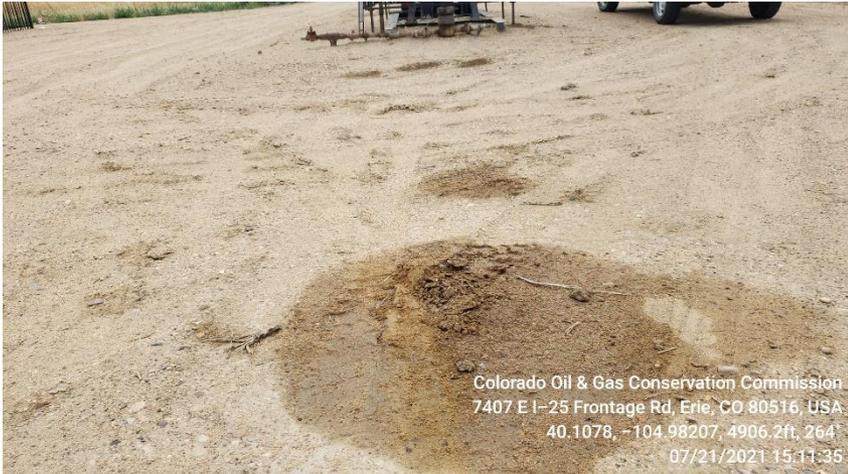
Photo 3 Stained soil to the east of the WH

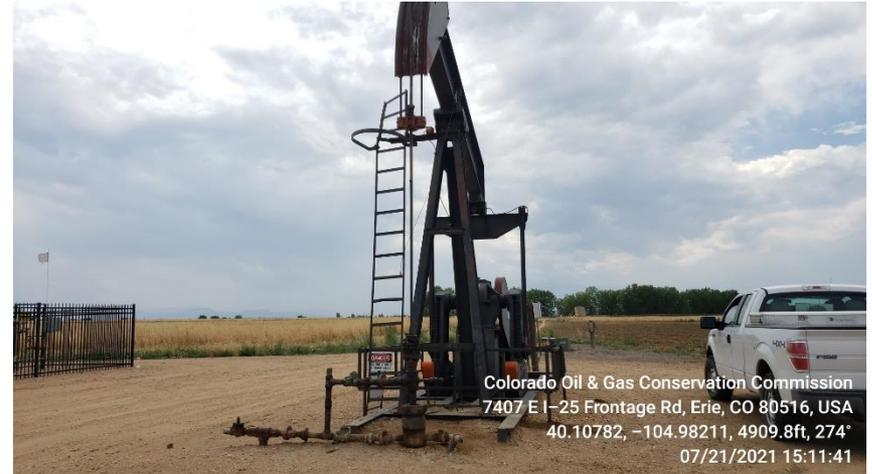
Photo 4 Pump Jack

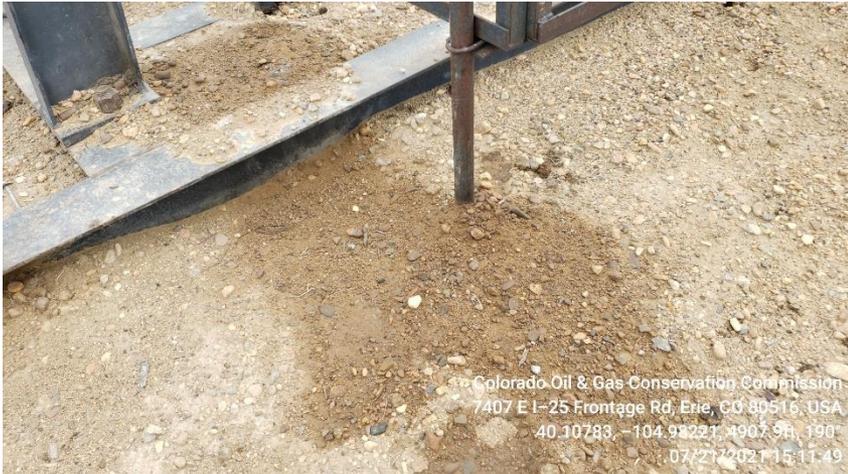
Photo 5 Stained soil at the base of the pump jack

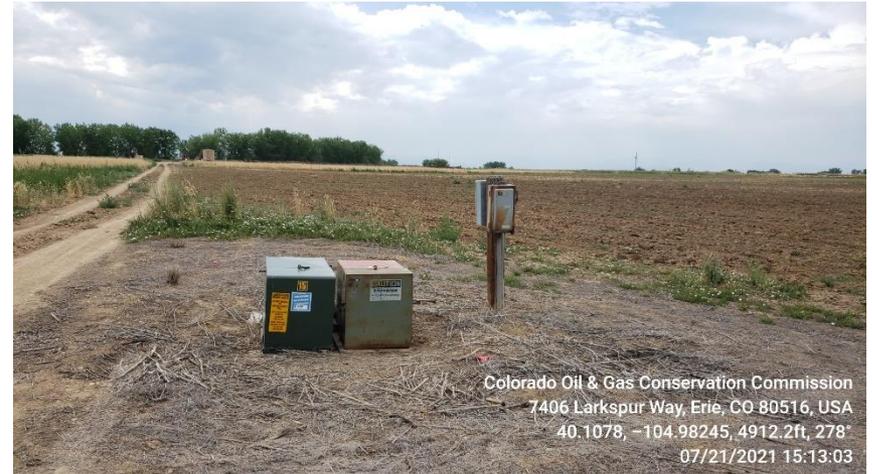
Photo 6 Ancillary equipment

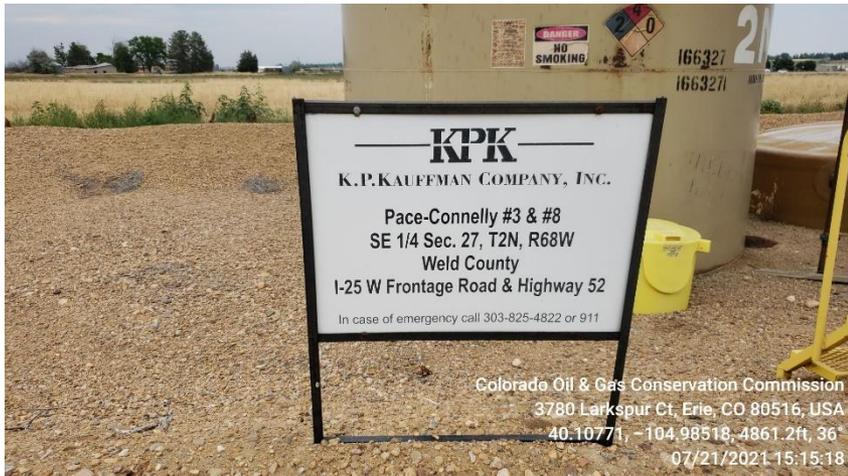
Photo 7 TB sign

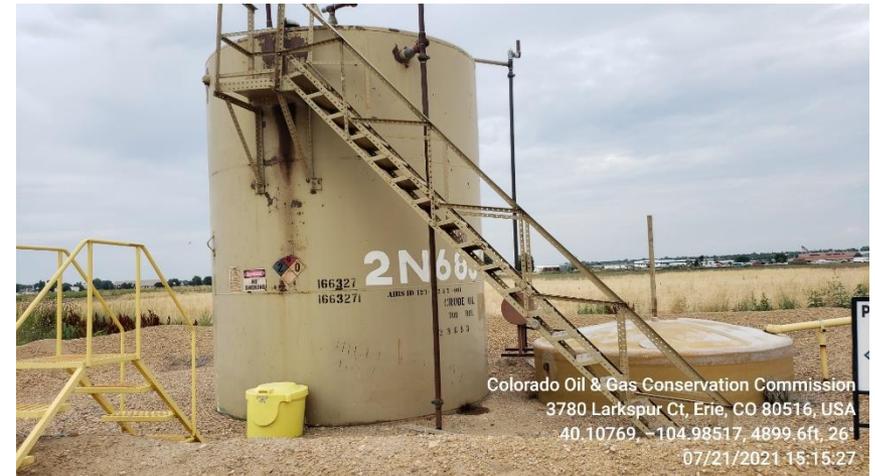
Photo 8 TB

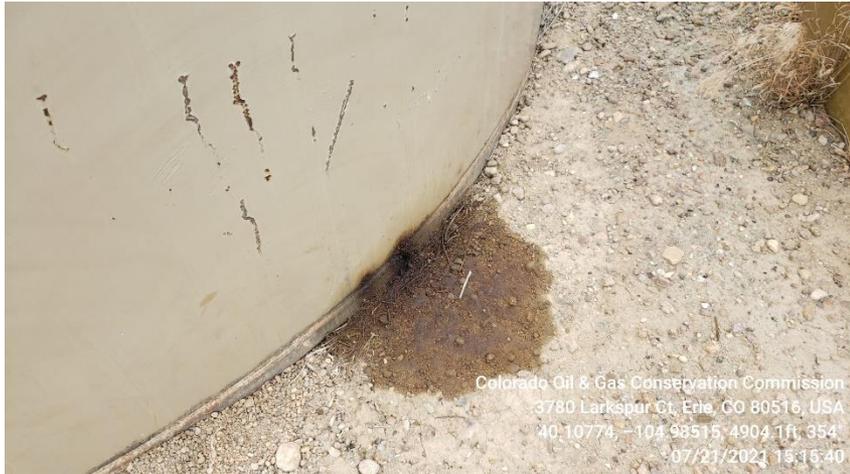
Photo 9 Stained soil on the SE side of the crude oil tank

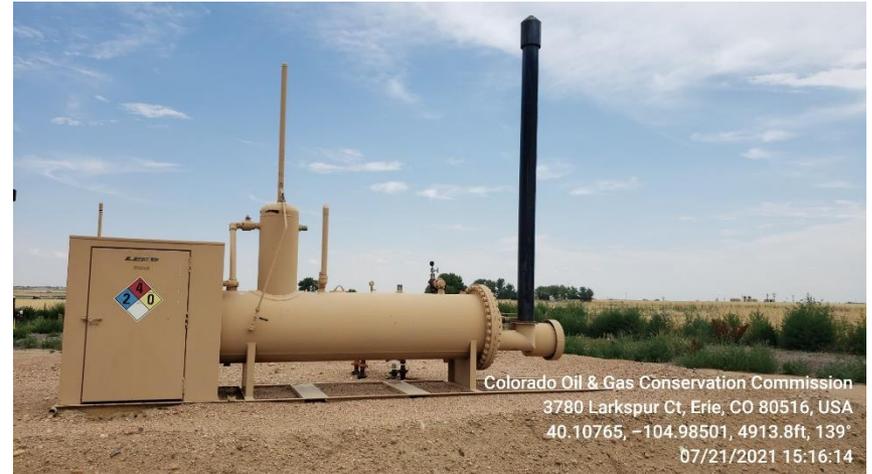
Photo 10 Horizontal Heated Separator

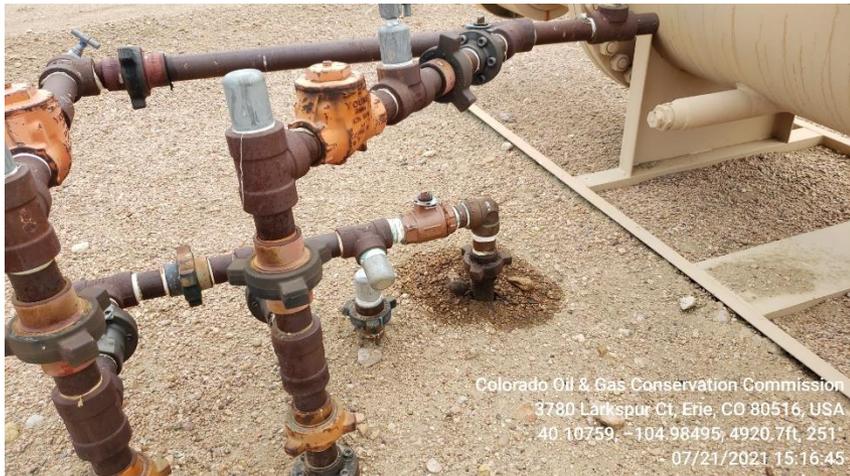
**Photo 11 Stained soil by the flow line riser at the Horiz.
Heated Sep.**

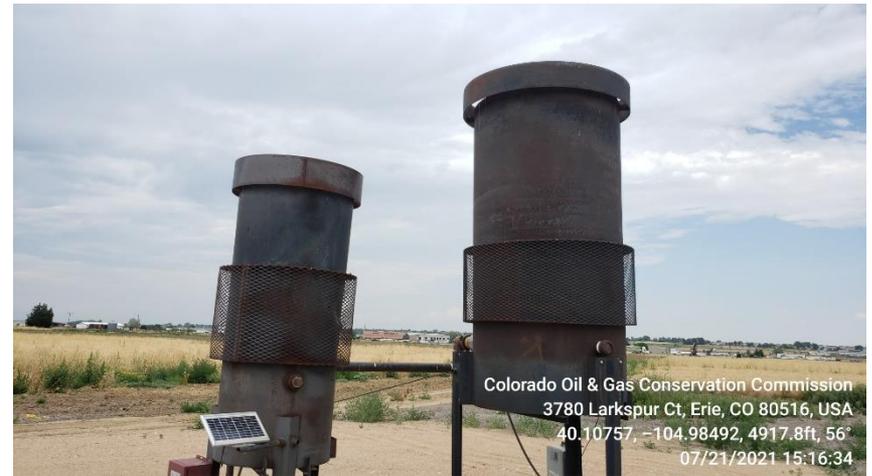
Photo 12 ECDs
