Inspection Photos

Location Name: CAERUS PICEANCE LLC SHORE-67S95W /16SWNE

Location ID: 334599

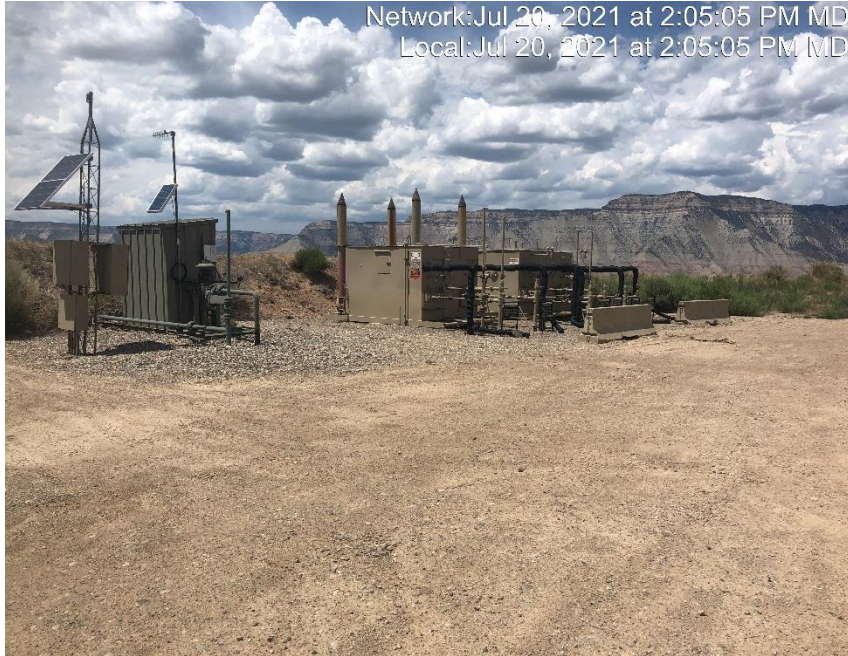
Photo #4504 from entrance to location.

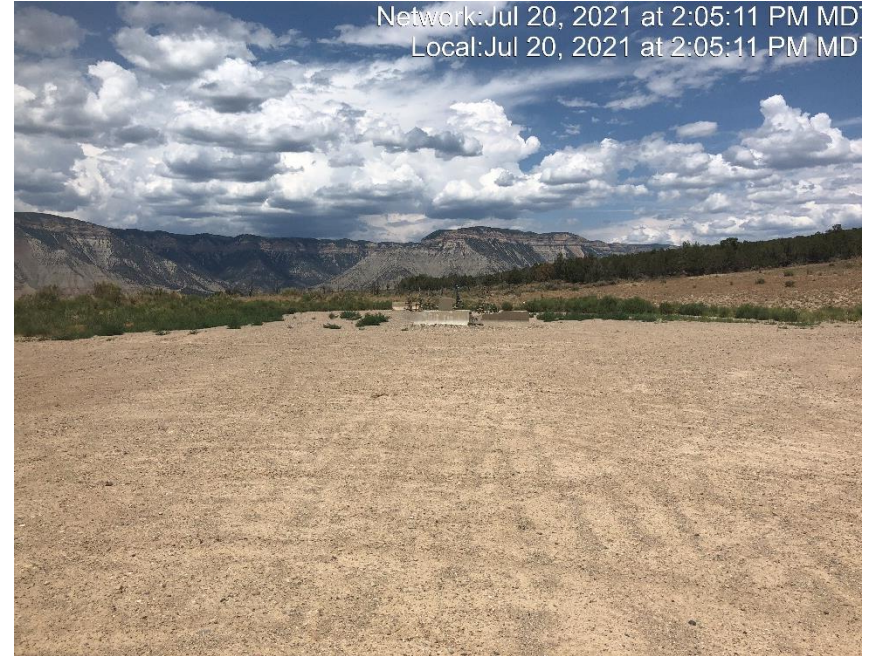
Photo #4505 from entrance to location.

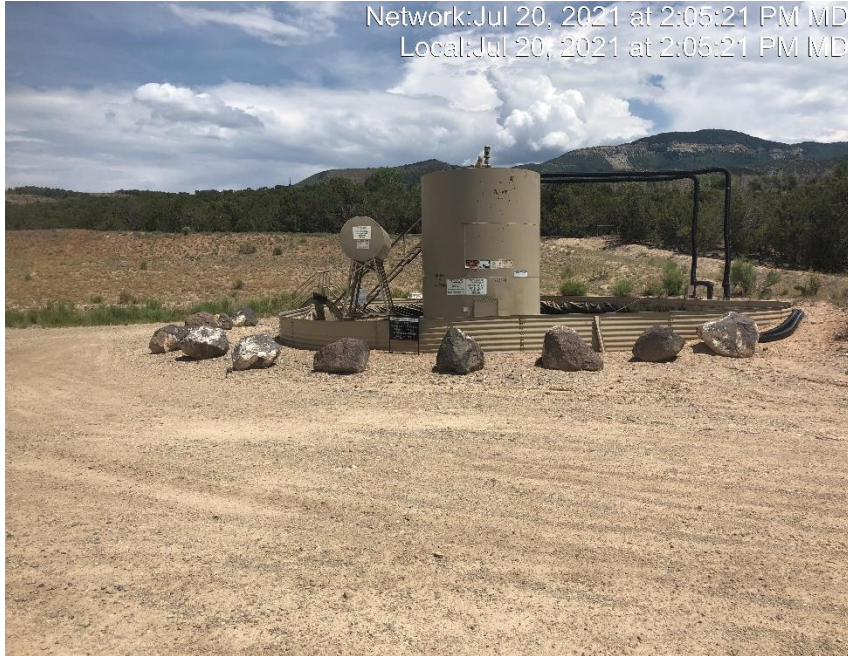
Photo #4506 from entrance to location.

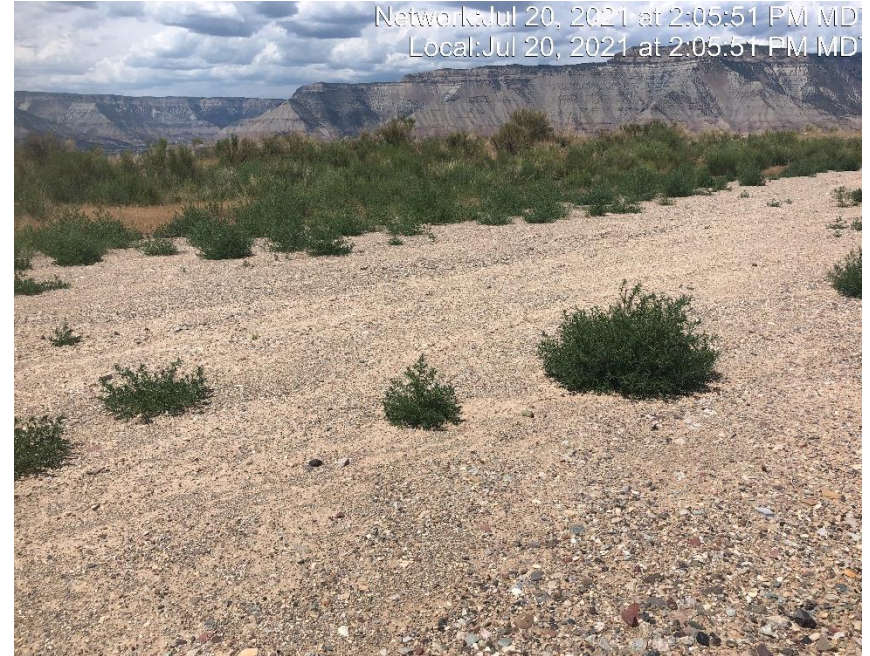
Photo #4507 Multiple places with undesirable plant species on location.

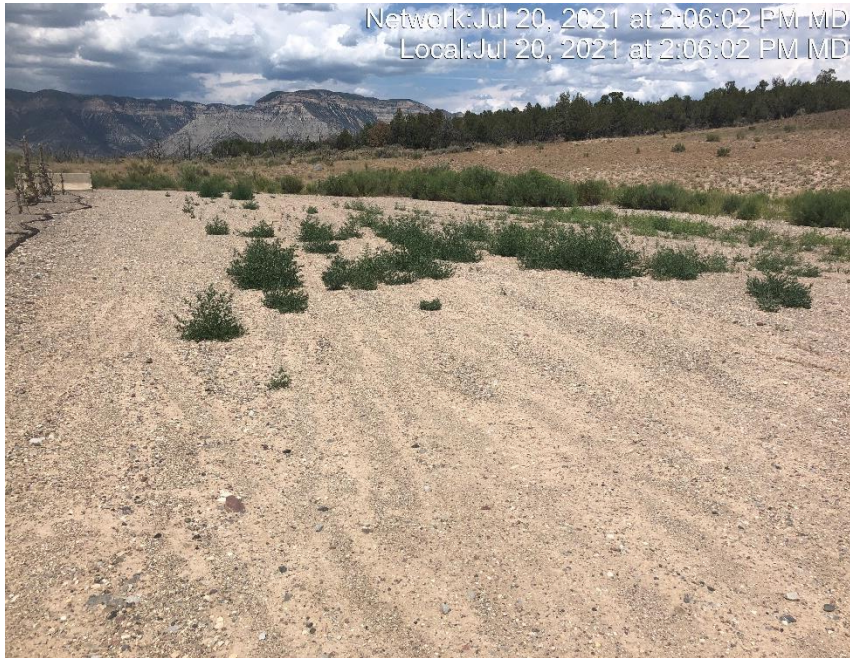
Photo #4508 Multiple places with undesirable plant species on location.

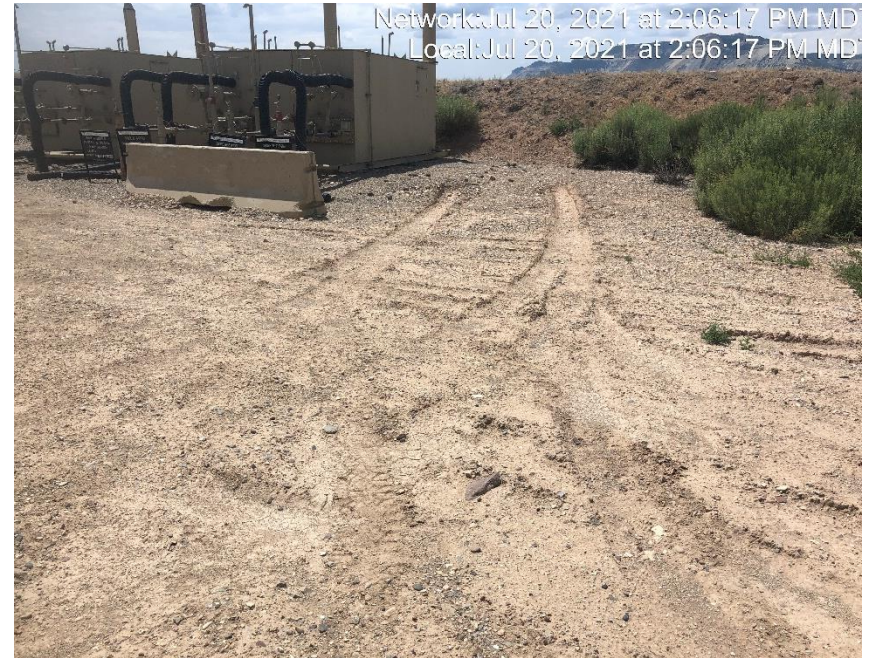
Photo #4509 location lacks stabilization.

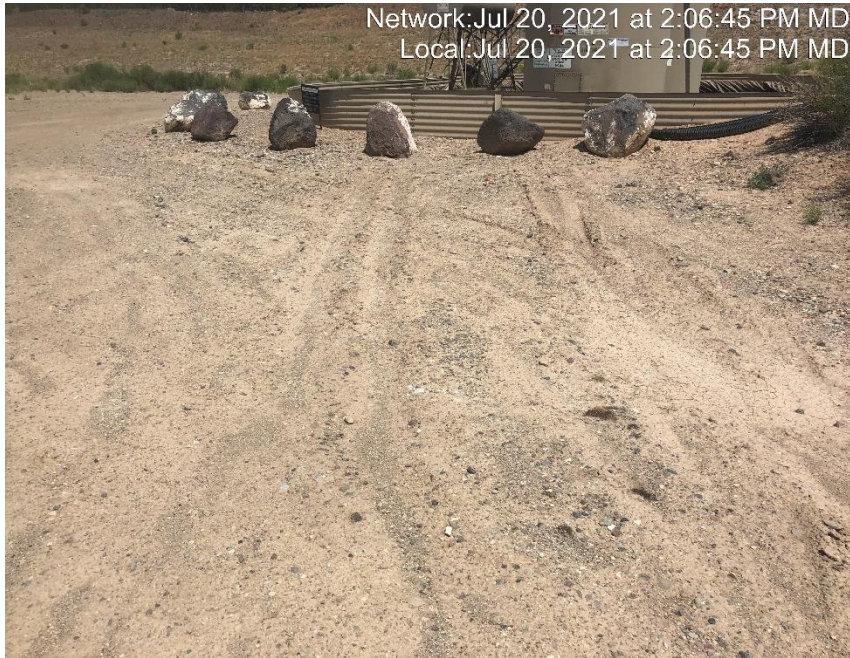
Photo #4510 location lacks stabilization.

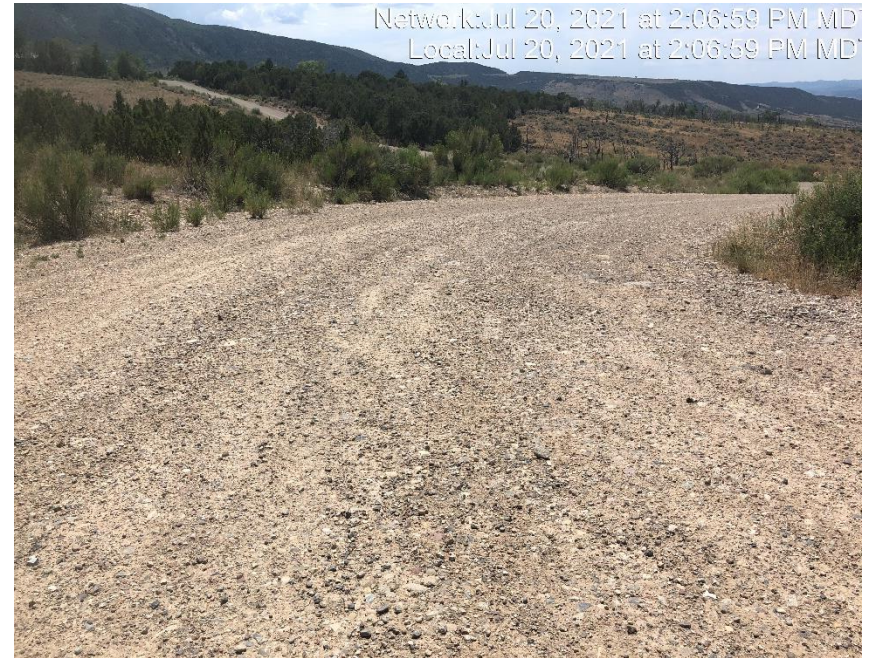
Photo #4511 no form of tracking BMP located at the entrance to location.
