## Inspection Photos

Location Name: CAERUS PICEANCE LLC GARDNER-67S95W /16NWSW

Location ID: 335025

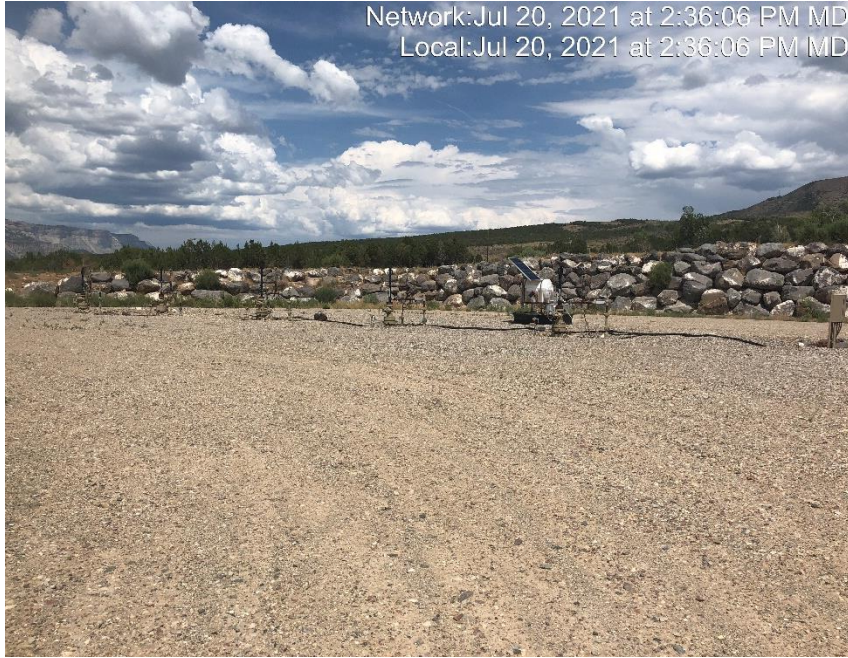
**Photo #4512 from entrance to location.**

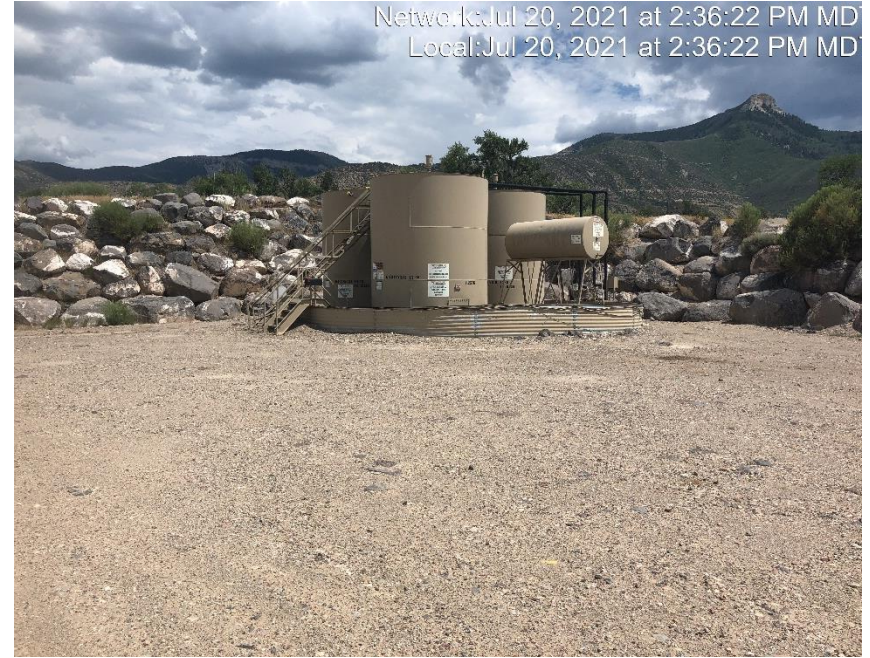
**Photo #4513 No battery sign located at the tank battery.**

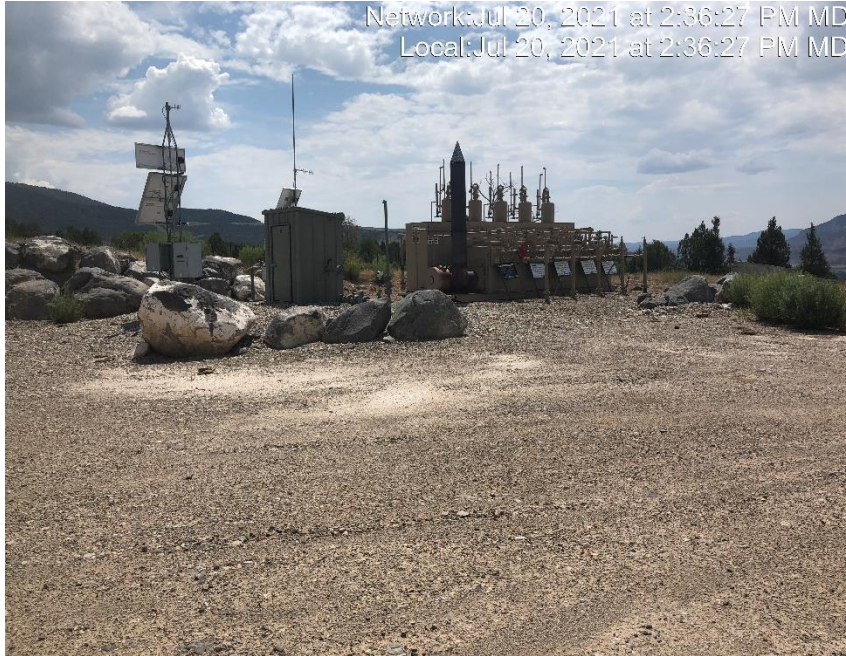
Photo #4514 from entrance to location.

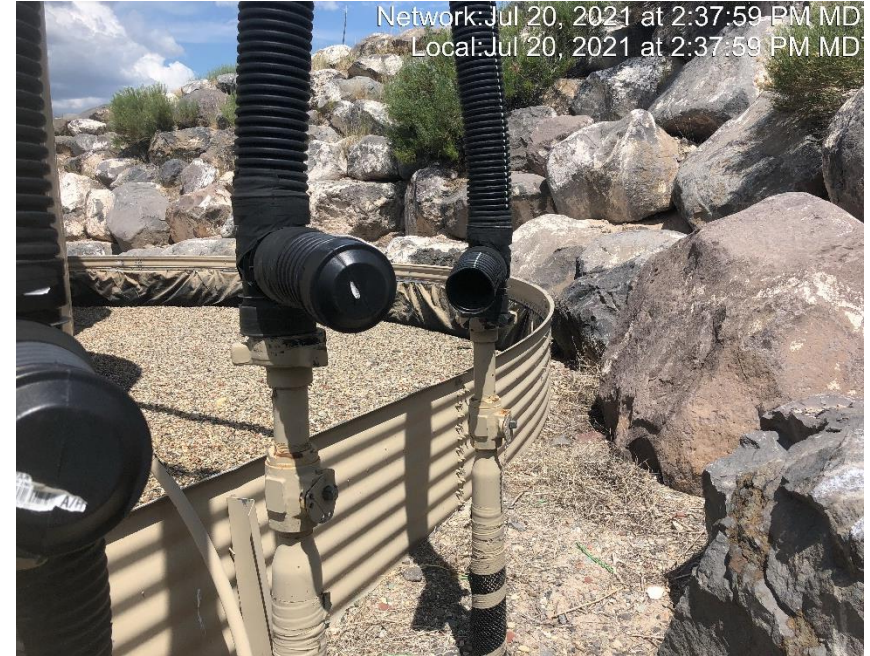
Photo #4515 Flow line heating insulation open ended and not capped.

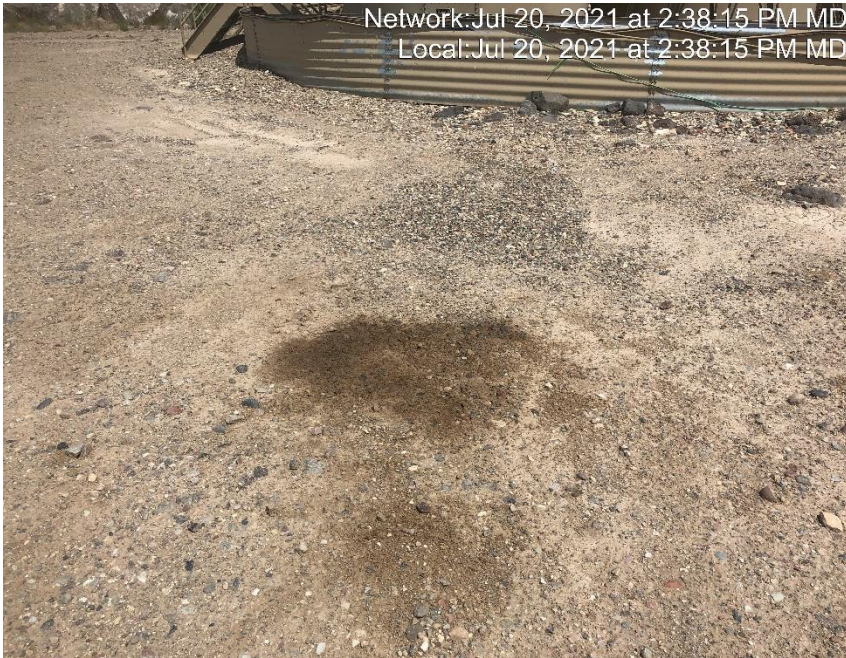
**Photo #4516 Stained soils outside of containment.**
