July 16, 2021

**Subject: Report of Work Completed
 Tank Battery Manway Release
 Parachute Creek 10 (PC-10)
 North Parachute Ranch (NPR)
 Garfield County, Colorado**

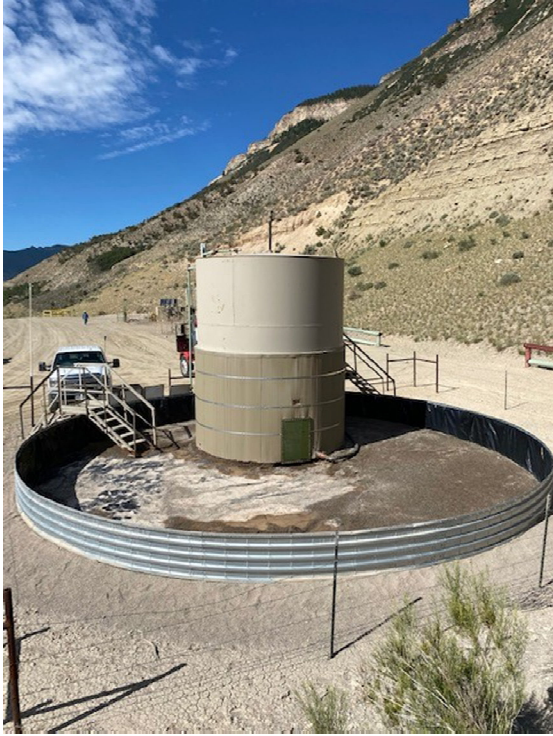
1	July 1, 2021	
Tank battery secondary containment overview with replaced manway cover; View south

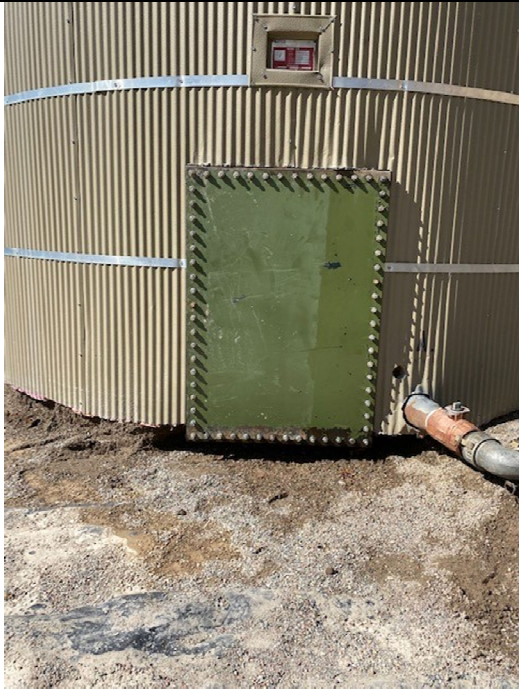
2	July 1, 2021	
Tank battery and replaced manway cover; View south

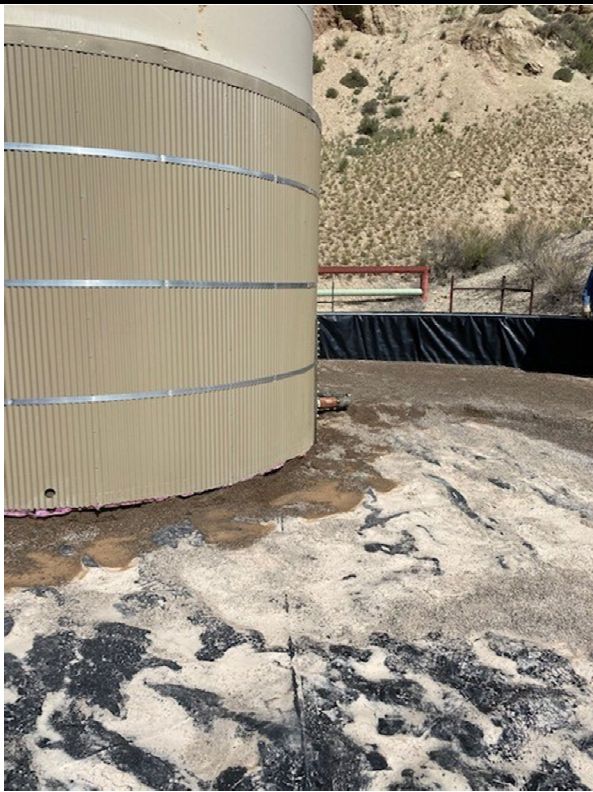
Photo No.	Date	
4	July 1, 2021	
Tank battery secondary containment liner integrity inspection; View west

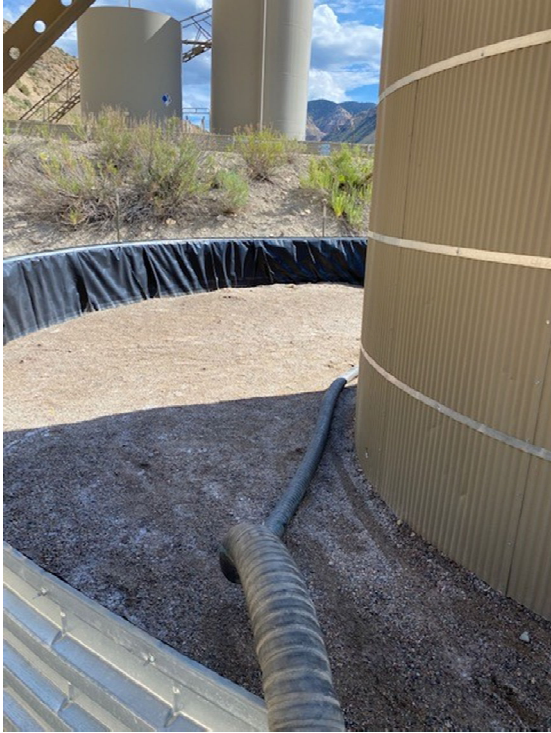
Photo No.	Date	
5	July 1, 2021	
Tank battery secondary containment liner integrity inspection with graveled surface; View north
