**Inspection Photos**  
**Location Name: W. Animas Wheeler #8-1**  
**API: 05-067-07841**

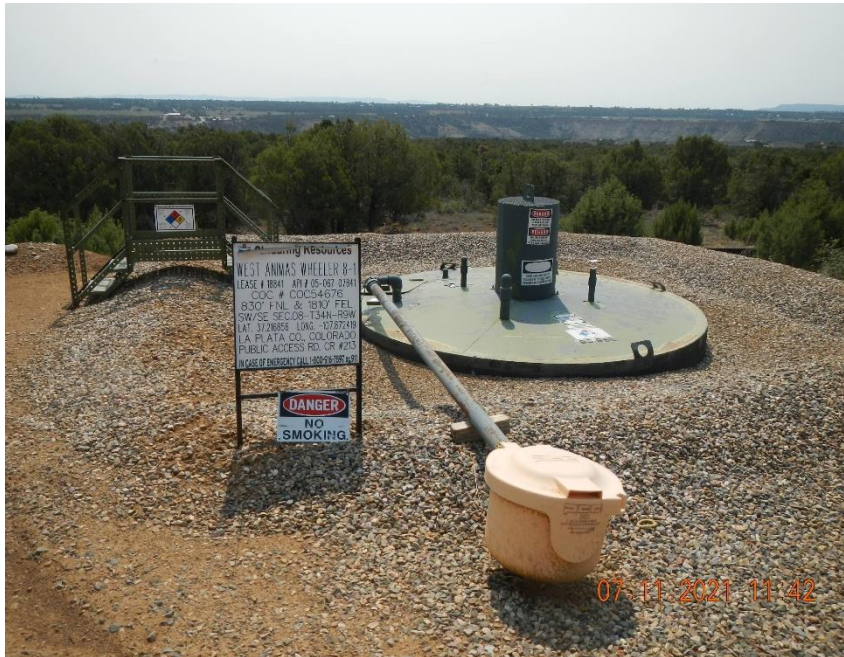
**W. Animas Wheeler #8-1 produced water PBV.**

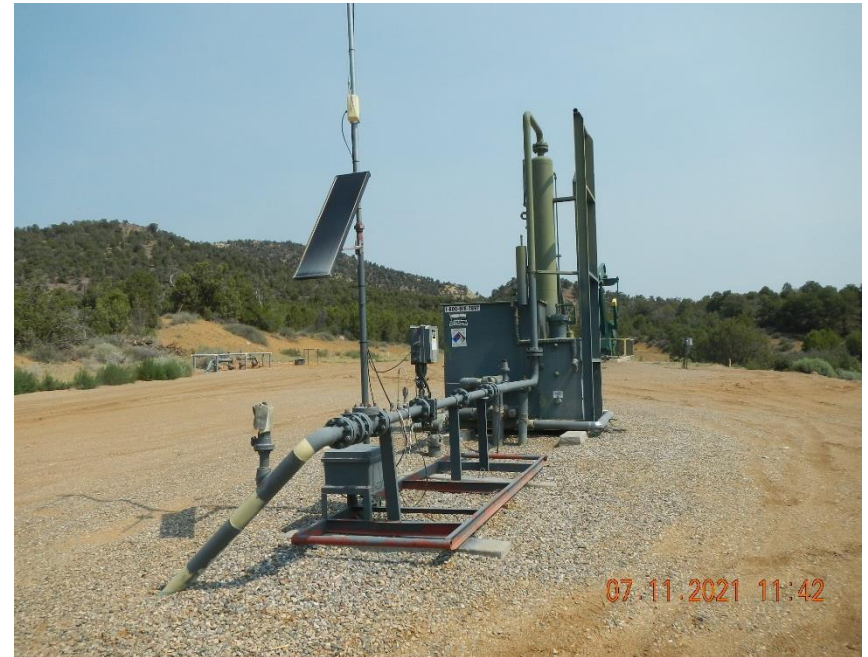
**W. Animas Wheeler #8-1 production equipment.**

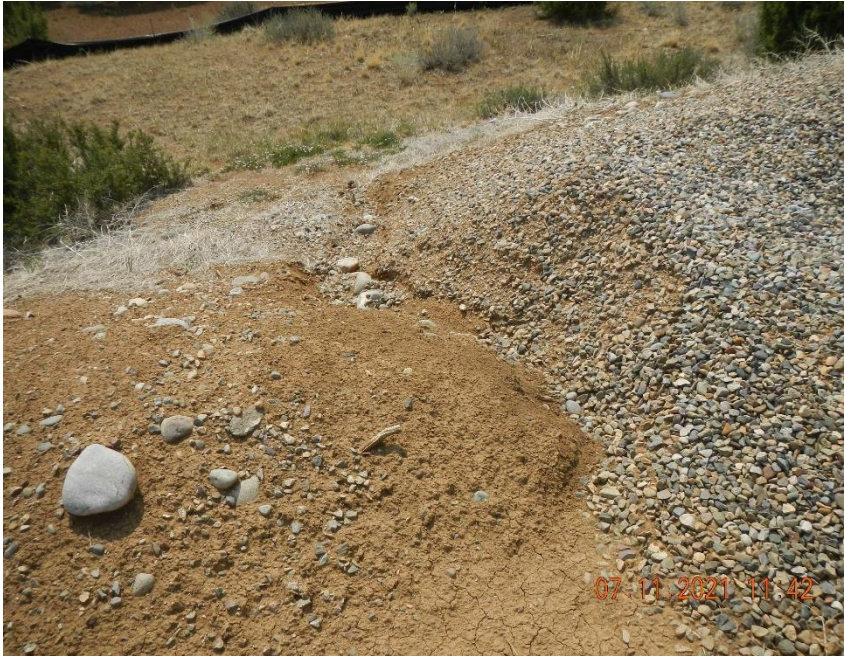
**Erosion along eastern edge of location.**

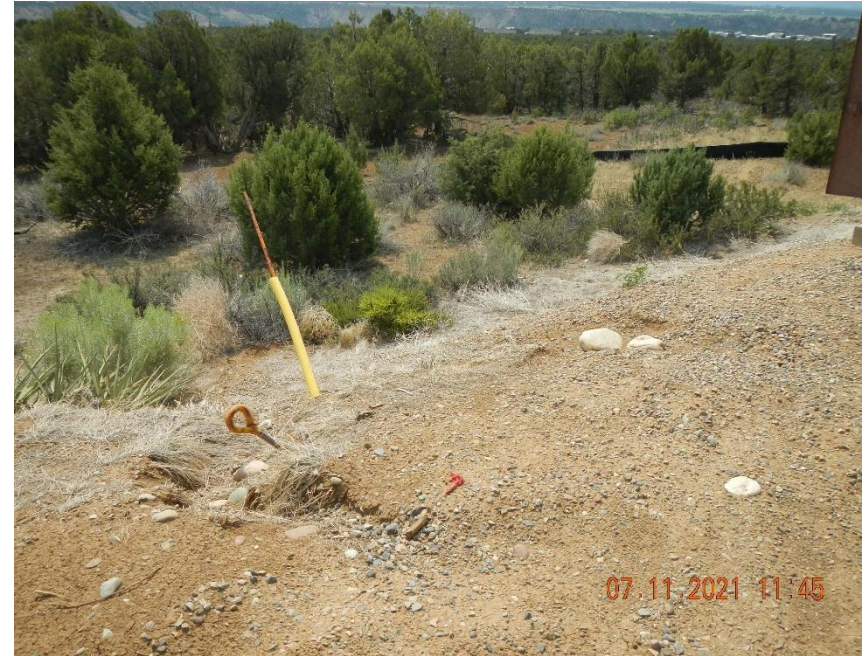
**Erosional channel along eastern edge of location.**

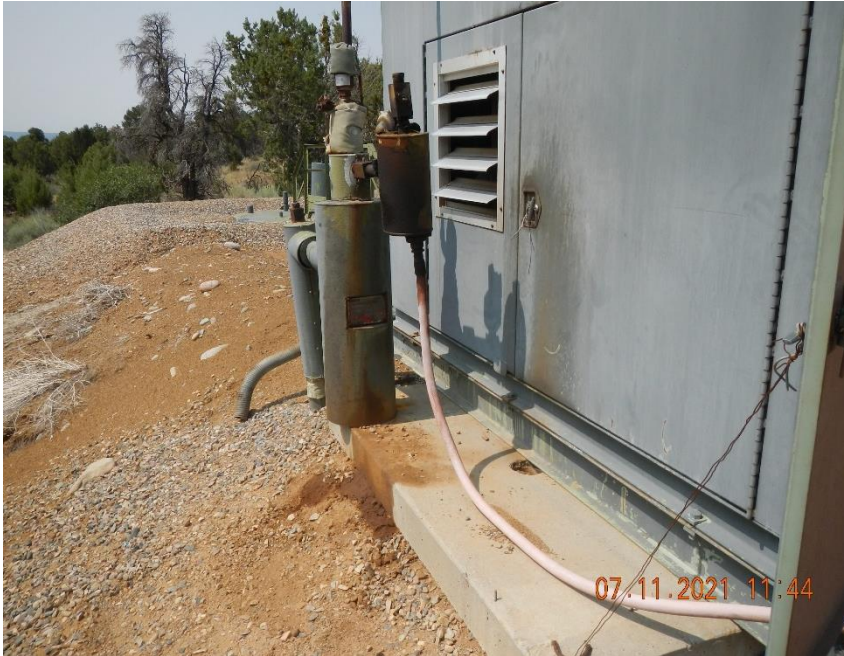
**Staining near generator.**

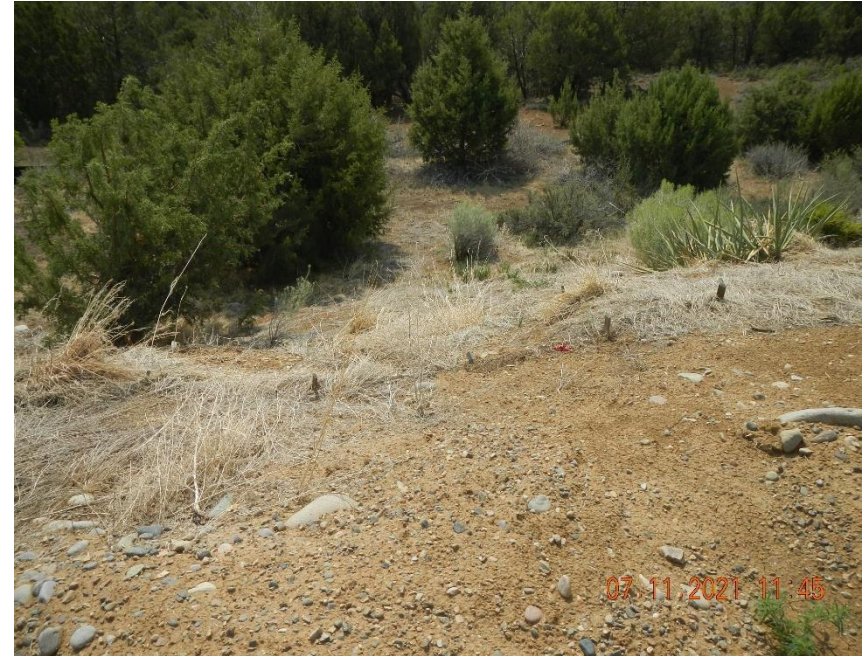
**Wattles along eastern edge require maintenance.**
