Inspection Photos
Operator: Enduring
API: 067-08489
Date: 7/20/2021

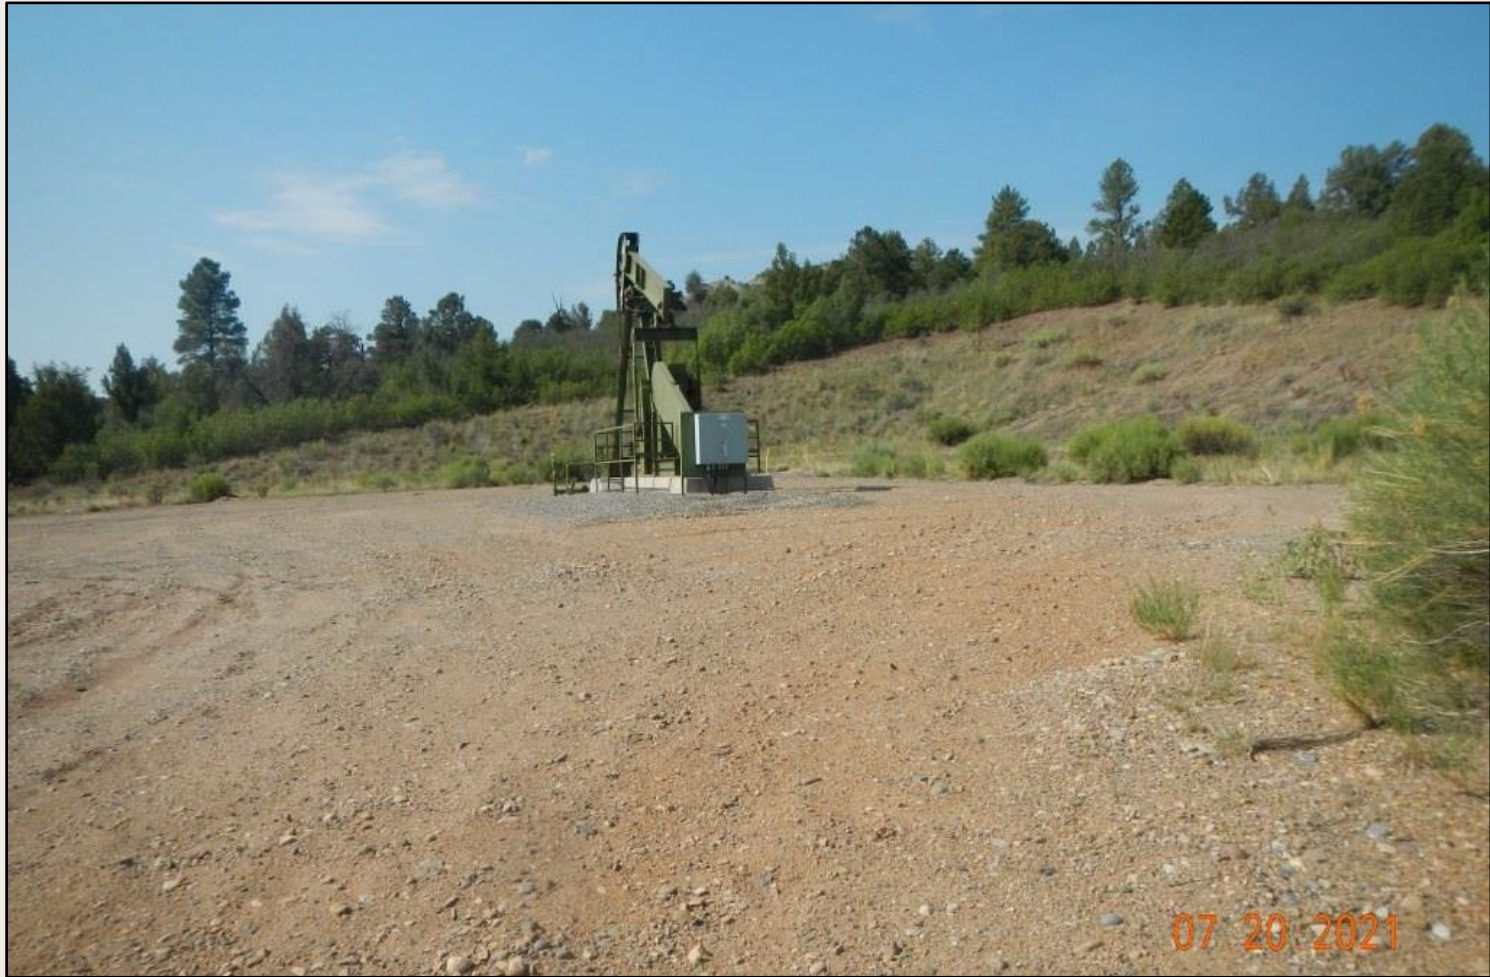
Photo 1. View the project area from the well pad entrance facing center.

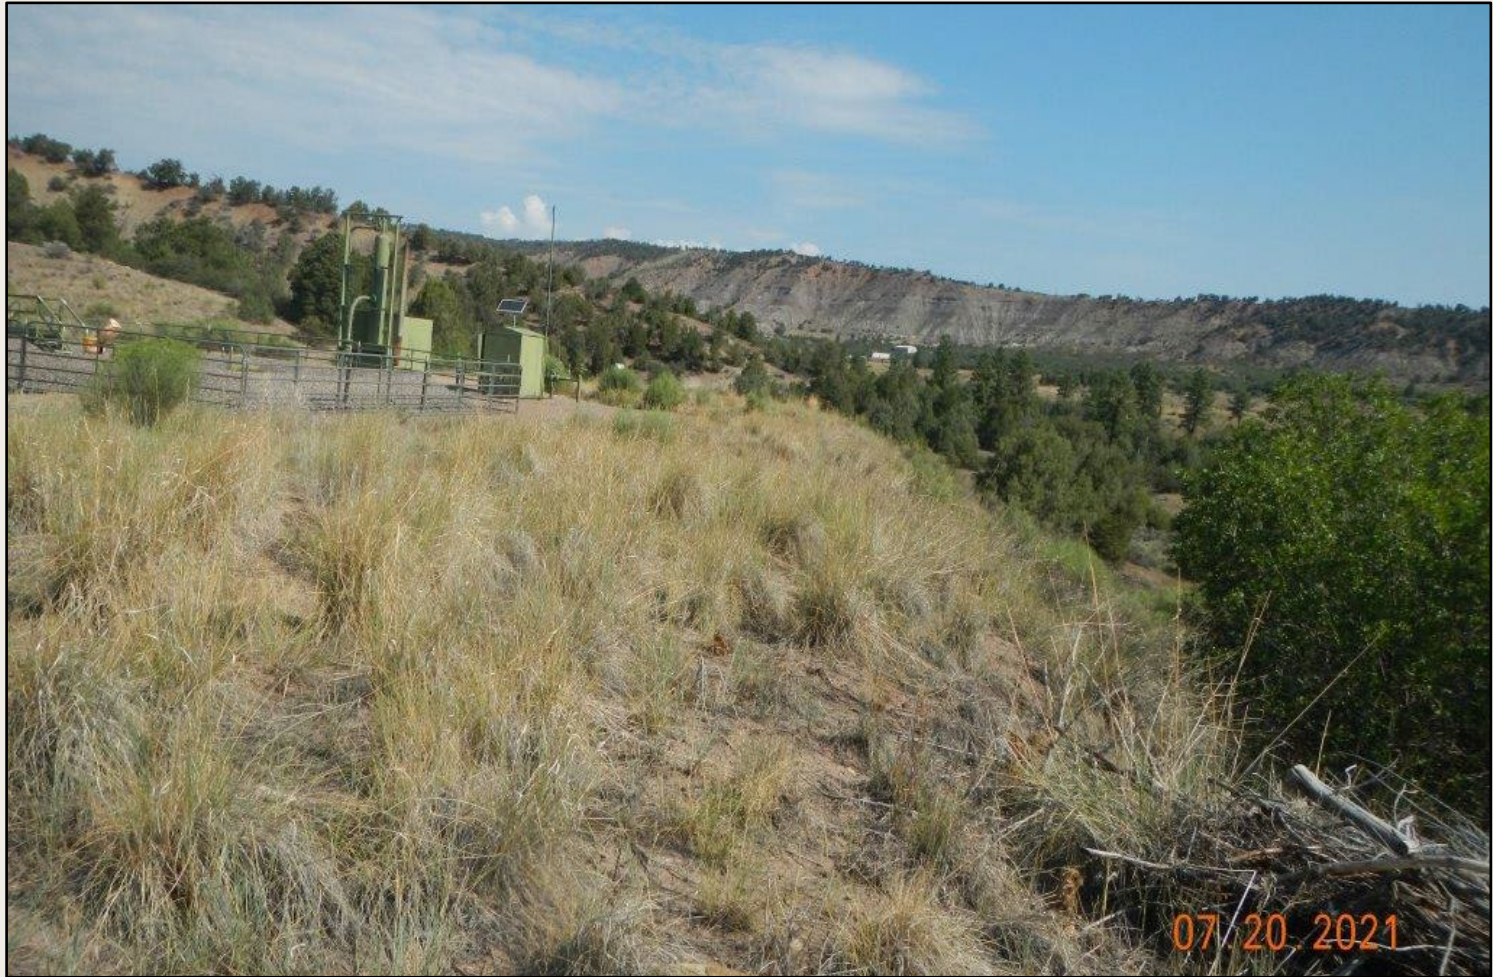
Photo 2. View of the northern project area from the northeastern corner facing westward. Revegetation is progressing with crested wheatgrass, intermediate wheatgrass, and crested wheatgrass.

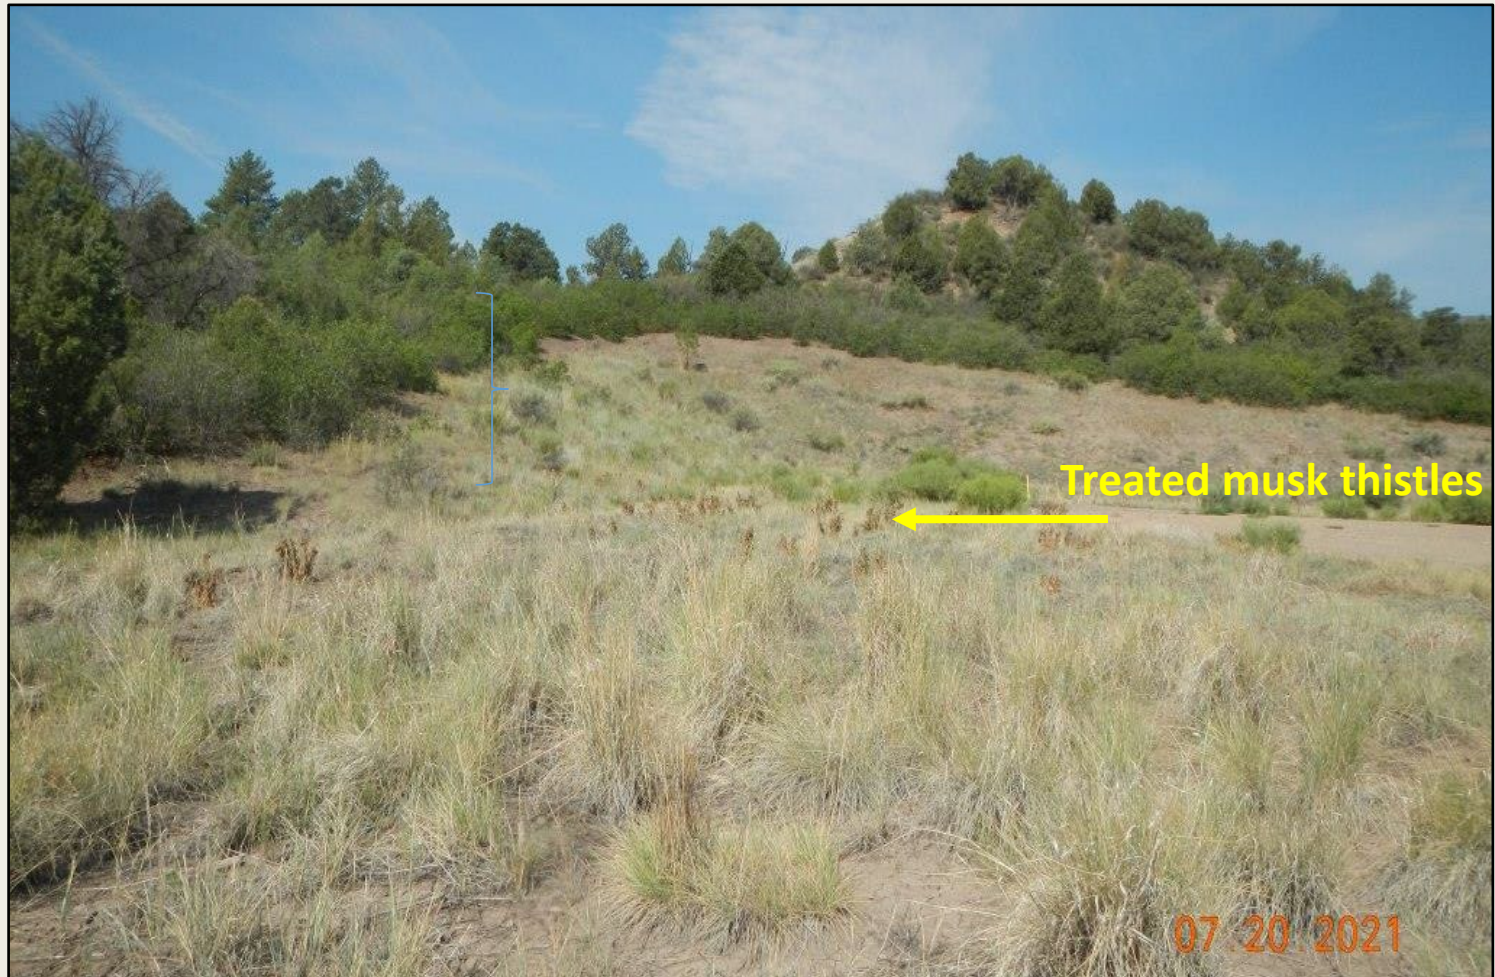
Photo 3. View of the eastern project area from the northeastern corner facing southward. Approximately 300 treated musk thistles observed.

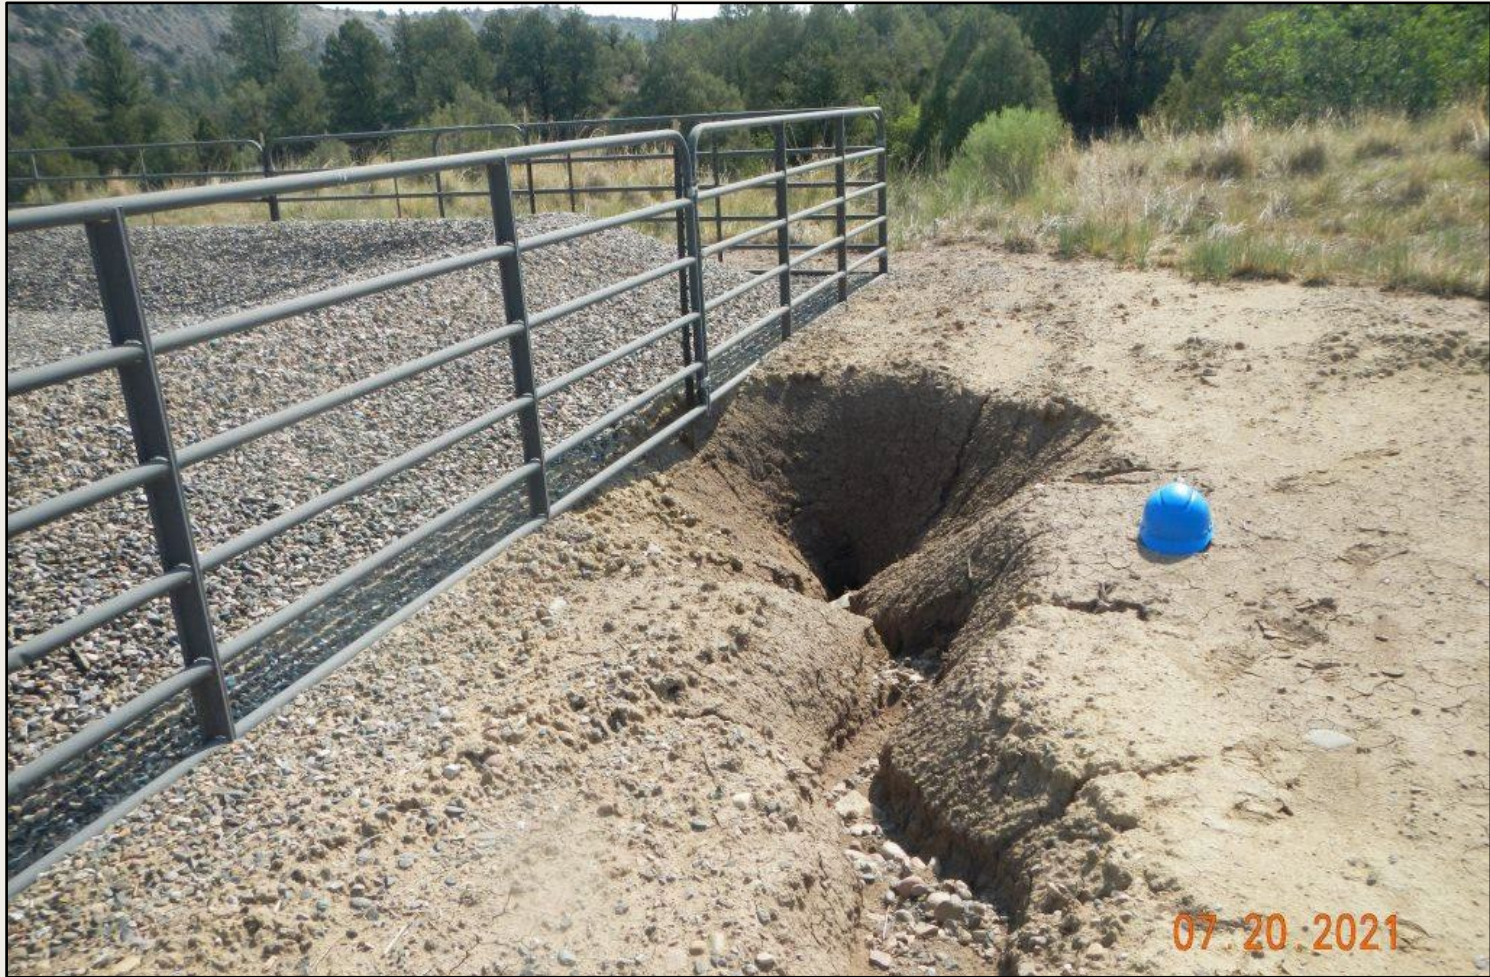
Photo 4. View of erosional tunnel in the northern project area approximately 3 feet wide (depth unknown).
