Inspection Photos
Operator: Benson Montin Greer
API: 067-06135
Date: 7/20/2021

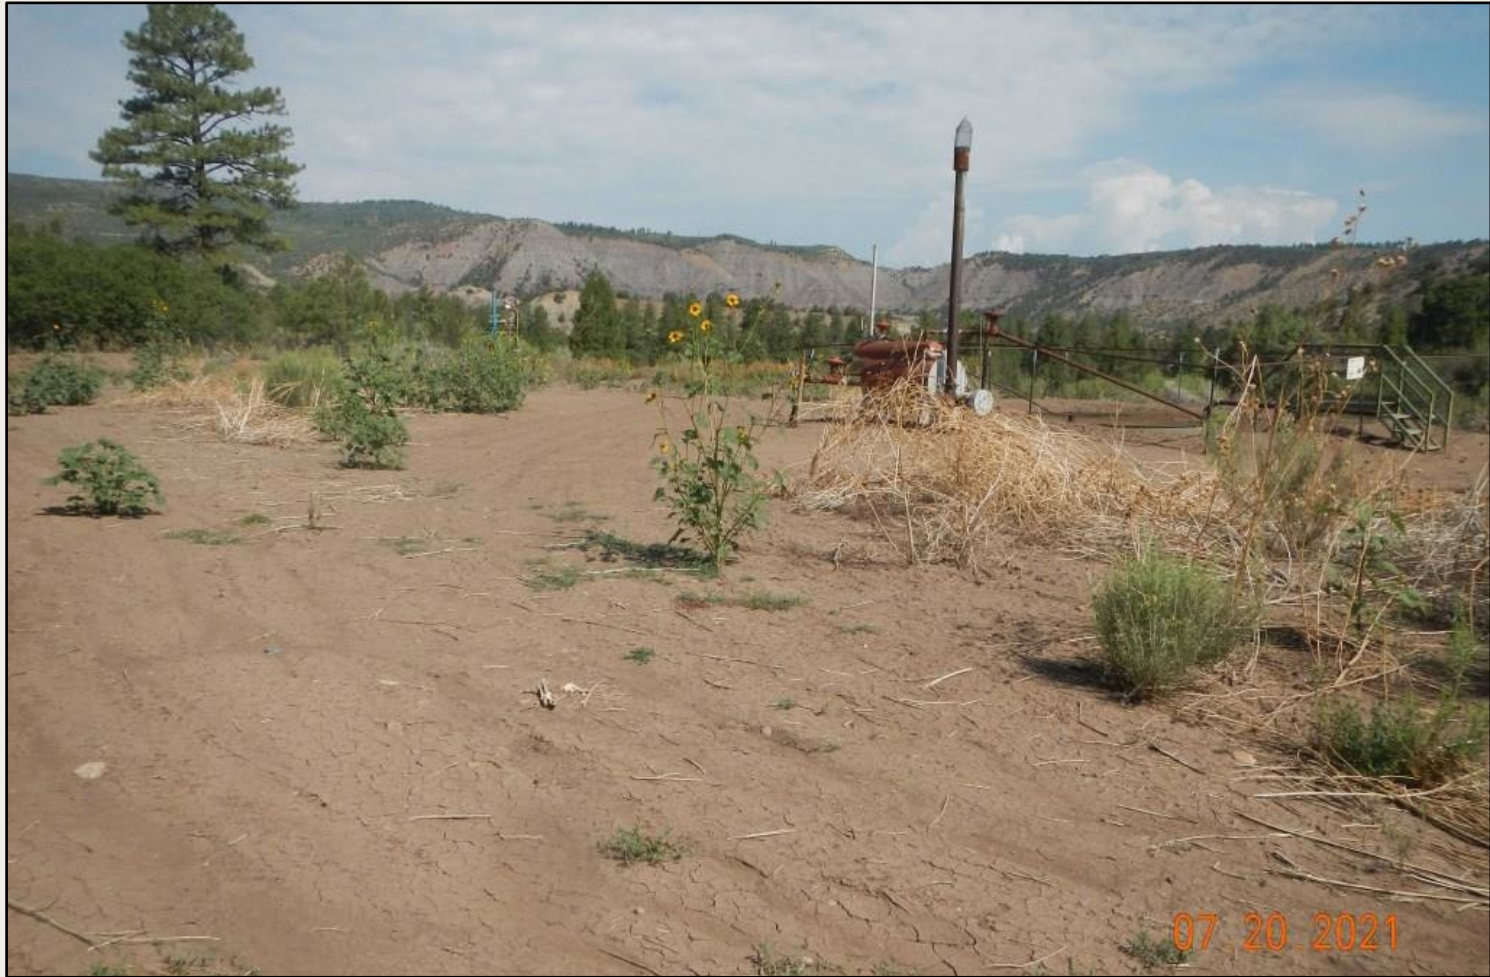
Photo 1. View the project area from the well pad entrance facing center.

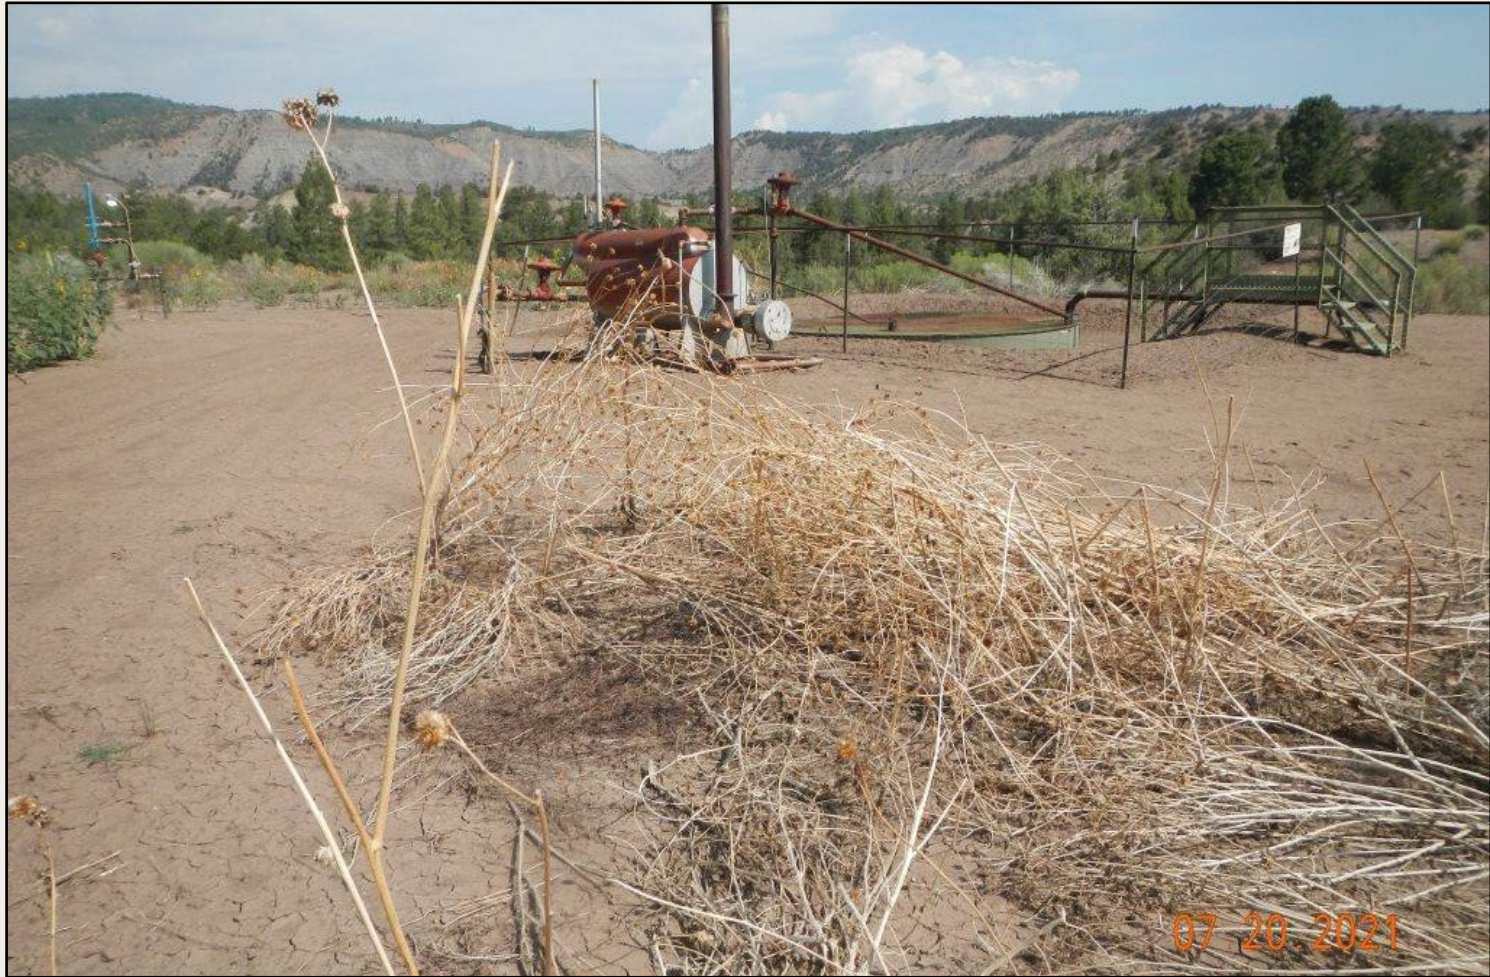
Photo 2. View of weed debris within the project area, needs to be removed.

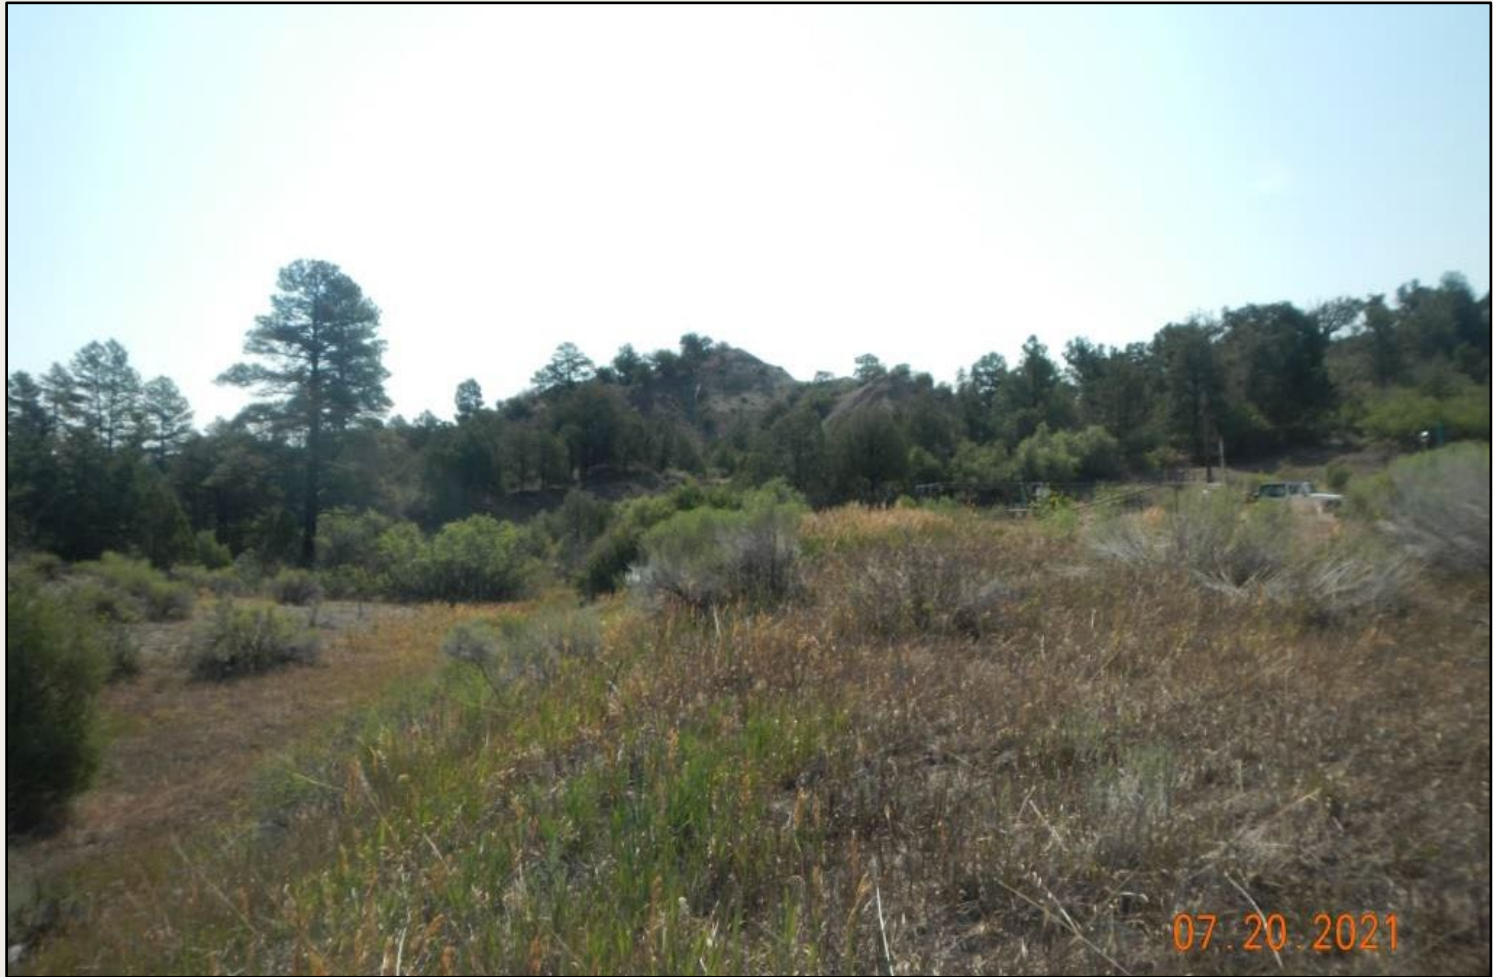
Photo 3. View of the northern fill slope from the northwestern corner facing eastward. Revegetation is progressing with smooth brome, Indian ricegrass, and rubber rabbitbrush.

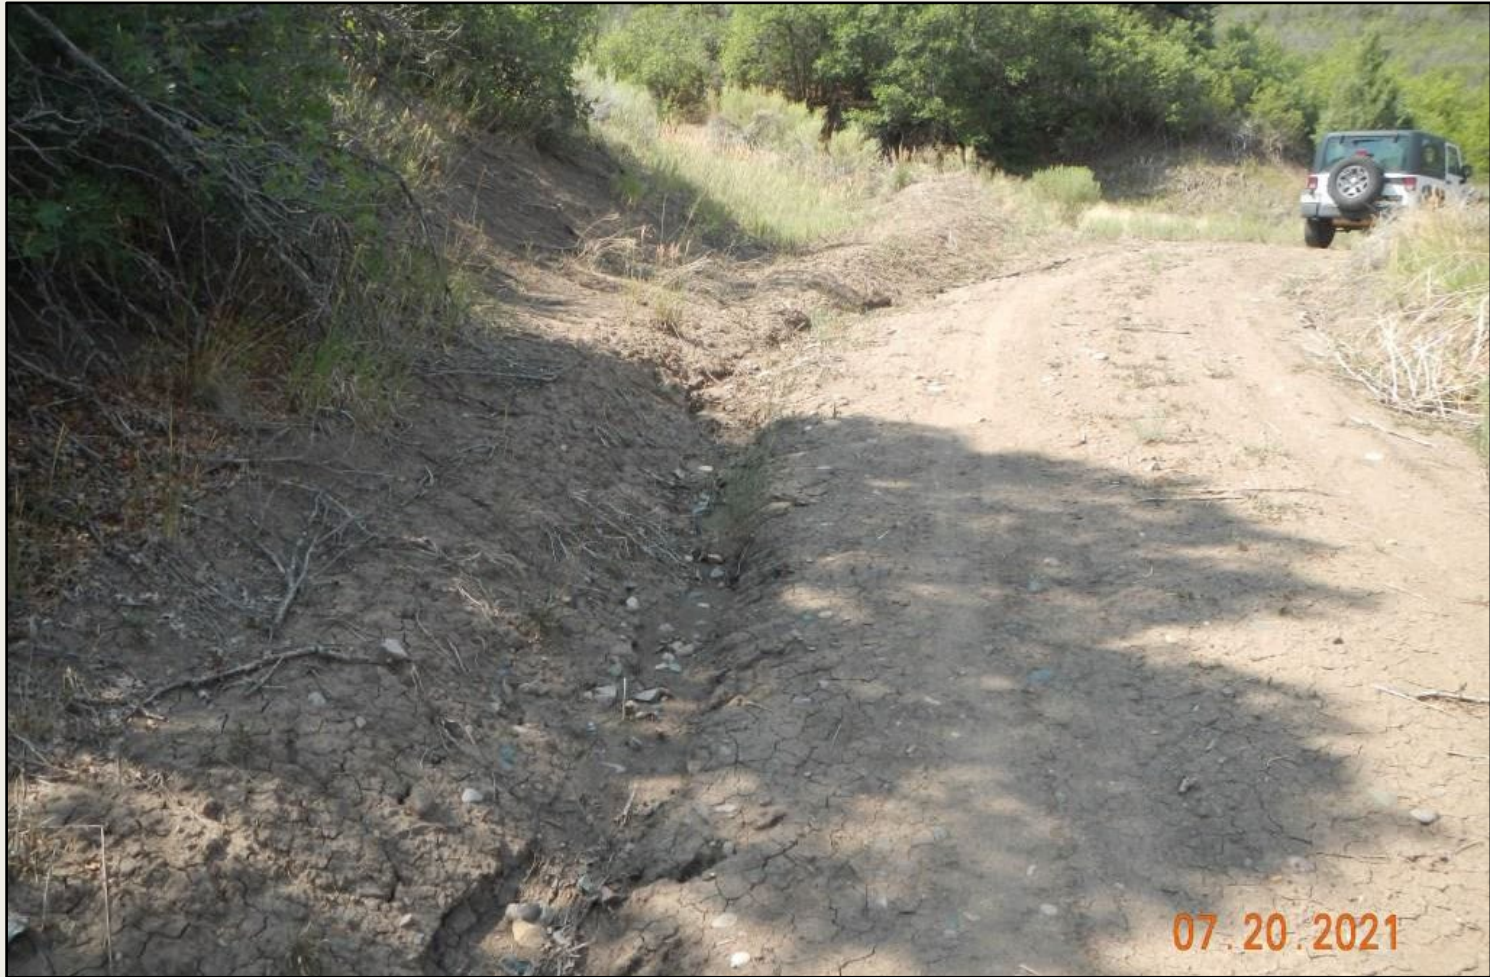
Photo 4. View of erosional channeling (approx. 12 inches wide and 4-6 inches deep) near the well pad entrance needing stabilization.

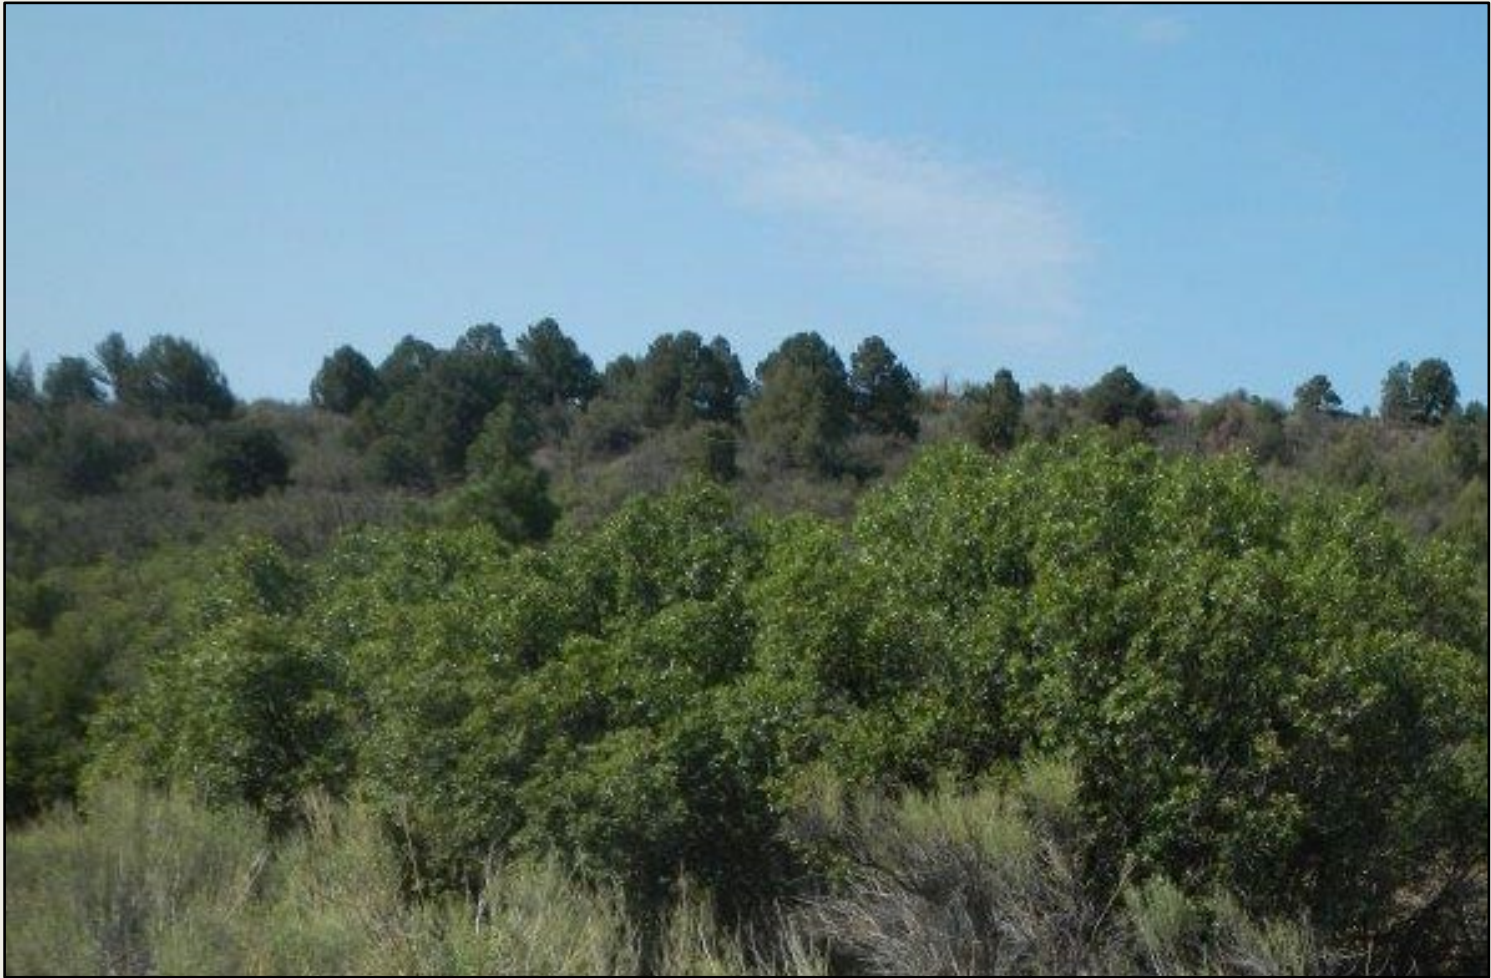
Photo 6. View the reference area comprised of gambel oak shrubland with pinyon and juniper trees and scattered ponderosa pine trees. Vegetation in the understory includes western wheatgrass, Indian ricegrass, Indian paintbrush, and goldenweed.
