Inspection Photos
Operator: Enduring
API: 067-08483
Date: 7/20/2021

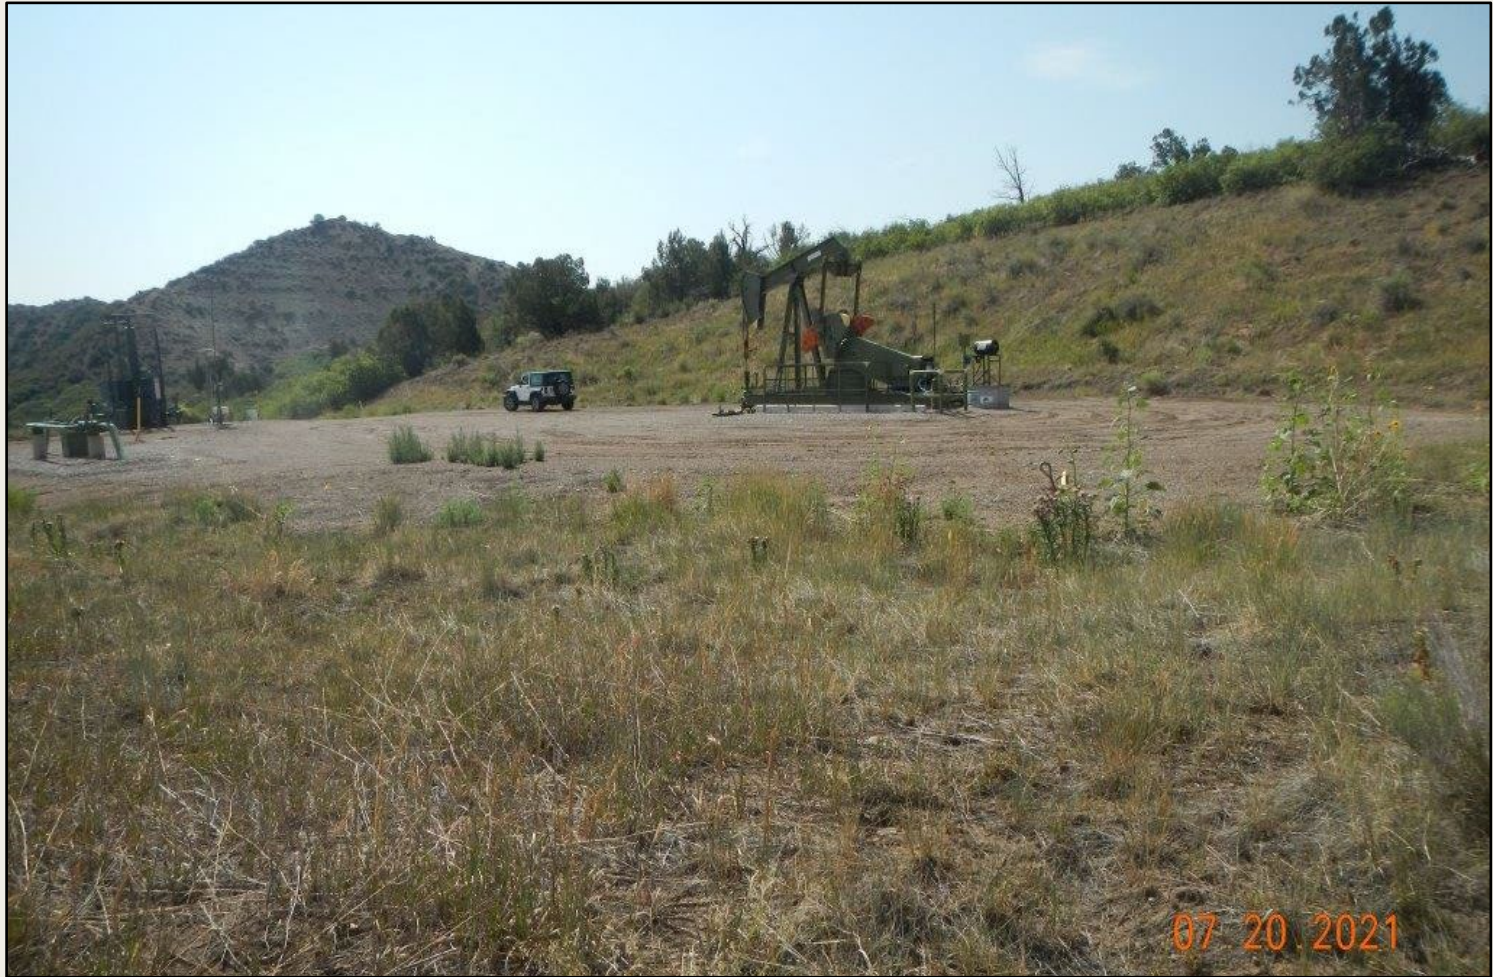
Photo 1. View the project area from the northwestern corner facing center.

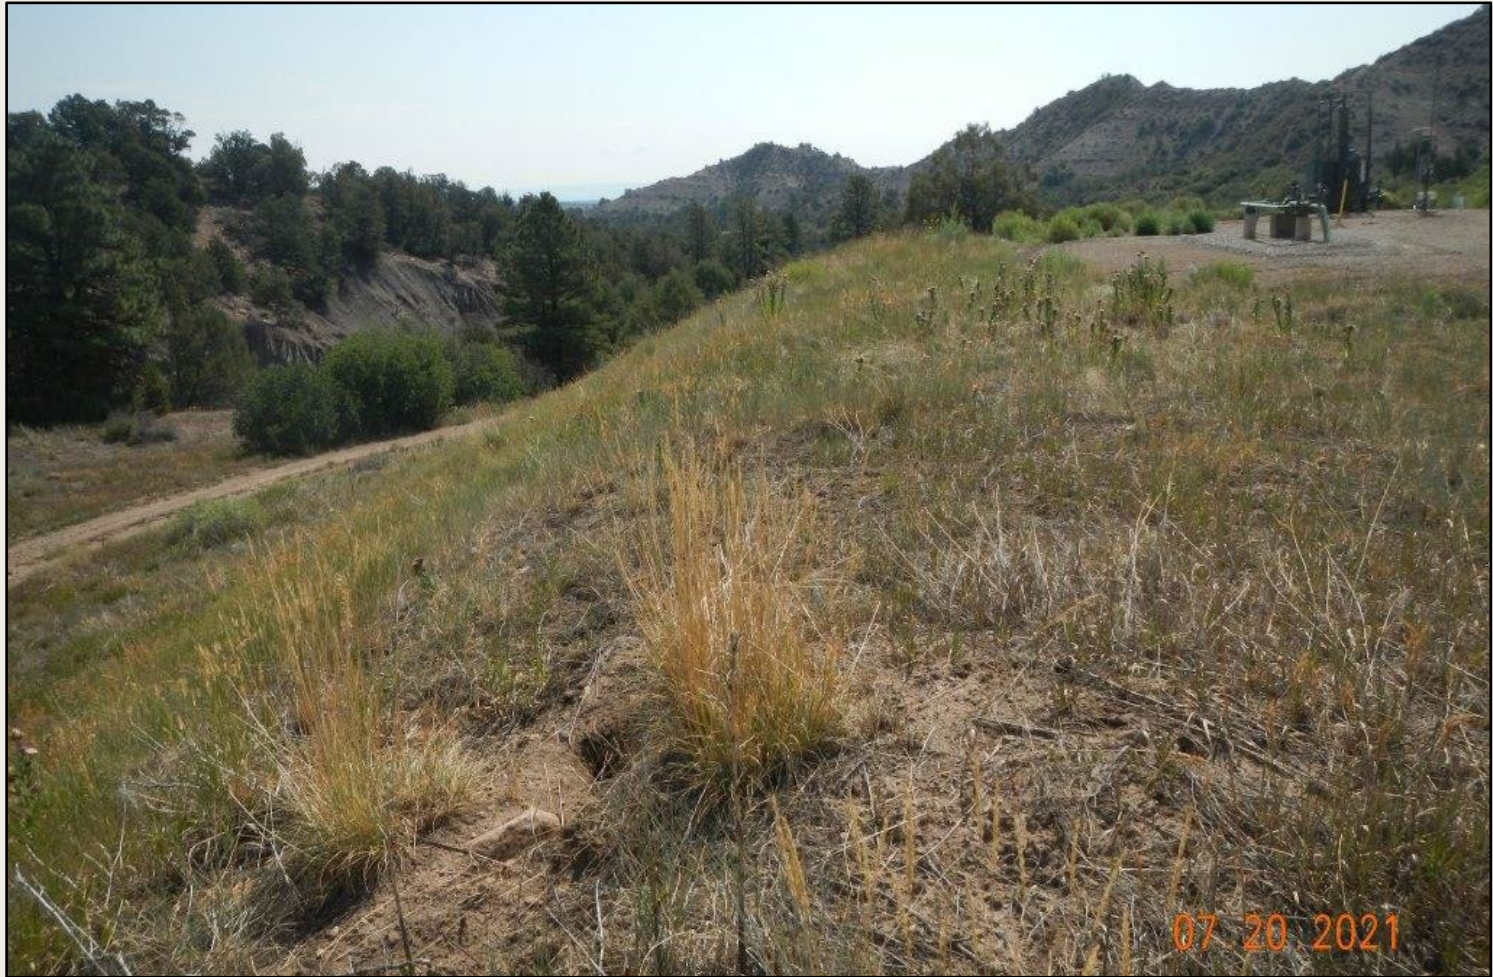
Photo 2. View of the northern project area from the northwestern corner facing eastward. Revegetation is progressing with smooth brome, crested wheatgrass, and western wheatgrass.

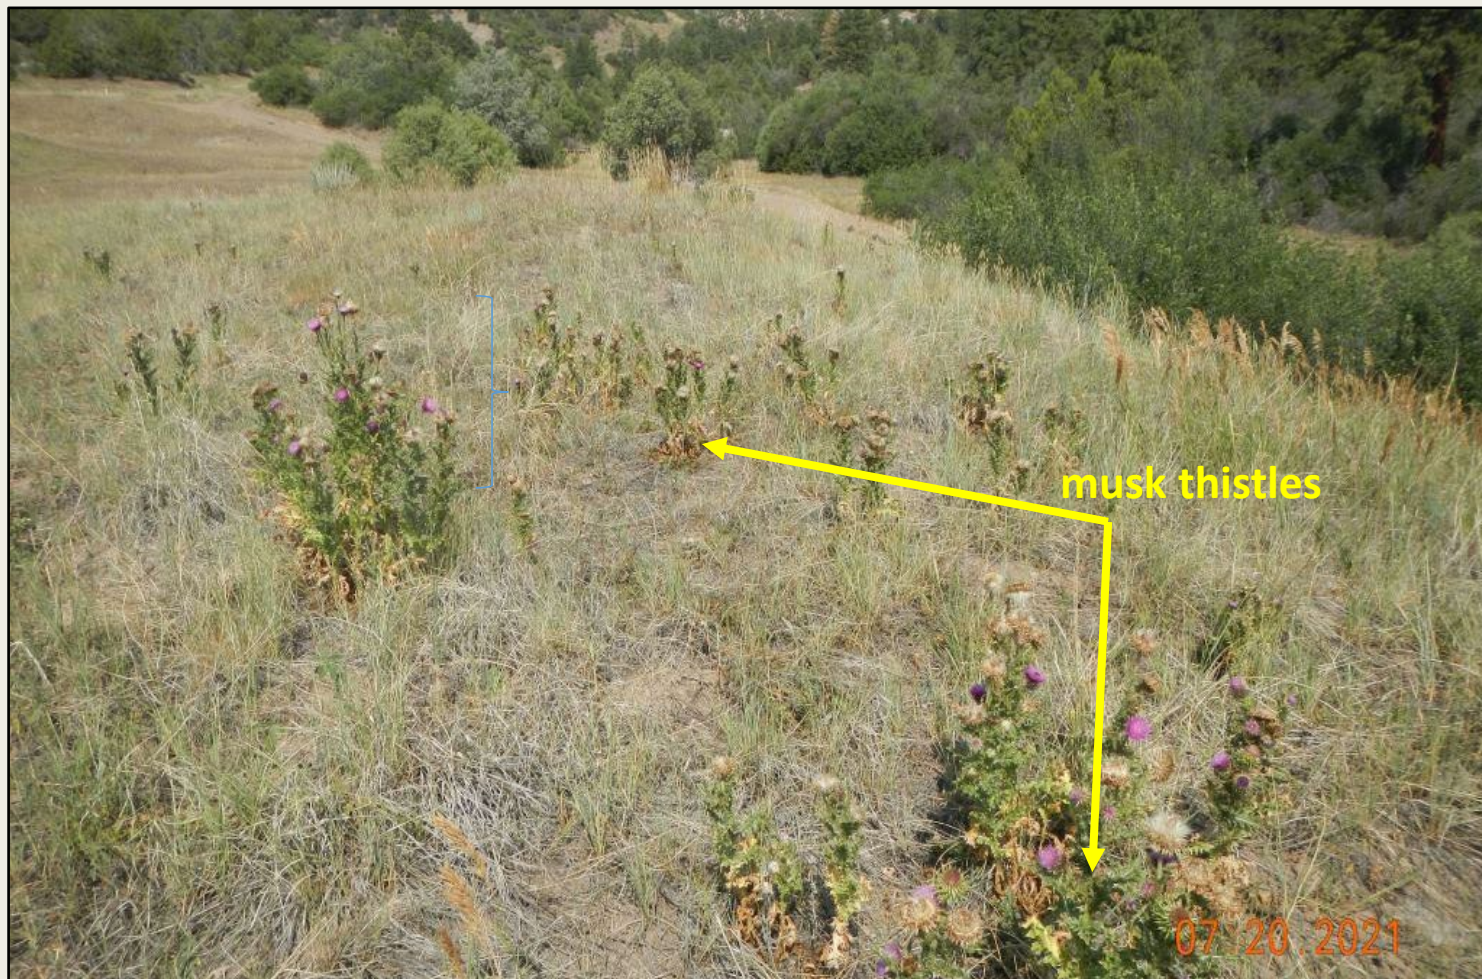
Photo 3. View of flowering musk thistles within the northern project area. Approximately 150 individuals observed.

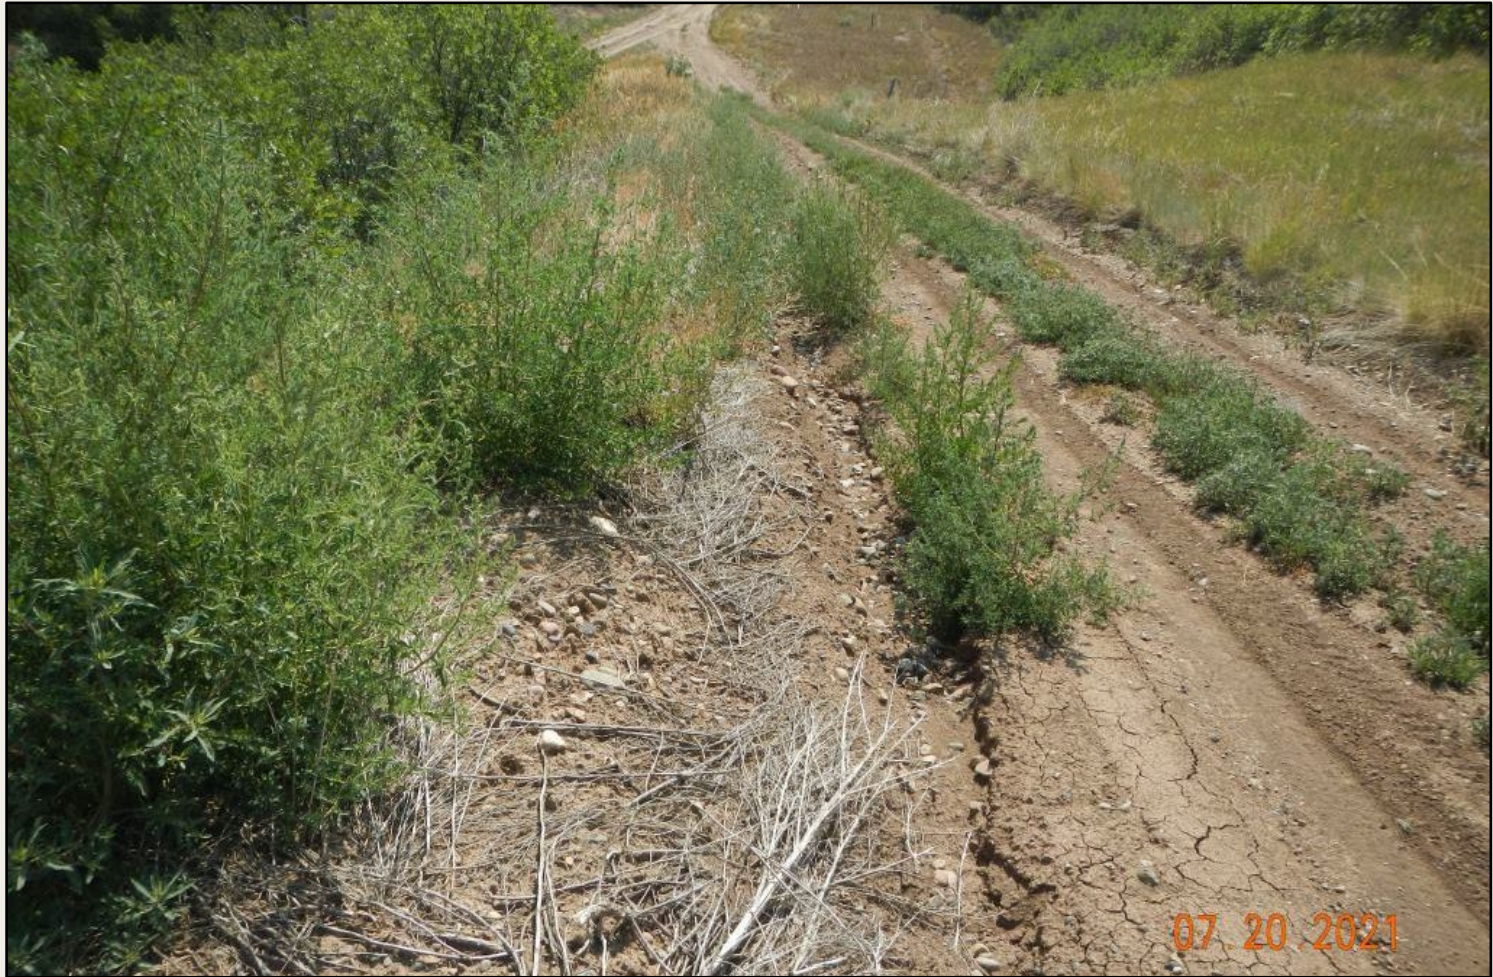
Photo 4. View of erosional channeling (approx. 12 inches wide and 4-6 inches deep) near the well pad entrance needing stabilization.

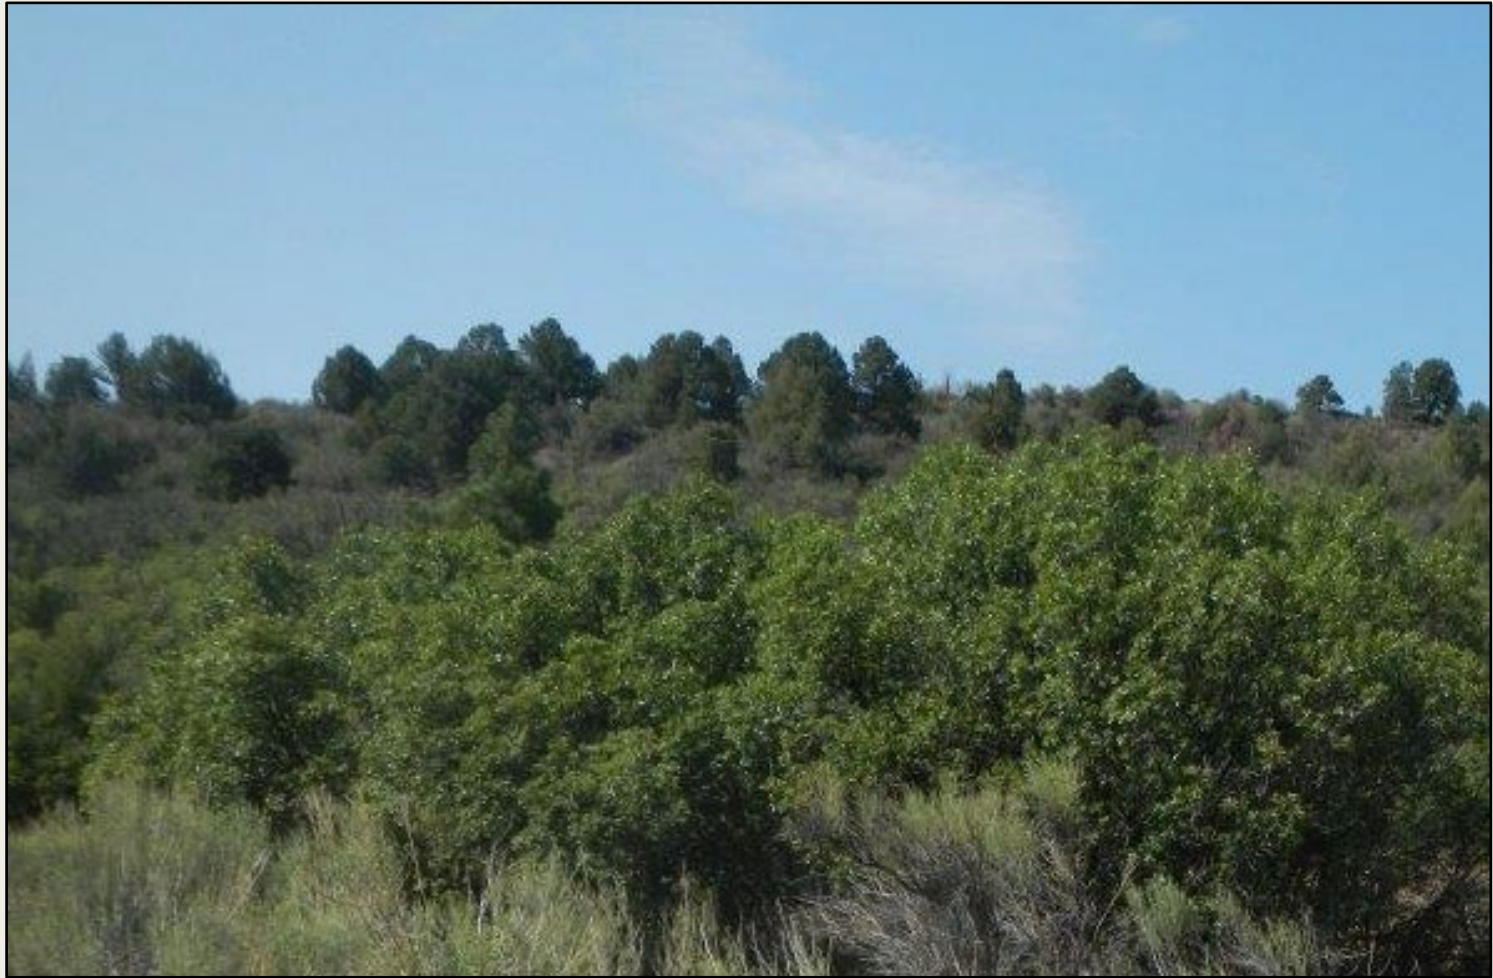
Photo 5. View the reference area comprised of gambel oak shrubland with pinyon and juniper trees and scattered ponderosa pine trees. Vegetation in the understory includes western wheatgrass, Indian ricegrass, Indian paintbrush, and goldenweed.
