Inspection Photos  
Operator: Benson Montin Greer  
API: 067-06291  
Date: 7/20/2021

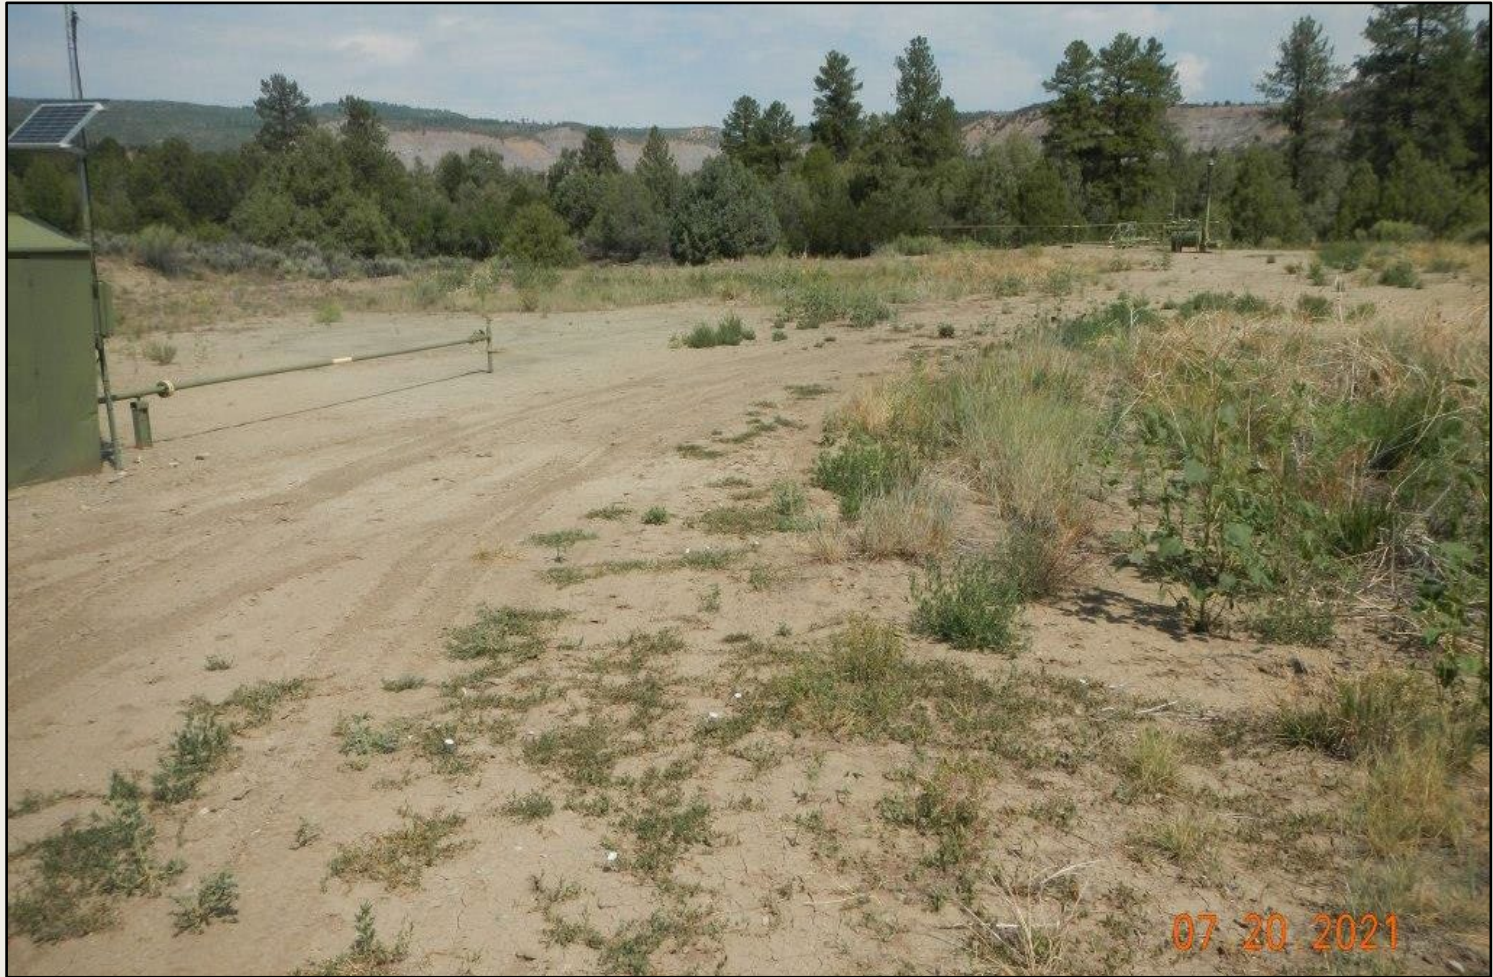
Photo 1. View the project area from the well pad entrance facing center.

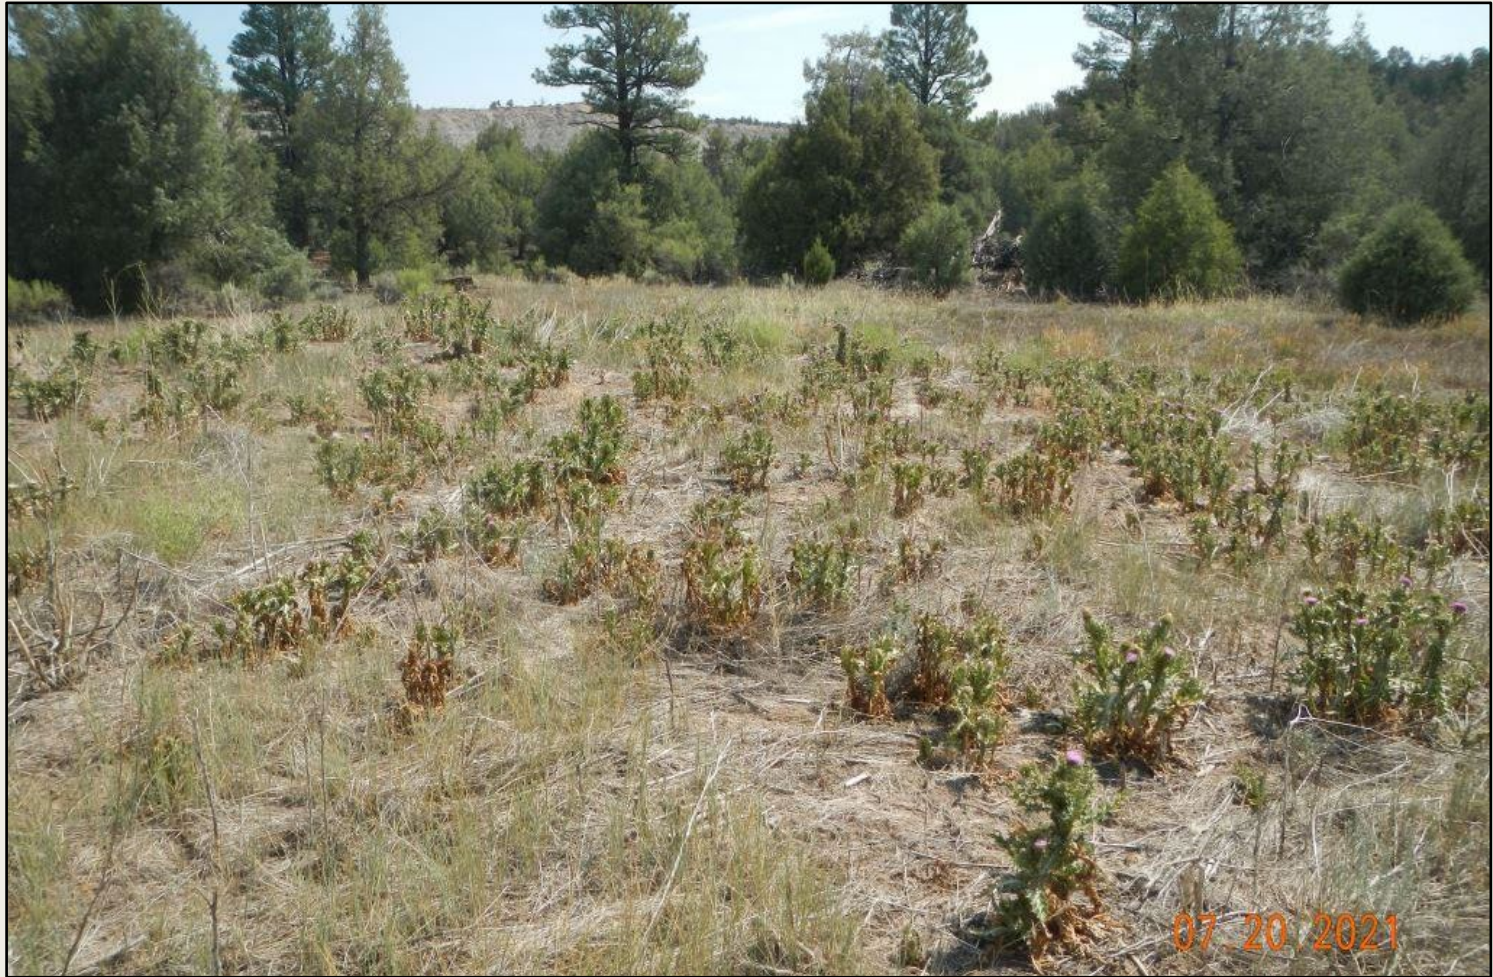
Photo 2. View the eastern project area facing eastward from the edge of the working area. Musk and Canada thistles are infesting the site. Approximately 500 individuals observed. Vegetation such as western wheatgrass, Indian ricegrass, and crested wheatgrass observed.

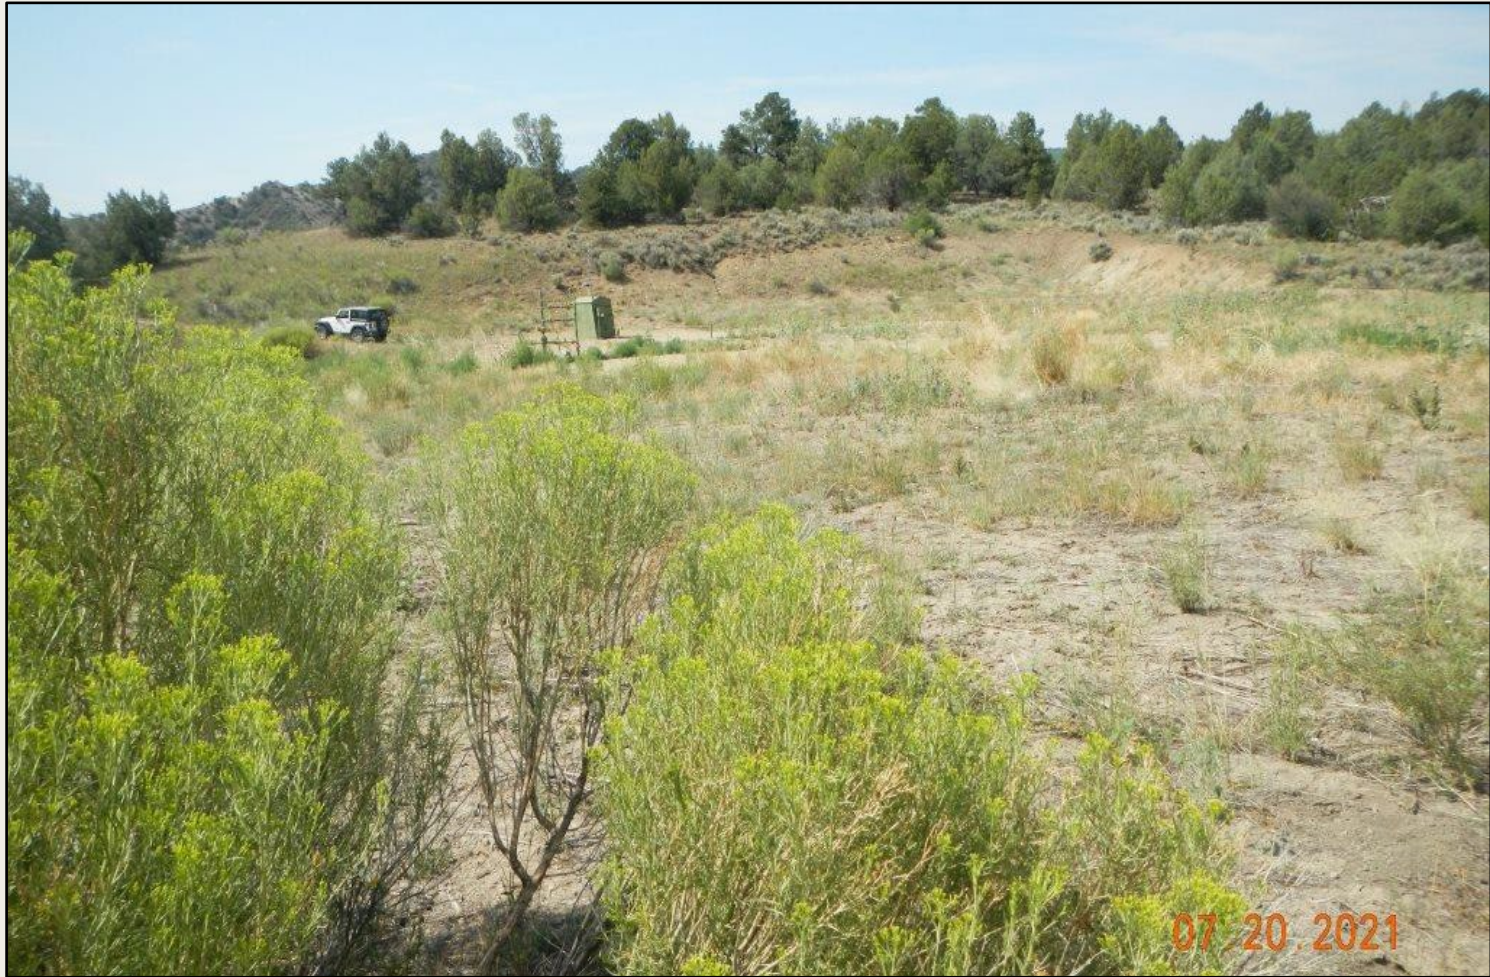
Photo 3. View of the western portion of the well pad facing southward.

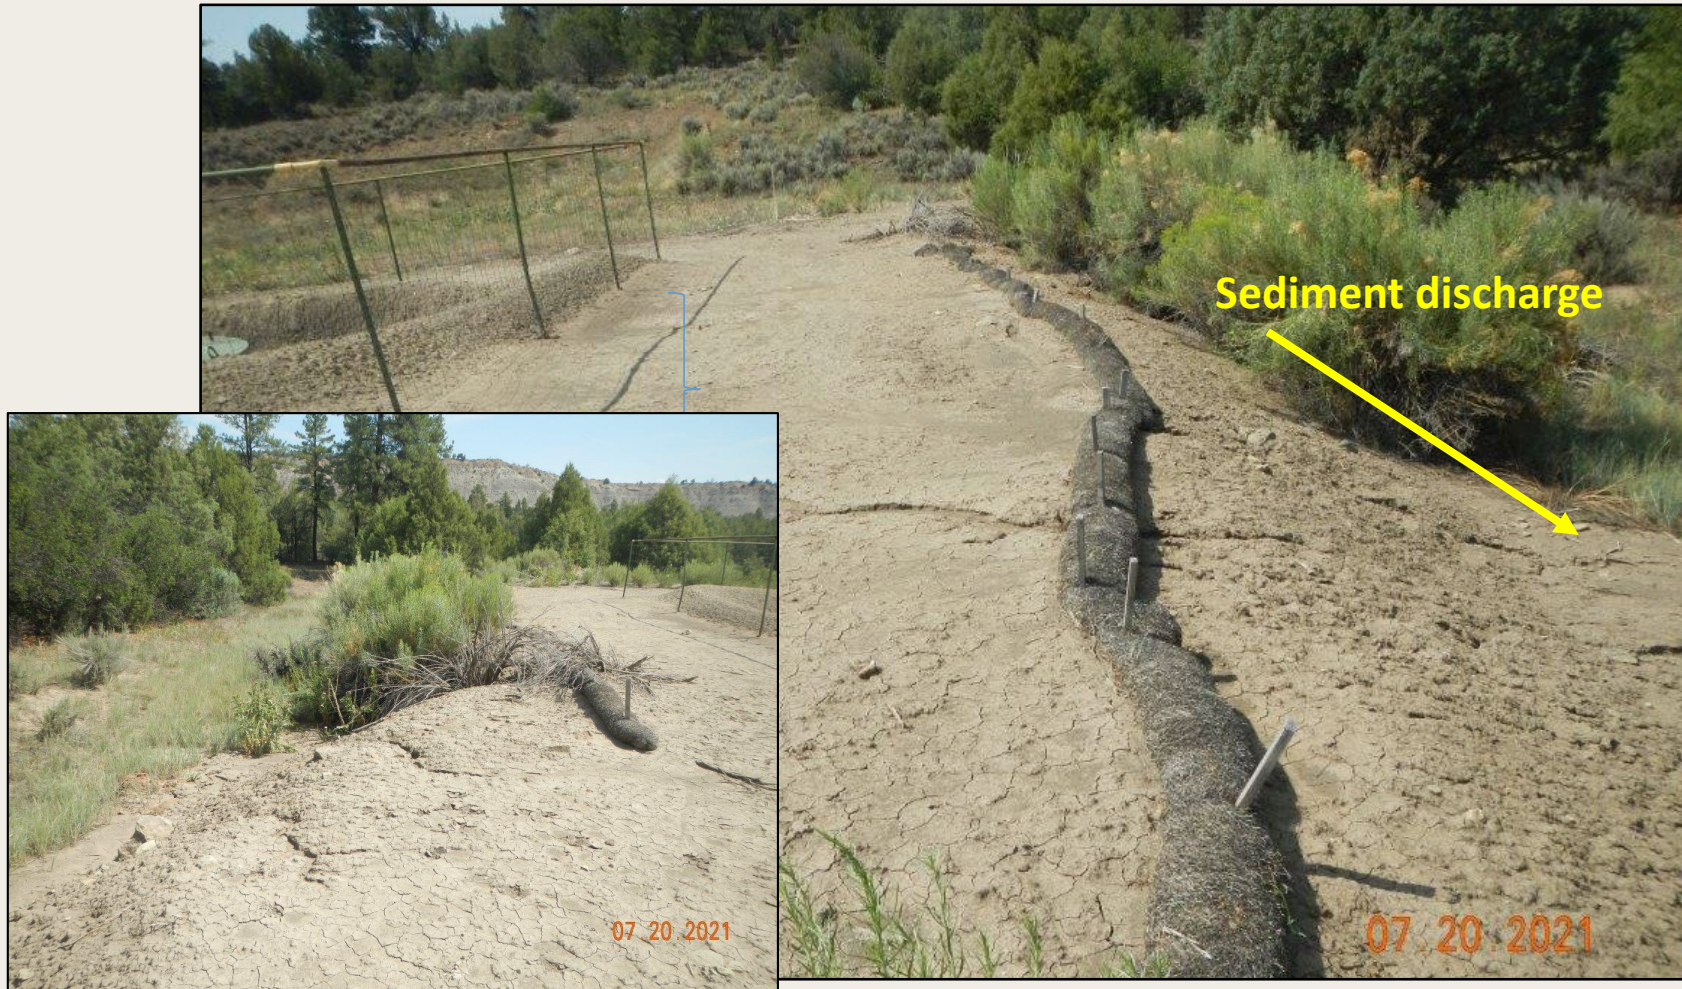
Photo 4. View of wattles along the western edge of the project area, full and no longer functioning, sediment deposition occurring. Length of wattles not adequate (see inset)

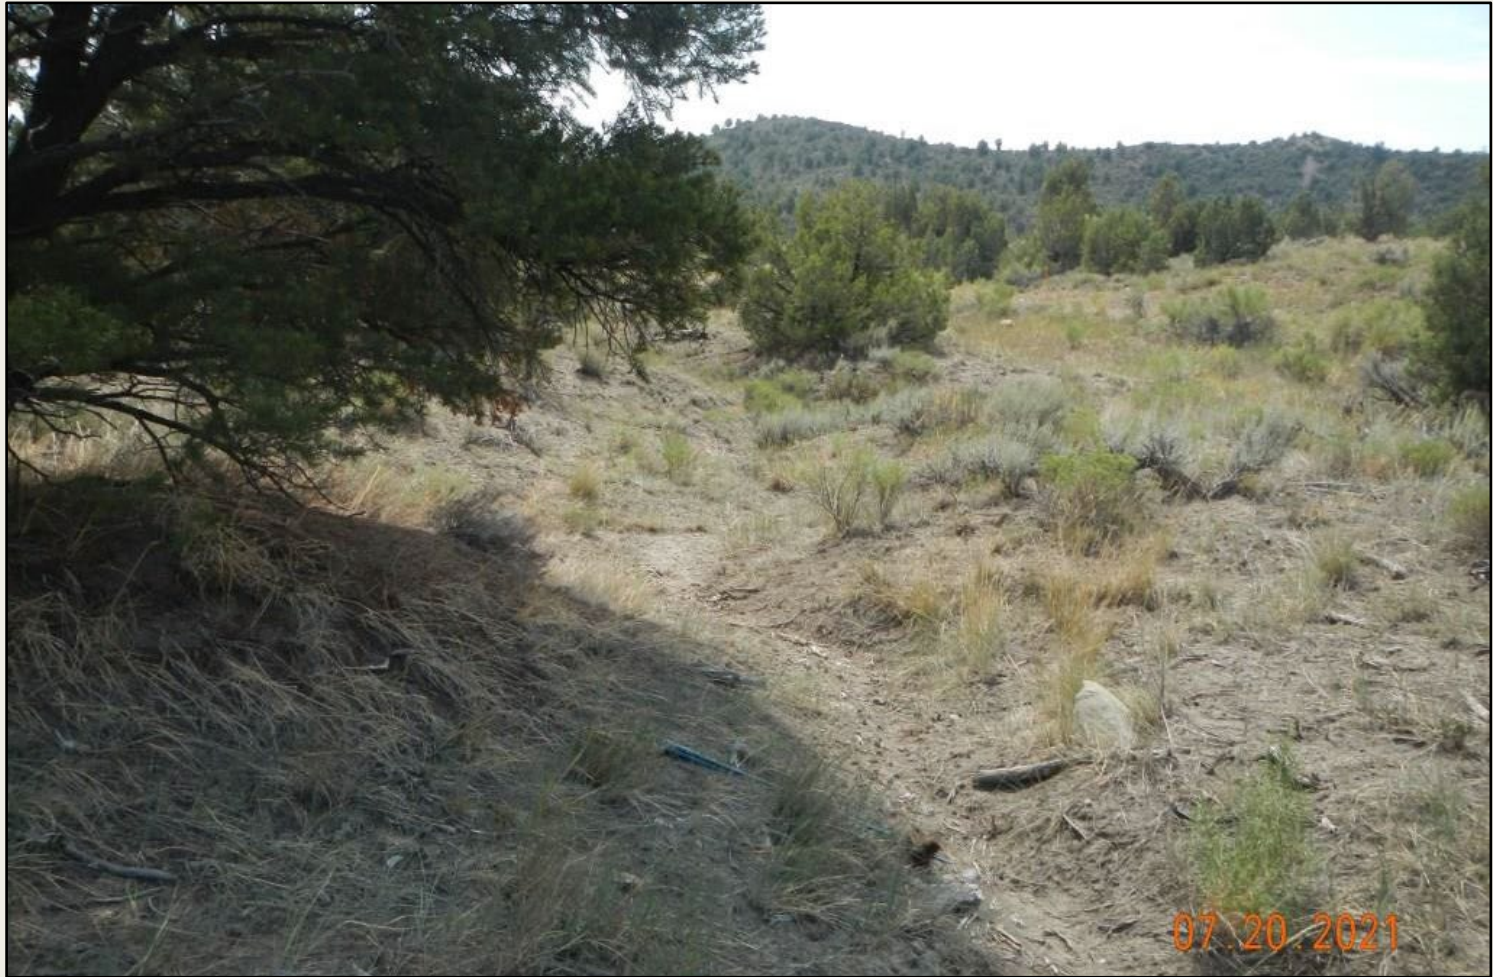
Photo 5. View the reference area comprised of pinyon and juniper woodland with scattered ponderosa pine trees and rubber rabbitbrush, western wheatgrass, Indian ricegrass, and sagebrush in the understory.
