Inspection Photos

Operator: Enduring Resources
API: 067-07915
Date: 7/20/2021

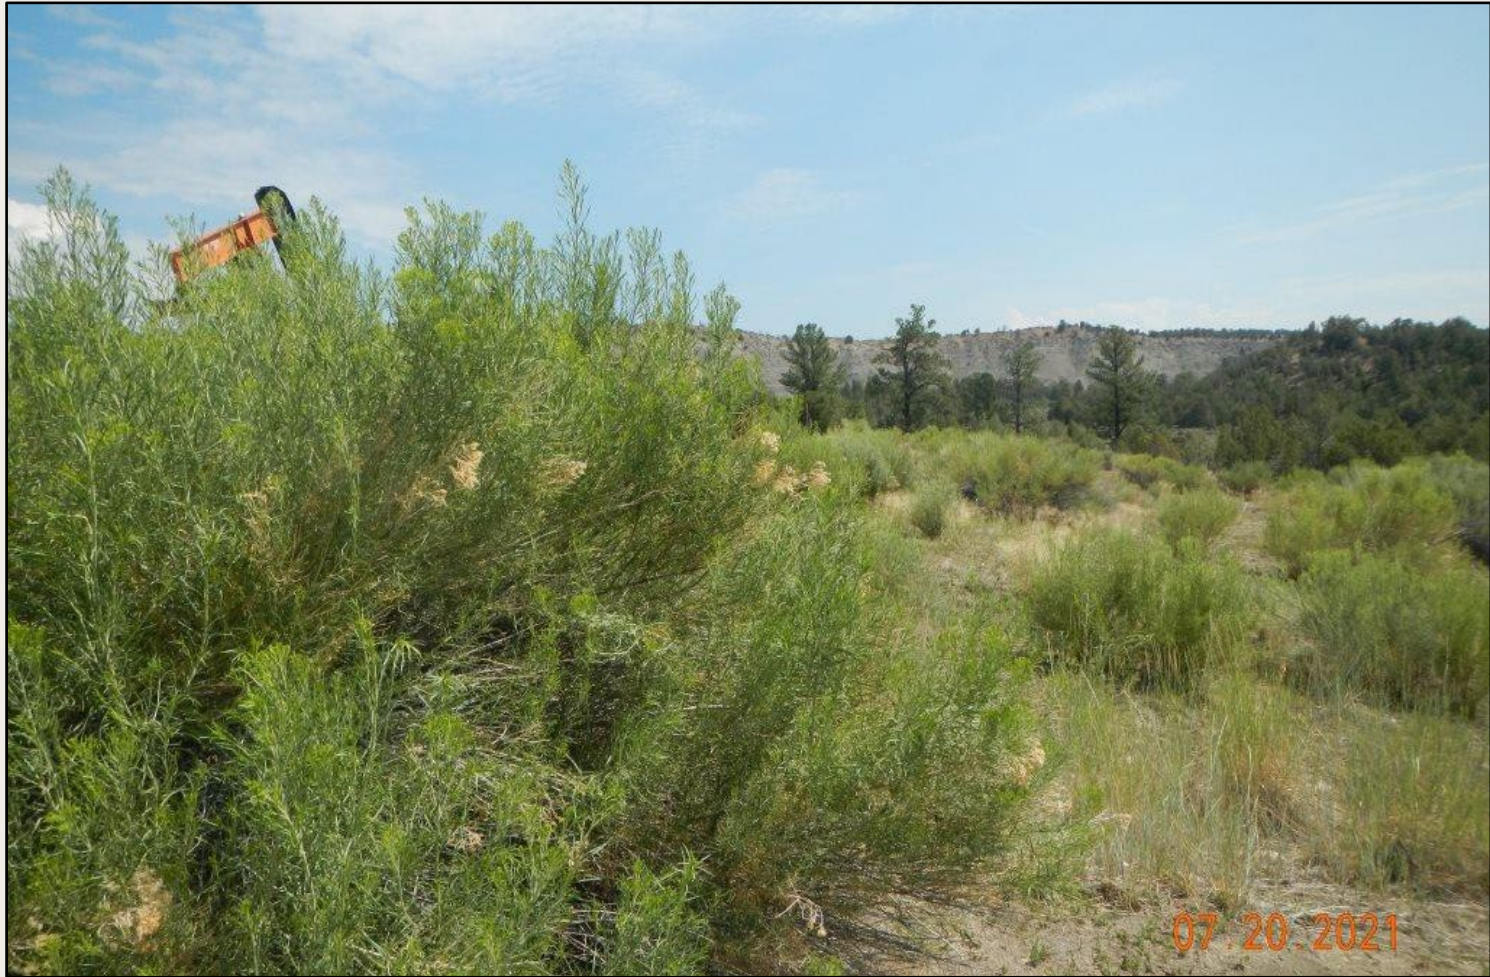
Photo 1. View of the southeastern fill slope facing northeastward. Revegetation is progressing with western wheatgrass, crested wheatgrass, and rubber rabbitbrush.

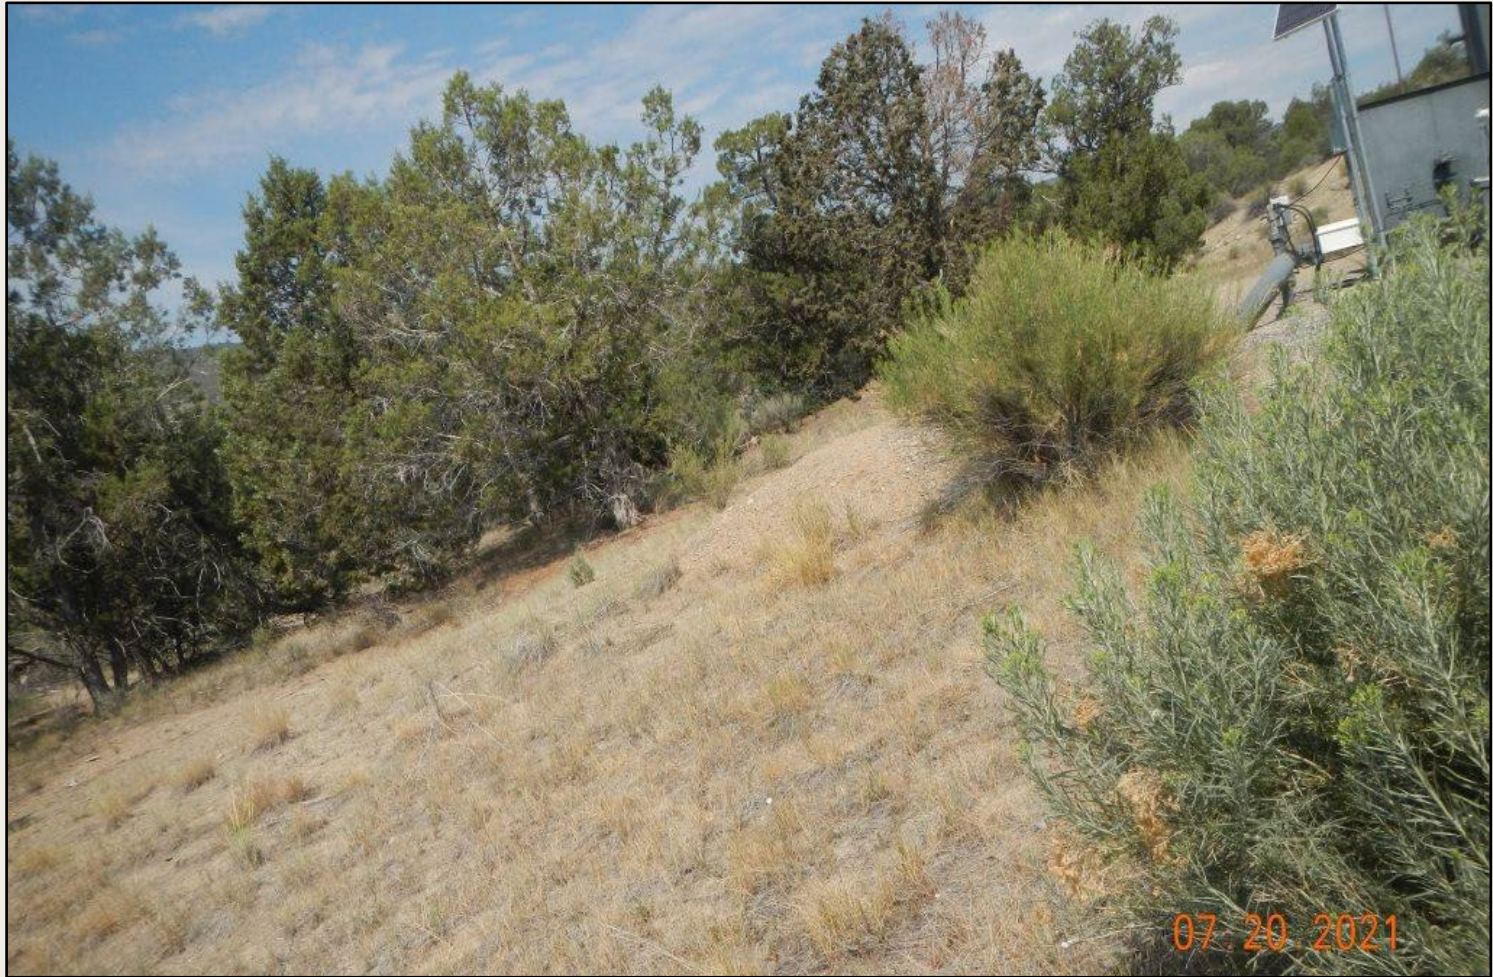
Photo 2. View of the southwestern project area from the southern corner facing northwestward.

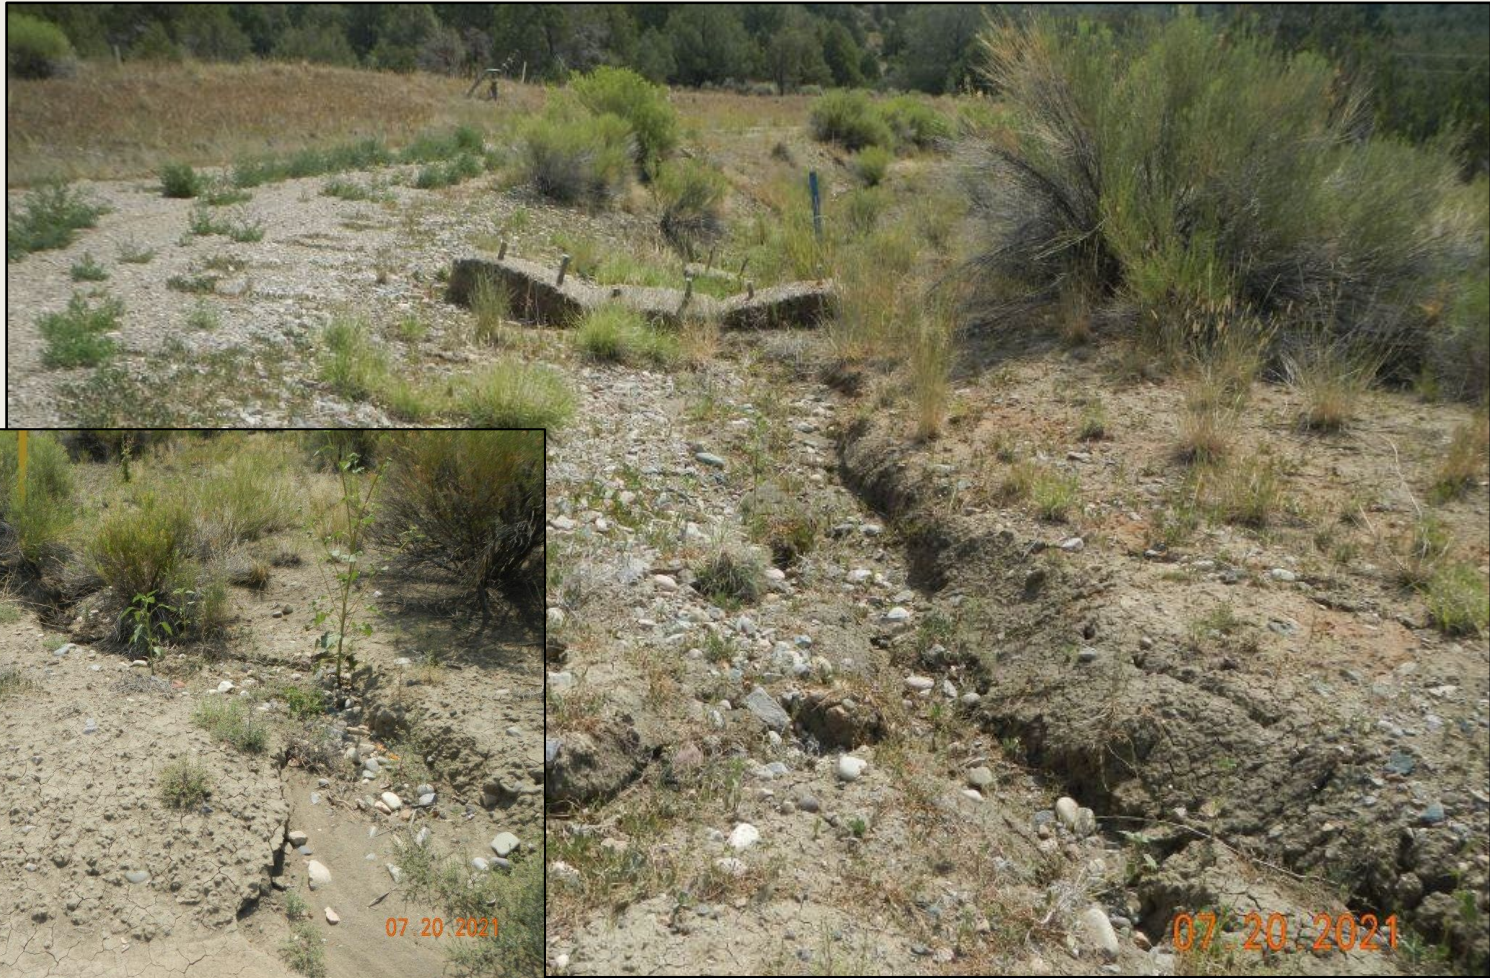
Photo 3. View of erosional rilling and channeling occurring along the access road. Straw bales are not functioning and are not an adequate BMP in this area. Inset shows erosional channeling from eroded berm on fill slope.

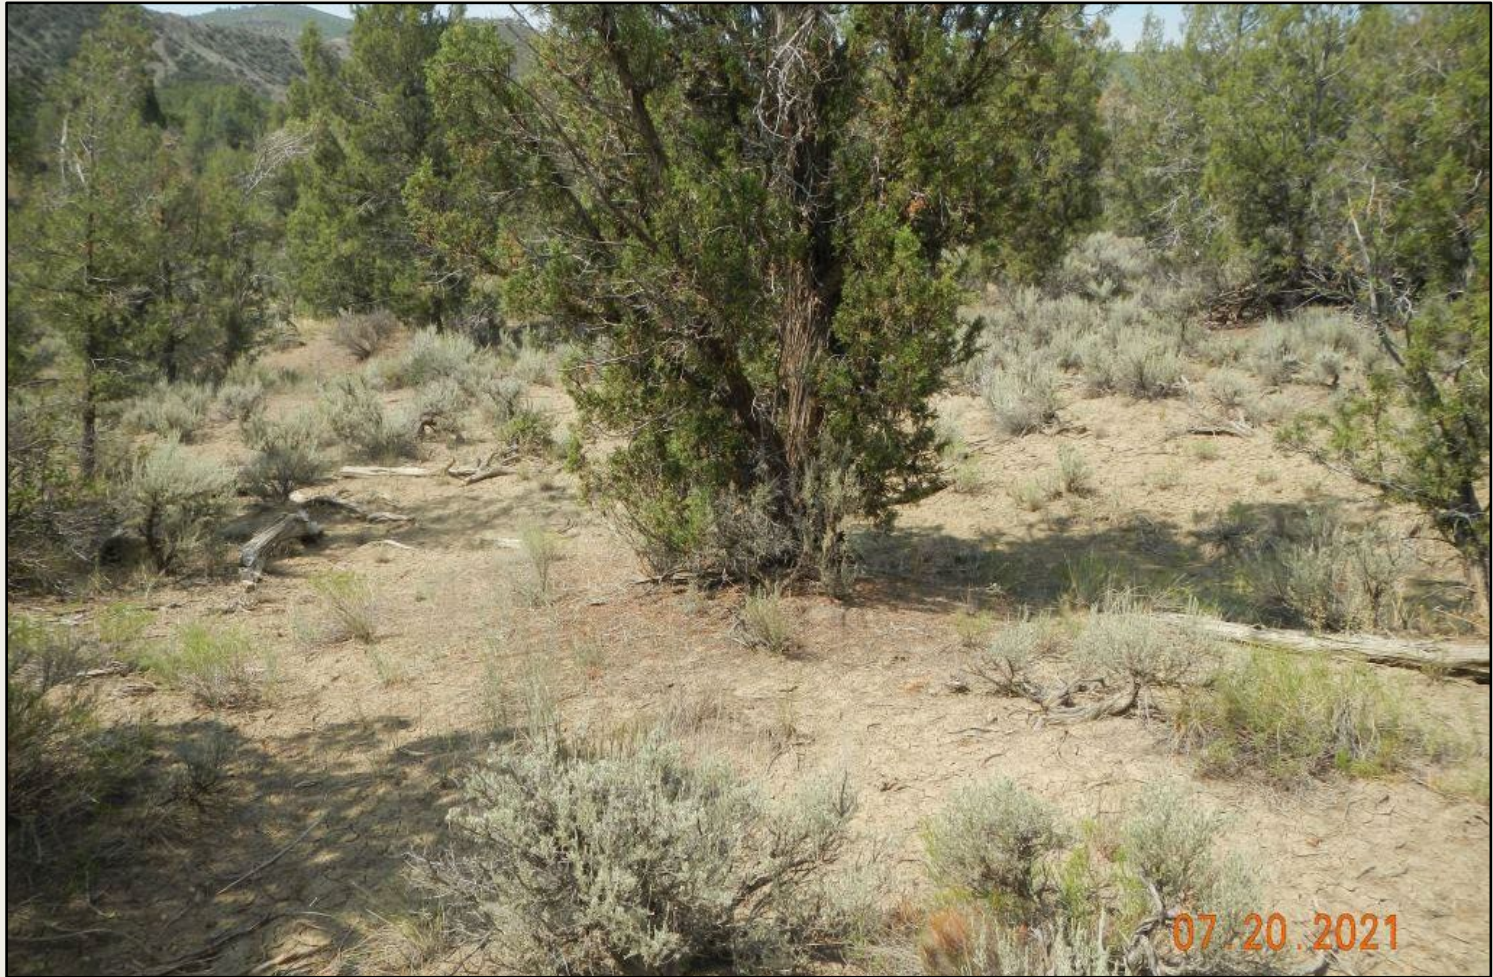
Photo 5. View the reference area comprised of pinyon and juniper woodland with scattered ponderosa pine trees and rubber rabbitbrush, western wheatgrass, Indian ricegrass, and sagebrush in the understory.
