# Inspection Photos

Operator: Hilcorp Energy  
API: 067-06524  
Date: 7/20/2021

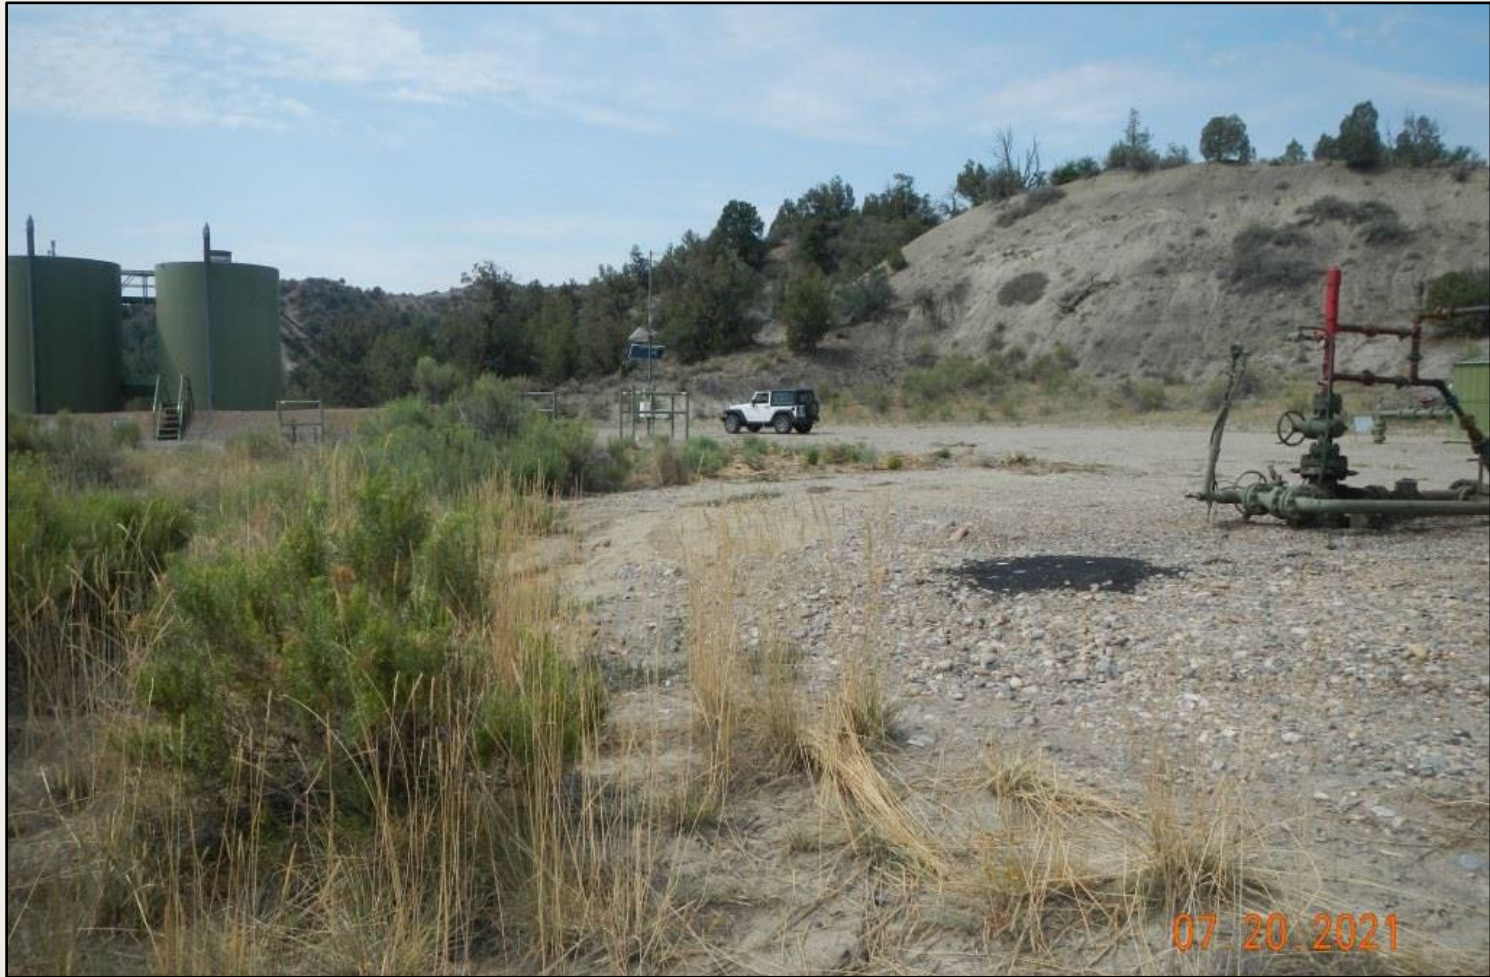
Photo 1. View of the project area from the northeastern corner facing center.

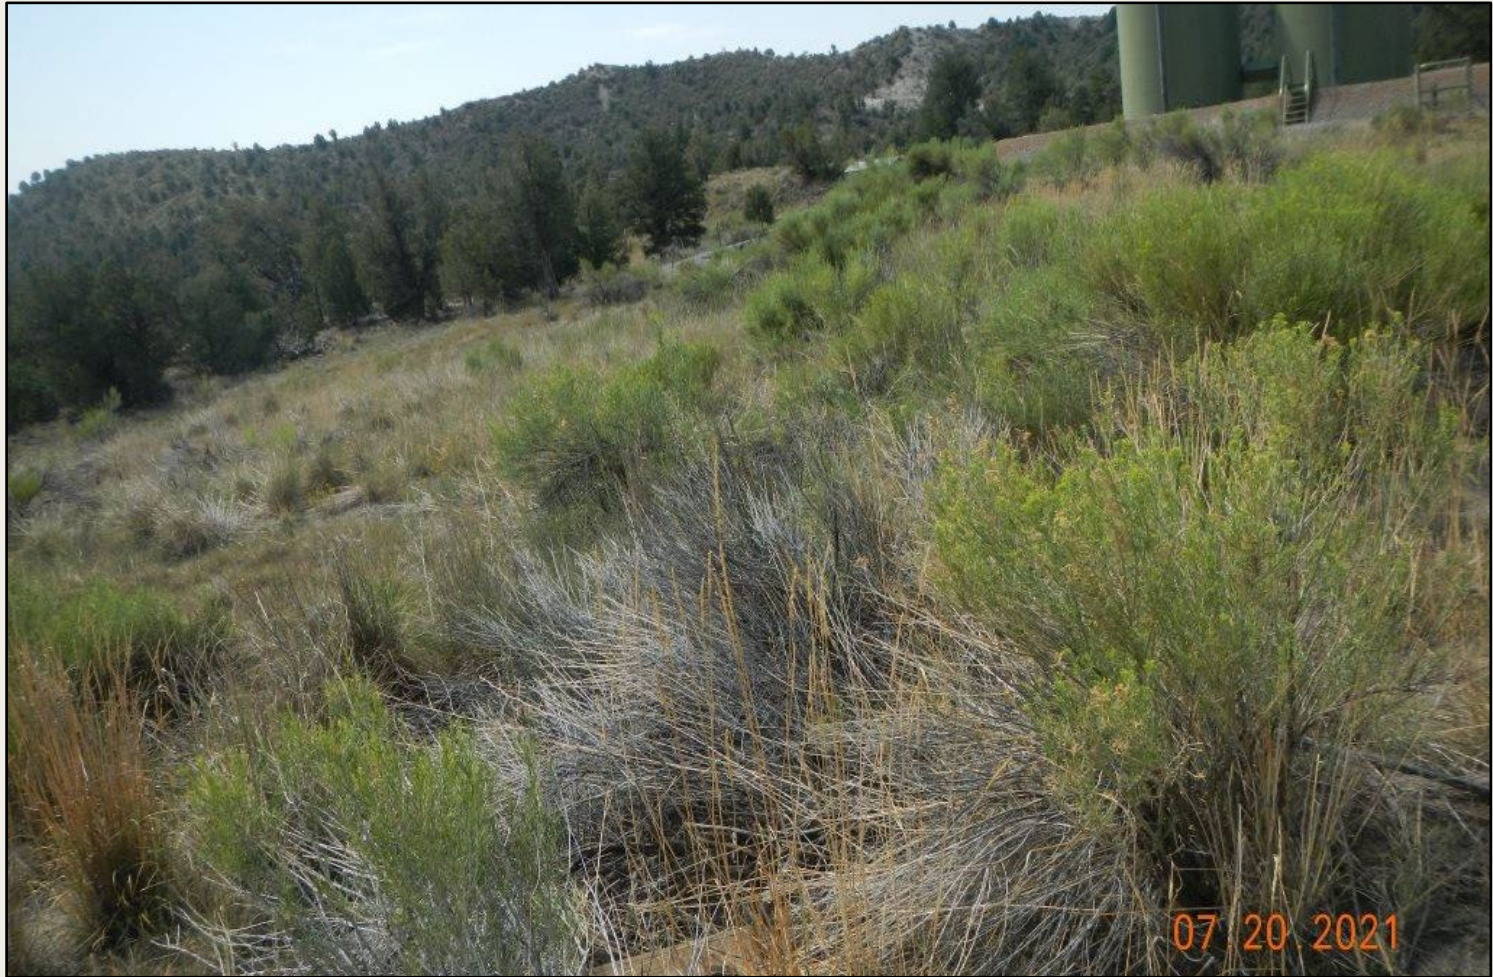
Photo 2. View of the eastern project area from the northeastern corner facing southward.

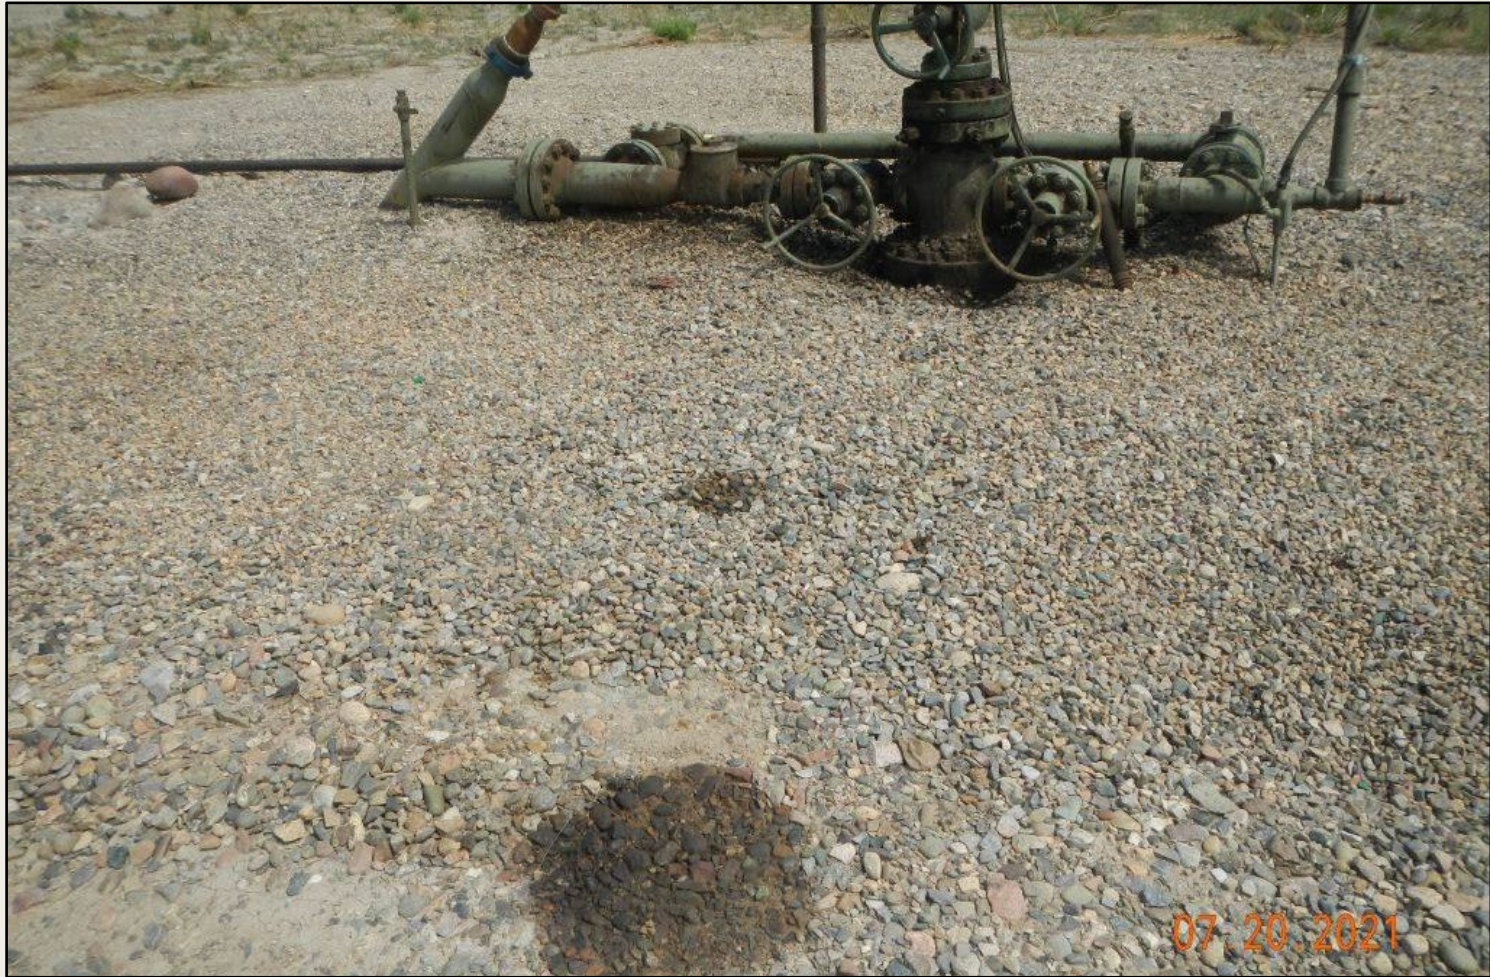
Photo 3. View of stained soils (approx. 2ft diam) near the well head.

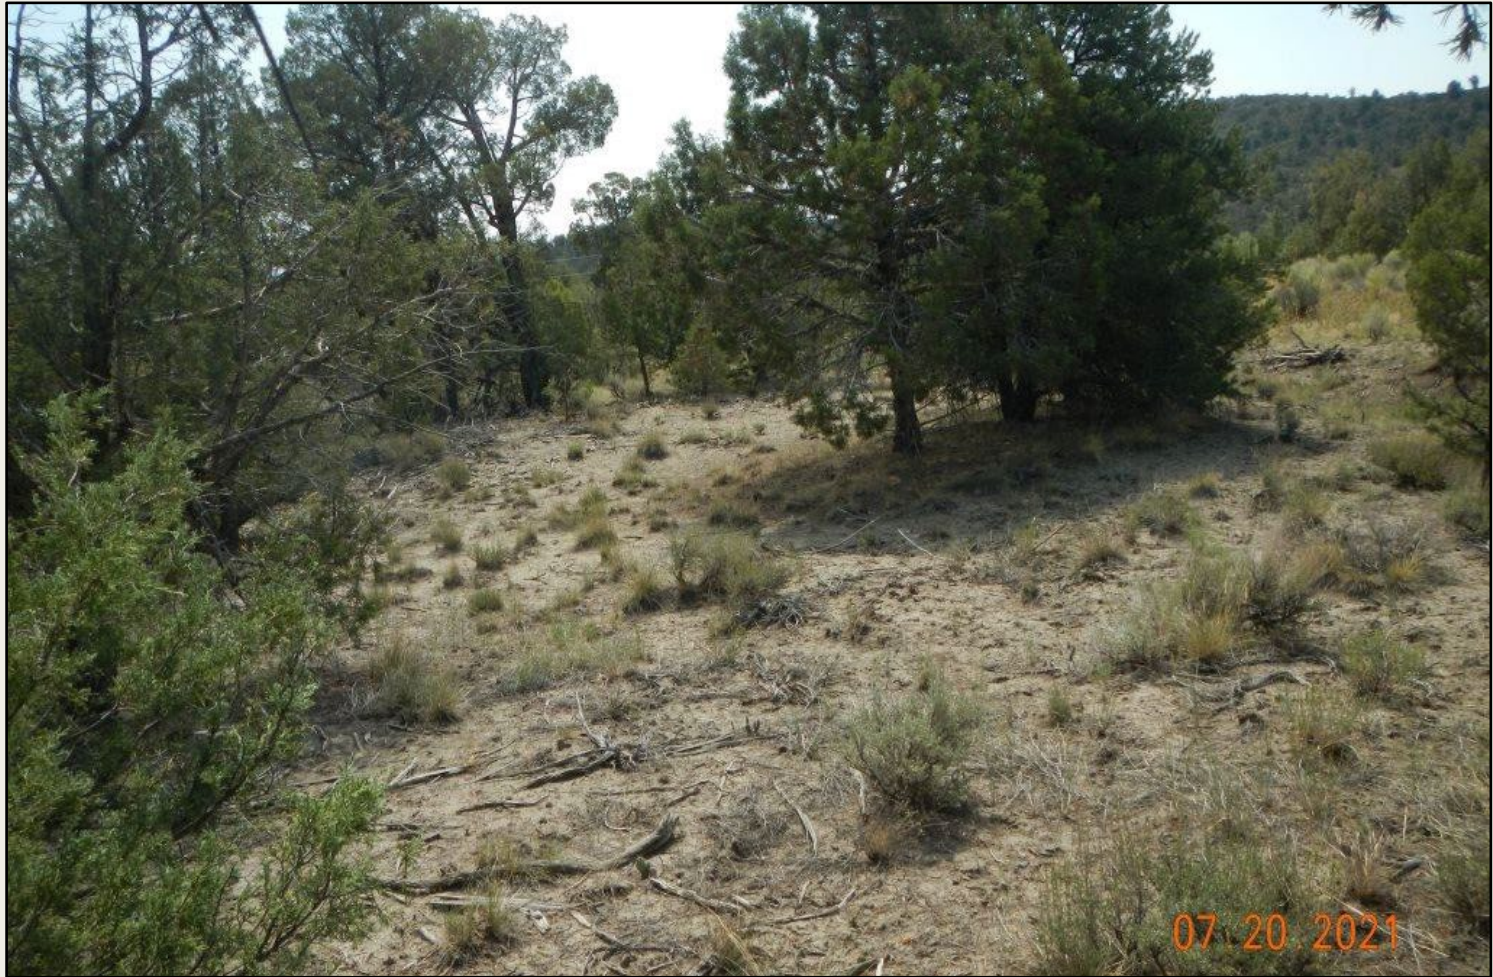
Photo 4. View the reference area comprised of pinyon and juniper woodland with black sage, snakeweed, Indian ricegrass, and James galleta.
