Inspection Photos

API: 071-07915

Operator: WAPITI OPERATING LLC

Inspection Date: 7/22/2021

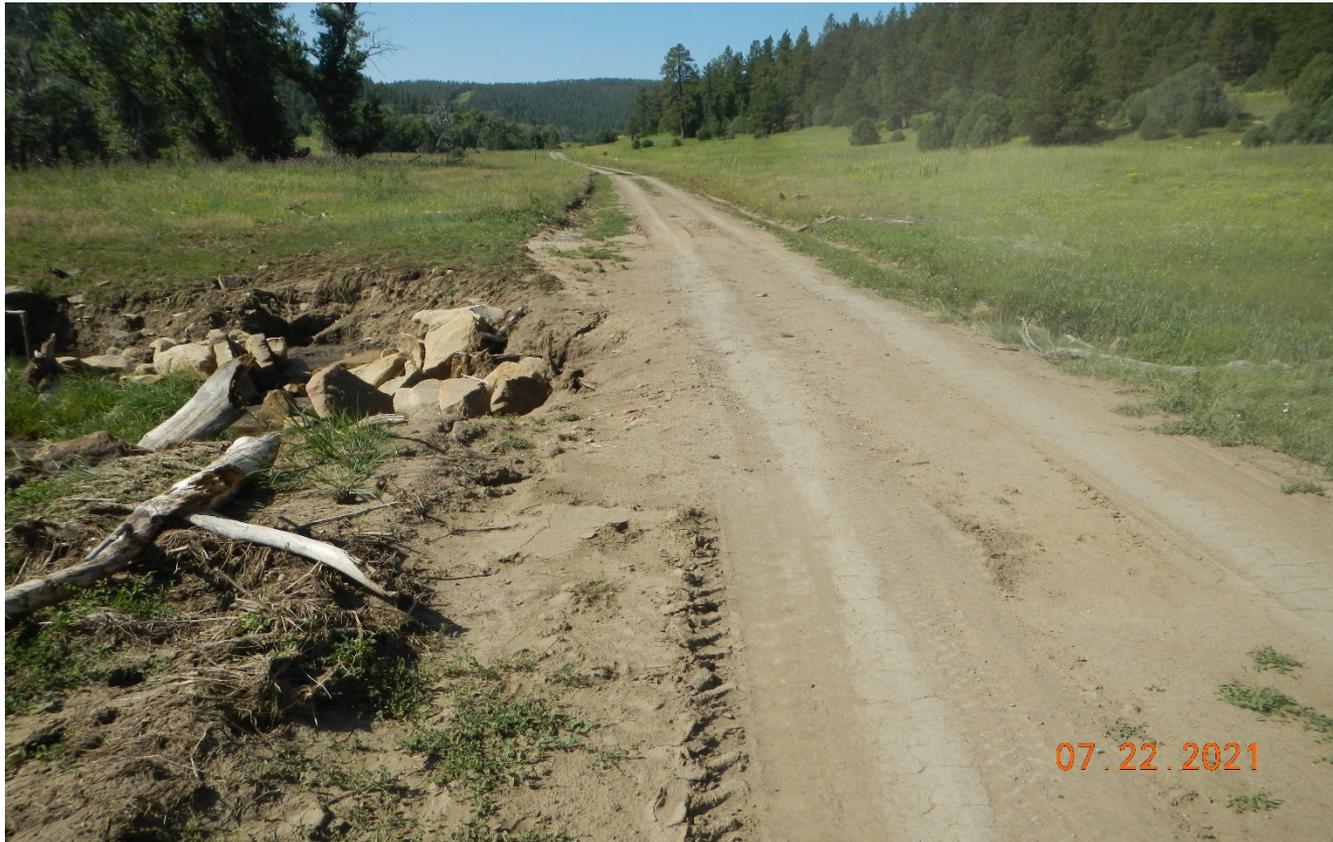
Photo 1. Facing southwest along the main road in the canyon. Stormwater has washed across the road causing erosion.

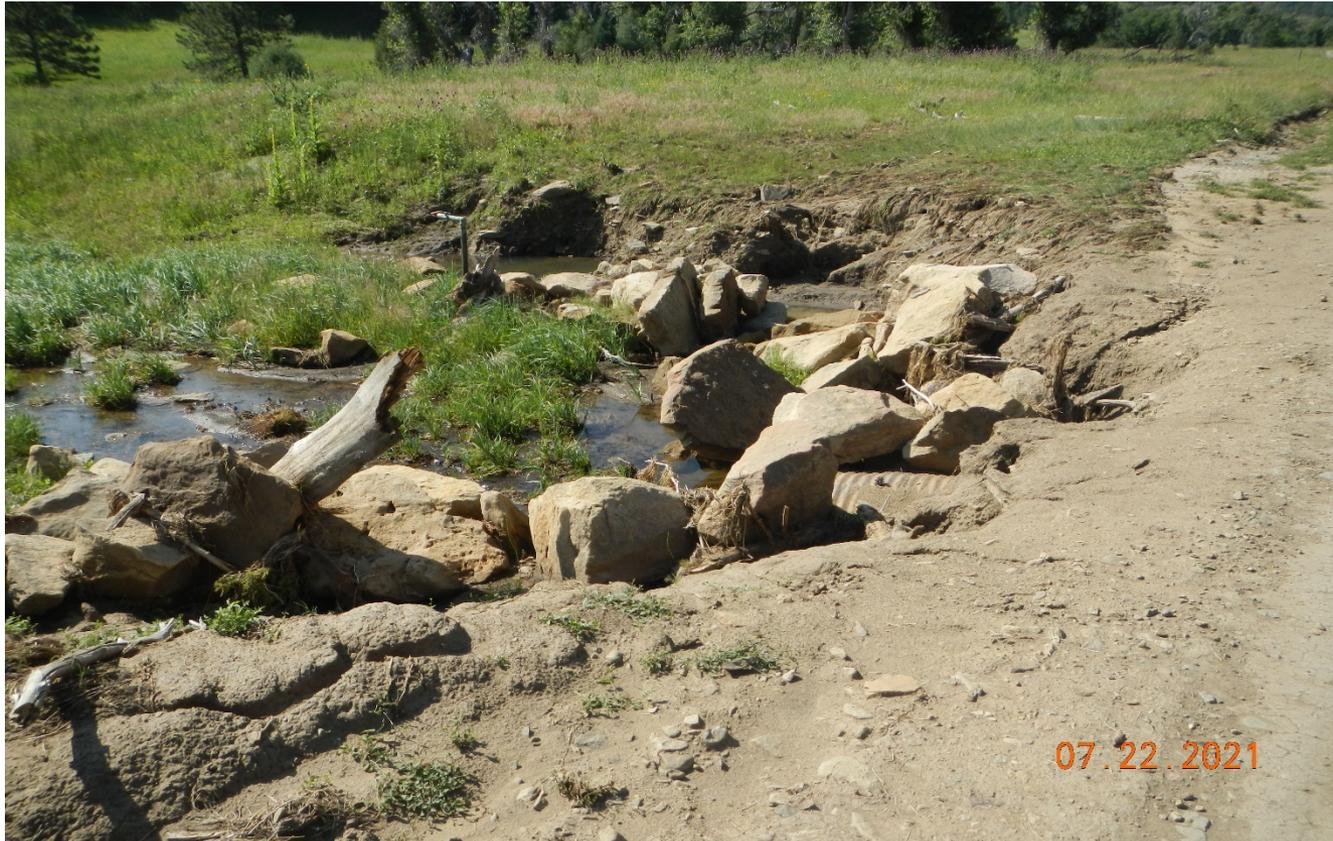
Photo 2. The culvert outlet has been eroded and will need to be repaired.

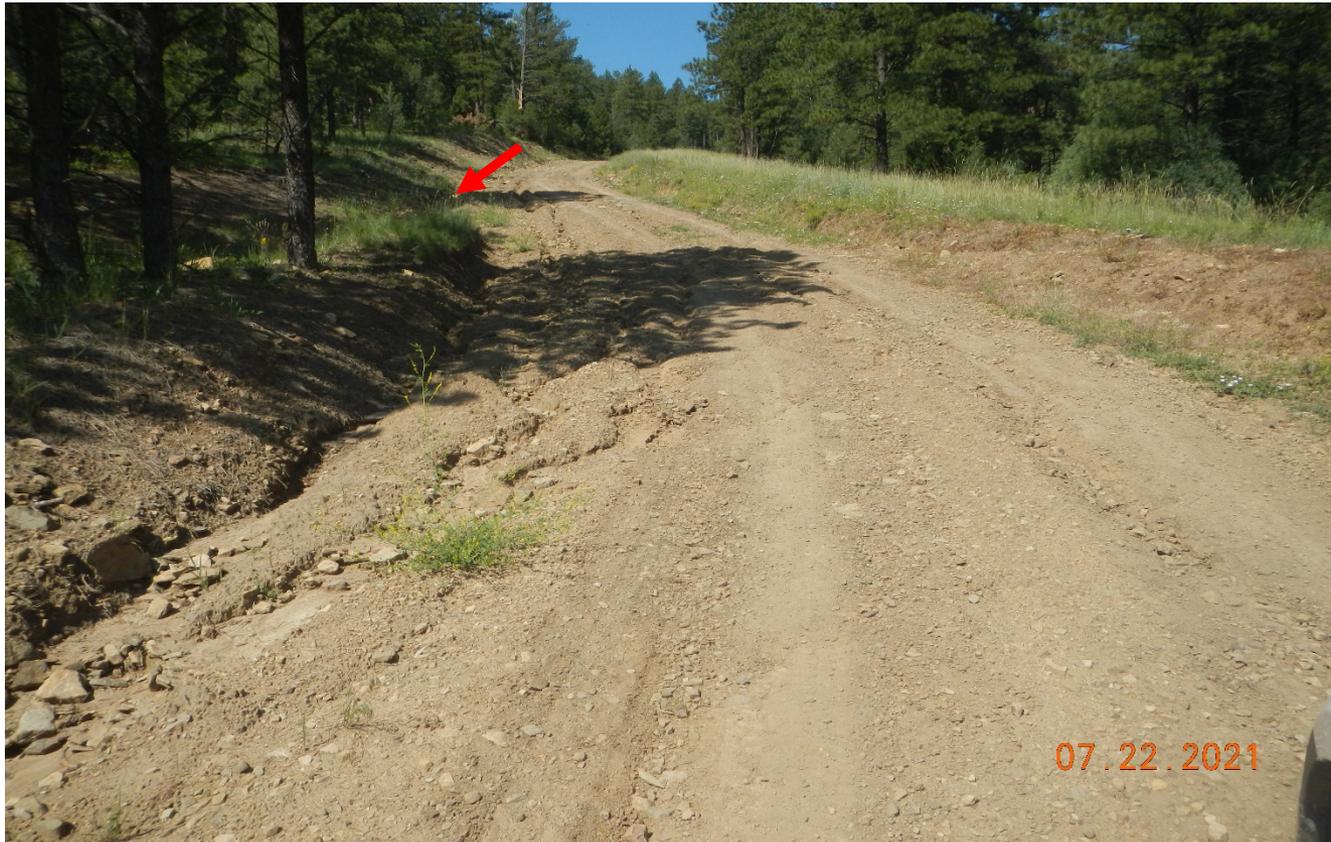
Photo 3. Facing west along the road ascending the hill toward the location. Stormwater is not properly diverted toward the ditch shown at red arrow.

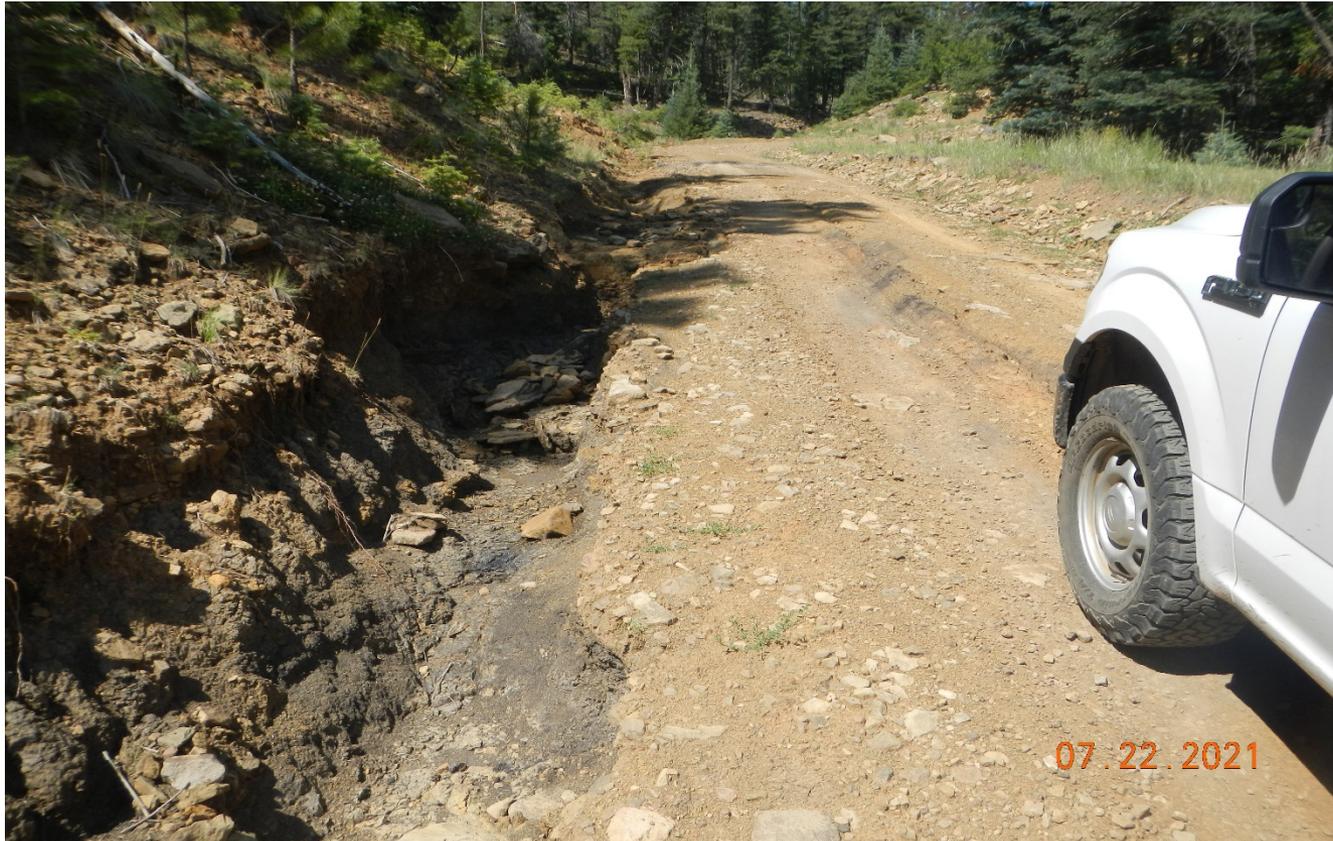
Photo 4. There is erosion along the side of the road which will need to be repaired and stabilized.

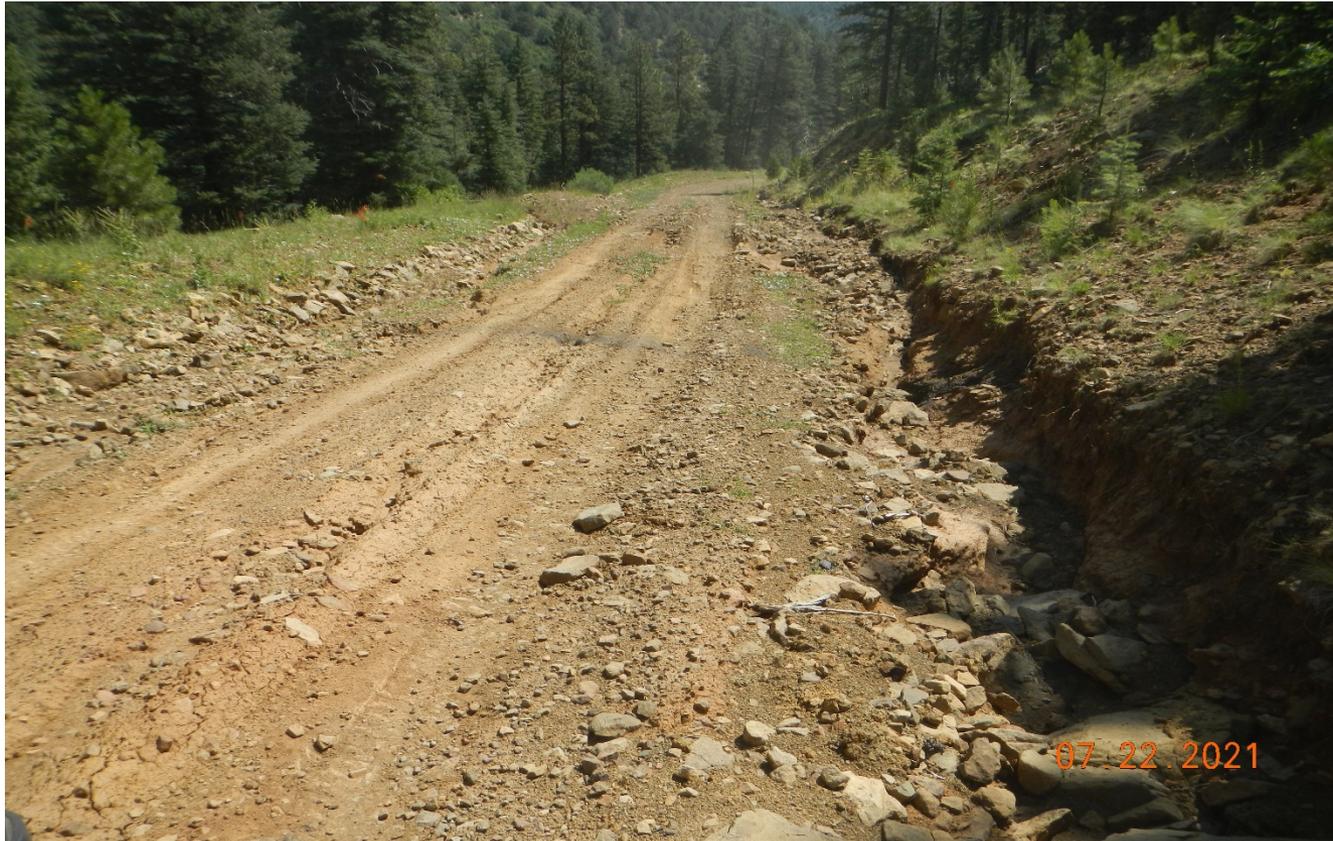
Photo 5. Facing back down the road.

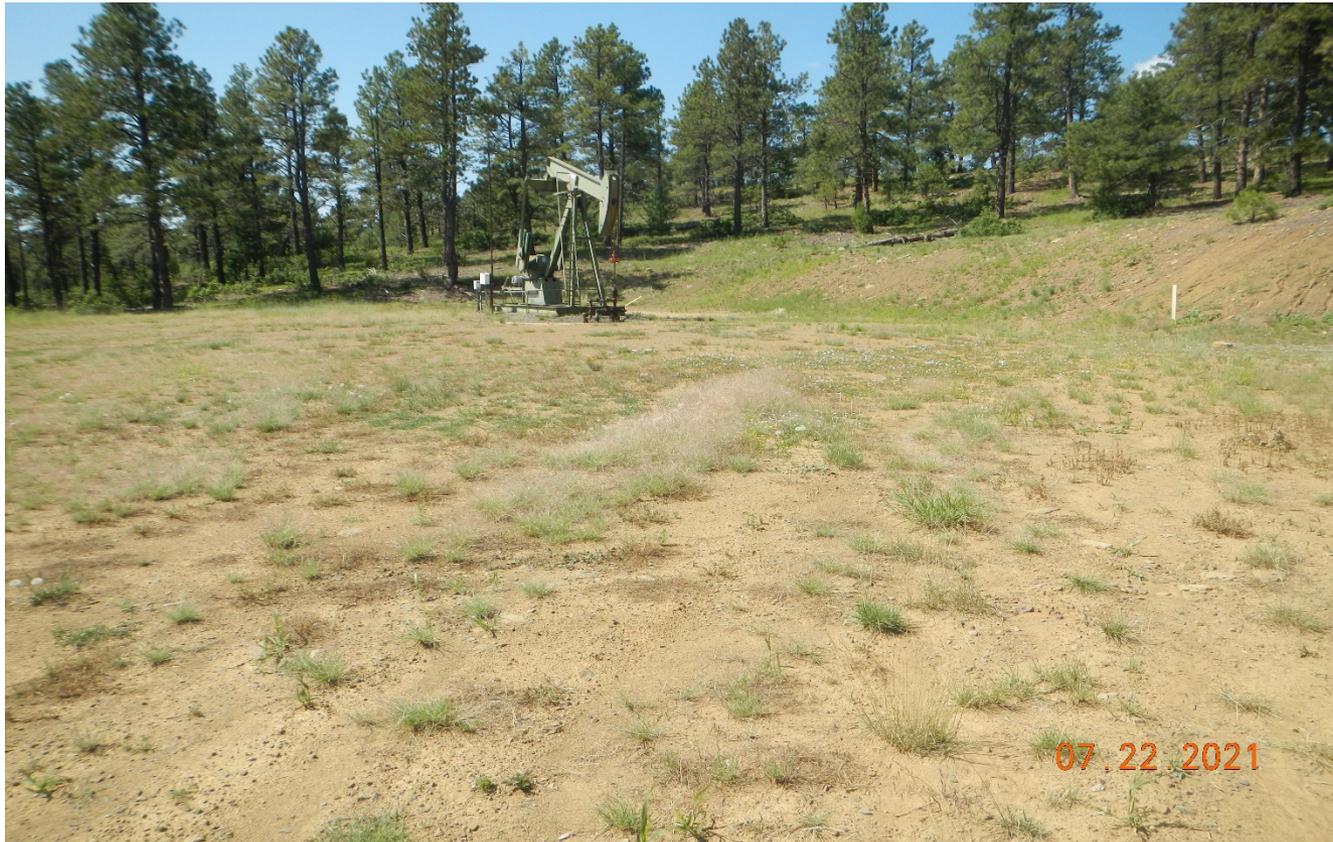
Photo 6. Facing toward the location.

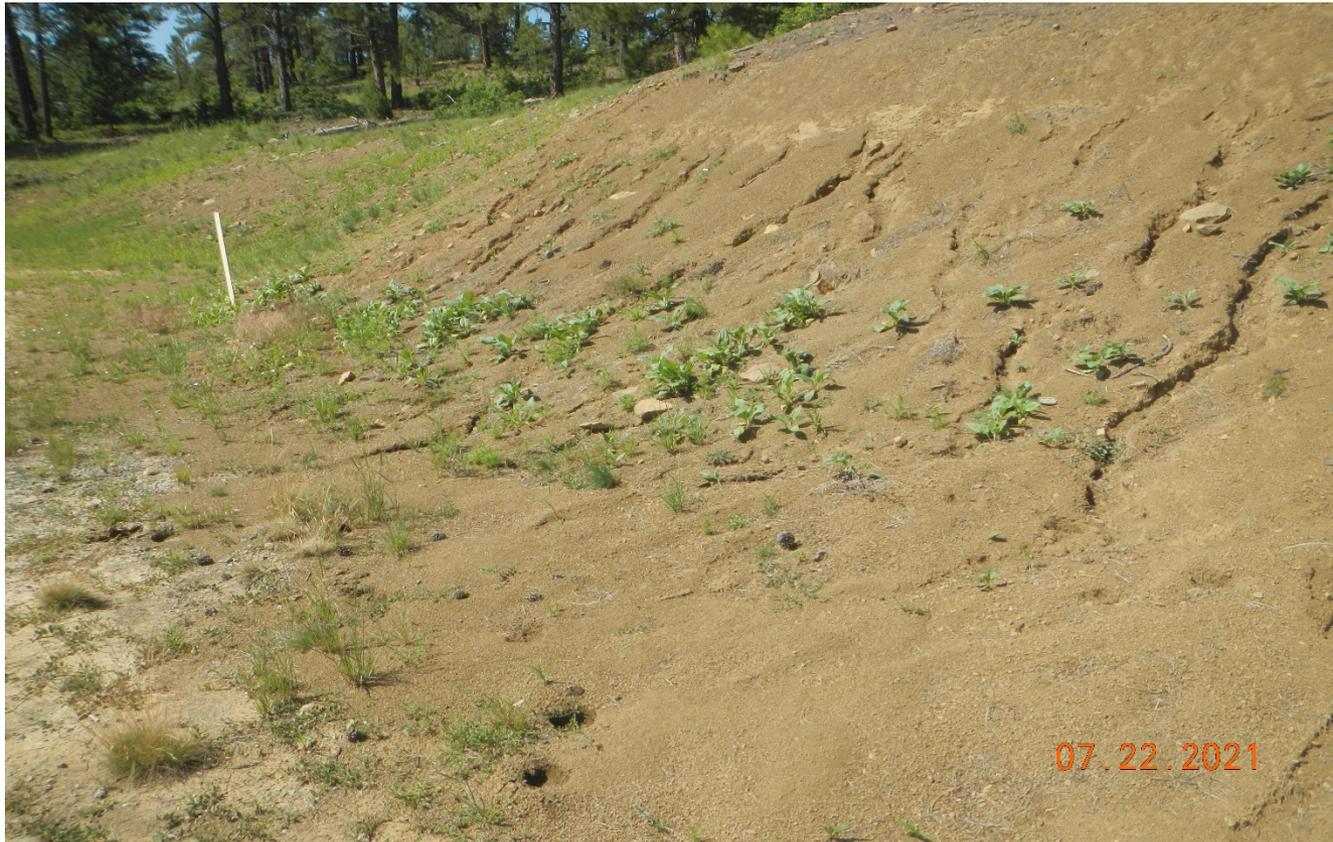
Photo 7. Facing toward the location. There are noxious weeds along the cut slope which need to be controlled.
