Inspection Photos

API: 071-08769

Operator: WAPITI OPERATING LLC

Inspection Date: 7/22/2021

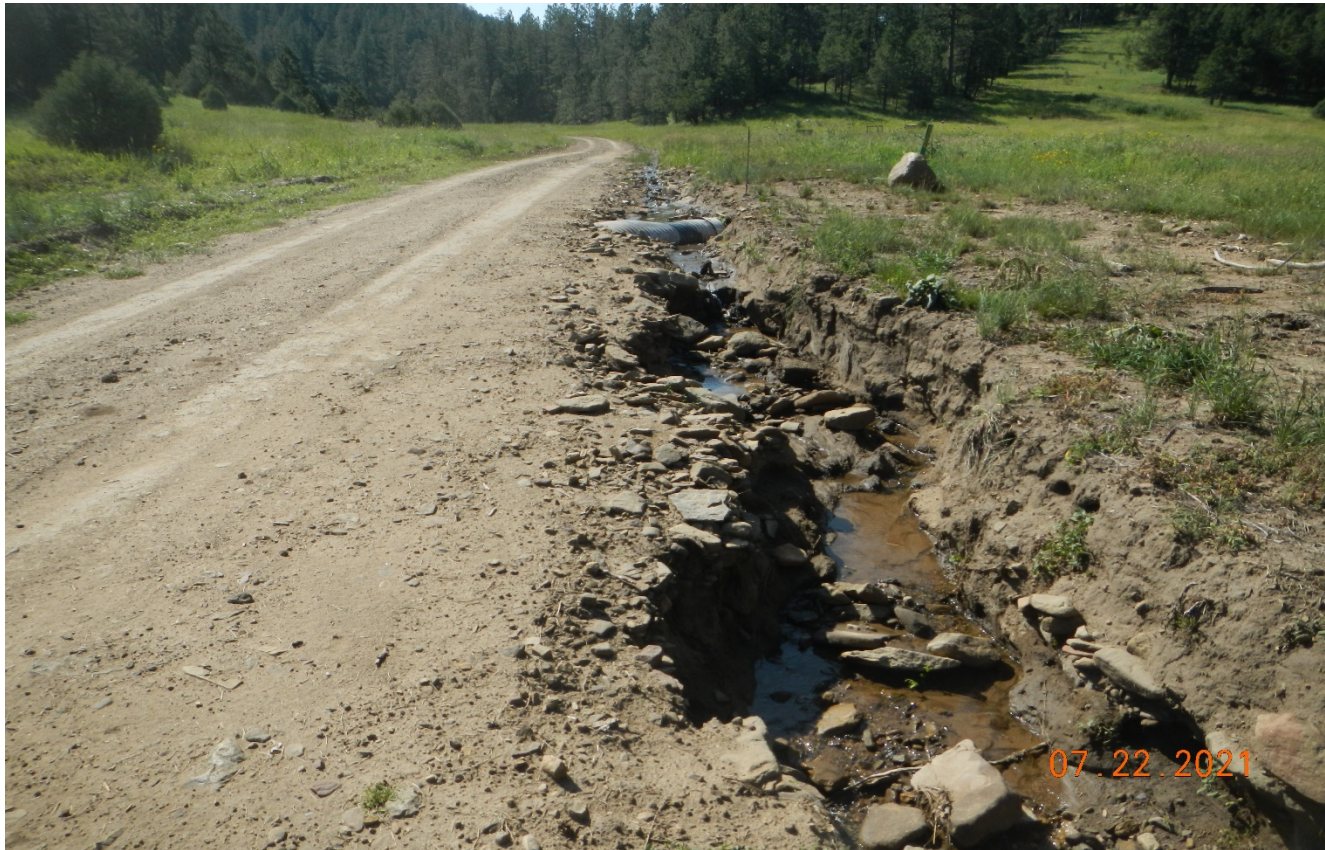
Photo 1. Facing southeast along the made road at the upper part of Lorencito Canyon. There is erosion along the road from recent storm event. Stormwater is bypassing the culvert.

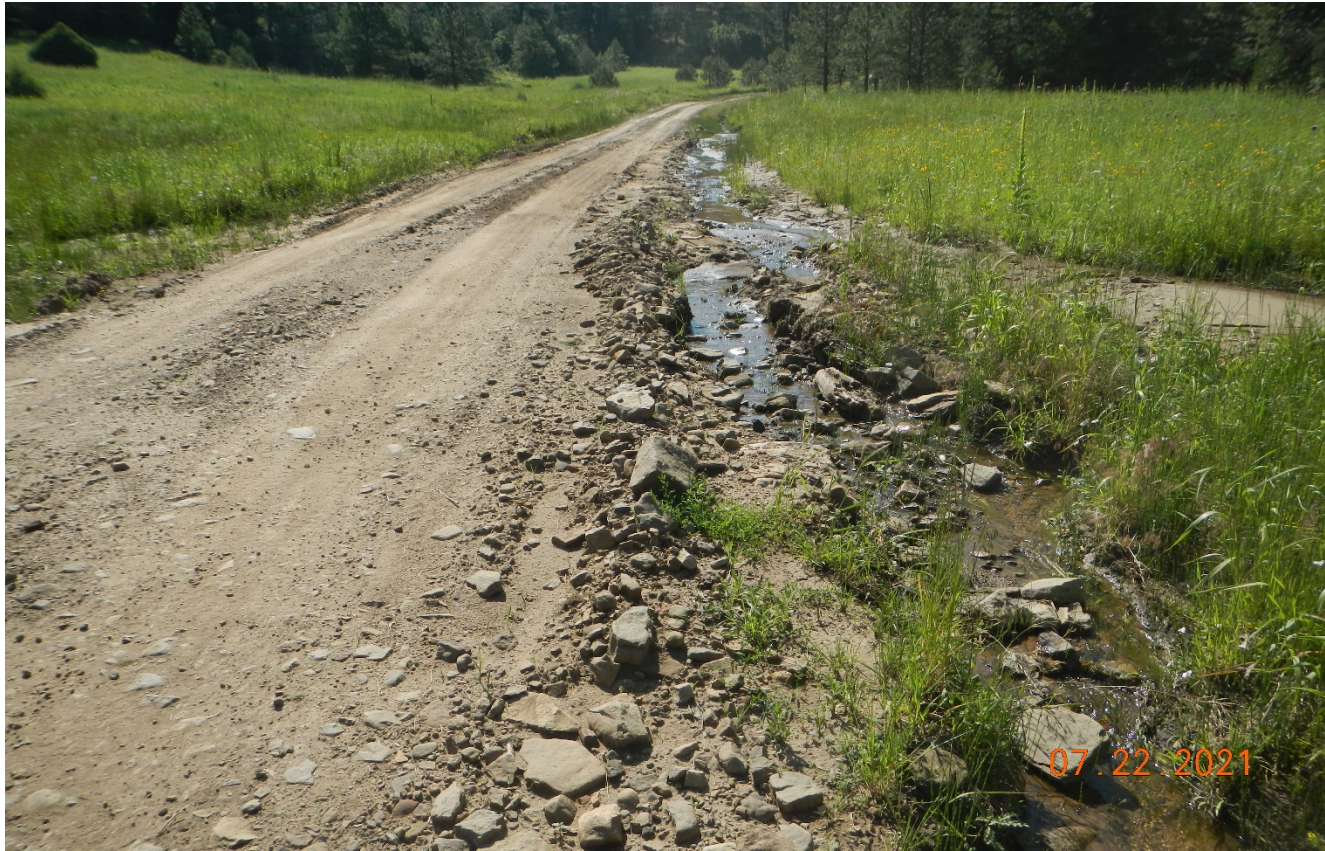
Photo 2. The culverts along the road are filled in with sediment causing stormwater to flow down the side of the road. Lat/Long:37.00499,-104.83742.

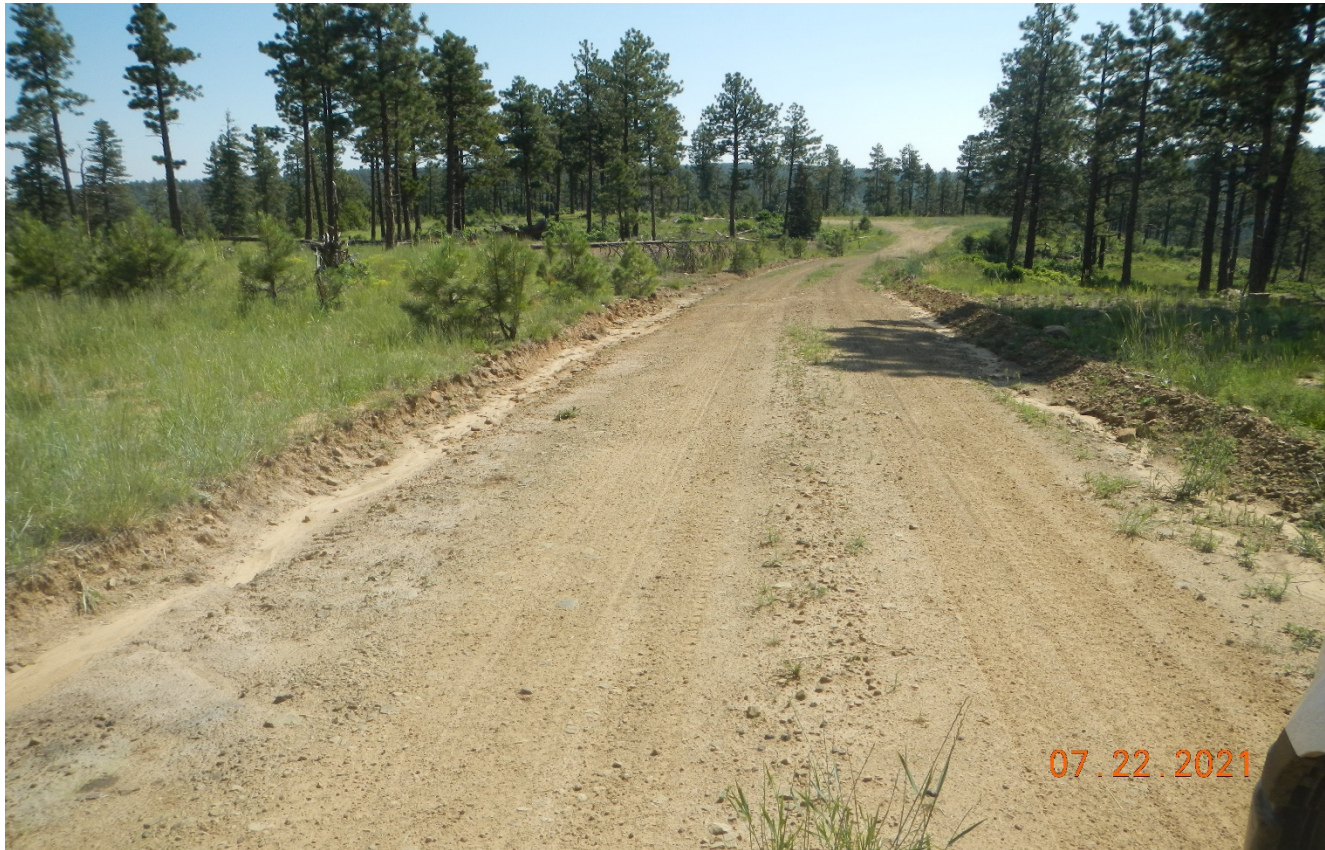
Photo 3. Facing east along the access road near the location.

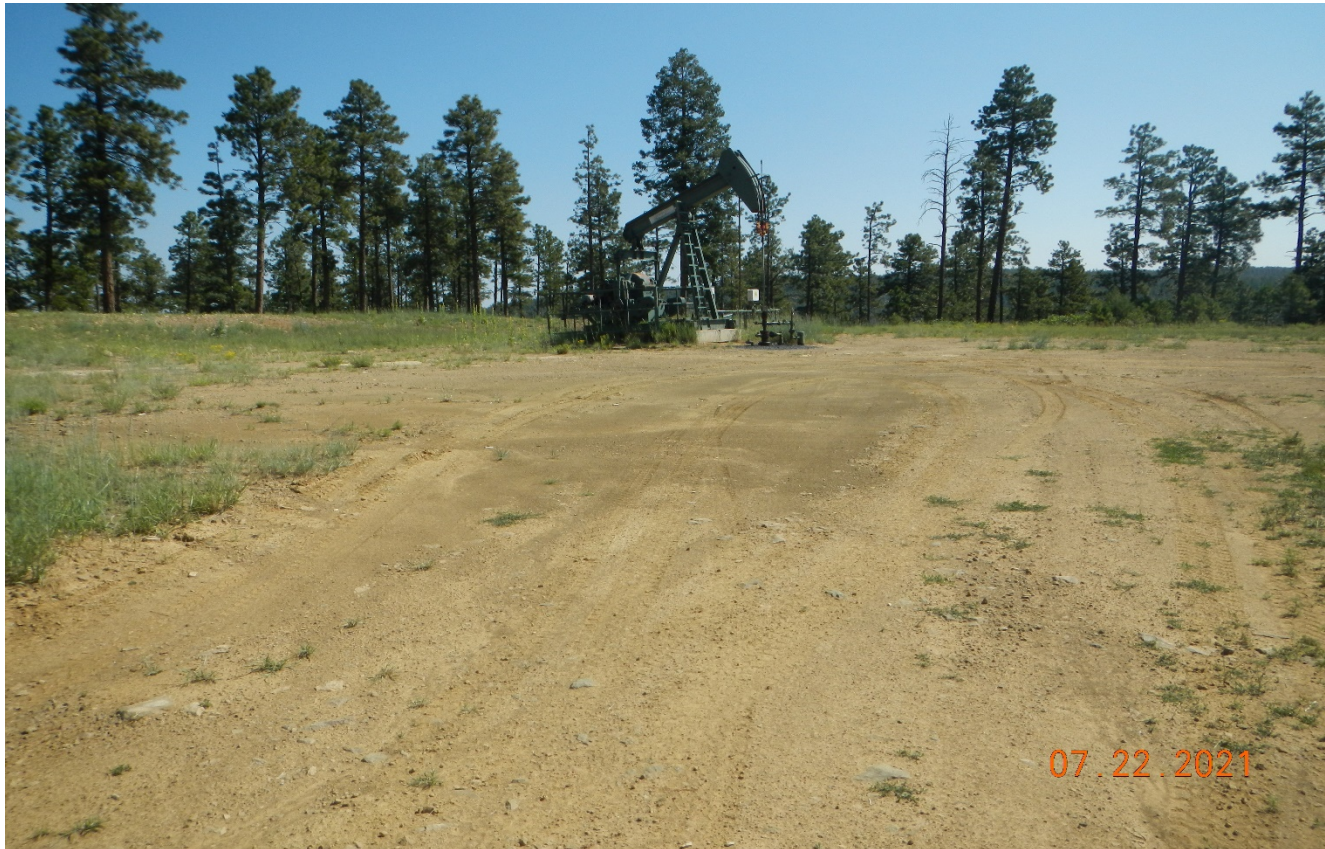
Photo 4. Facing toward the location.
