Inspection Photos

API: 071-09838

Operator: WAPITI OPERATING LLC

Inspection Date: 7/22/2021

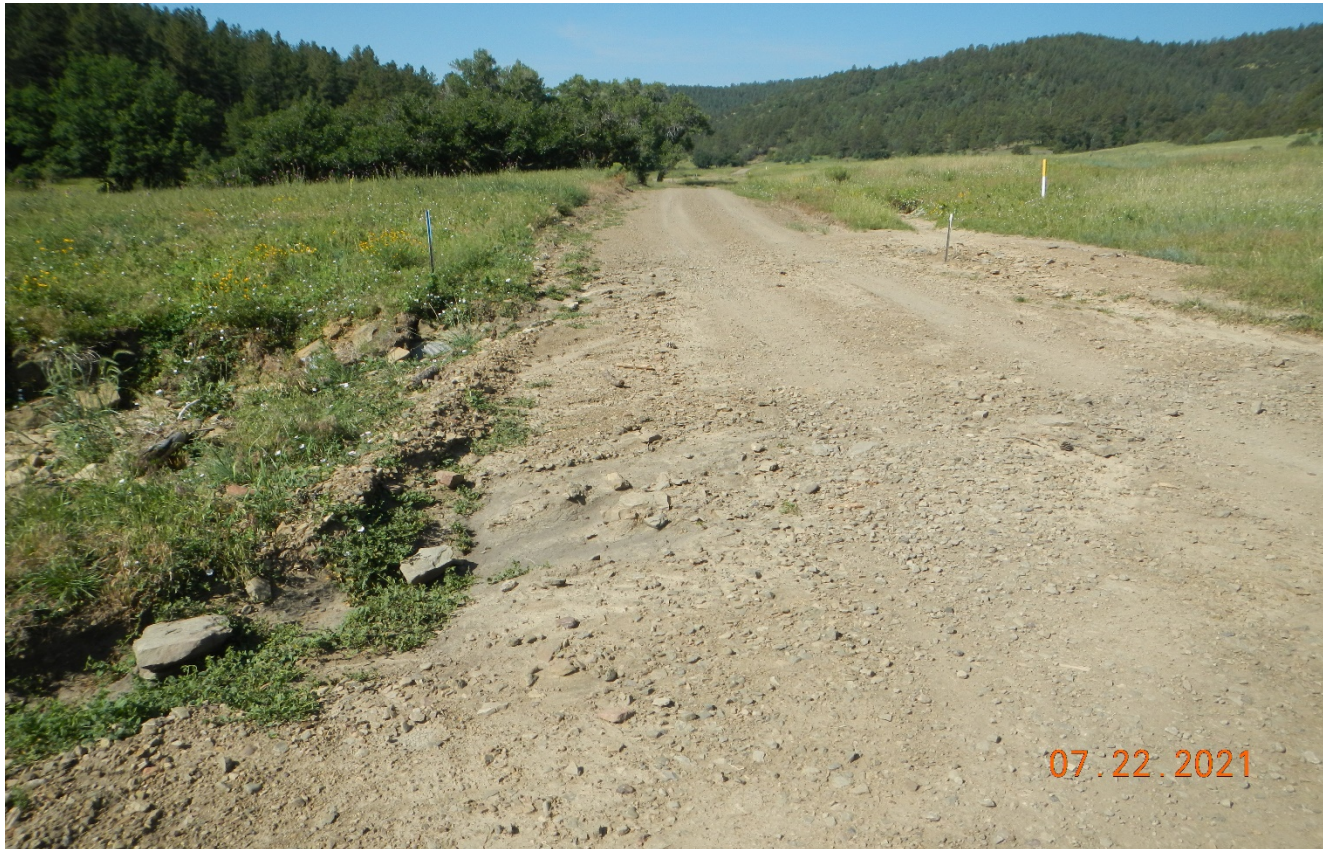
Photo 1. Facing southwest along the made road near the well site. Stormwater has washed across the road causing erosion. The culvert is filled in with sediment.

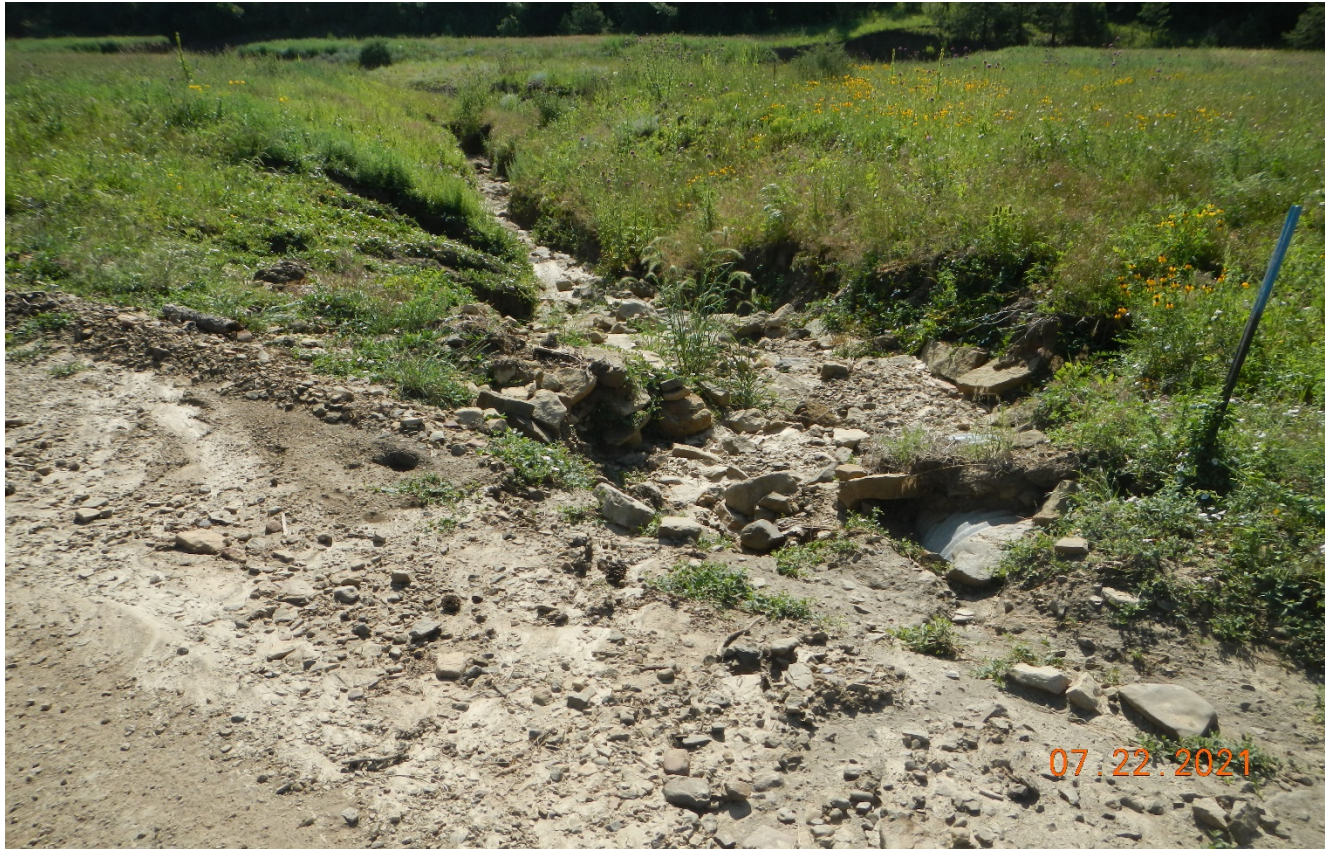
Photo 2. The culvert outlet will need to be repaired and stabilized with outlet protection.

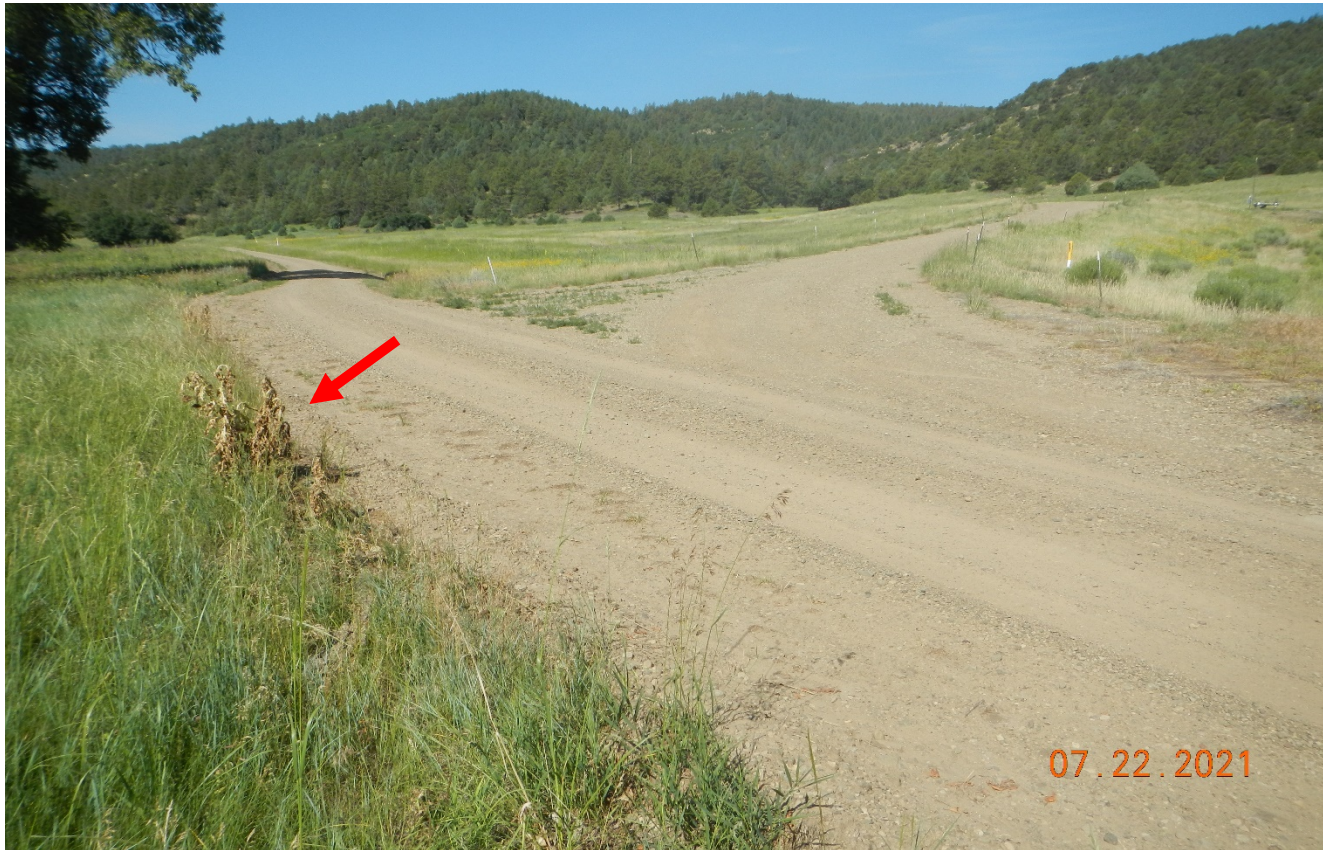
Photo 3. Facing southwest toward the access road. There are noxious weeds that are wilted along the main road and at the location. (shown at red arrow)

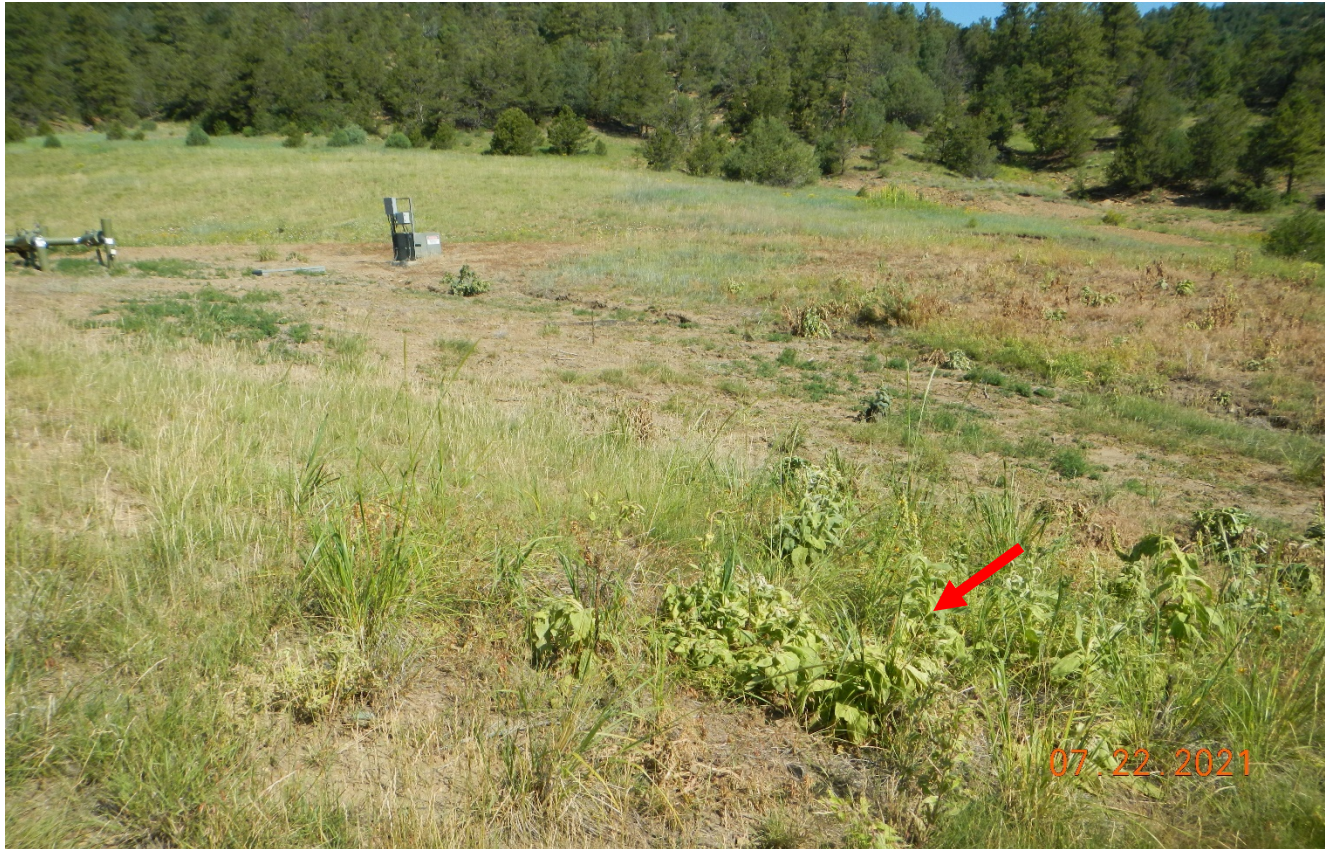
Photo 4. There are noxious weeds that are wilted at the location. (shown at red arrow)

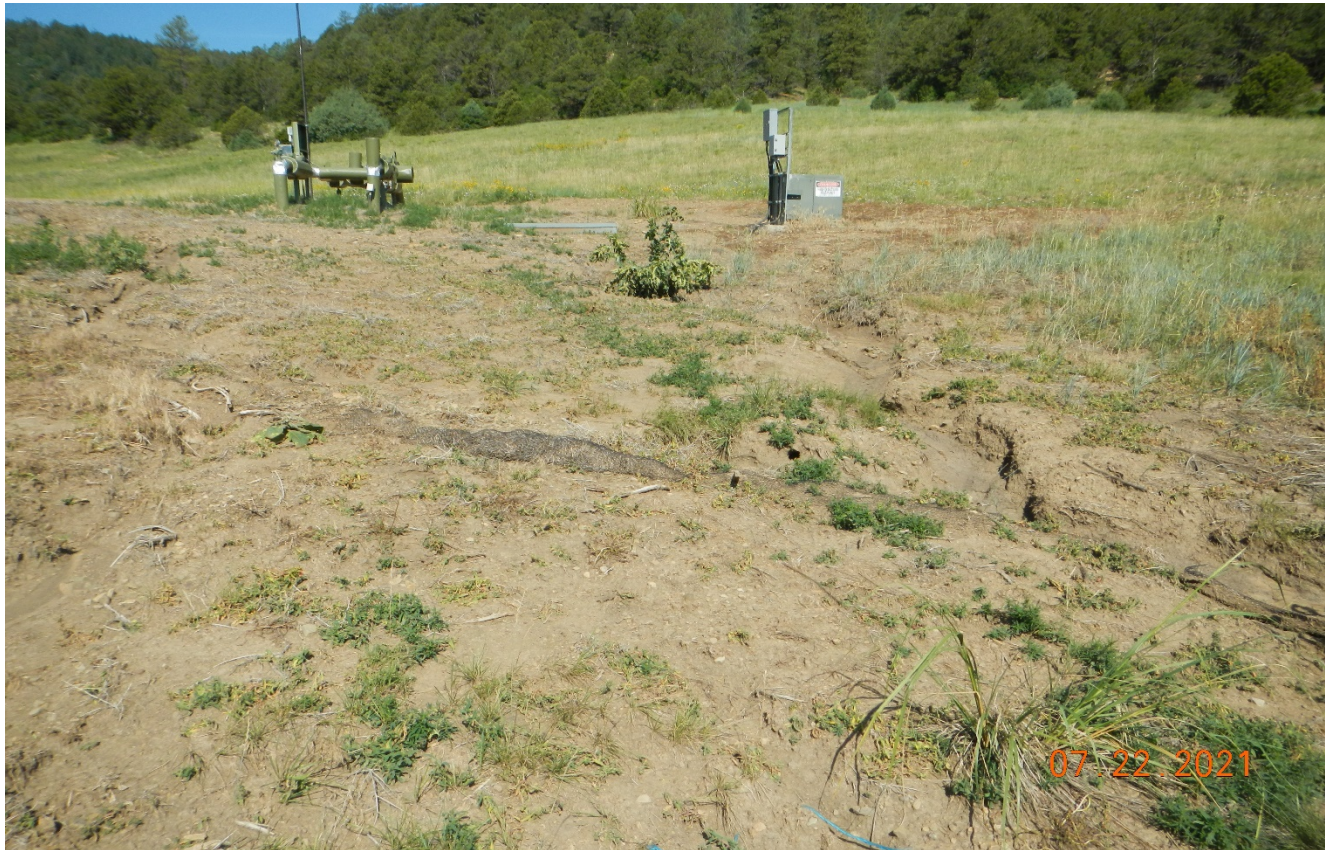
Photo 5. Facing west at the northeast side of the location. This area is not stabilized and there is an erosion channel that will need to be repaired.

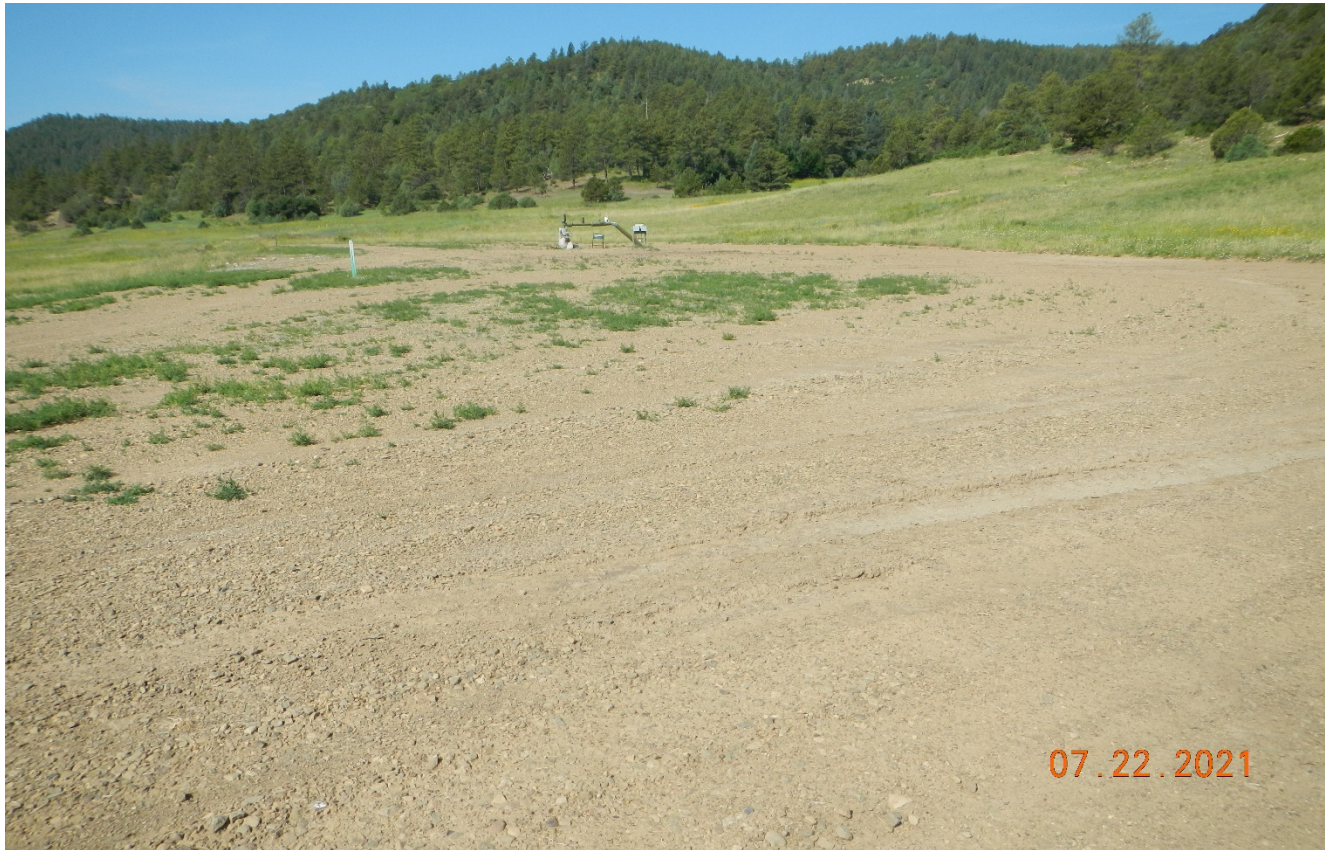
Photo 6. Facing toward the location.
