# Inspection Photos

7/21/2021

Operator: GUNNISON ENERGY LLC # 10515

Location ID: 324464

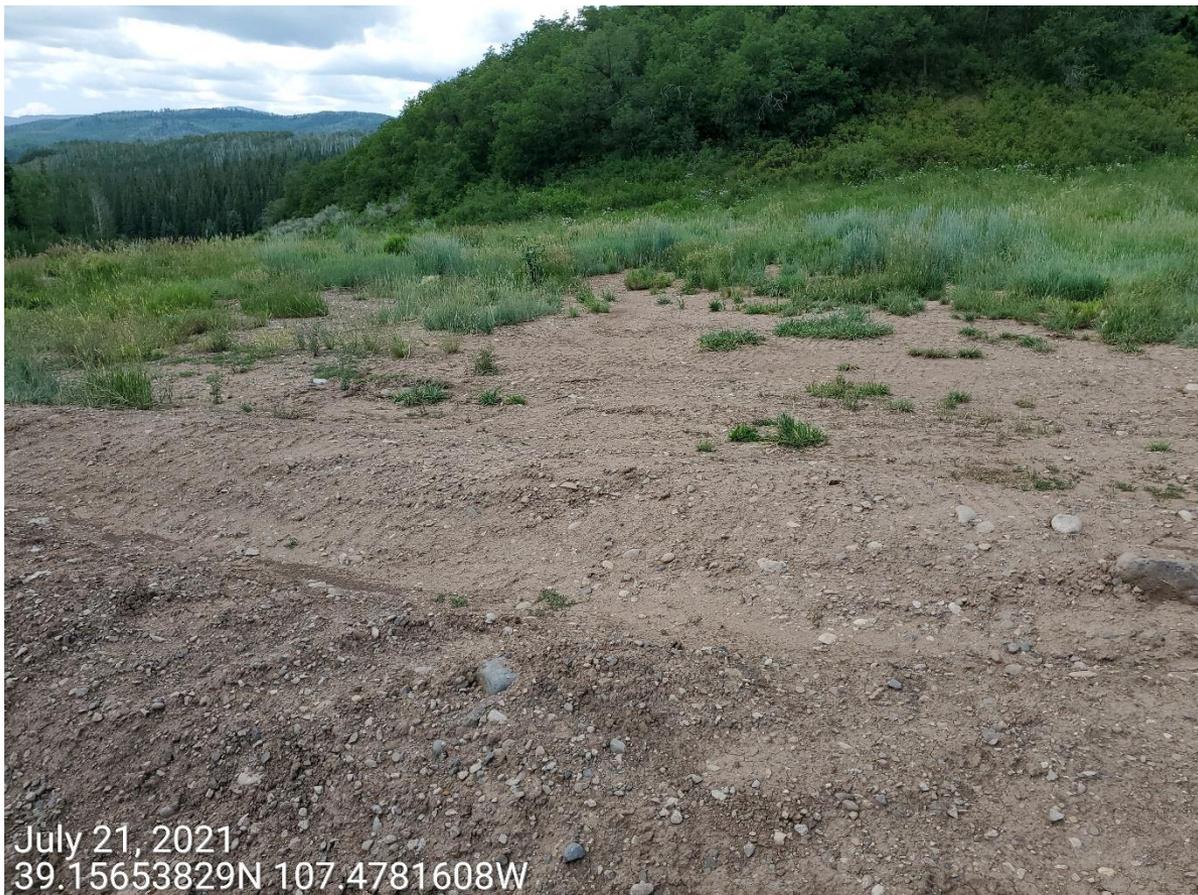
**Photo 1:** Photo shows areas on the northwest end of the Location have not been reclaimed in accordance with Rule 1003.b.

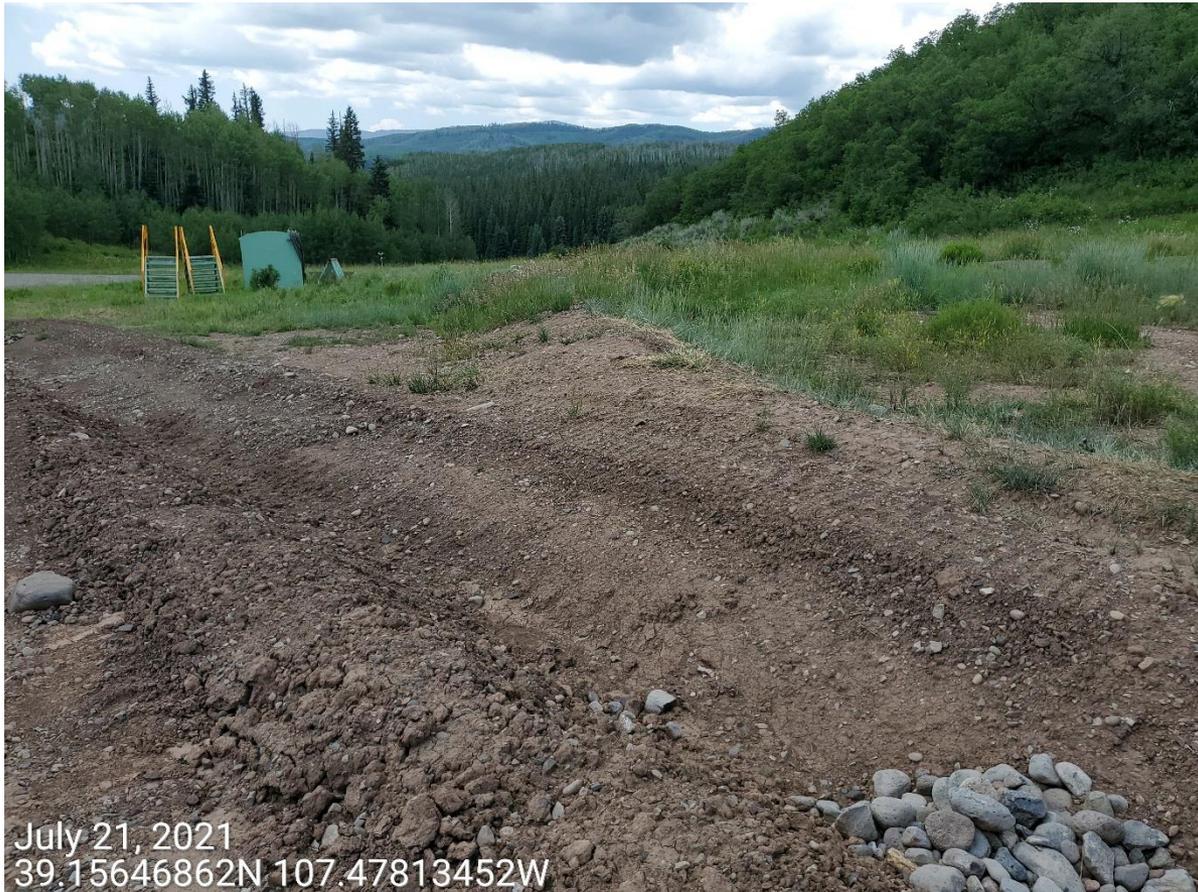
**Photo 2:** Photo shows areas on the northwest end of the Location have not been reclaimed in accordance with Rule 1003.b.

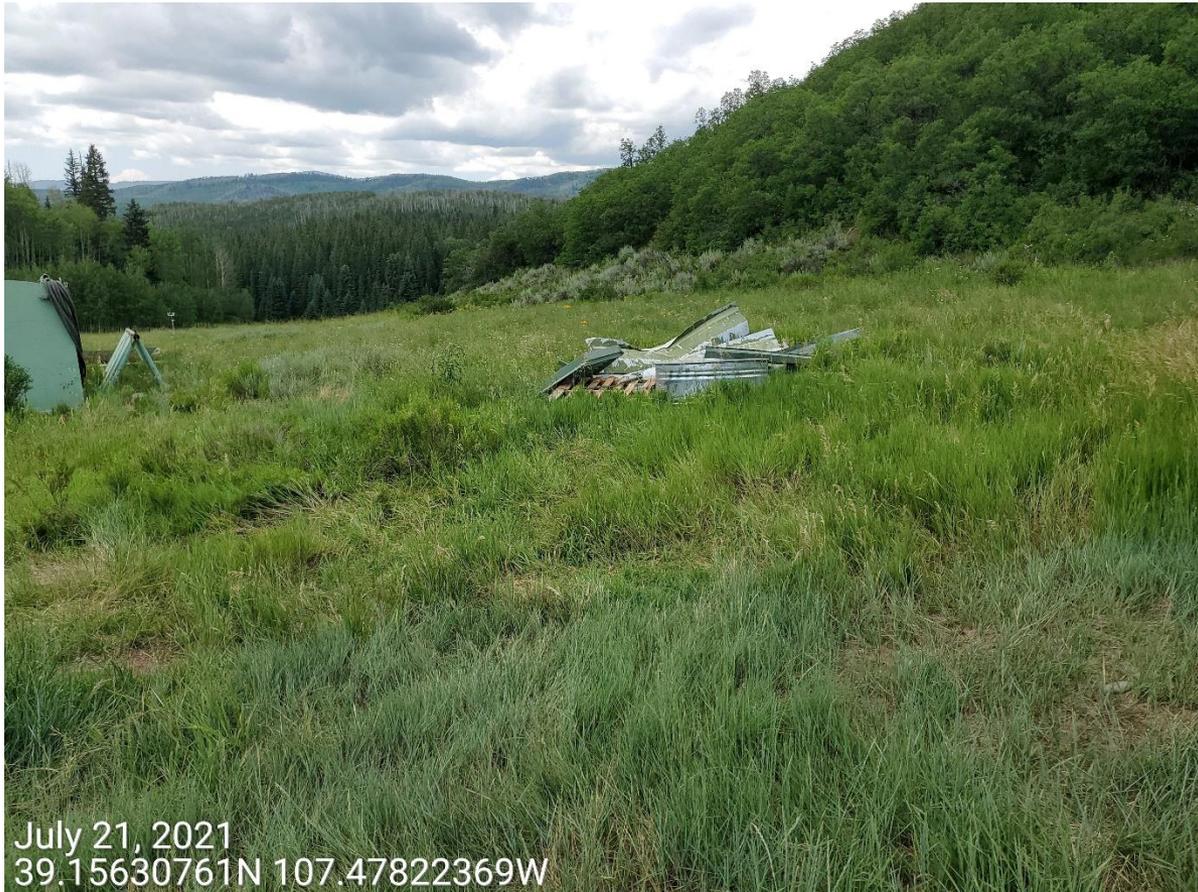
**Photo 3:** Photo taken from the west of the Location. Photo shows various unused equipment and/or debris now being stored off of the Location.

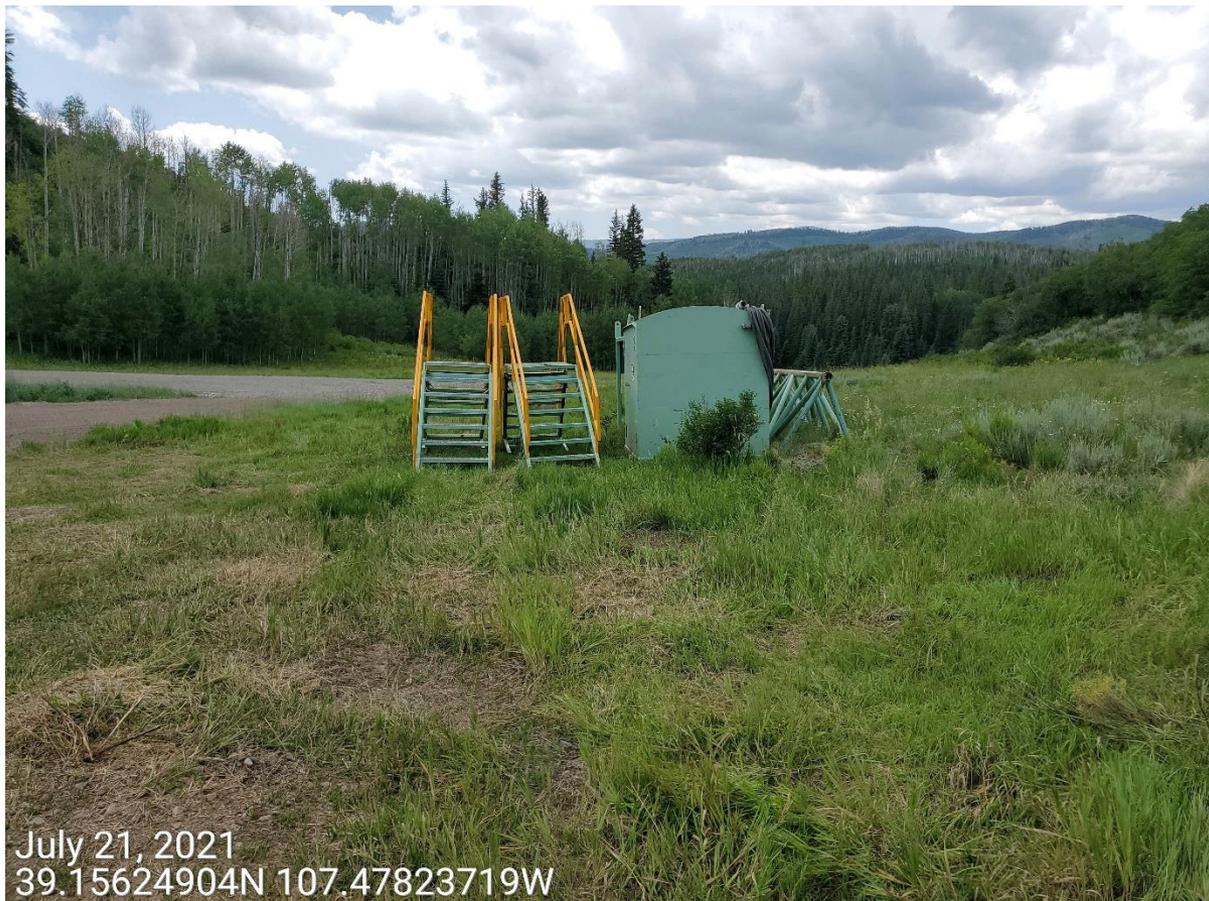
**Photo 4:** Photo taken from the west of the Location. Photo shows various unused equipment and/or debris now being stored off of the Location. .

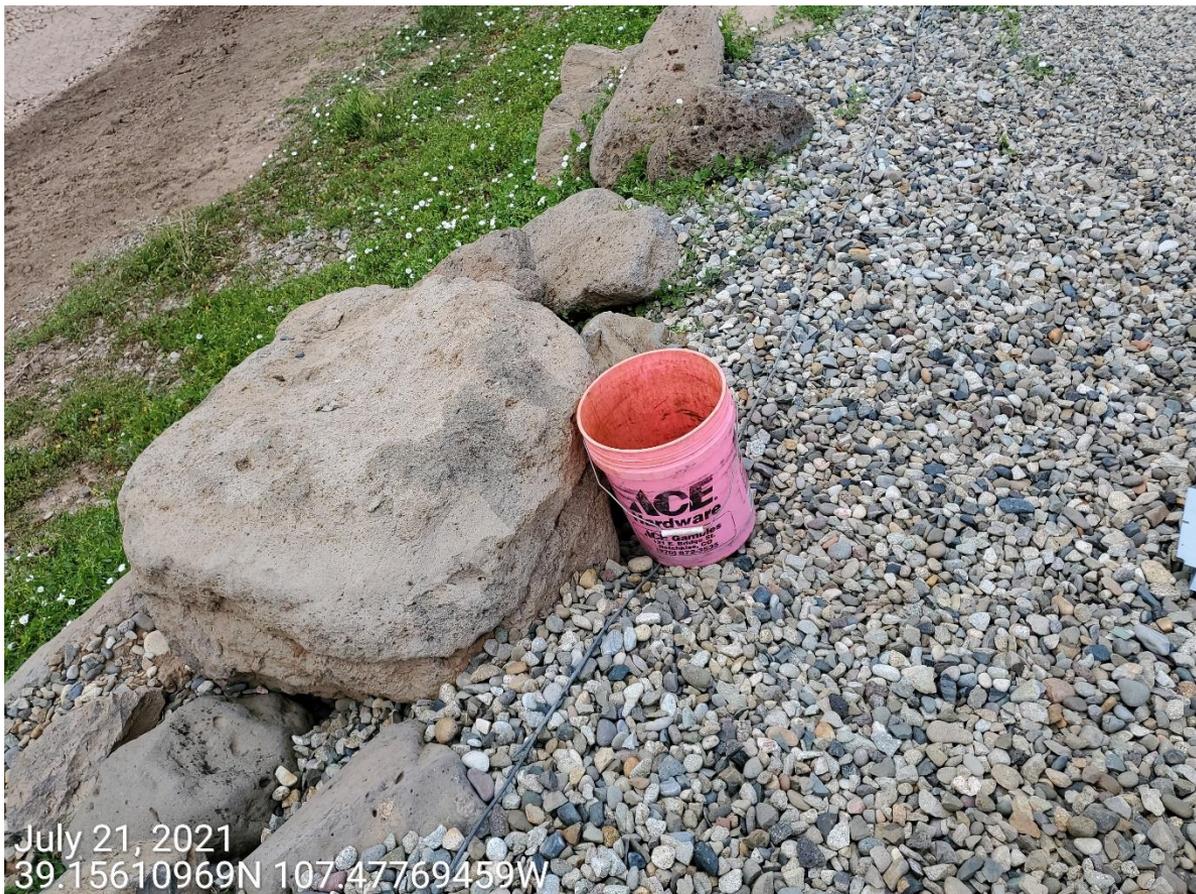
**Photo 5:** Photo taken from the west end of the Location. Photo shows a bucket containing unknown fluids; no safety labeling has been applied identifying contents; bucket has not been placed into secondary containment.

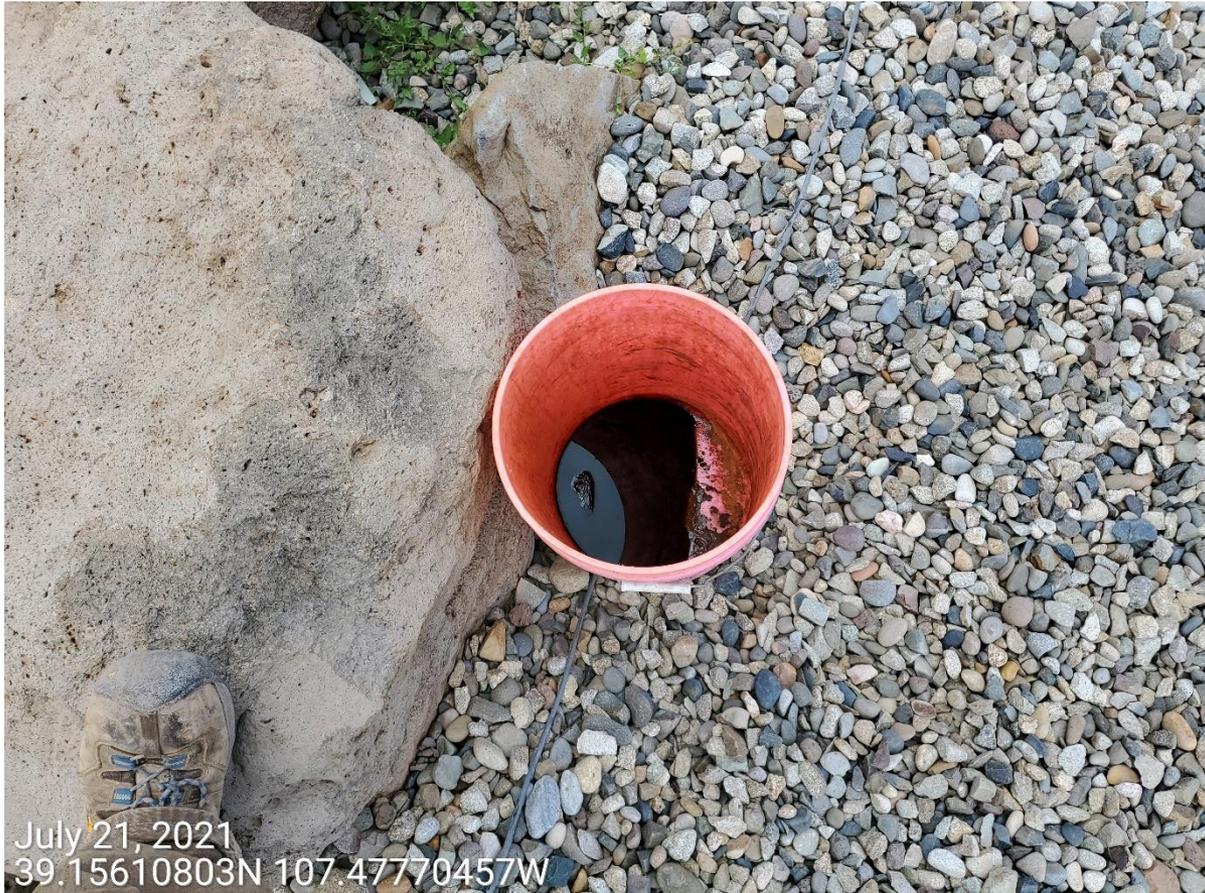
**Photo 6:** See comments under photo 5.

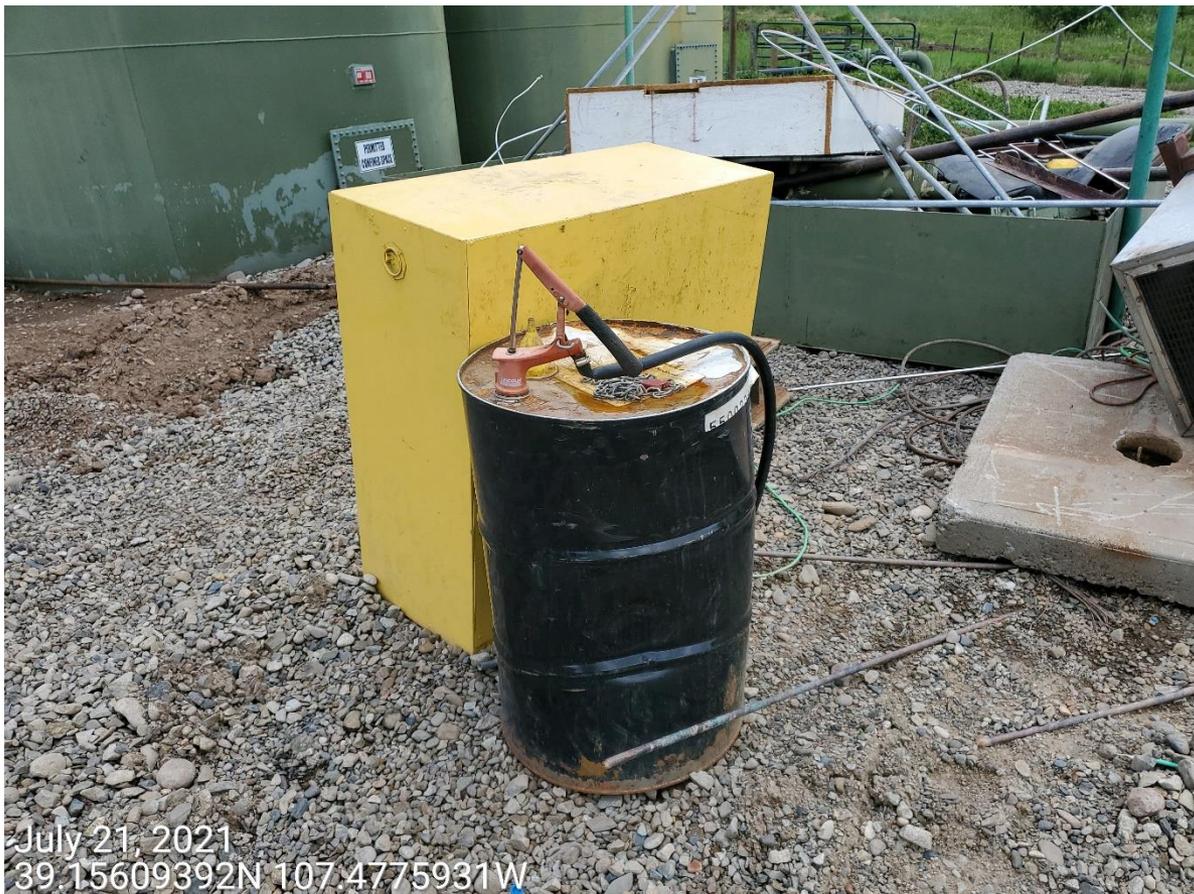
**Photo 7:** Photo shows barrel containing antifreeze/coolant. Barrel requires secondary containment.

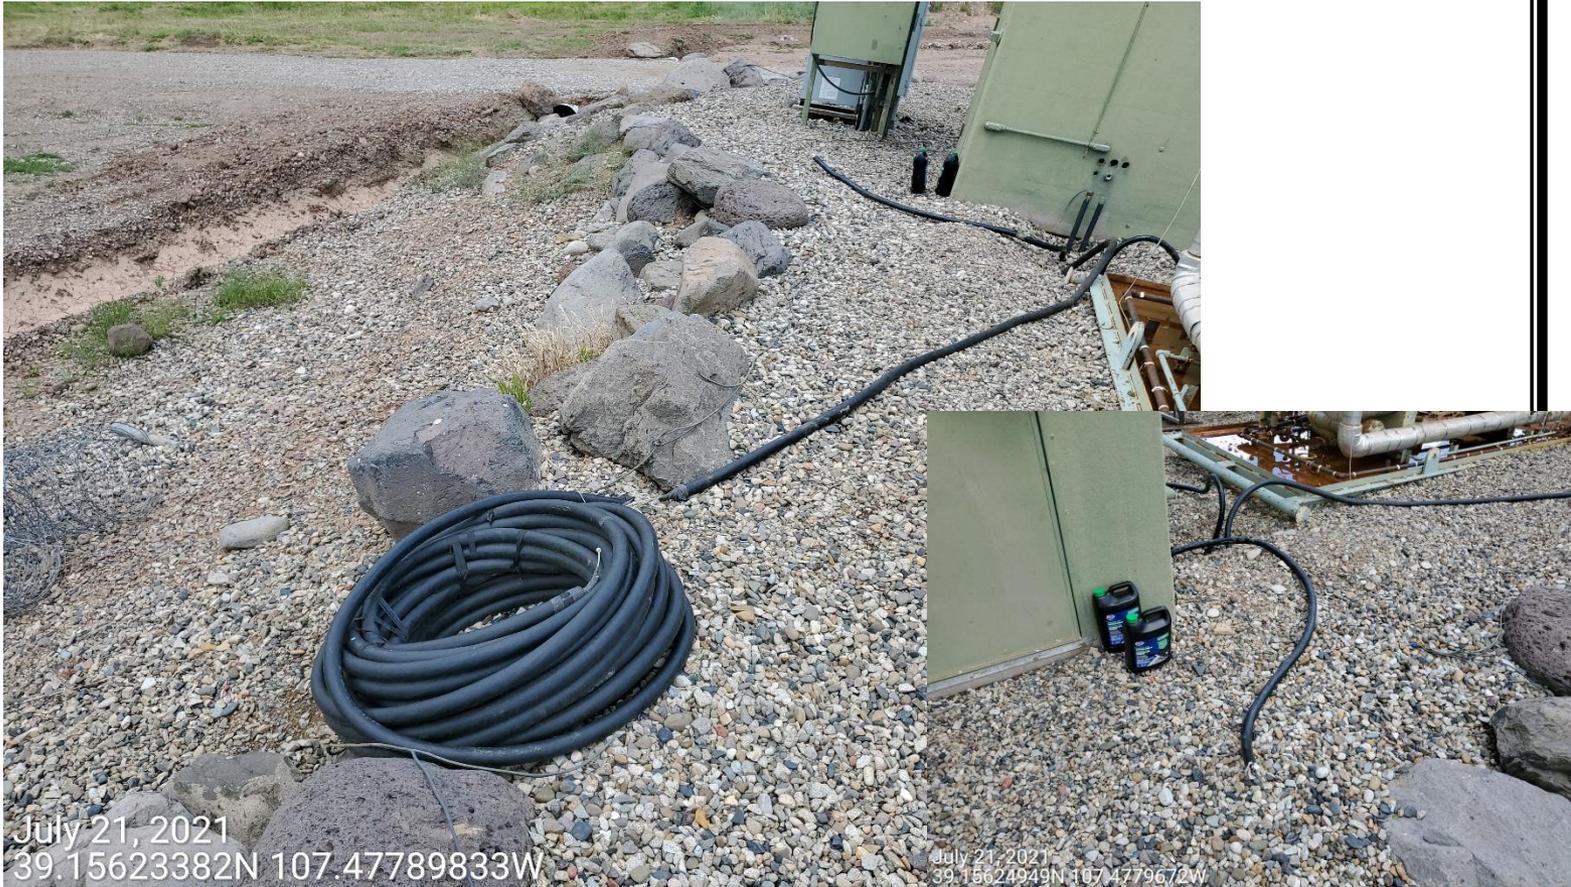
**Photo 8:** Previous inspections observed that good-housekeeping practices were not being performed; various unused equipment, trash debris, and equipment not necessary for production on this Location stored on the site. Photos 8-12 shows equipment/debris/etc.. has not been removed. Additionally, new pipe has been brought onto the location (Photos 10,11); this pipe is also not necessary for production on this Location, and has not been stored in a workman-like manner.

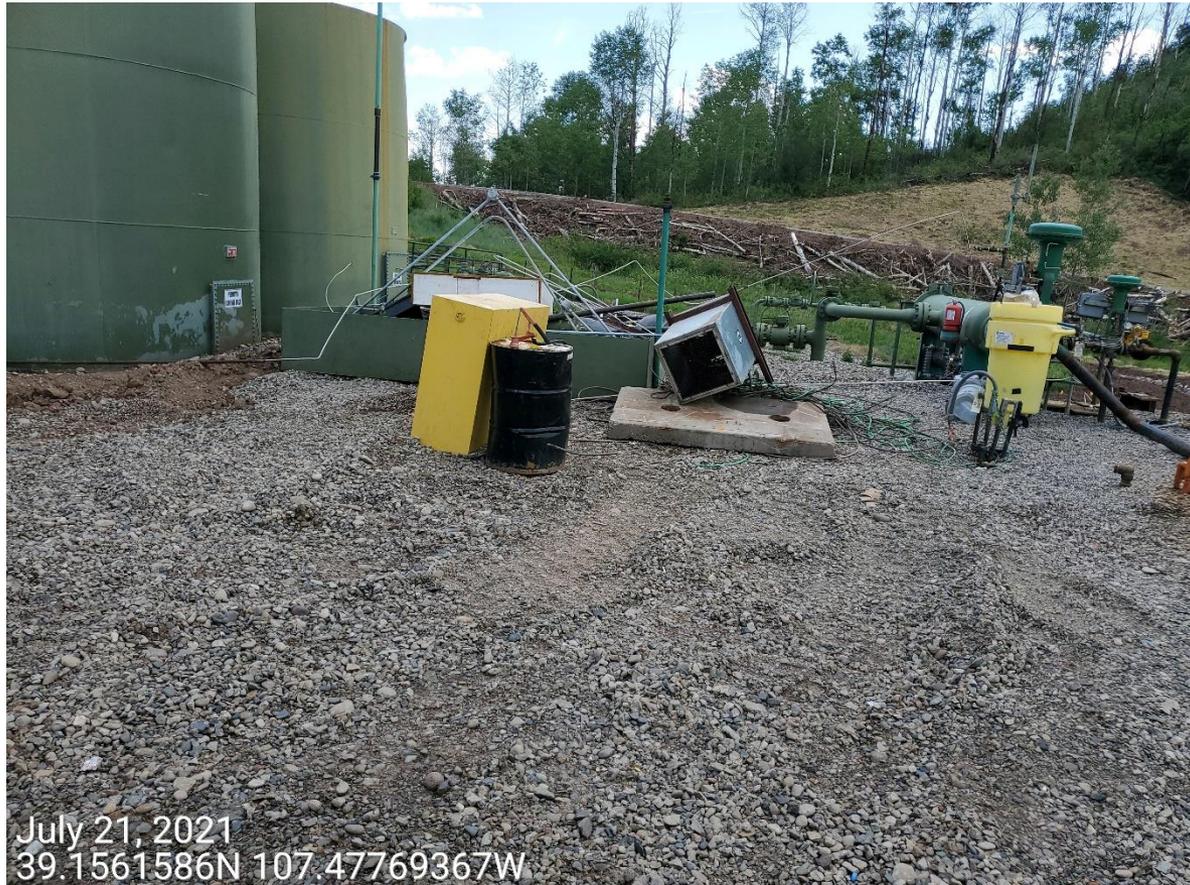
**Photo 9:** See comments under photo 8.

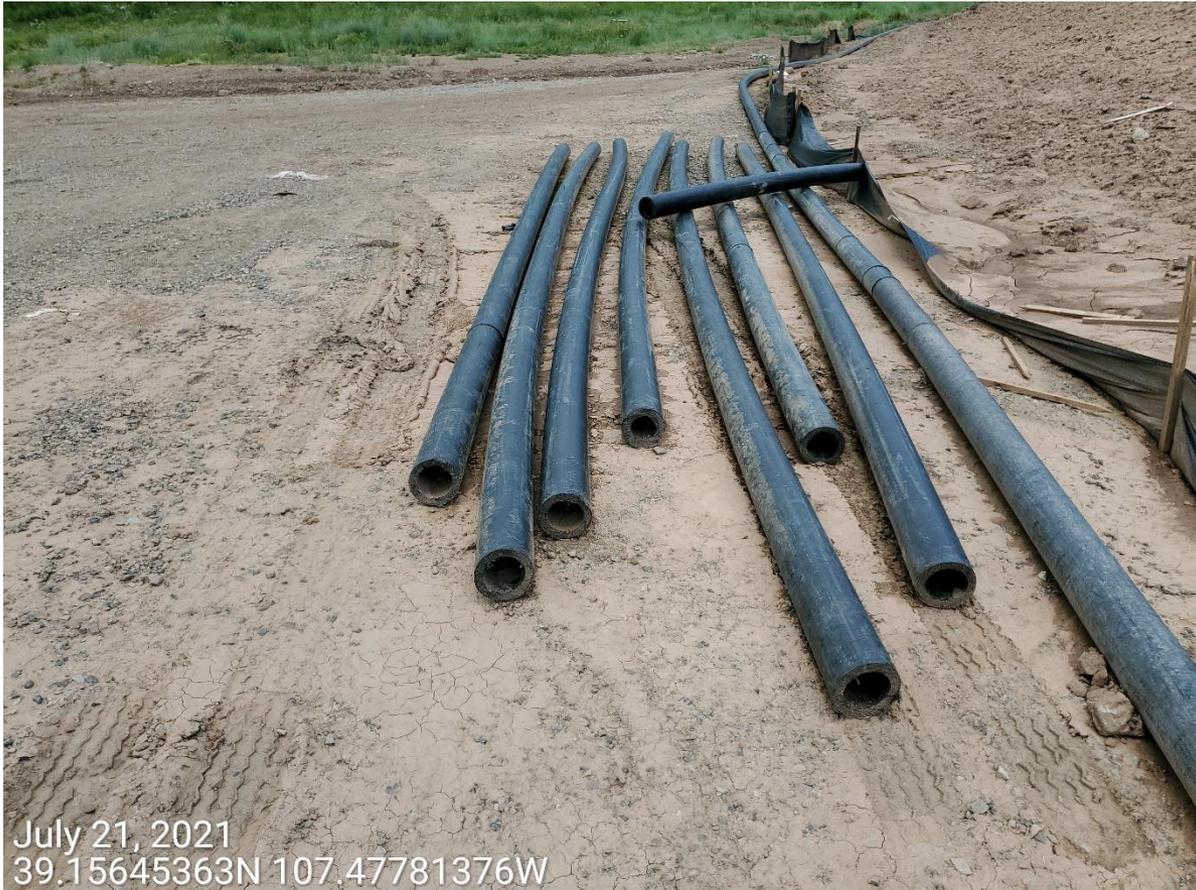
**Photo 10:** See comments under photo 8.

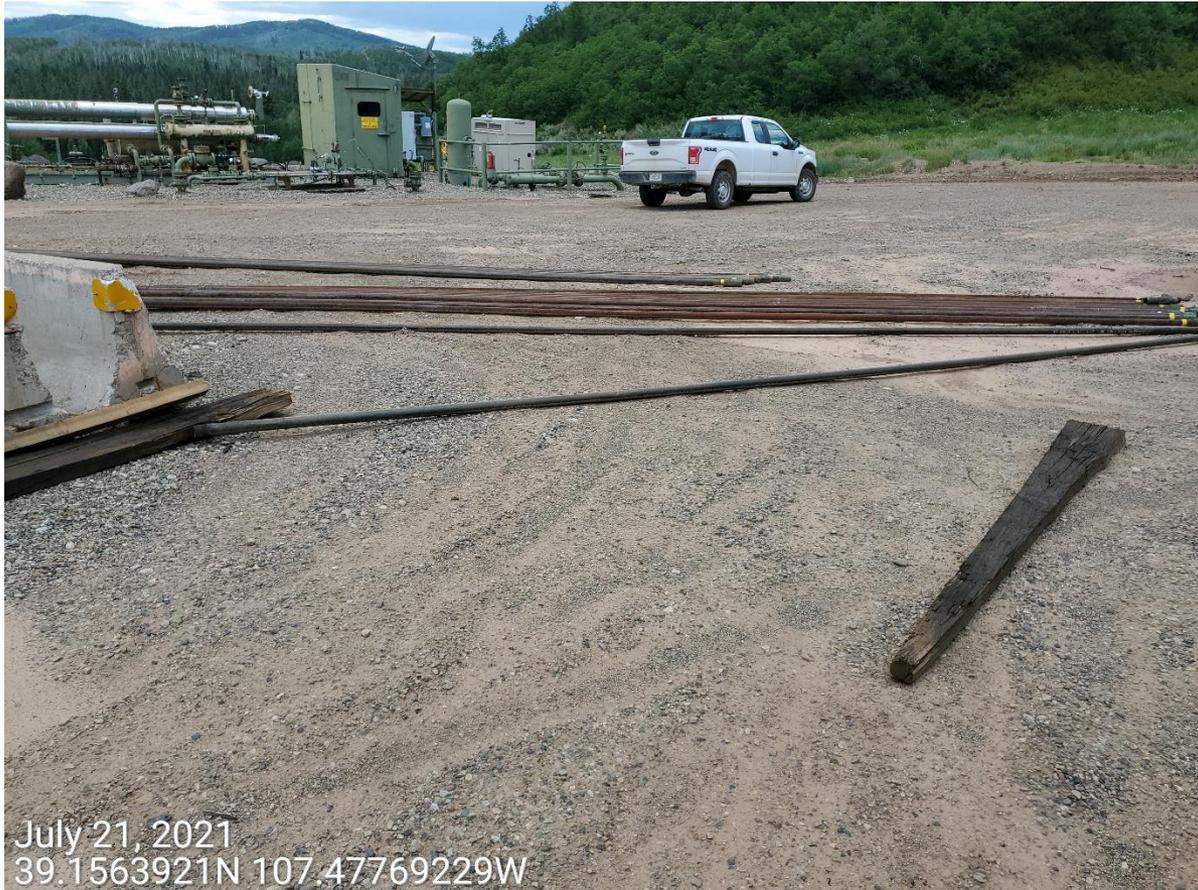
**Photo 11:** See comments under photo 8.

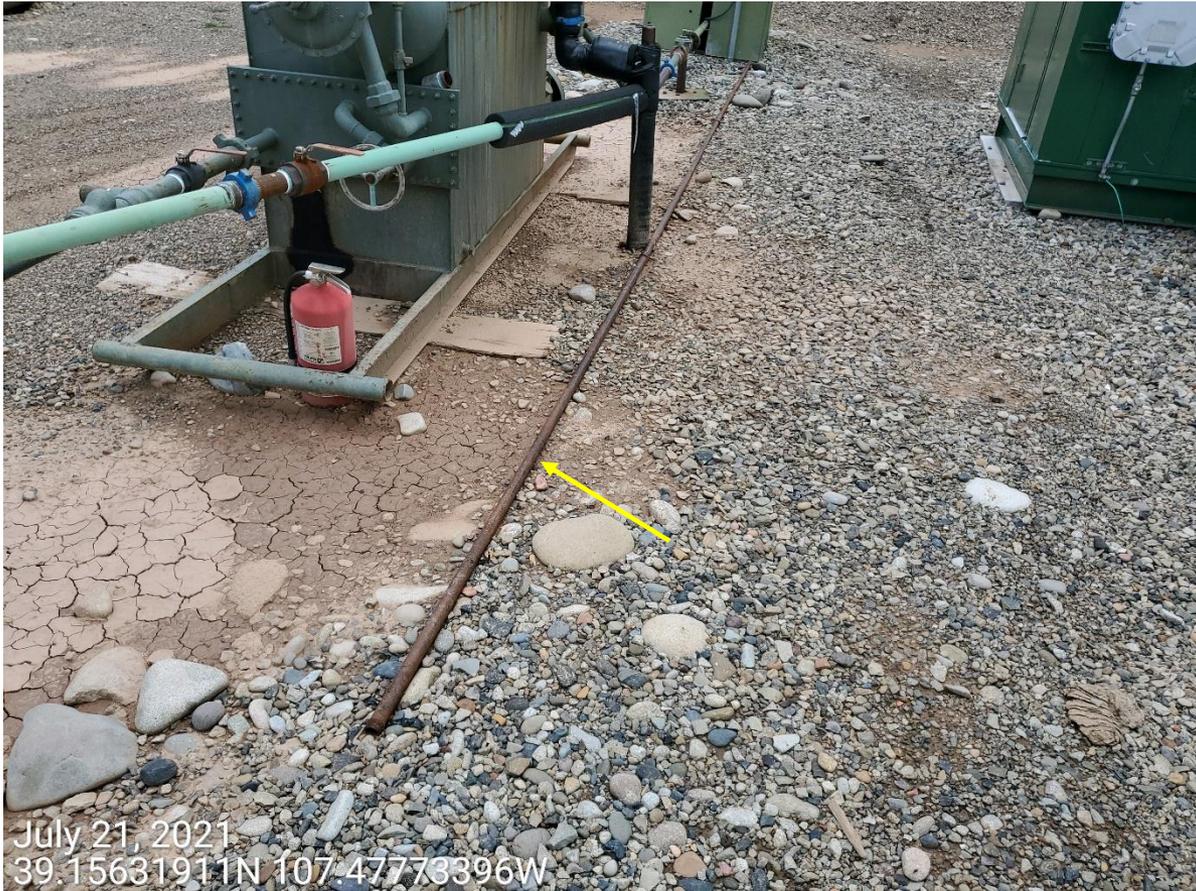
**Photo 12:** See comments under photo 8.

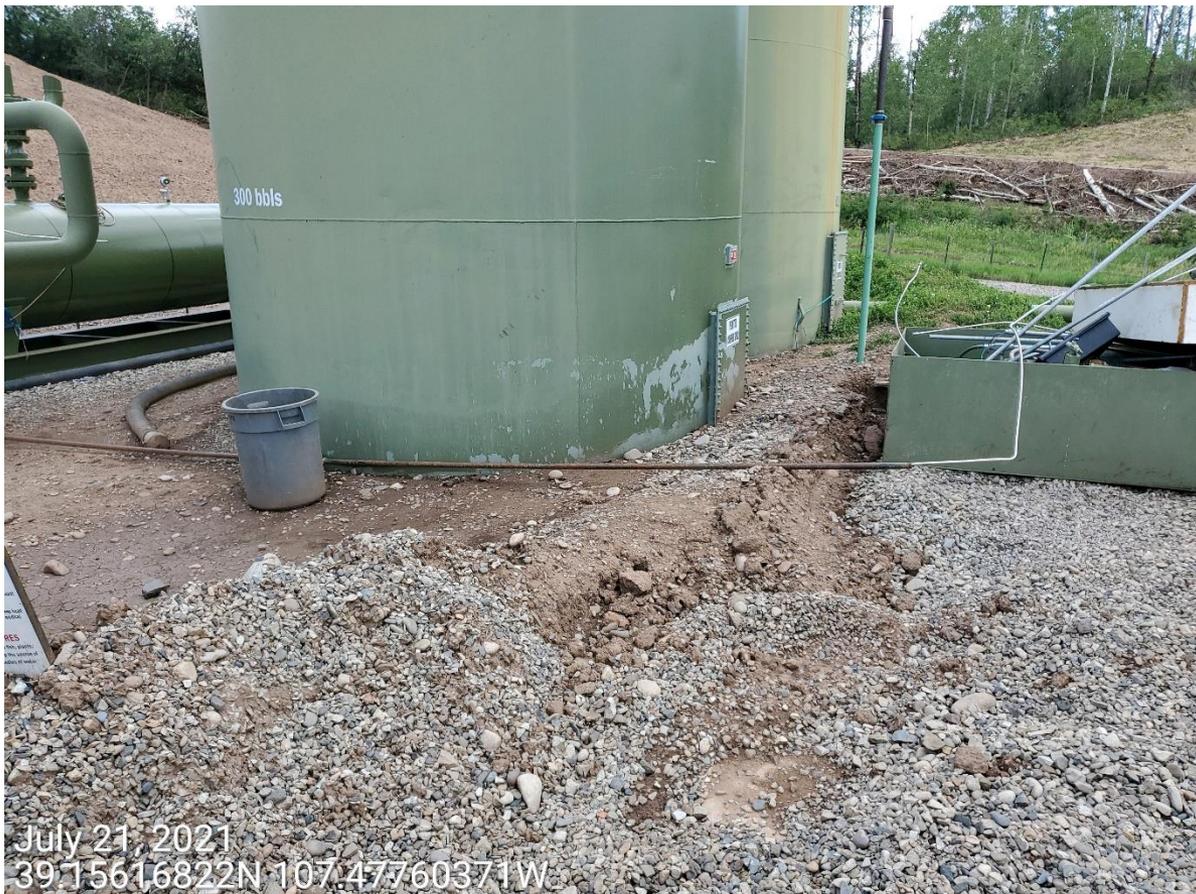
**Photo 13:** Photo shows secondary containment around the tank battery remains inadequate.

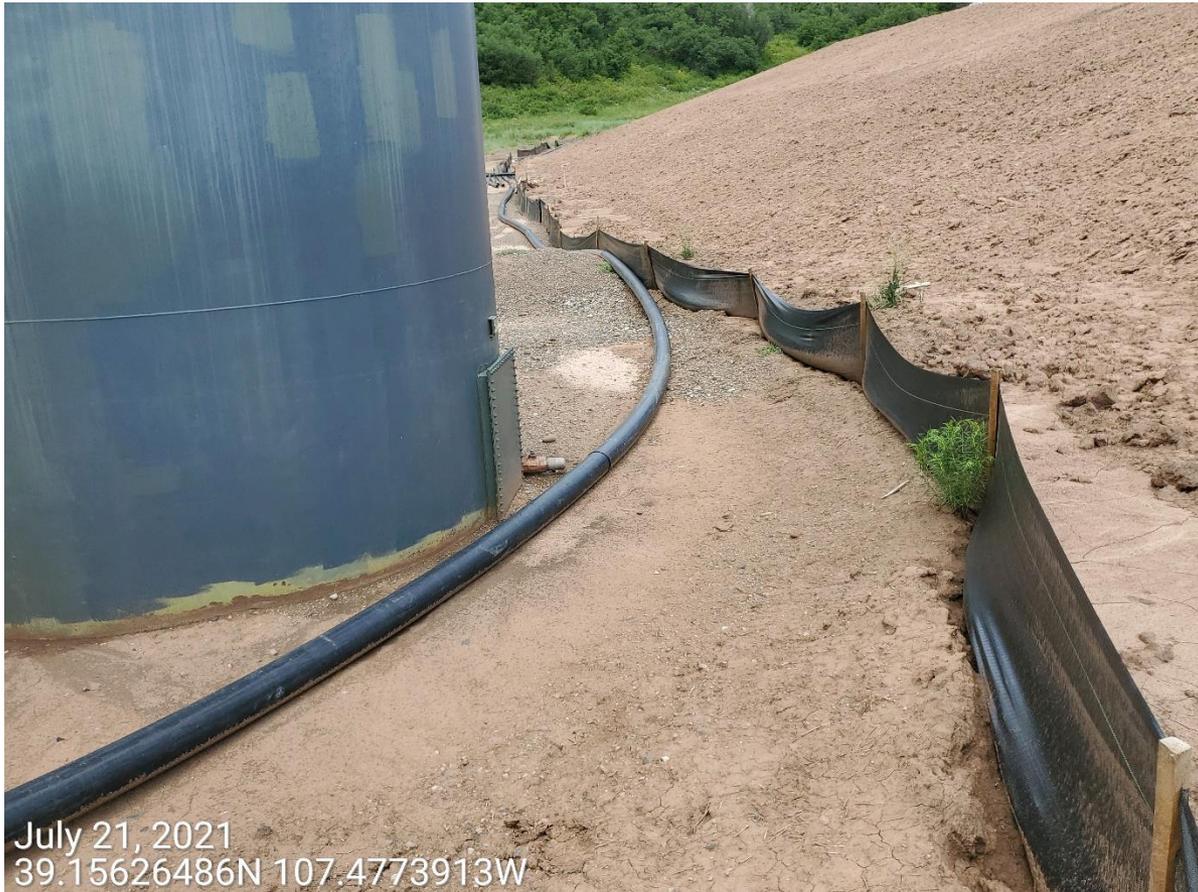
**Photo 14:** Photo shows secondary containment around the tank battery remains inadequate.

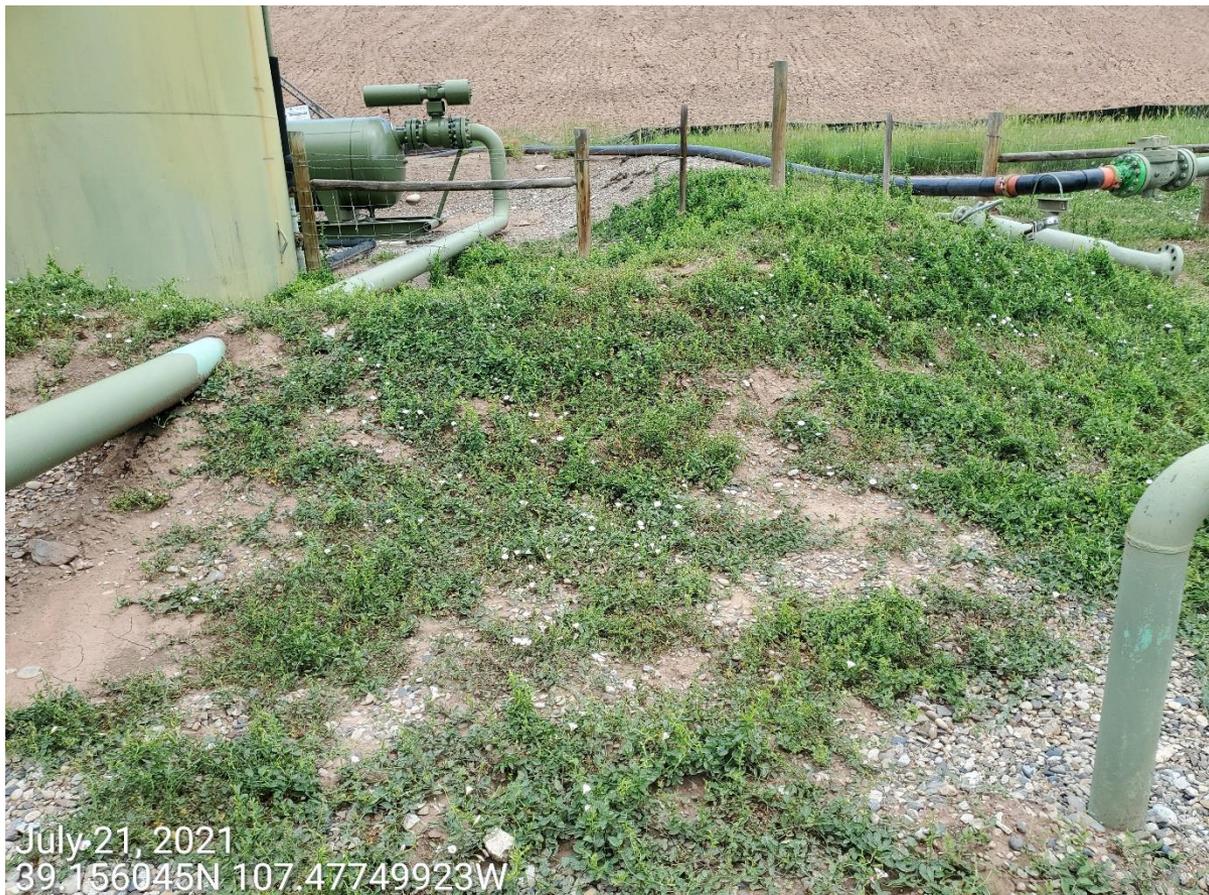
**Photo 15:** Photo taken from the southwest end of the Location, facing east. Photo shows noxious weed establishment on the Location.

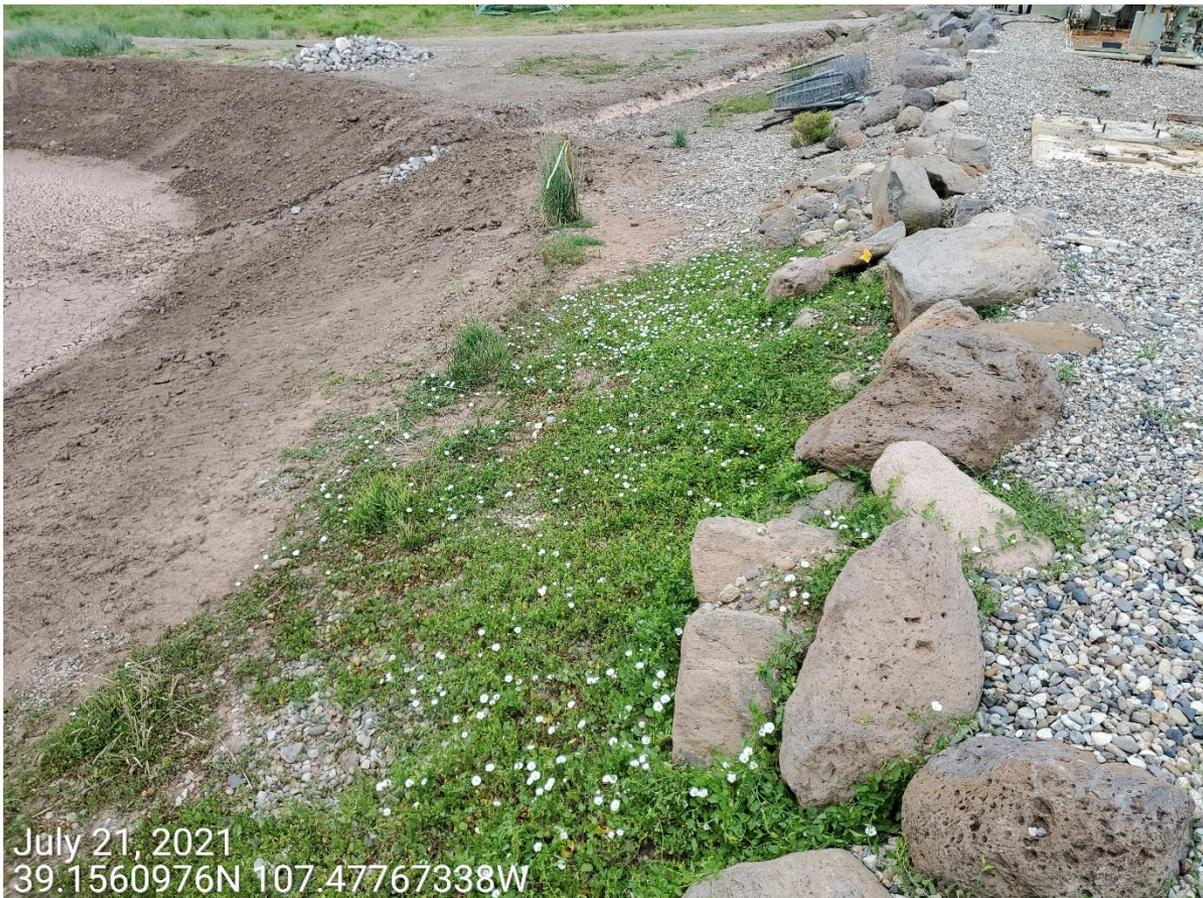
**Photo 16:** Photo taken from the southwest end of the Location, facing south. Photo shows noxious weed establishment on the Location.
