Inspection Photos  
Operator: Simcoe  
API: 067-07088  
Date: 7/23/2021

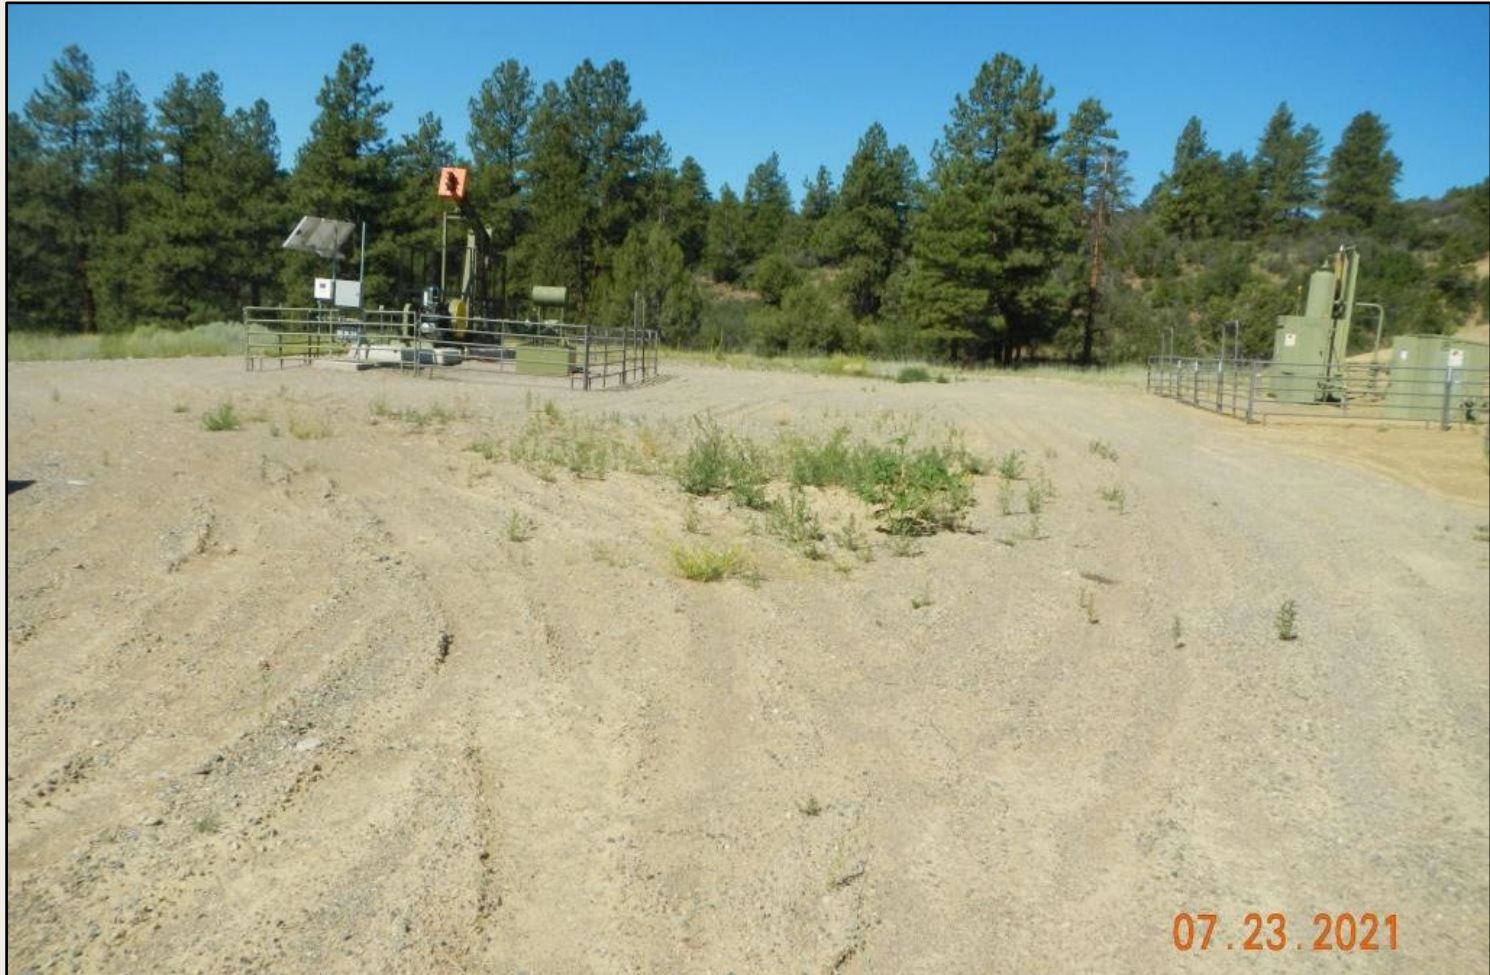
Photo 1. View of the project area from the well pad entrance facing center.

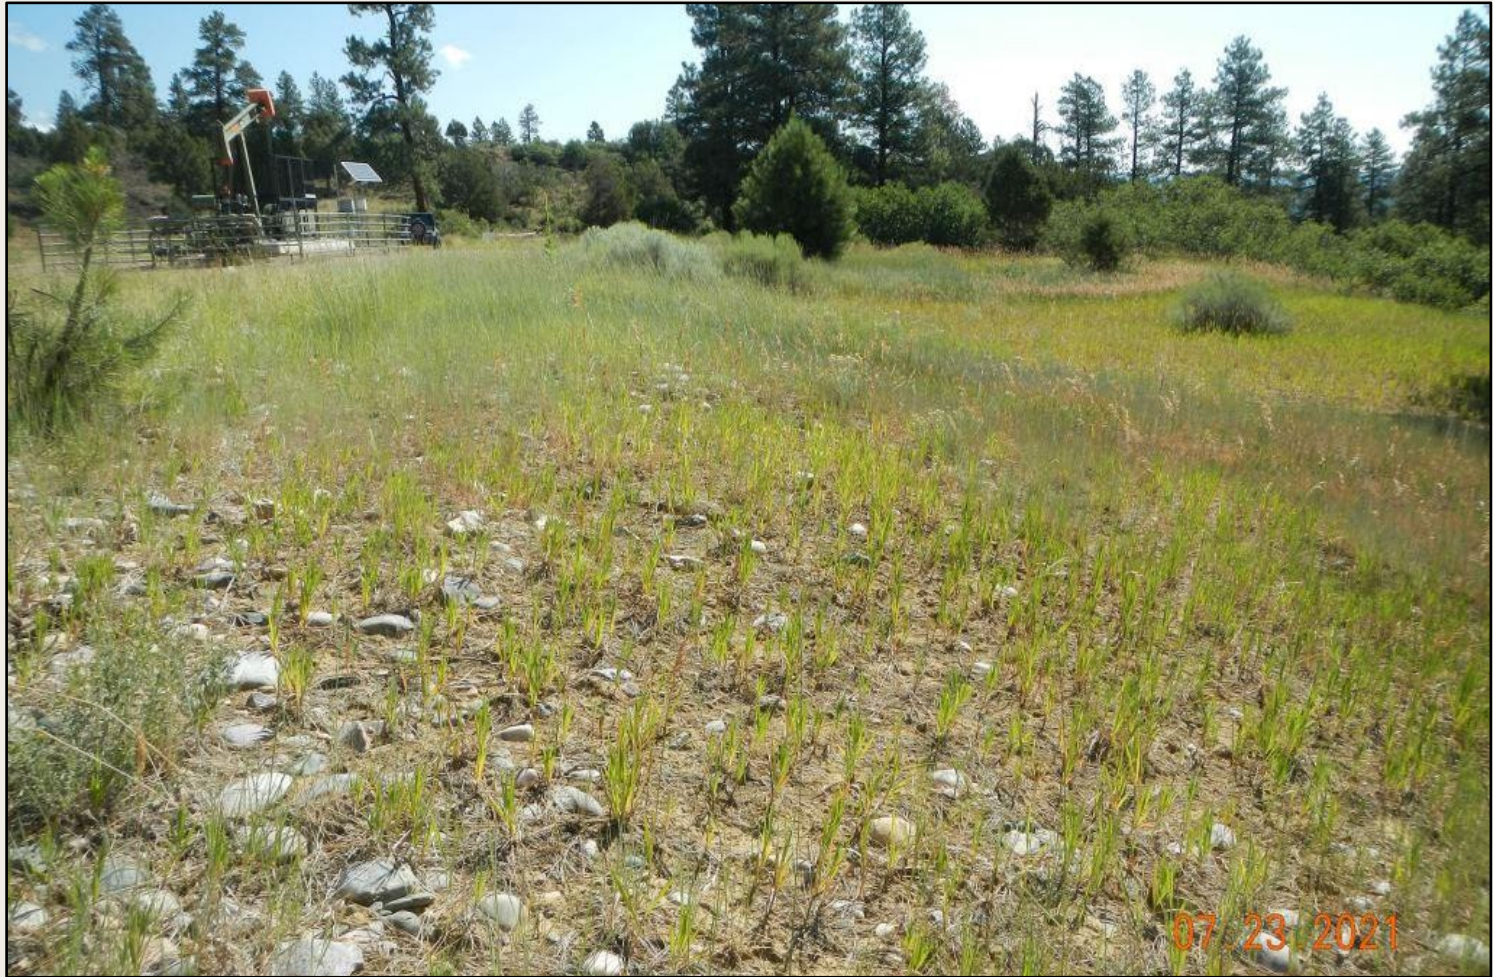
Photo 2. View of the southern project area from the southwestern corner facing eastward. Revegetation is progressing with western wheatgrass and smooth brome.

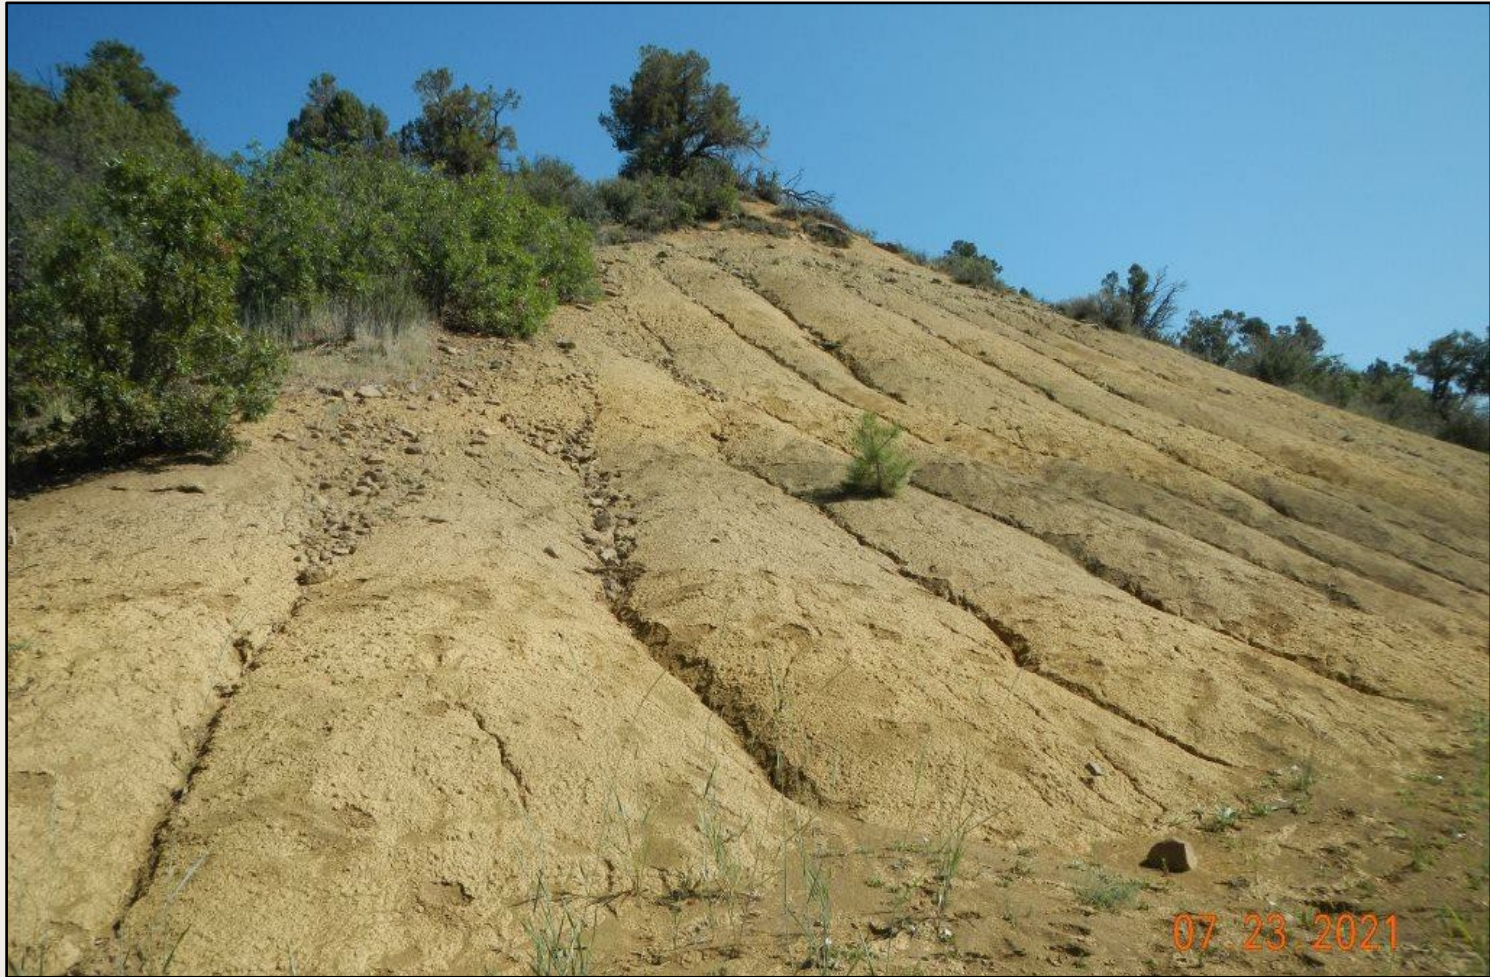
Photo 3. View of unstabilized cut-slope in the northern project area with erosional rilling and channeling up to 18 inches wide and deep. Long term stabilization measures are needed on exposed and eroding soils.

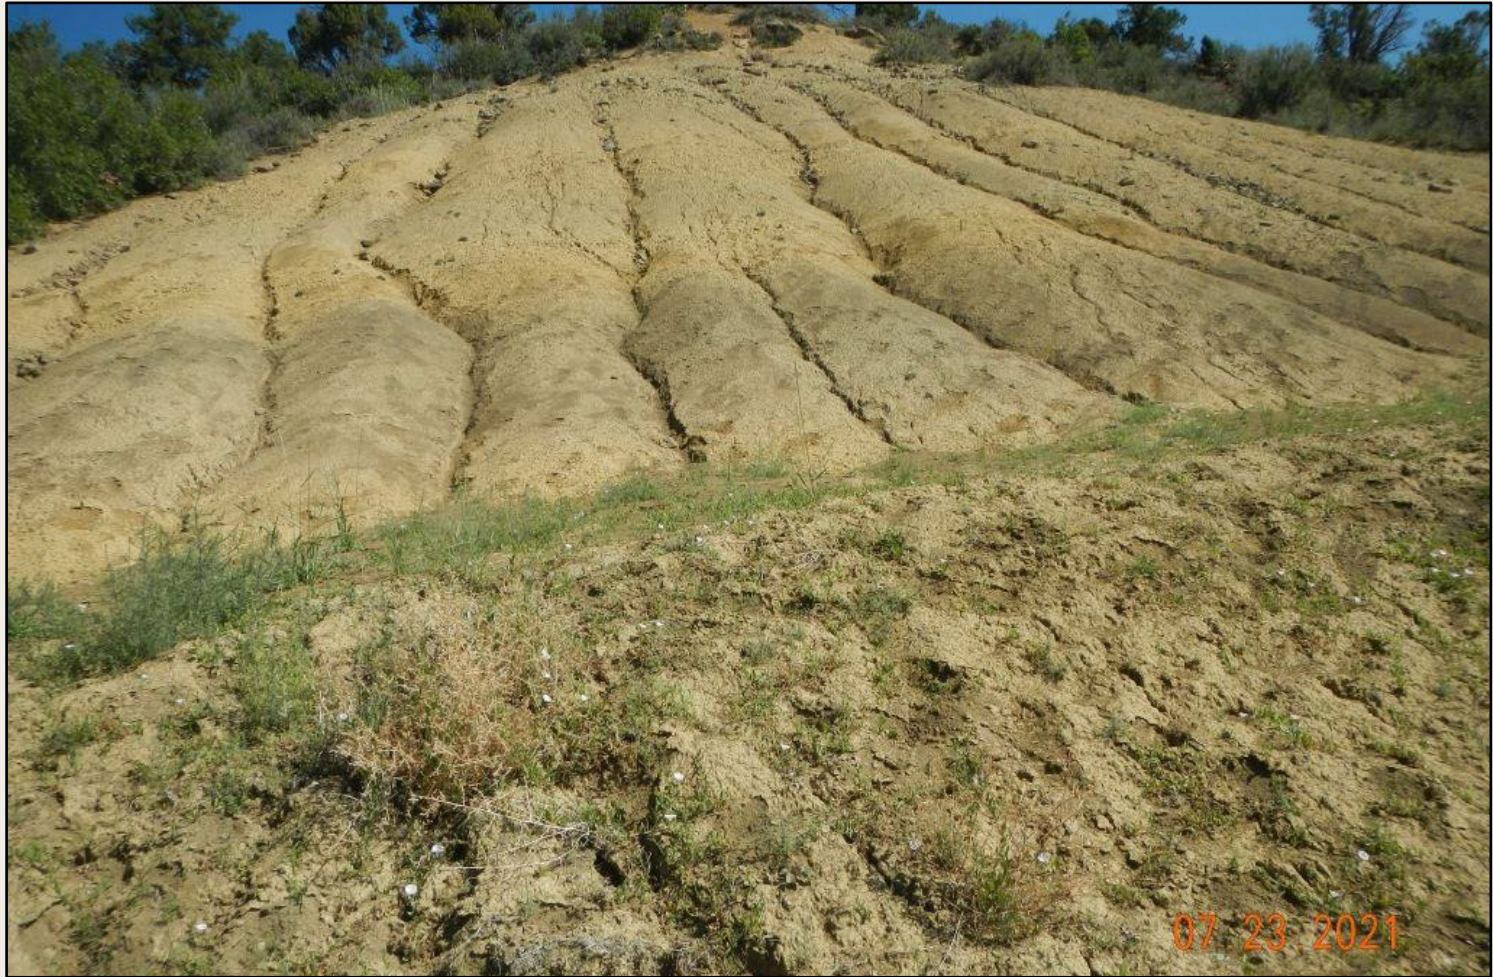
Photo 4. Another view of erosional rilling on the well pad cut-slope and sediment deposition at the base. Photo looking up-slope.

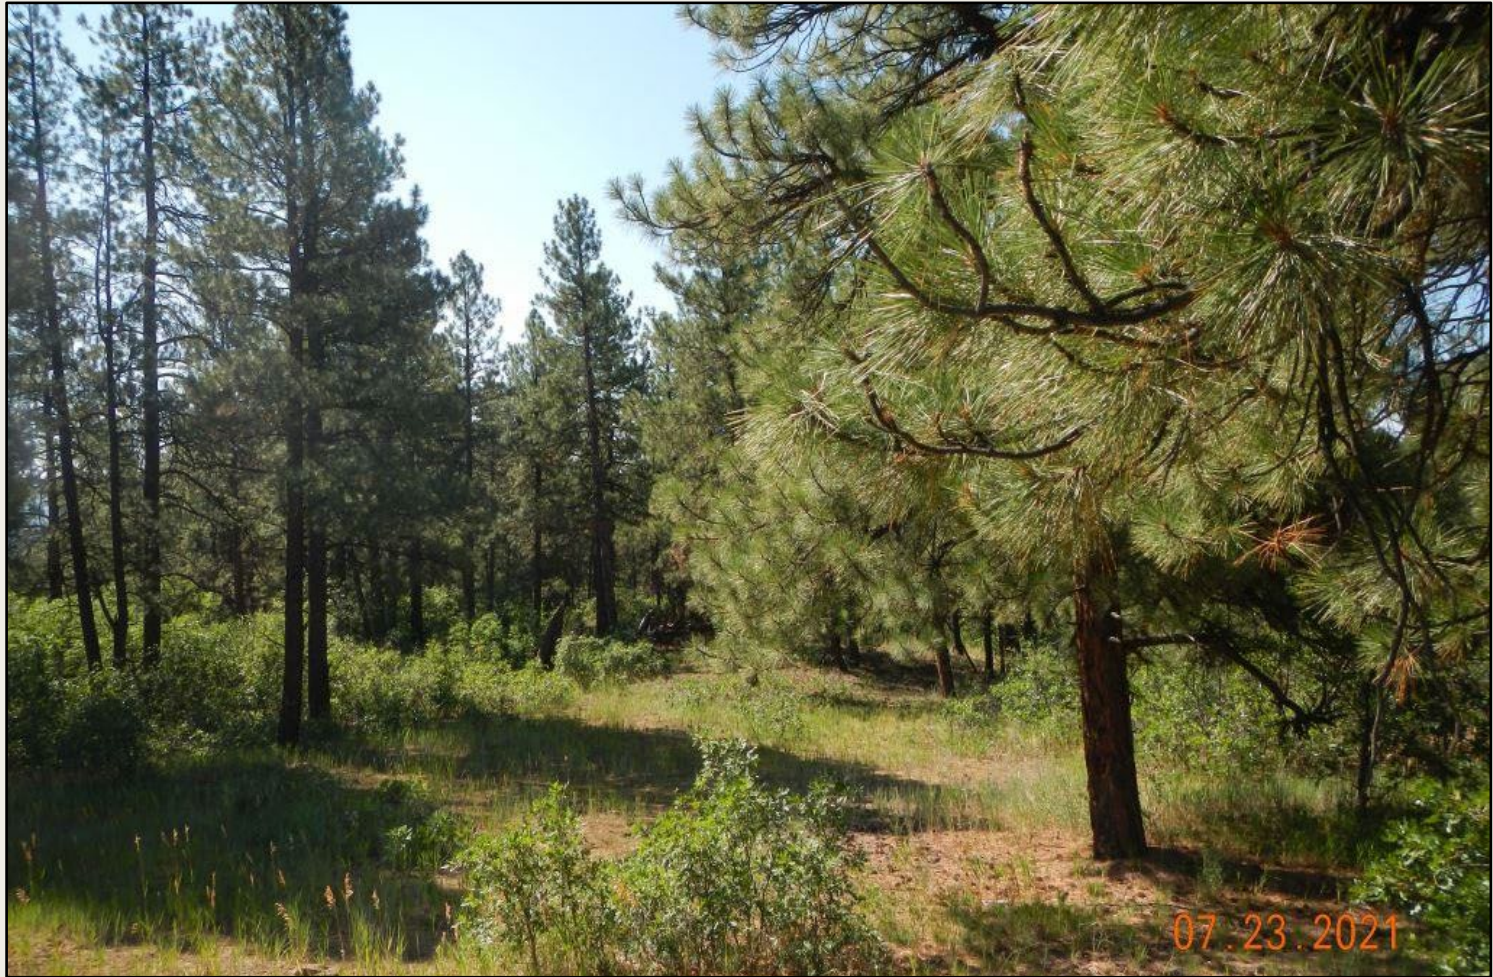
Photo 5. View the reference area comprised of ponderosa pine woodland with understory of gambel oak, serviceberry, western wheatgrass, and Oregon grape.
