Final Reclamation Inspection

Operator: KERR MCGEE OIL & GAS ONSHORE LP #47120

Location ID: 320377

Inspection Document #: 697503082

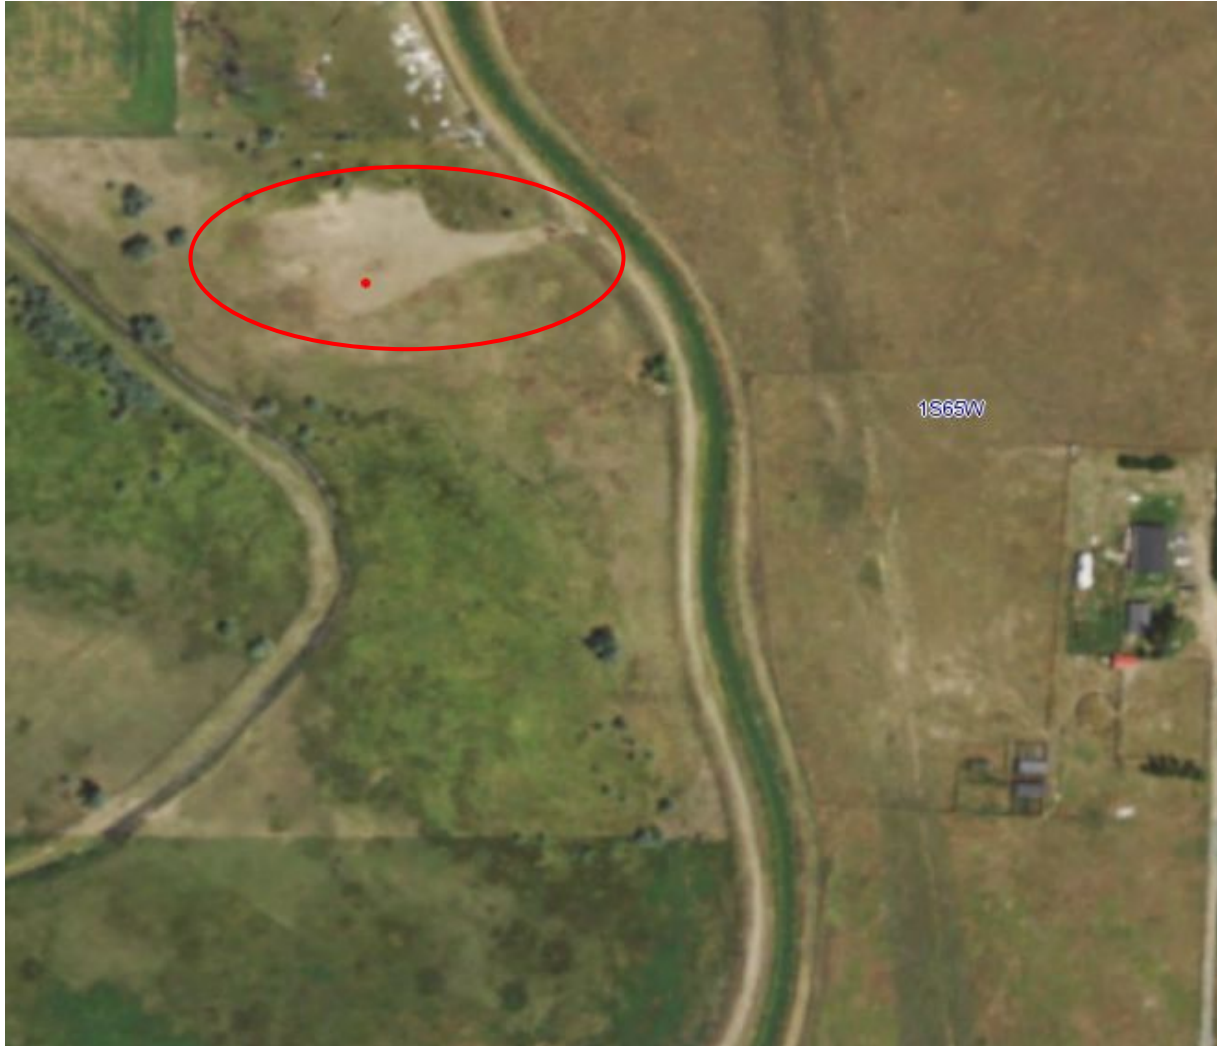
Photo 1. 2019 aerial imagery illustrates the well location and associated tank battery. There is a pre-existing main access road utilized for ditch water access right-of-way that is not the responsibility of the Operator to reclaim.

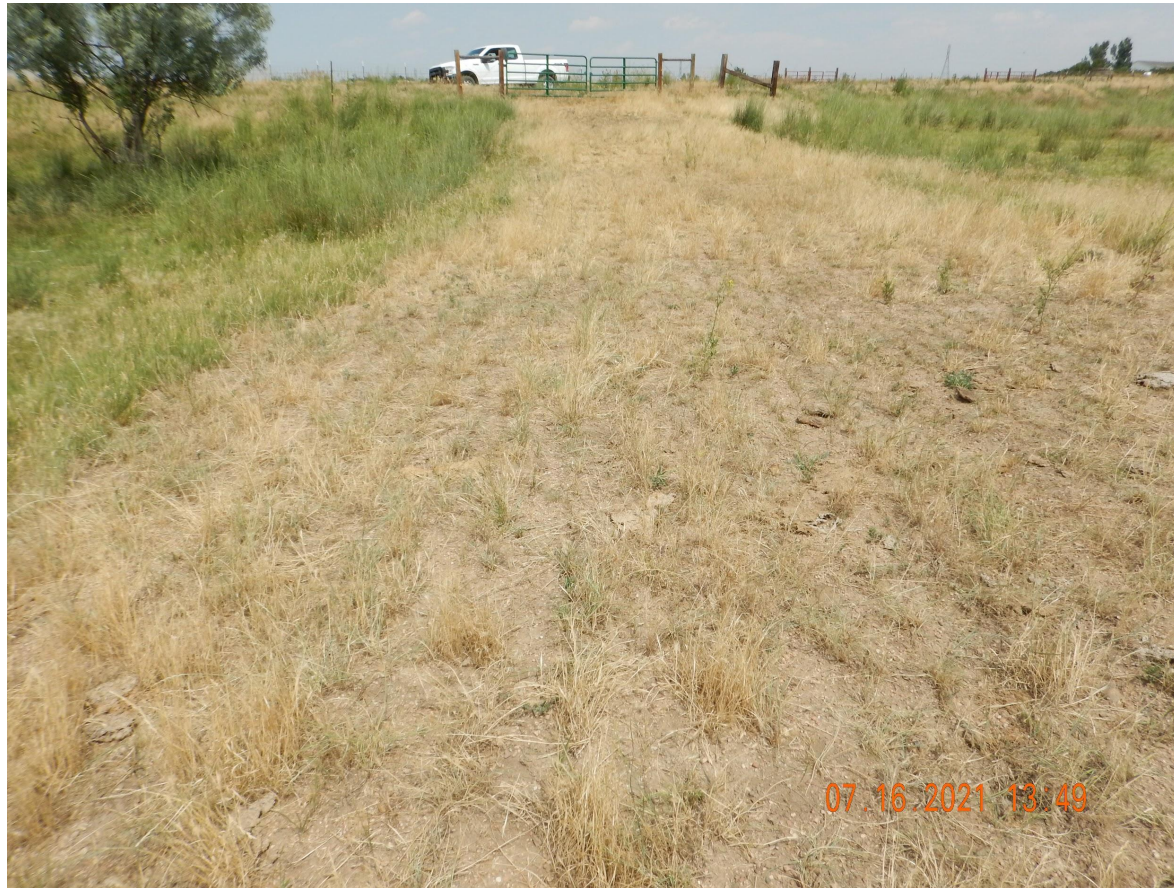
Photo 2. Photo taken from the eastern location, facing East. Photo illustrates in response to the previous corrective action inspection from May 2018, reclamation has been performed at the location. Desirable perennial vegetation was observed but the location will remain in-process until it meet Rule 1004 vegetative requirements.

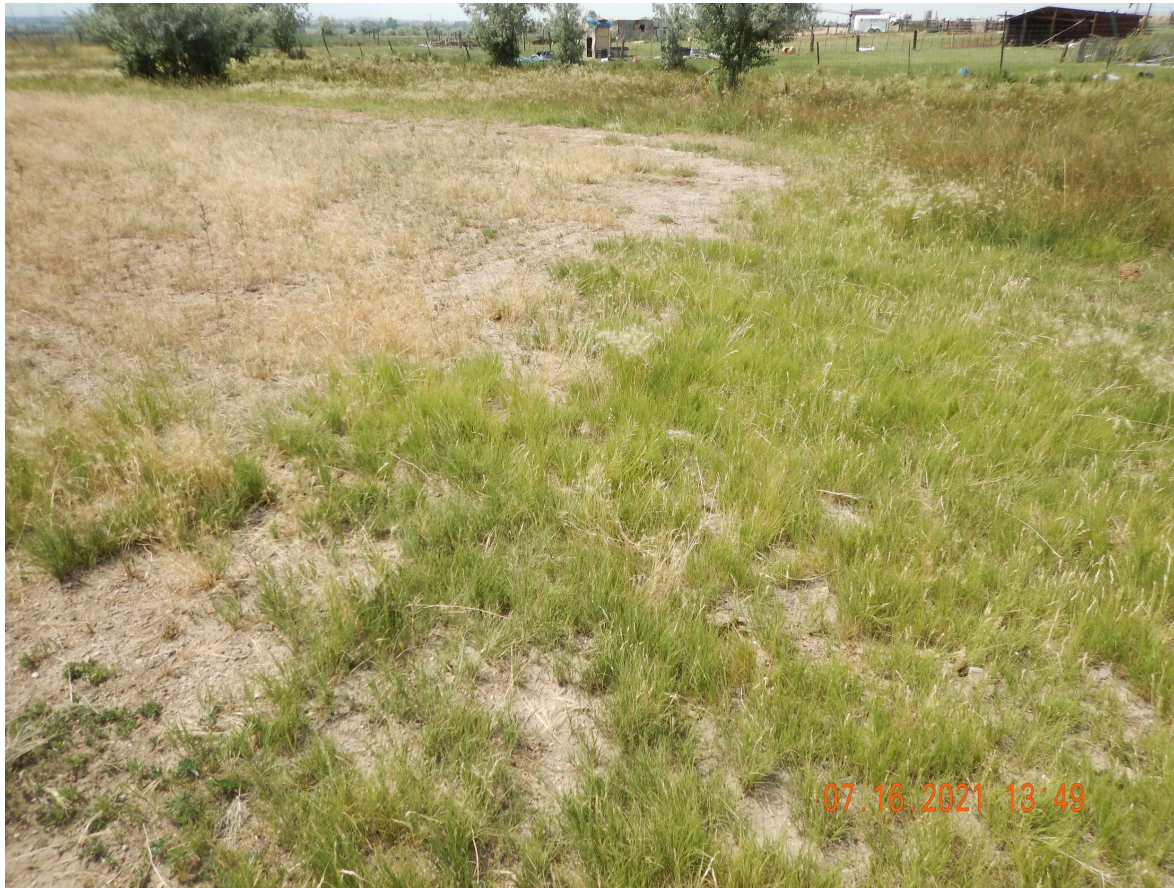
Photo 3. Photo taken from the eastern location, facing West. See comments under Photo 2.

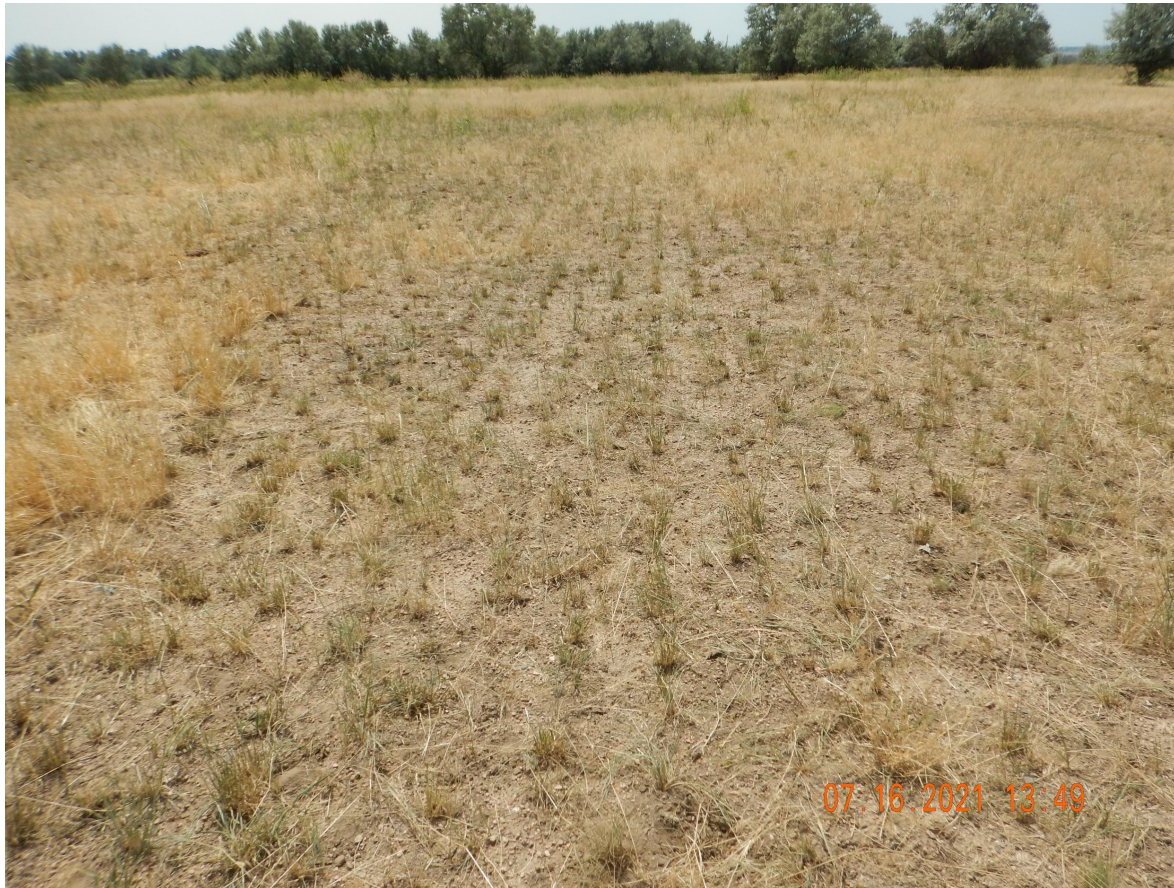
Photo 4. Photo taken from the central location, facing Southwest. See comments under Photo 2.

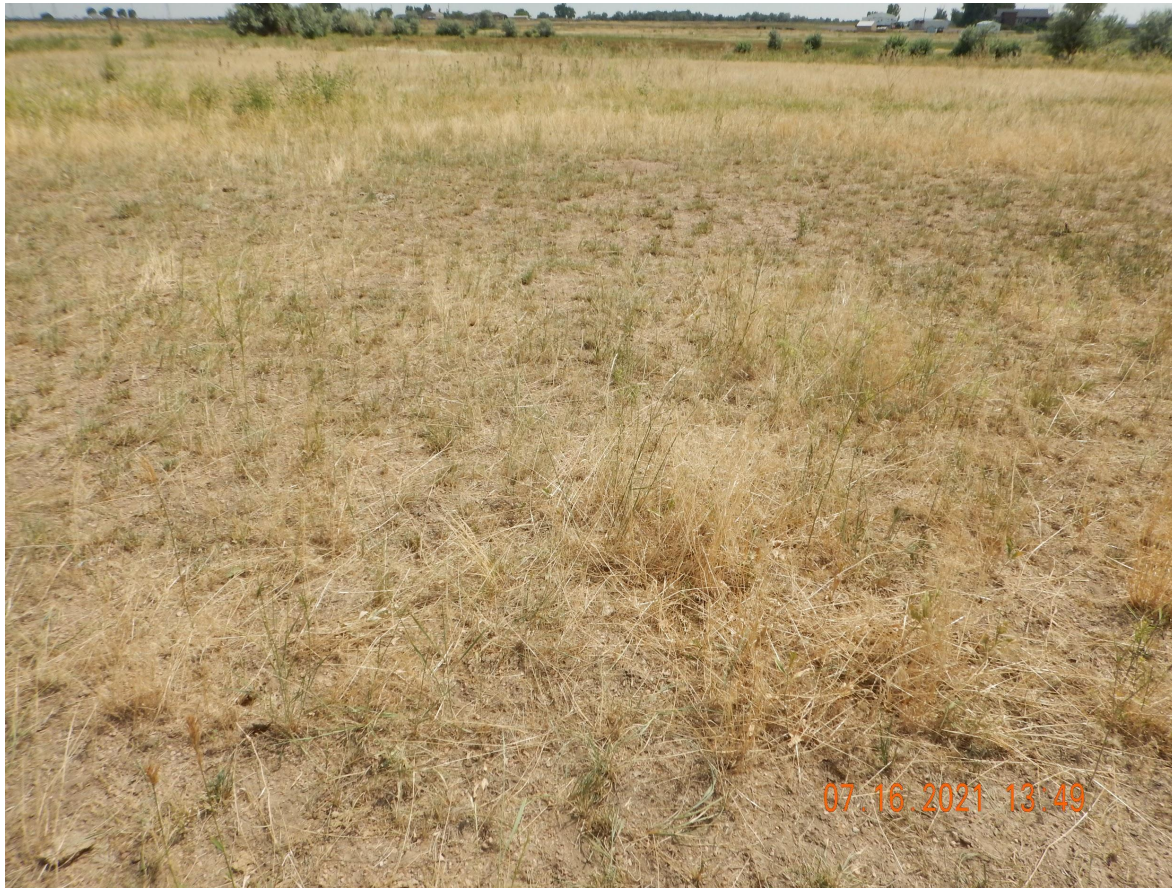
Photo 5. Photo taken from the central location, facing South. See comments under Photo 2.
