Inspection Photos

Location Name:TEP ROCKY MOUNTAIN LLC FEDERAL-66S96W /36NWNW

Location ID: 335189

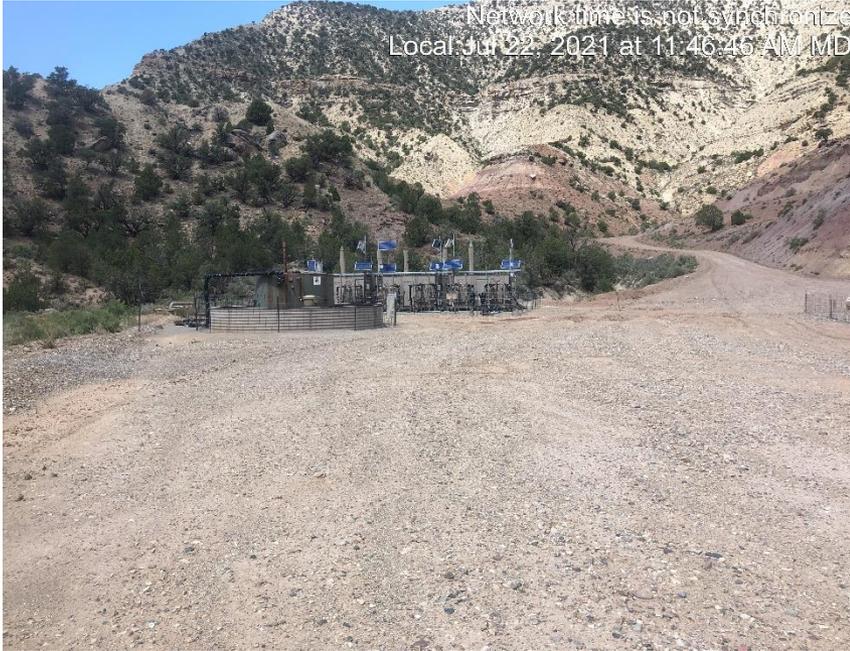
Photo #4535 from entrance to location.

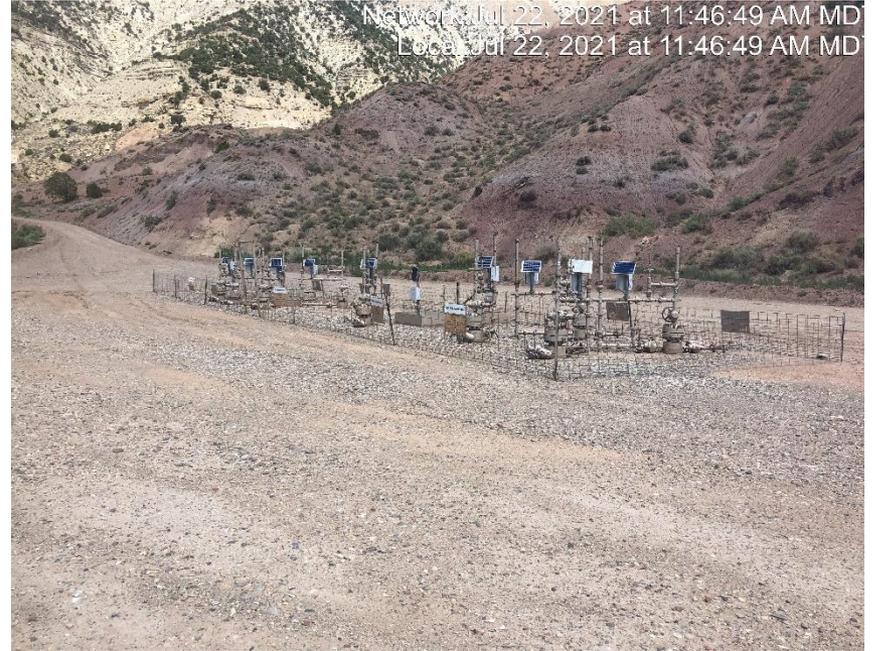
Photo #4536 from entrance to location.

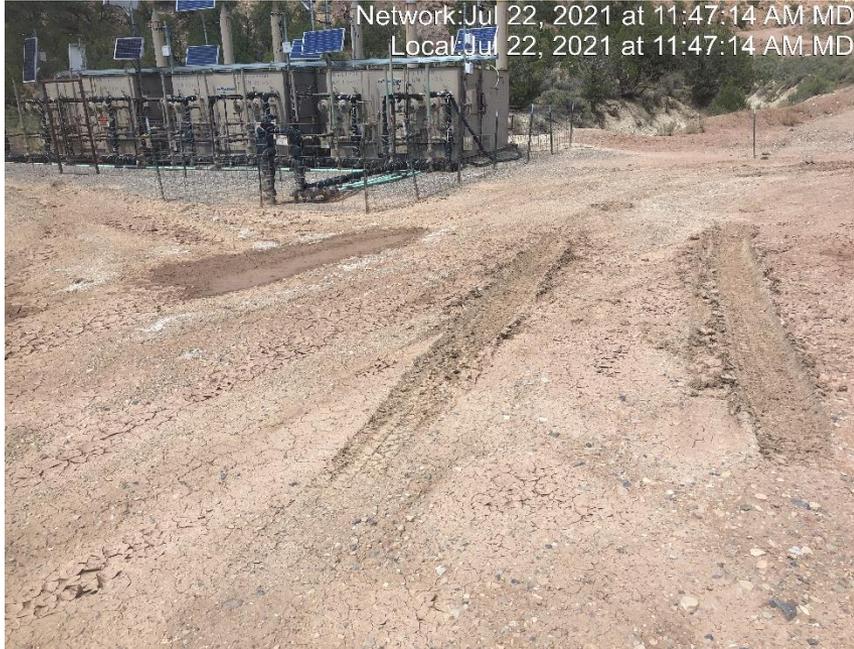
Photo #4537 Location lacks stabilization.

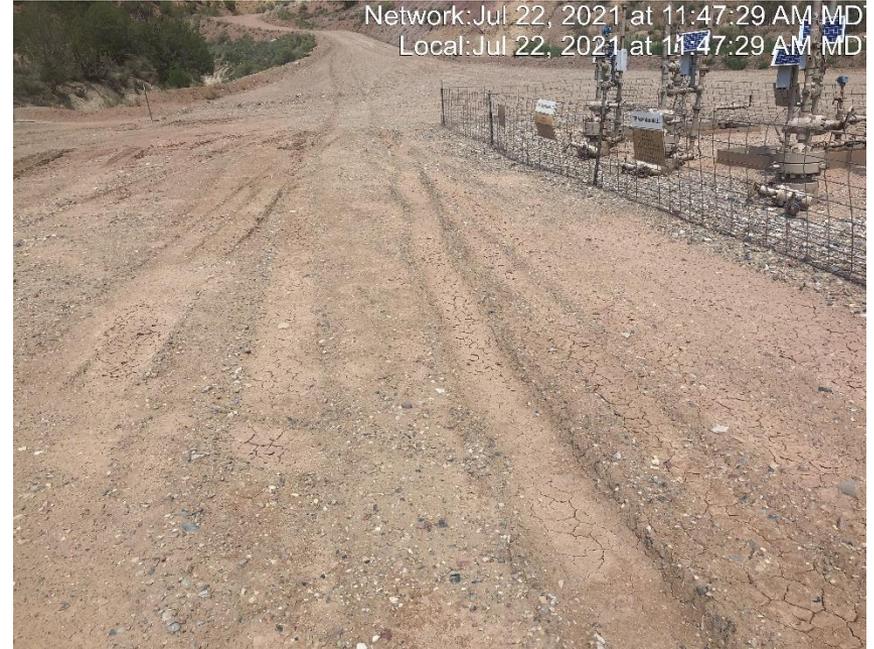
Photo #4538 Location lacks stabilization.

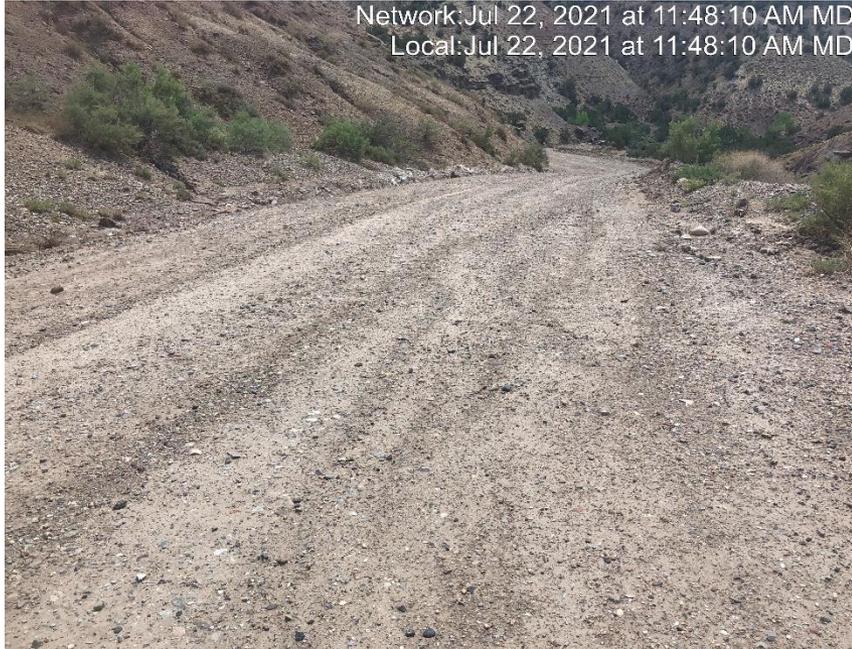
Photo #4539 No form of tracking BMP located at entrance to location.

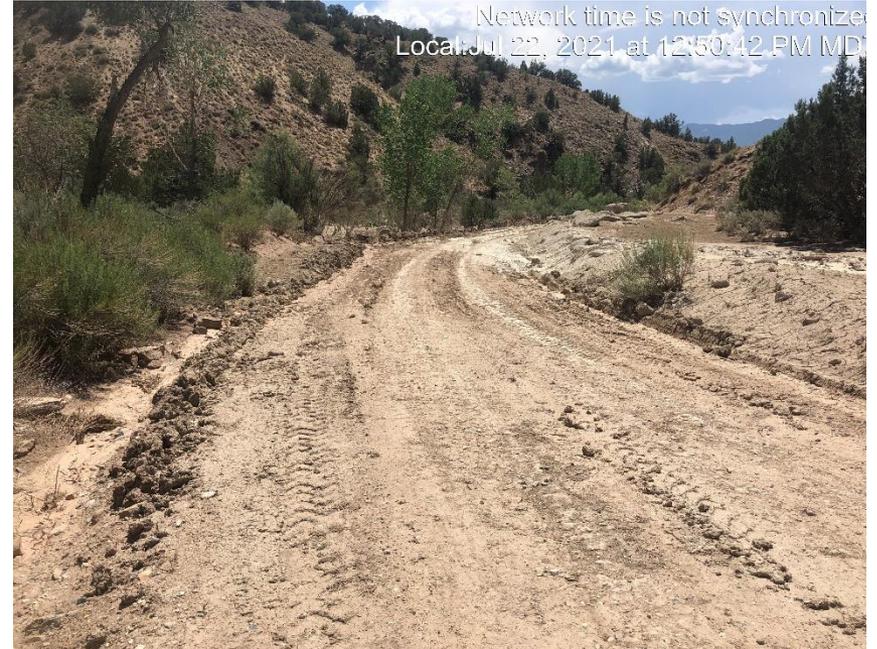
Photo #4540 Sediment and debris that over ran the access road.

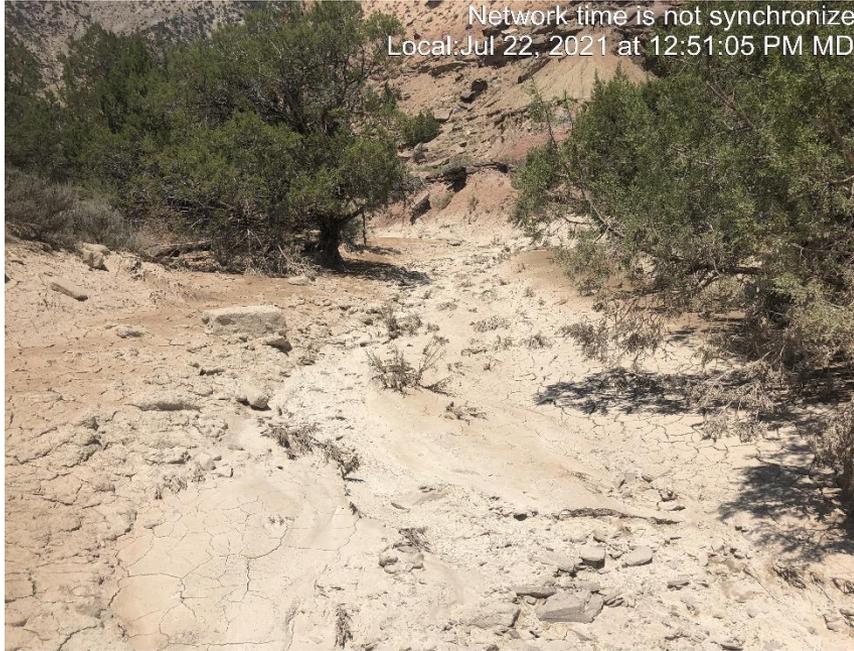
Photo #4541 Drainage that intersects access road.

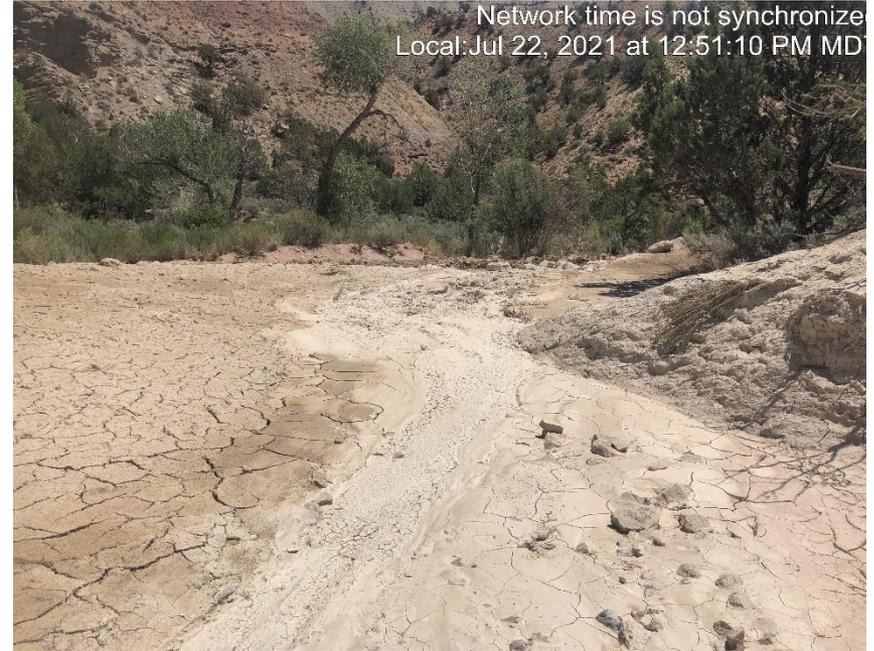
Photo #4542 Drainage that intersects access road.

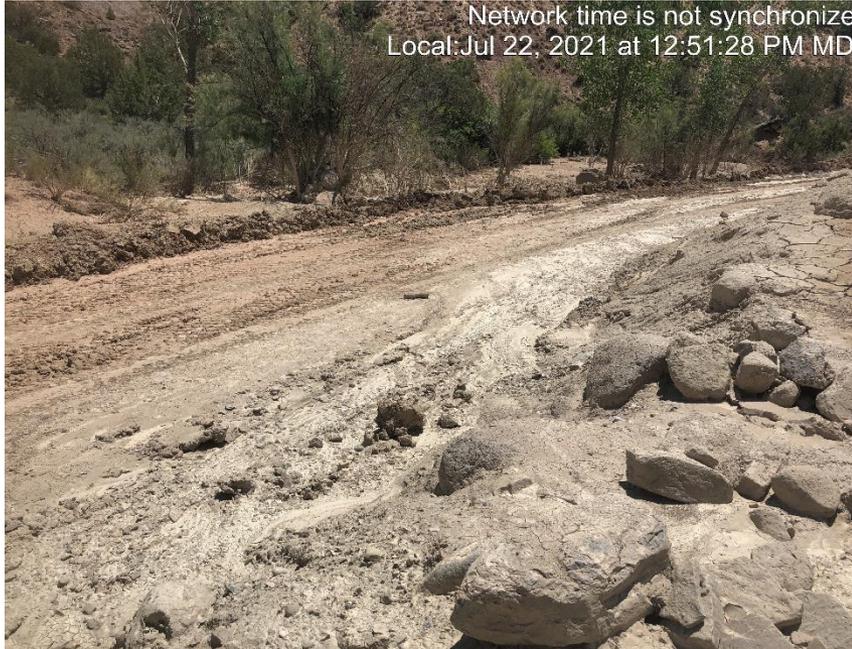
Photo #4543 Sediment and debris that over ran the access road.

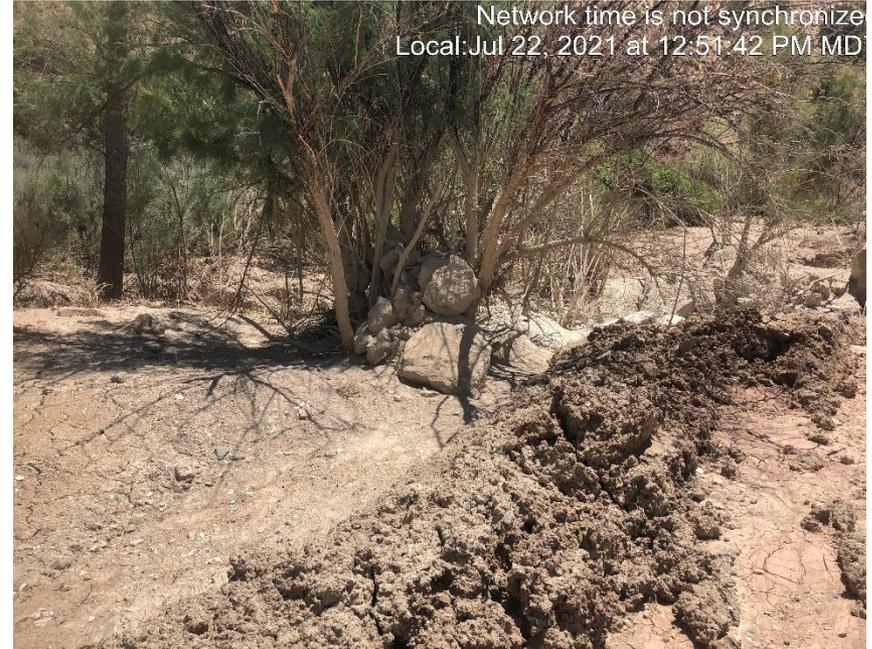
Photo #4544 Sediment choking off vegetation.

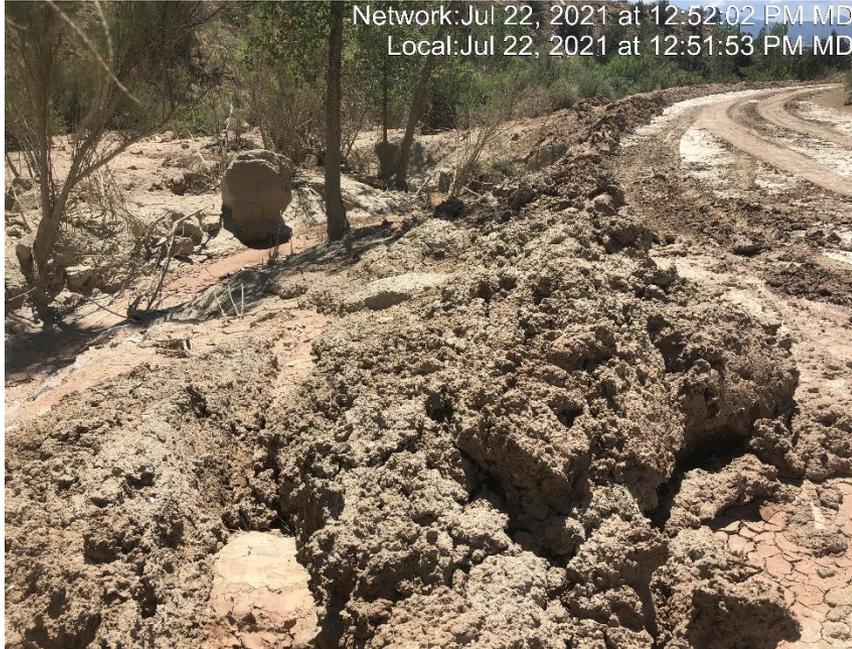
Photo #4545 Sediment appears to have been bladed to the side of access road.

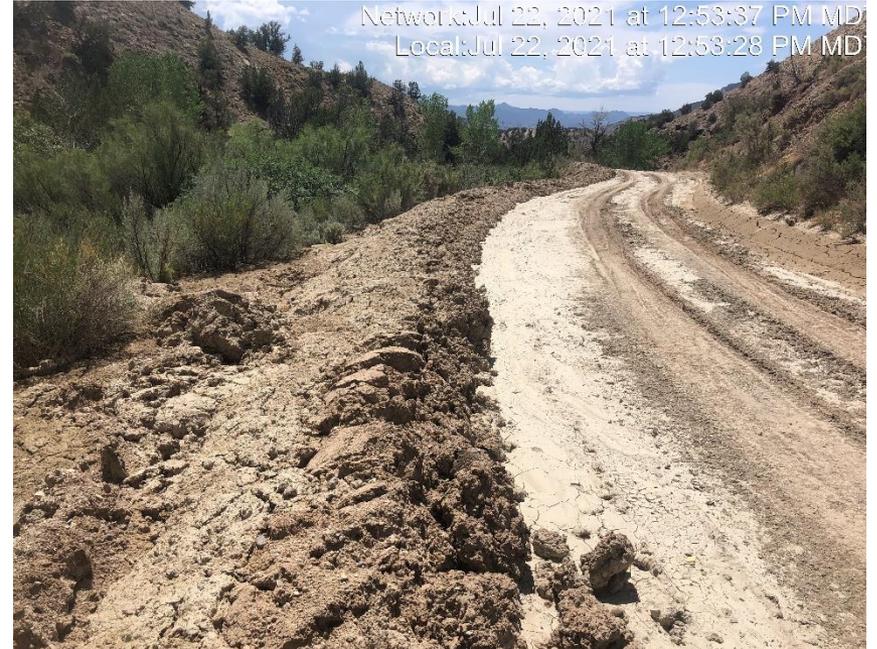
Photo #4546 Sediment appears to have been bladed to the side of access road.

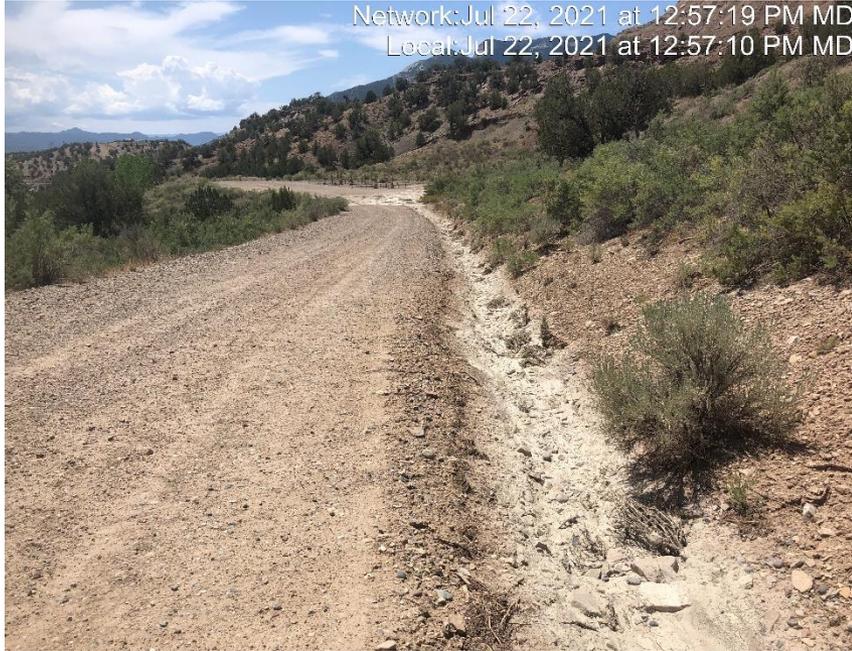
Photo #4549 Ditch that sediment was transported down and on to location #335096.

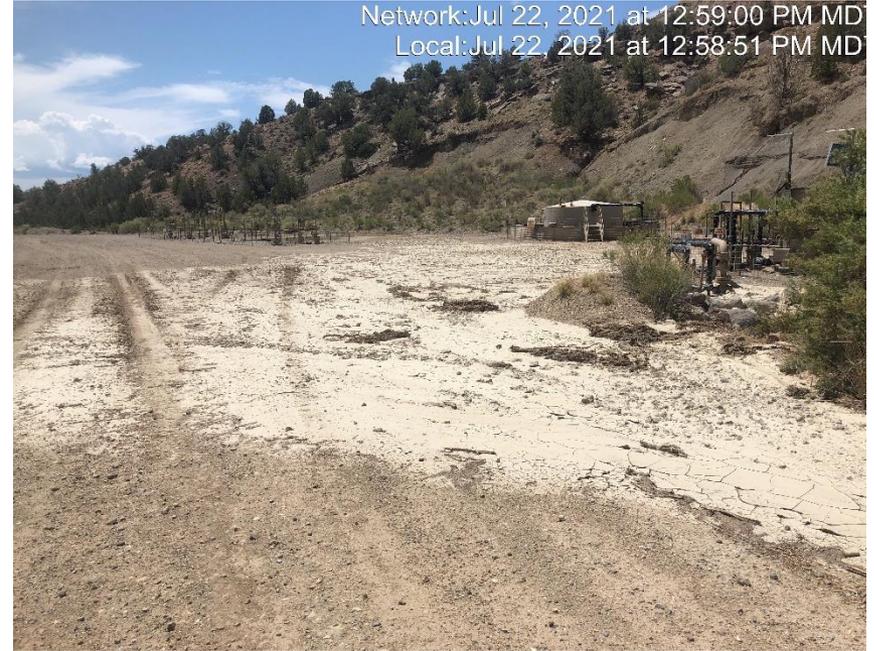
Photo #4550 Sediment and debris encroaching on production equipment.

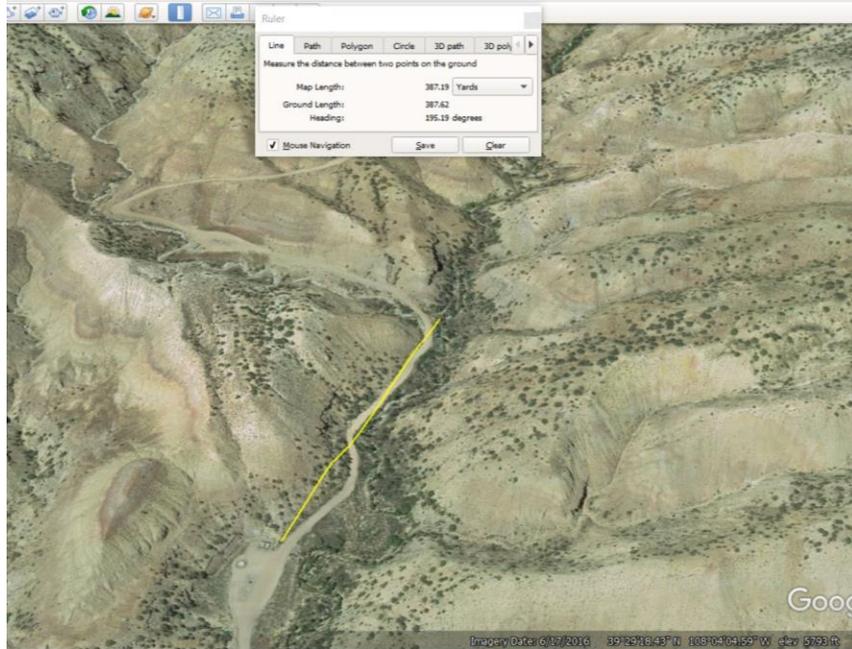
Sediment has been transported approximately 380 yards on to location #335096.
